Re: Owner Opposition to Historic Zoning/Designation – 907 E. 13th St.

STRUCTURAL ASSESSMENT REPORT

FEI Project Number: 1710
Site Address: 907 E. 13th St.
Austin, TX

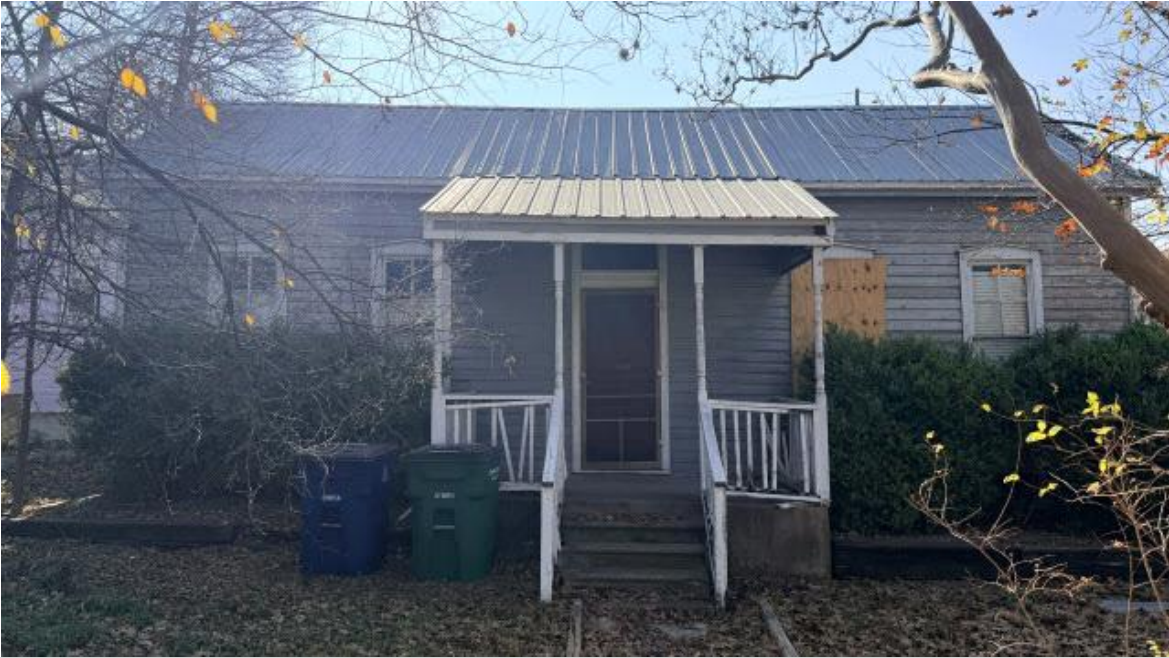
Photo 1

- Sagging was observed across all roof slopes on both the main structure and the addition (see Photographs #1 through #3).
- Deterioration of the foundation cover was observed around the perimeter of the structure (see Photograph #5).

During the exterior inspection, pronounced sagging was observed across roof slopes. Excessive deflection of the roof planes is generally indicative of inadequate structural capacity within the roof framing system. Such conditions may result from original design or construction deficiencies, long-term deterioration associated with prolonged environmental exposure, or acute loading events such as wind or snow.

The observed sagging is considered symptomatic of underlying structural deficiencies that adversely affect the intended load path and overall stability of the roof system. In addition, evidence suggests prolonged roof leakage, which has likely contributed to deterioration of structural framing members. As a result, the roof system does not appear to be performing as intended, and corrective measures are required to restore structural integrity and compliance with applicable building codes and safety standards.

Overview of the front (north) elevation.

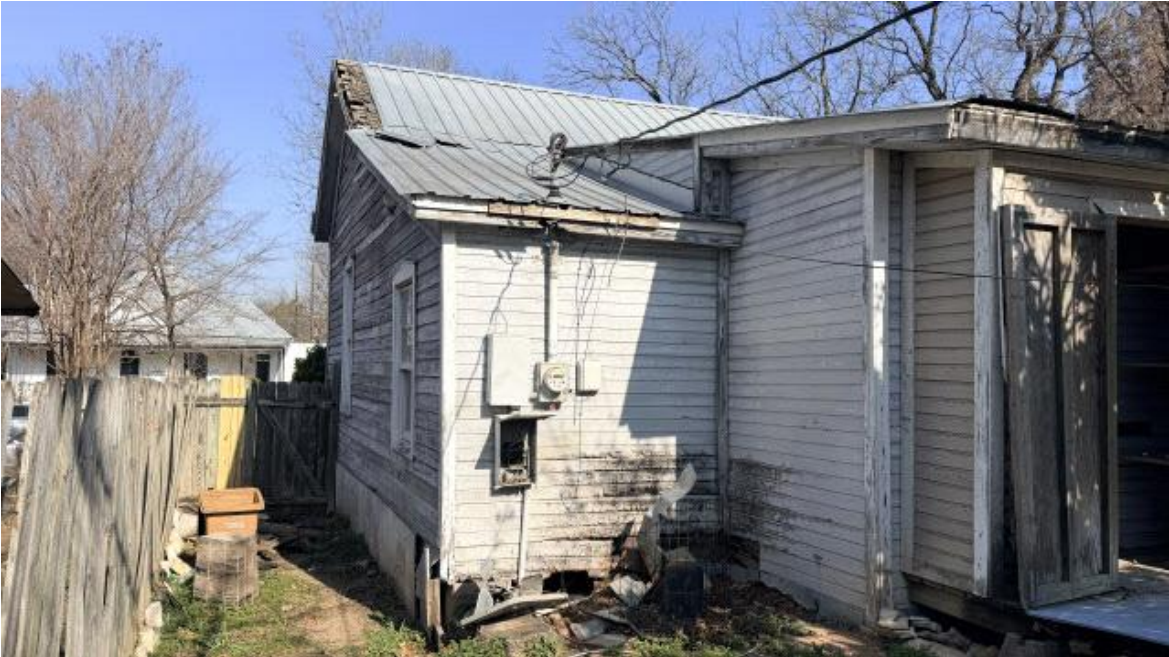
Photo 2

Overview of the right (west) elevation.

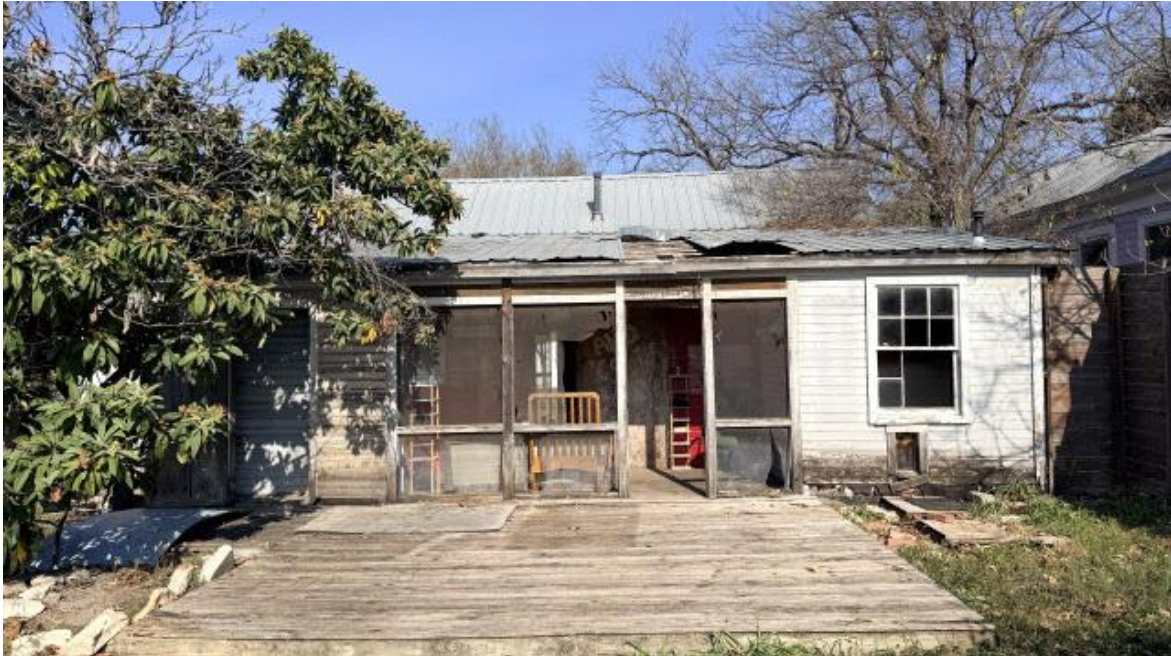
Photo 3

Overview of the rear (south) elevation.

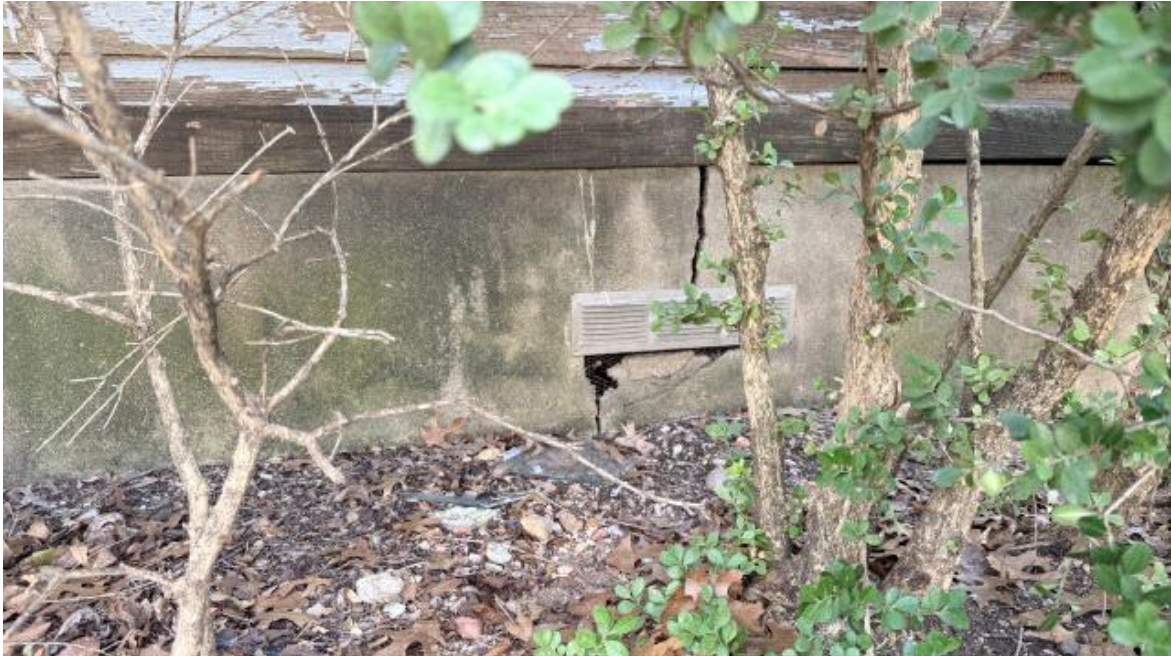
Photo 5

Exterior view showing cracked concrete and deterioration of the foundation cover.

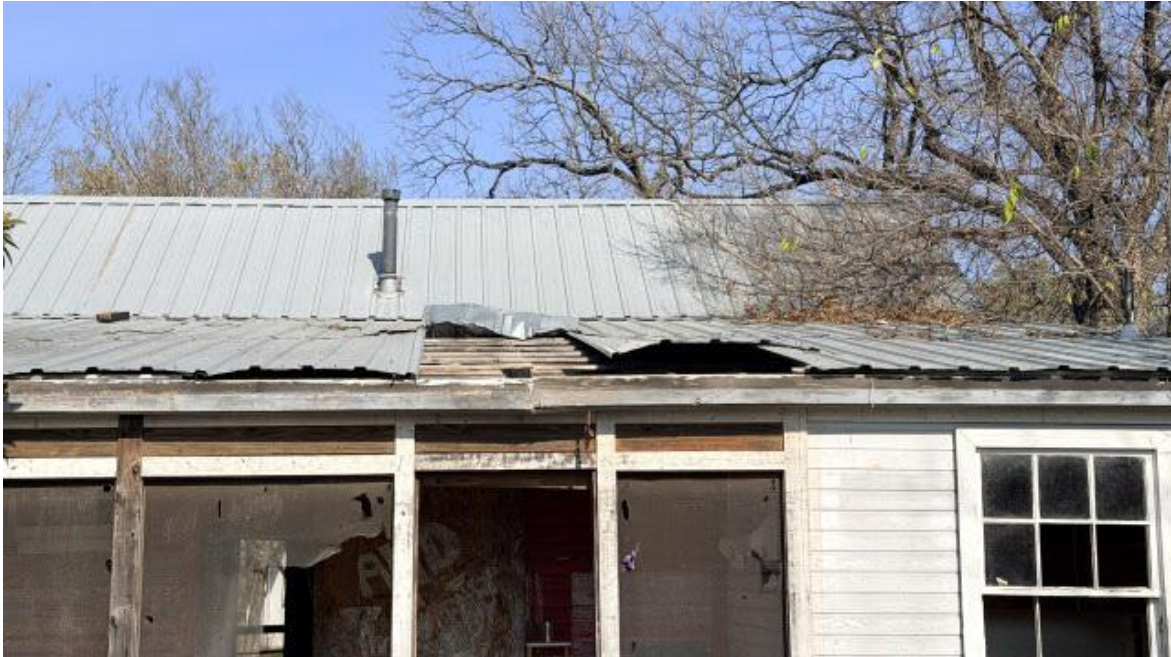
Photo 6

- Detached, peeled-back, and missing roof panels were documented (see Photographs #6 and #7).
- Evidence of prior fire-related damage was observed (see Photographs #8 and #9).

Roof view. Detached and peeled roof panels observed, consistent with wind-related uplift from an elevated wind event.

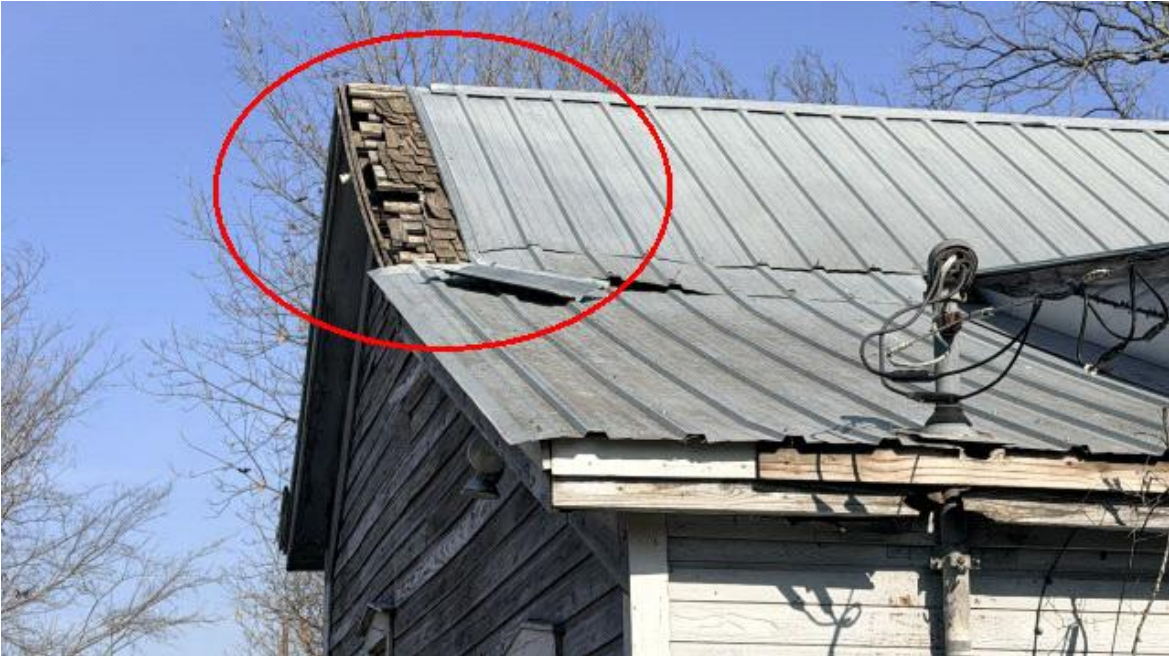
Photo 7

Roof view. Detached and missing roof panels observed, consistent with wind-related uplift from an elevated wind event.

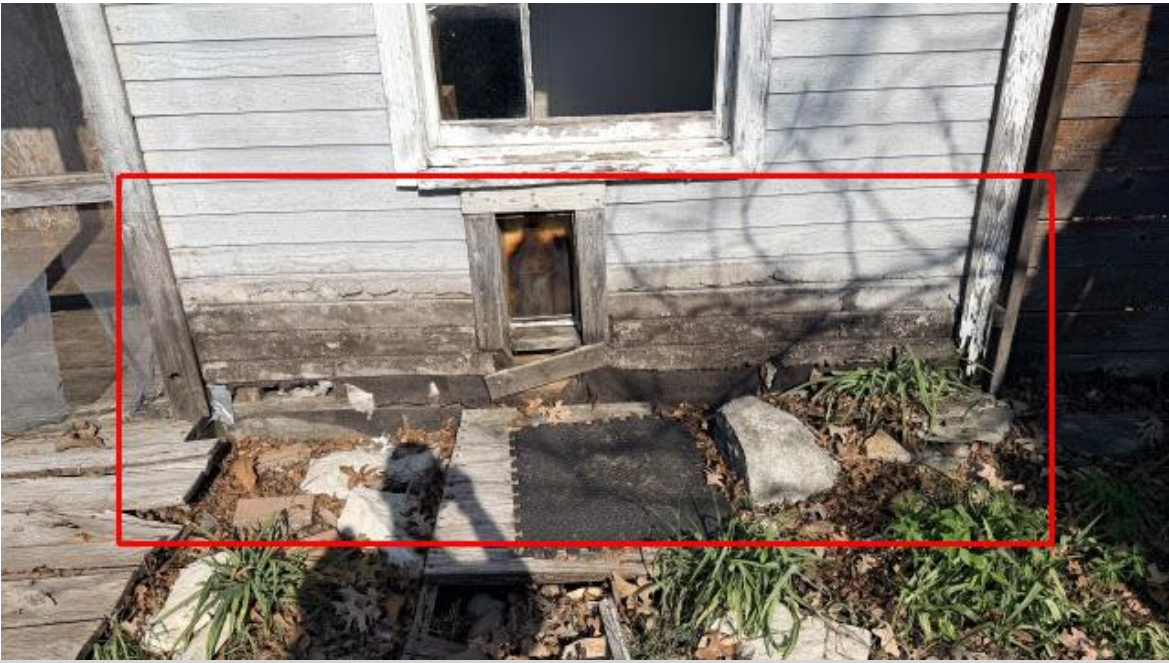
Photo 8

Exterior view. Evidence of prior fire-related damage observed.

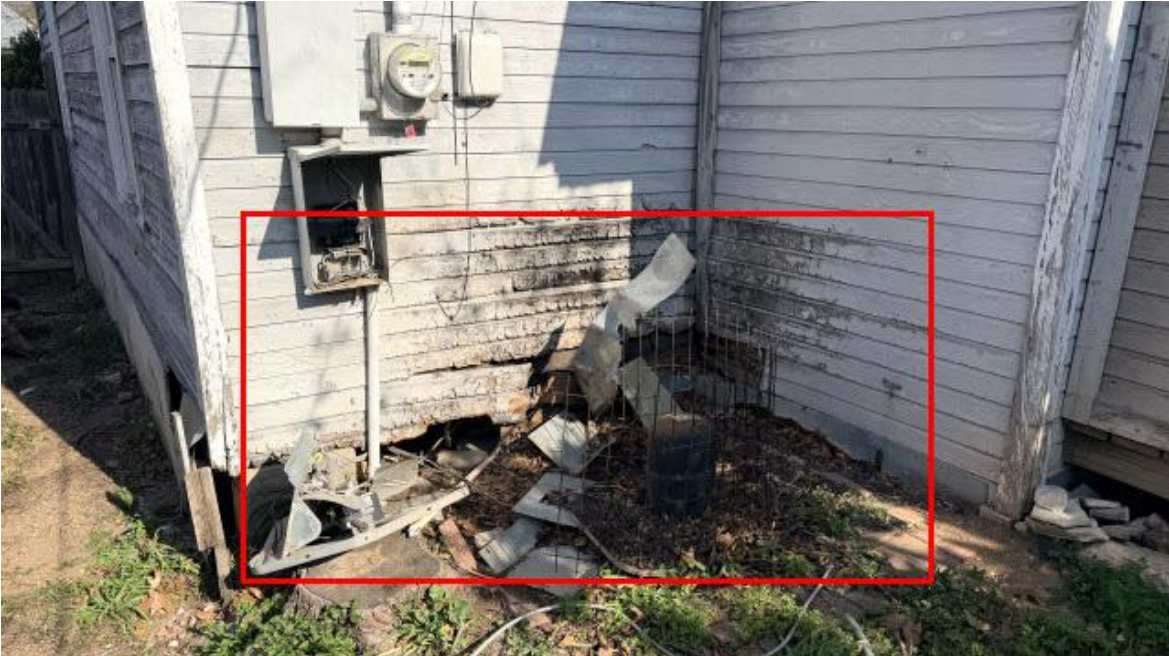
Photo 9

Exterior view. Evidence of prior fire-related damage observed.

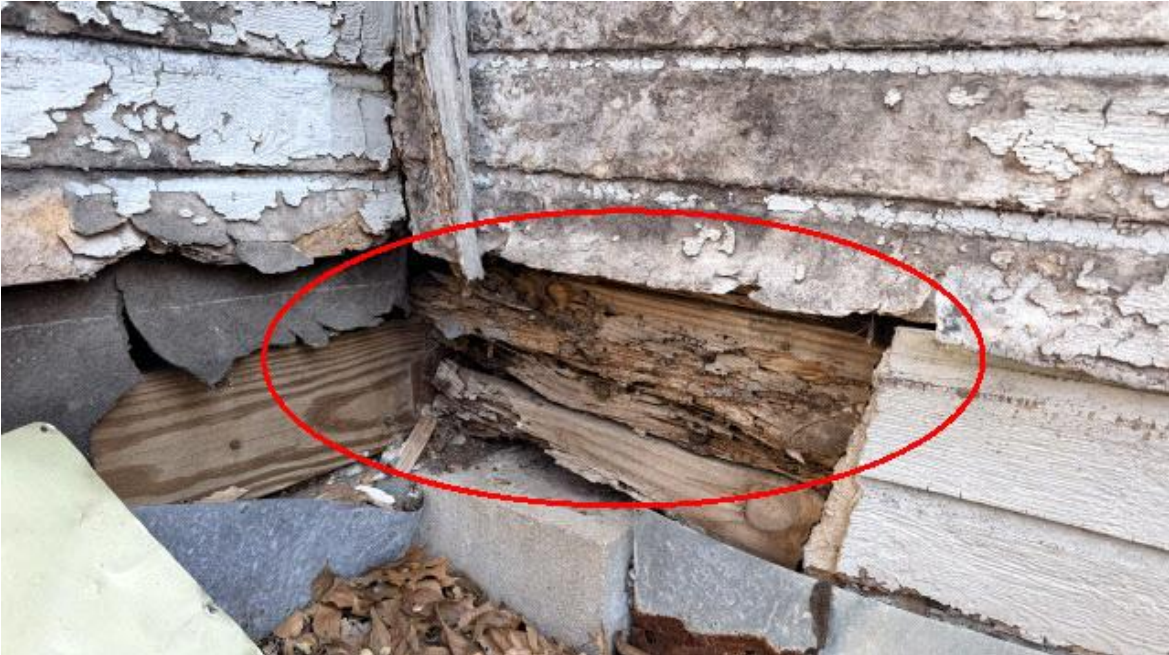
Photo 10

- Advanced deterioration was documented along the perimeter foundation beam (see Photograph #10).
- Advanced wood deterioration was observed at wall-to-ceiling, and wall-to-floor framing along exterior wall locations (see Photographs #13, through #17, and #24).

Exterior view showing advanced deterioration of the foundation beam.

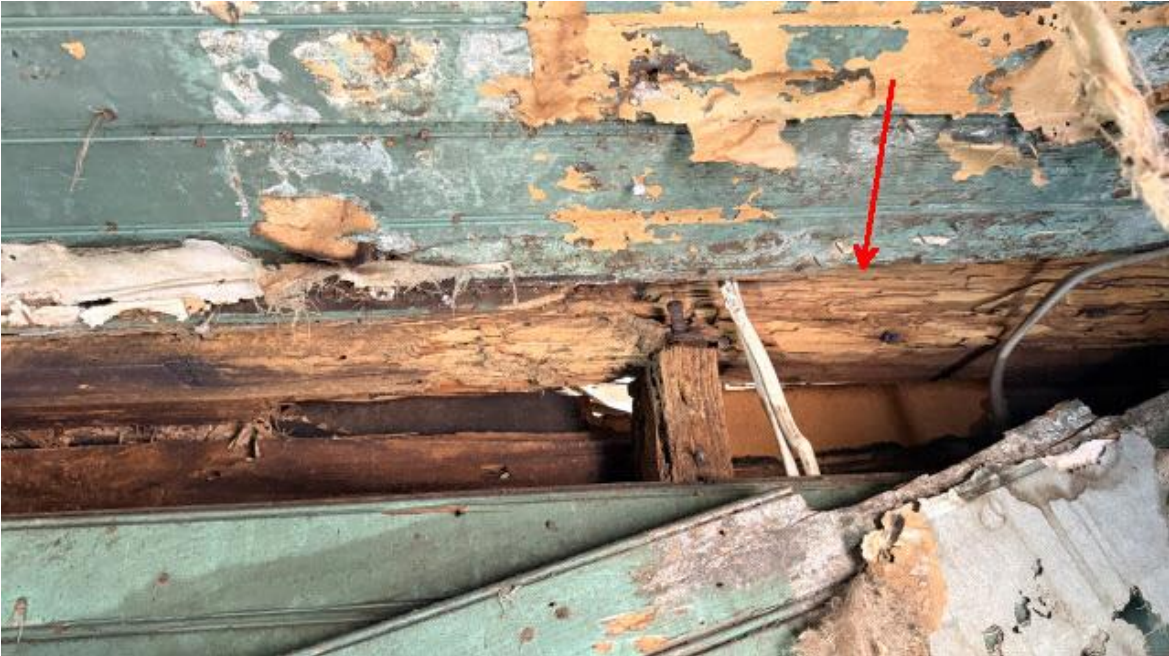
Photo 13

Significant structural deficiencies were observed throughout the building envelope and primary framing systems. The ceiling and wall framing across the residence, and particularly within the addition, exhibited advanced wood decay and deterioration consistent with prolonged moisture exposure. Evidence of chronic moisture intrusion included material degradation, loss of cross-sectional capacity, and conditions conducive to biological growth. Additionally, existing structural attachment and connection details were observed to be substandard and inadequate, contributing to ineffective load transfer and a reduction in overall structural integrity.

View of wall-to-ceiling framing showing advanced wood deterioration along the exterior wall.

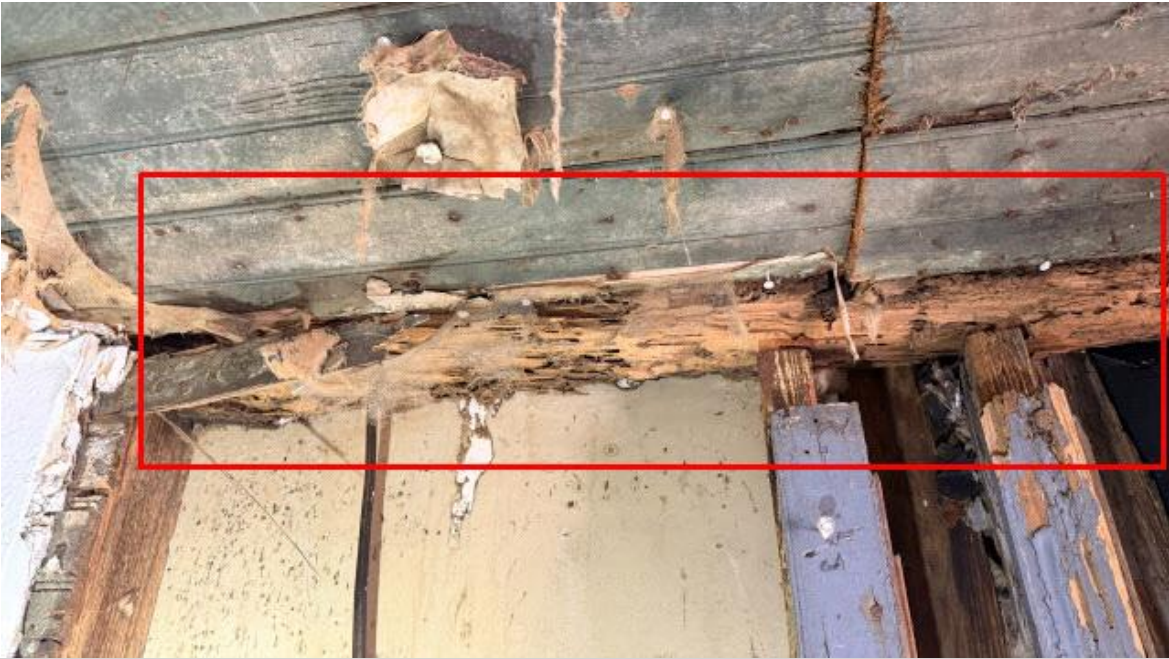
Photo 14

View of wall-to-ceiling framing showing advanced wood deterioration along the exterior wall.

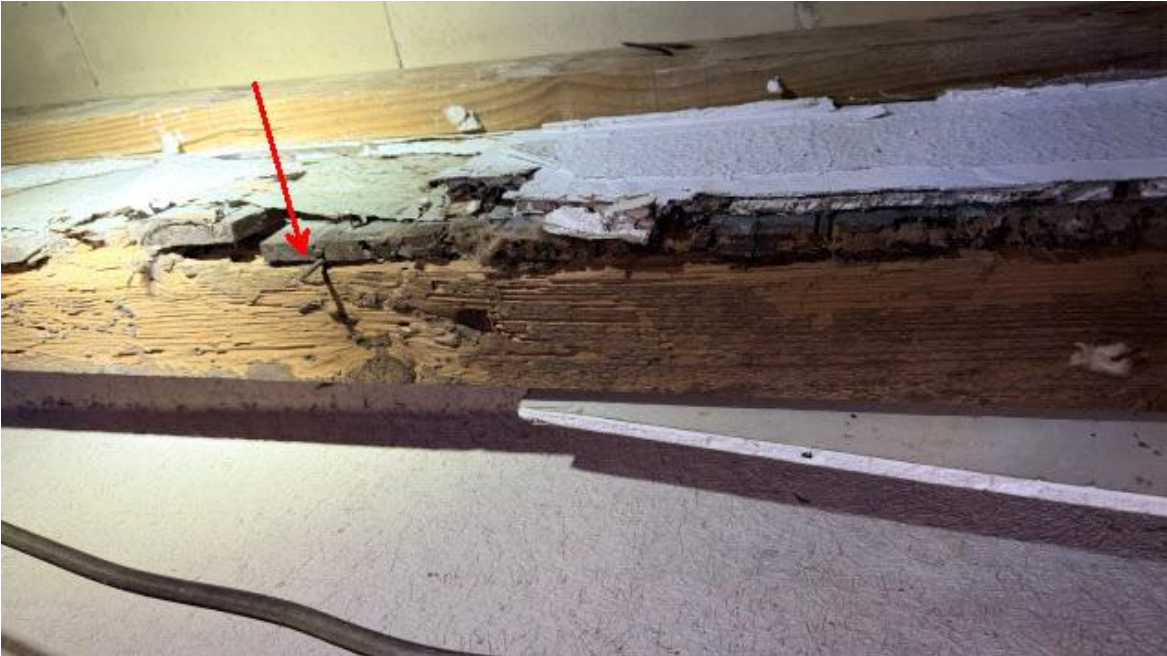
Photo 15

View of wall-to-ceiling framing showing advanced wood deterioration along the exterior wall.

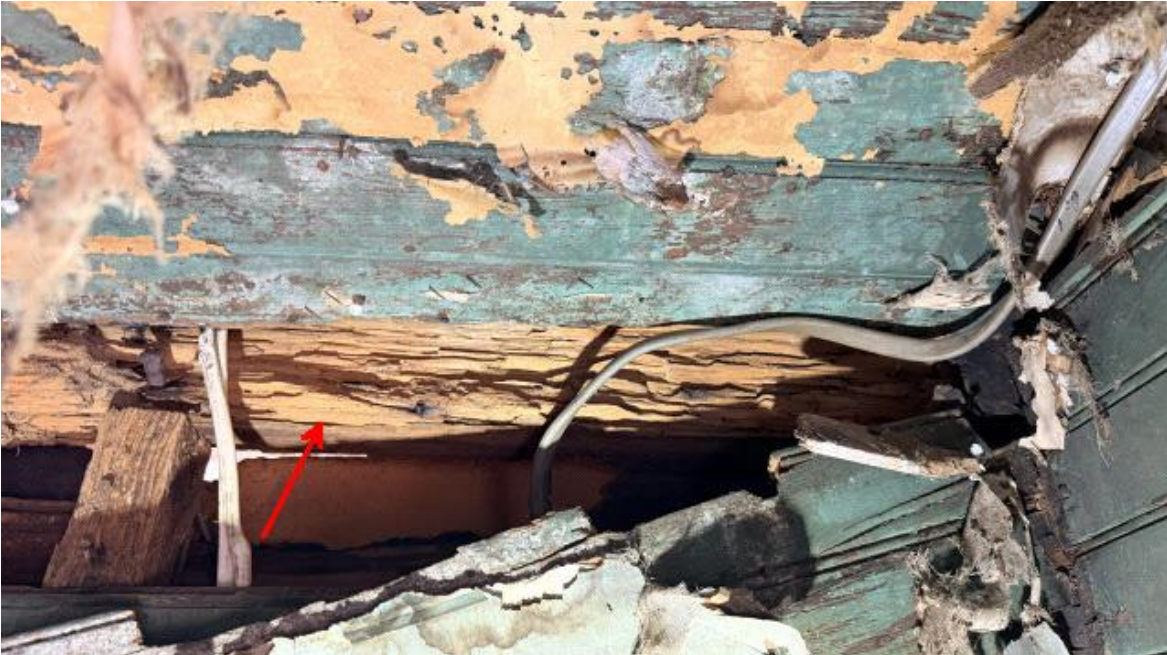
Photo 16

View of wall-to-ceiling framing showing advanced wood deterioration along the exterior wall.

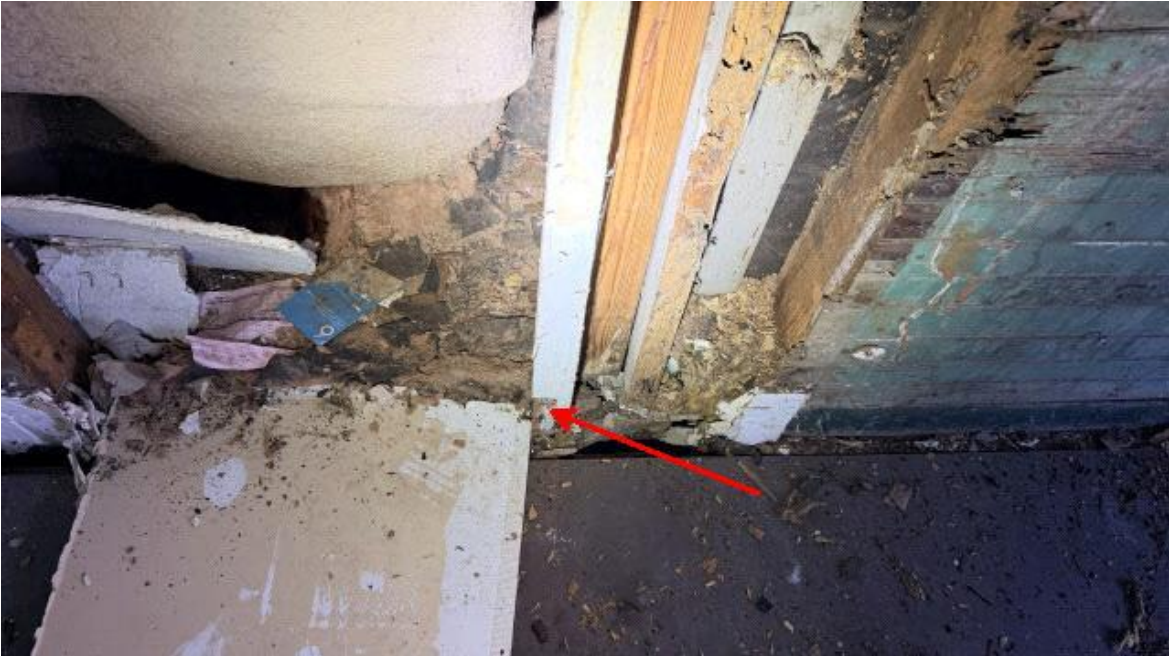
Photo 17

View of wall-to-floor framing showing advanced wood deterioration along the exterior wall.

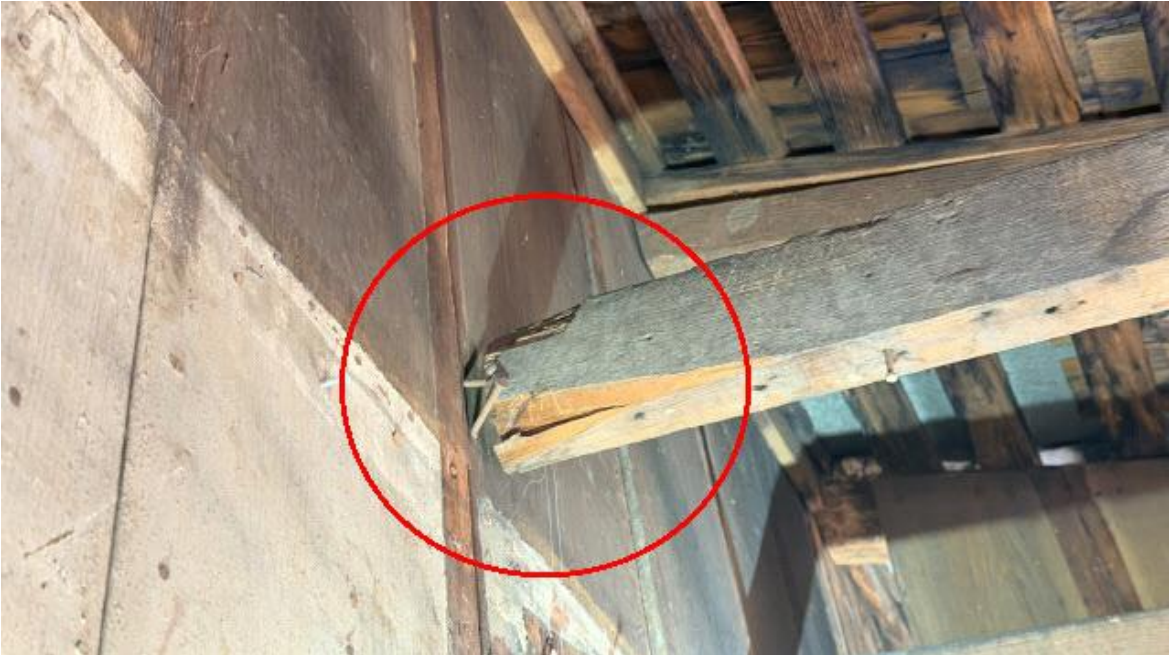
Photo 18

- Improper attachment conditions were observed at wall-to-ceiling connections at multiple locations (see Photographs #18 through #23).
- Efflorescence, likely resulting from prolonged water intrusion through the roof, was observed at wall-to-ceiling junctions and within the attic space (see Photographs #21, #22, and #25).

View of wall-to-ceiling framing showing improper attachment conditions.

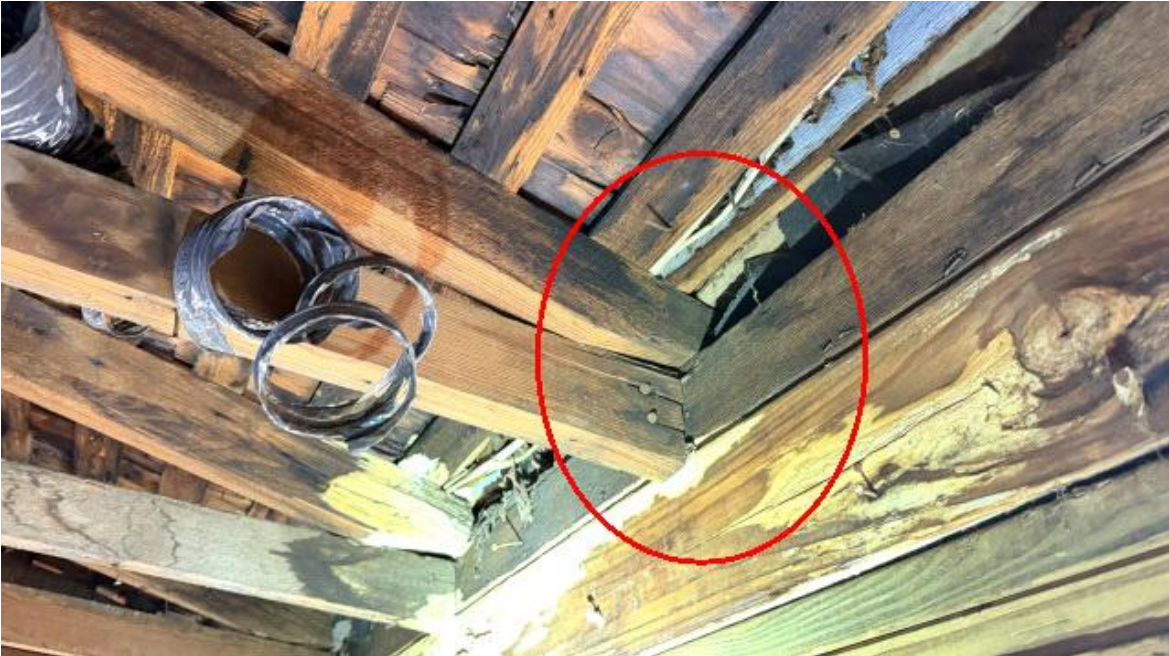
Photo 19

View of wall-to-ceiling framing showing improper attachment conditions.

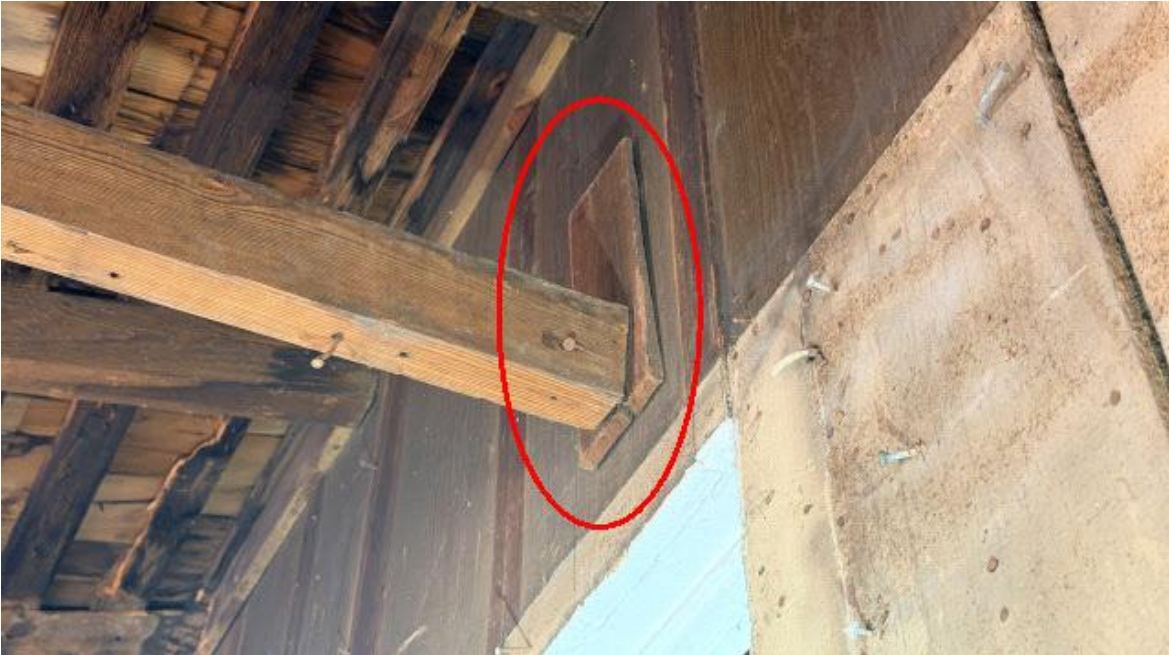
Photo 20

View of wall-to-ceiling framing showing improper attachment conditions.

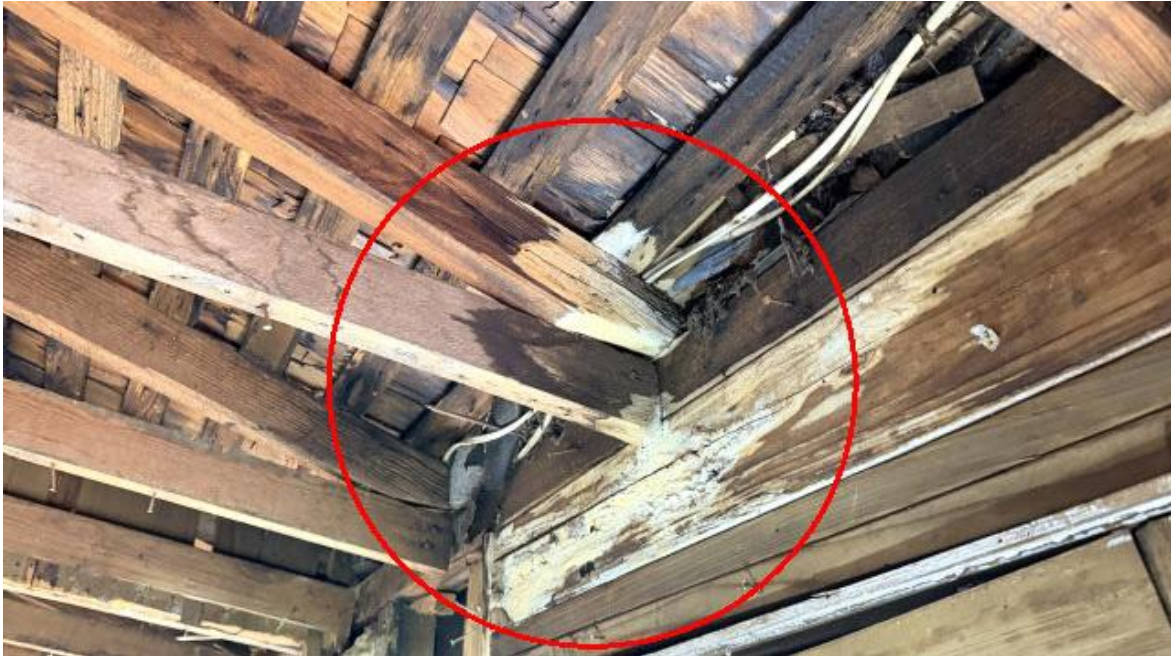
Photo 21

View of wall-to-ceiling framing showing improper attachment conditions.

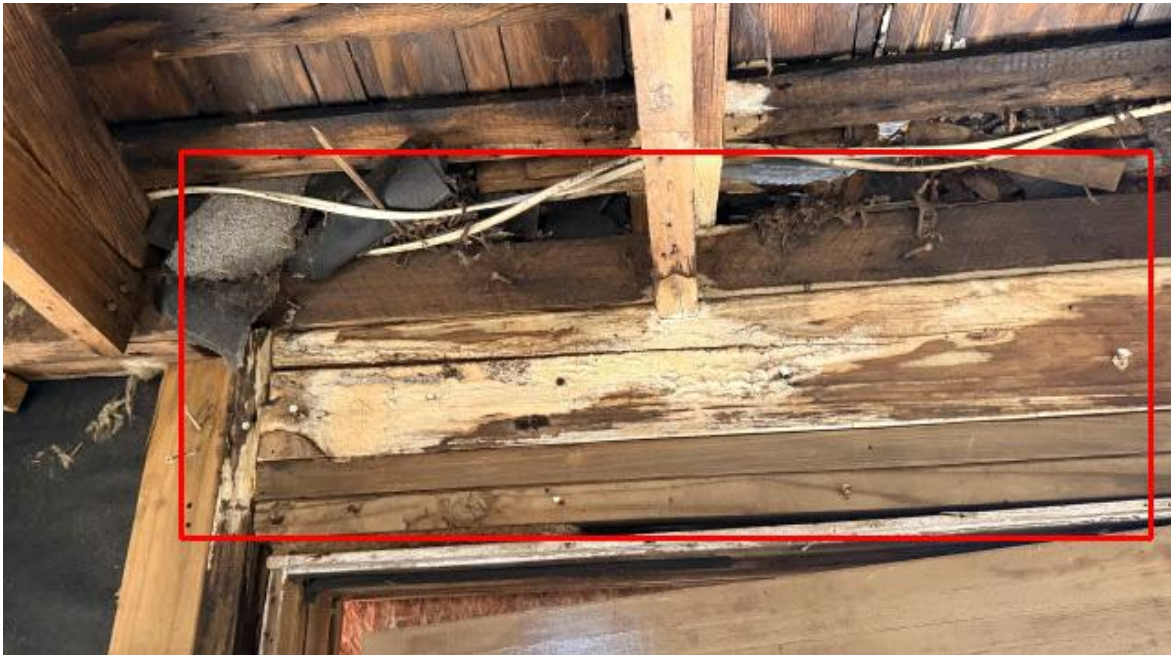
Photo 22

View of wall-to-ceiling framing showing efflorescence, likely resulting from prolonged water intrusion through the roof.

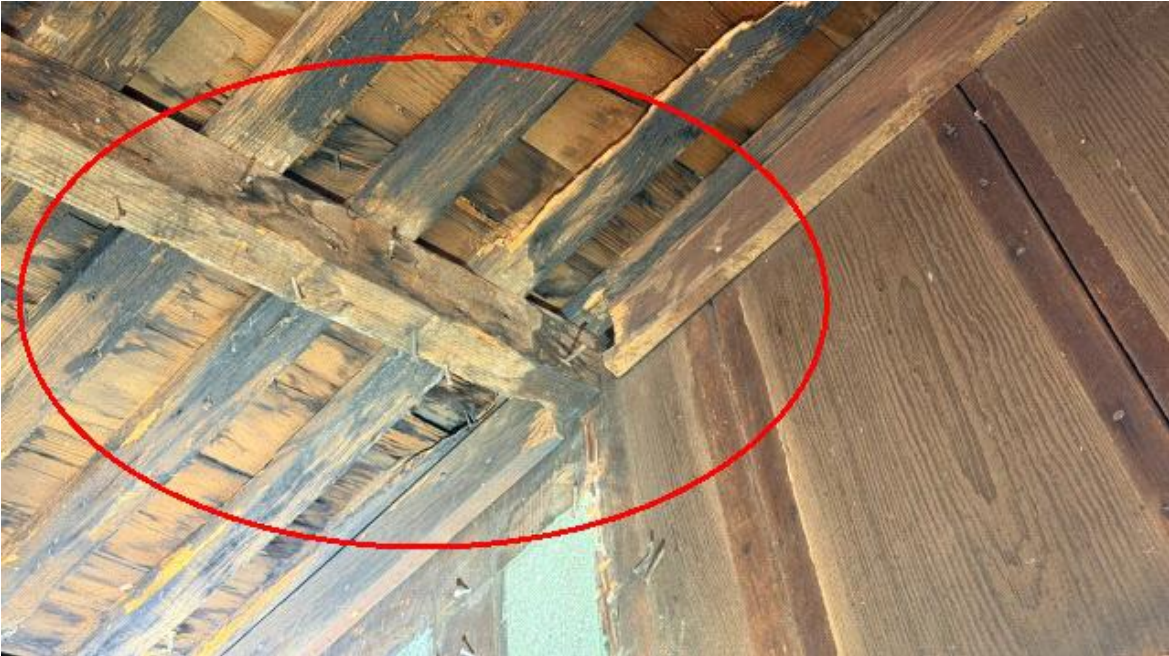
Photo 23

View of wall-to-ceiling framing showing improper attachment and advanced wood deterioration.

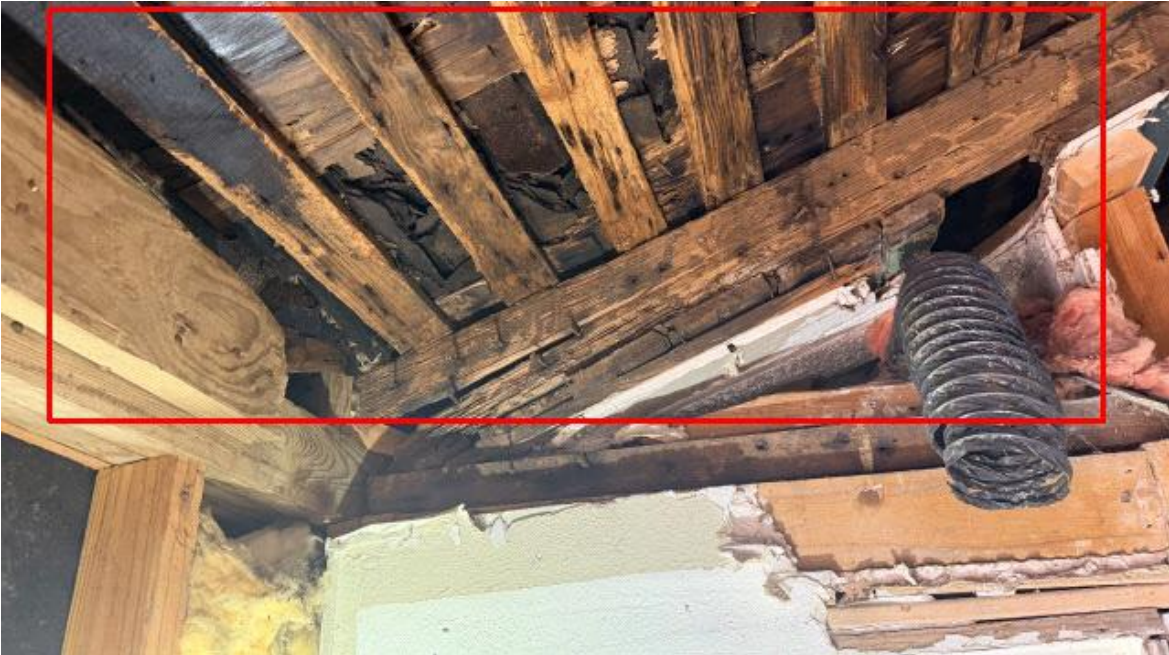
Photo 24

View of wall-to-ceiling framing showing improper attachment and advanced wood deterioration.

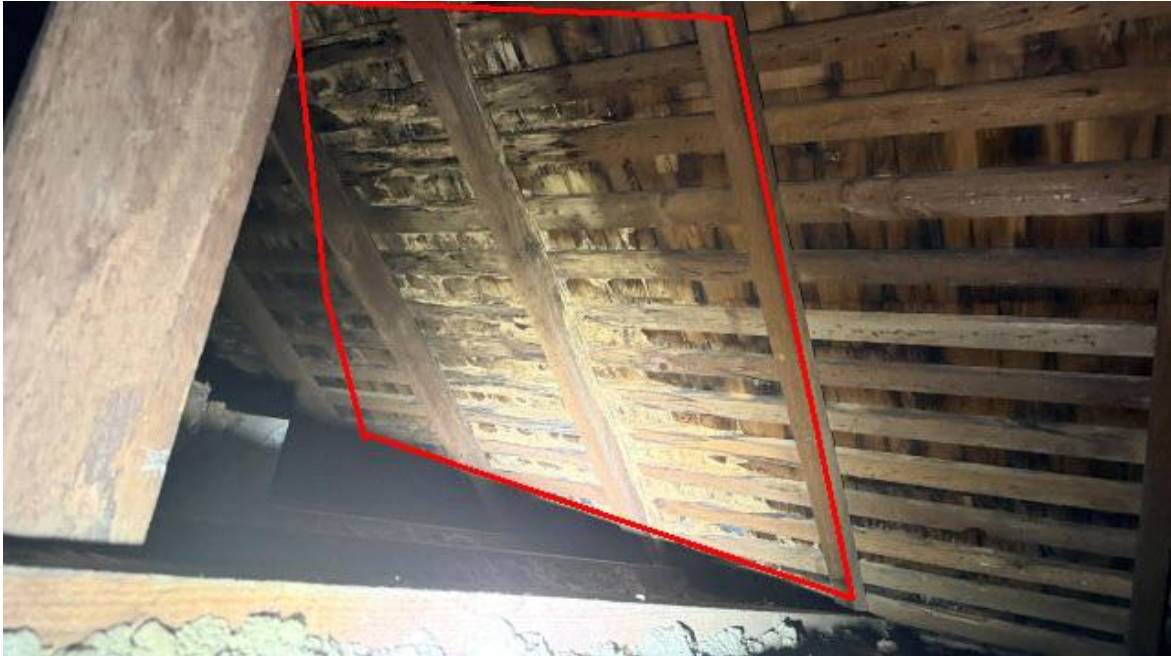
Photo 25

View of attic roof framing showing efflorescence, likely resulting from prolonged water intrusion through the roof.

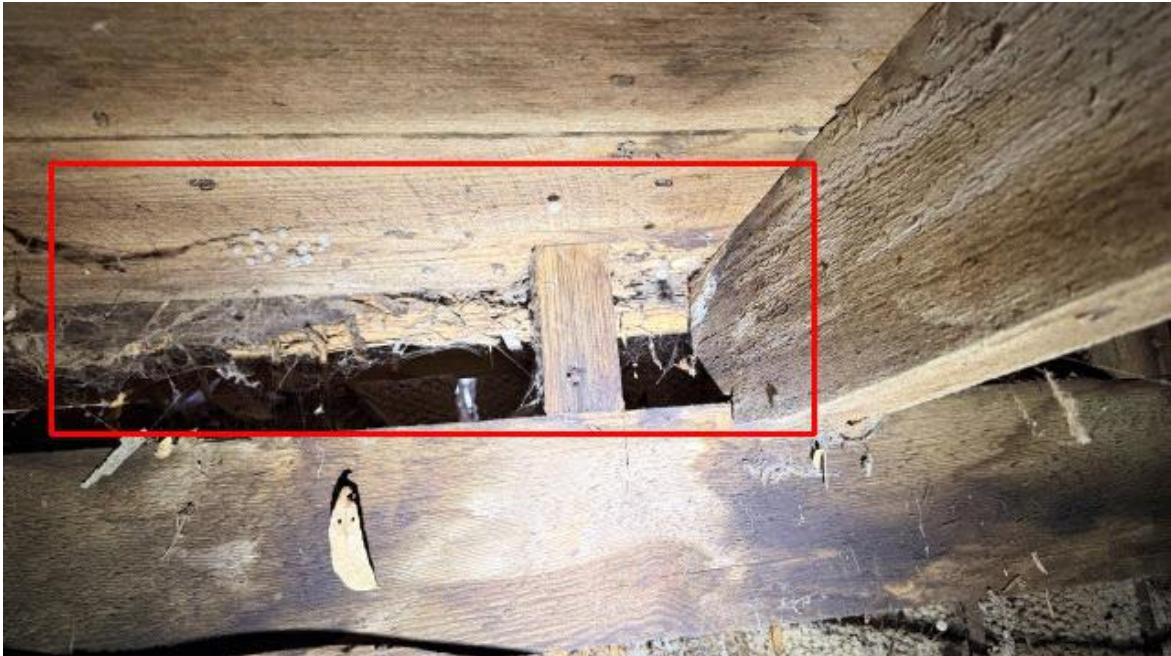
Photo 26

- Advanced wood deterioration and broken structural elements were observed throughout the pier-and-beam foundation system within the crawl space (see Photographs #26 and #31 through #34).

- Widespread wood deterioration, including advanced decay and microbial growth, affecting primary structural members throughout the crawl space.
- Inadequate crawl space ventilation contributing to accelerated deterioration of wood framing components.

Crawl space view showing advanced wood deterioration (typical).

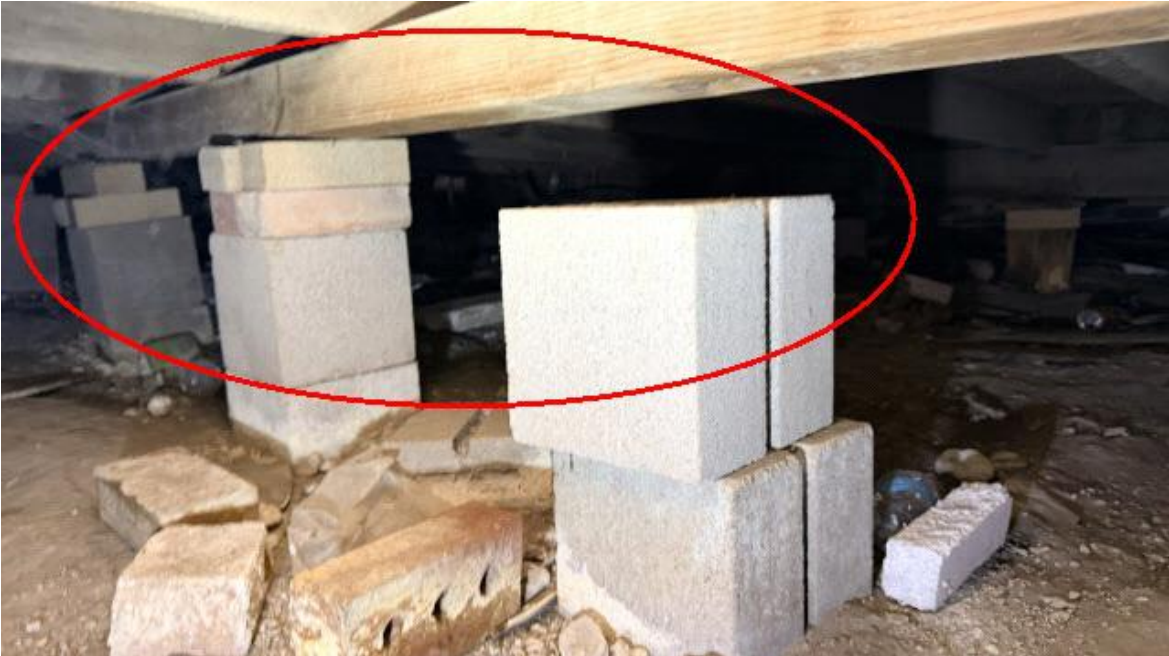
Photo 27

- Substandard footings, evidence of footing settlement, support elements lacking footings, and rotated footings were observed within the foundation system (see Photographs #27 through #31).

Crawl space view showing loose support elements lacking attachment to the framing.

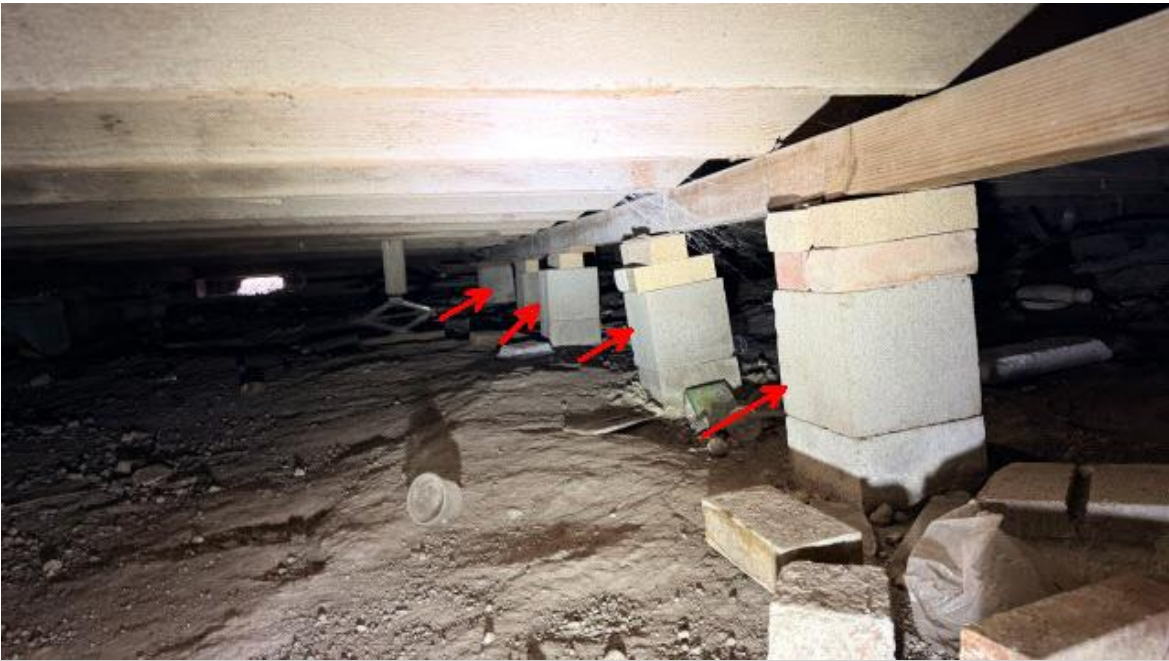
Photo 28

Crawl space view showing loose and rotated support elements lacking footings (typical condition).

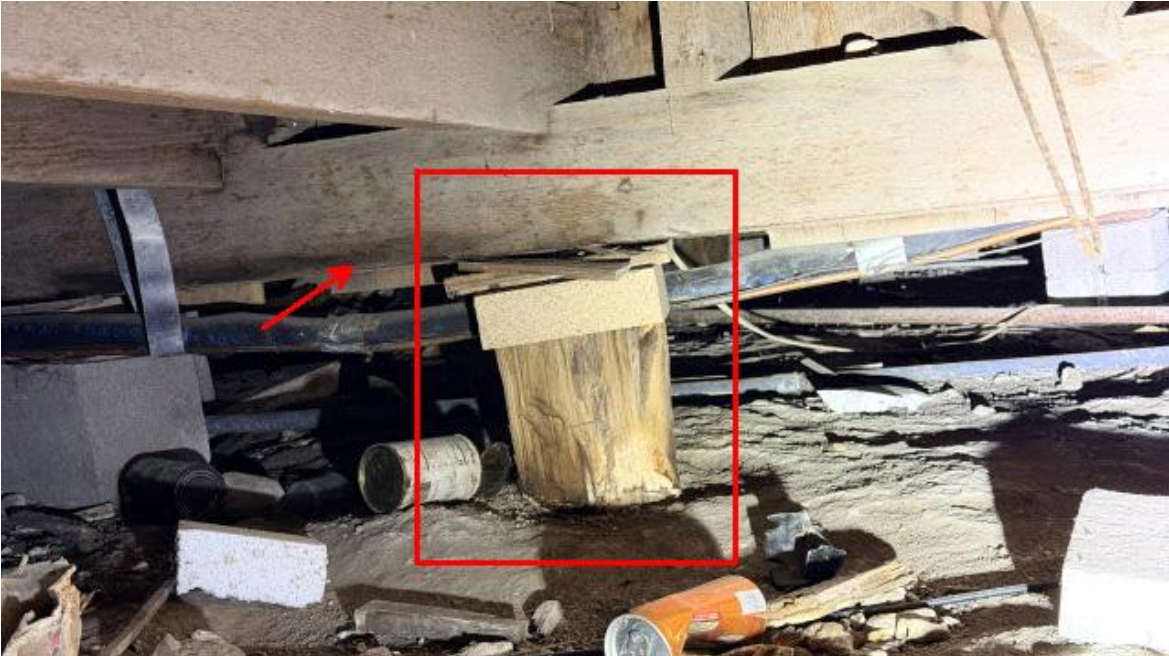
Photo 29

- Improper and substandard footing systems, including the use of tree trunks and concrete masonry units (CMUs) placed directly on native soil without engineered footings, as well as footings that have experienced settlement, rotation, and lateral displacement.

- Rotated, leaning, and structurally compromised support posts and beams, indicating loss of load-bearing capacity and ineffective load transfer to the foundation system.

Crawl space view showing substandard footing and a rotated beam (typical).

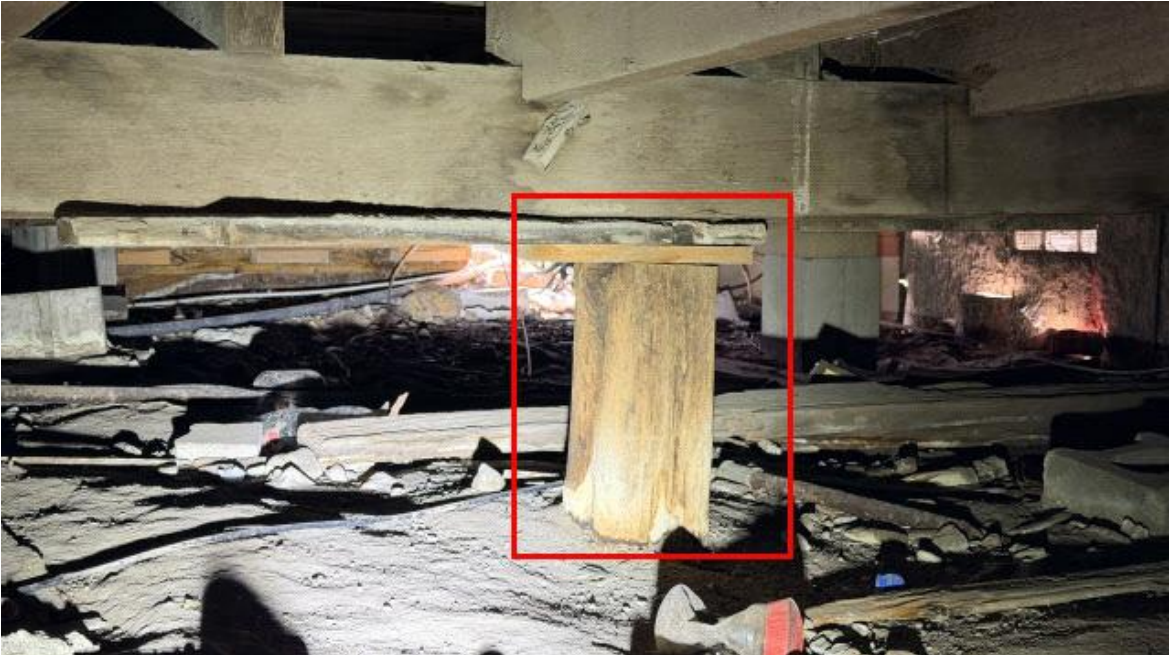
Photo 30

Crawl space view showing substandard footing (typical).
