Re: Owner Opposition to Historic Zoning/Designation – 907 E. 13th St.

STRUCTURAL ASSESSMENT REPORT

FEI Project Number: 1710
Site Address: 907 E. 13th St.
Austin, TX

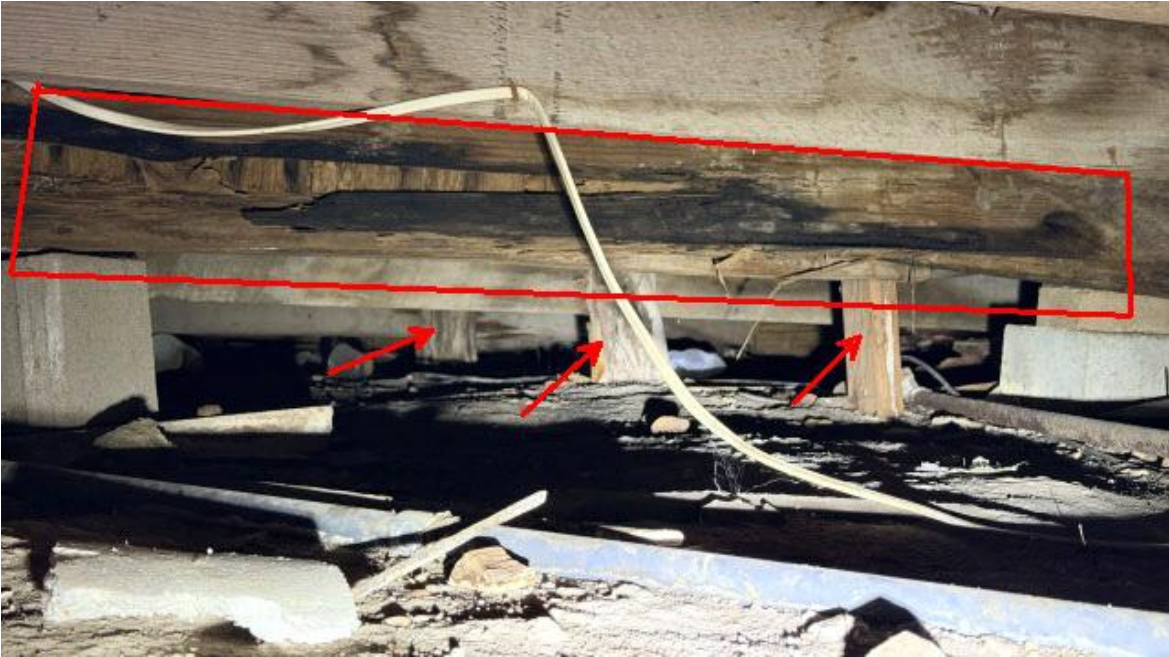
Photo 31

- Advanced wood deterioration and broken structural elements were observed throughout the pier-and-beam foundation system within the crawl space (see Photographs #26 and #31 through #34).

- Substandard footings, evidence of footing settlement, support elements lacking footings, and rotated footings were observed within the foundation system (see Photographs #27 through #31).

Crawl space view showing substandard footing and advanced wood deterioration (typical).

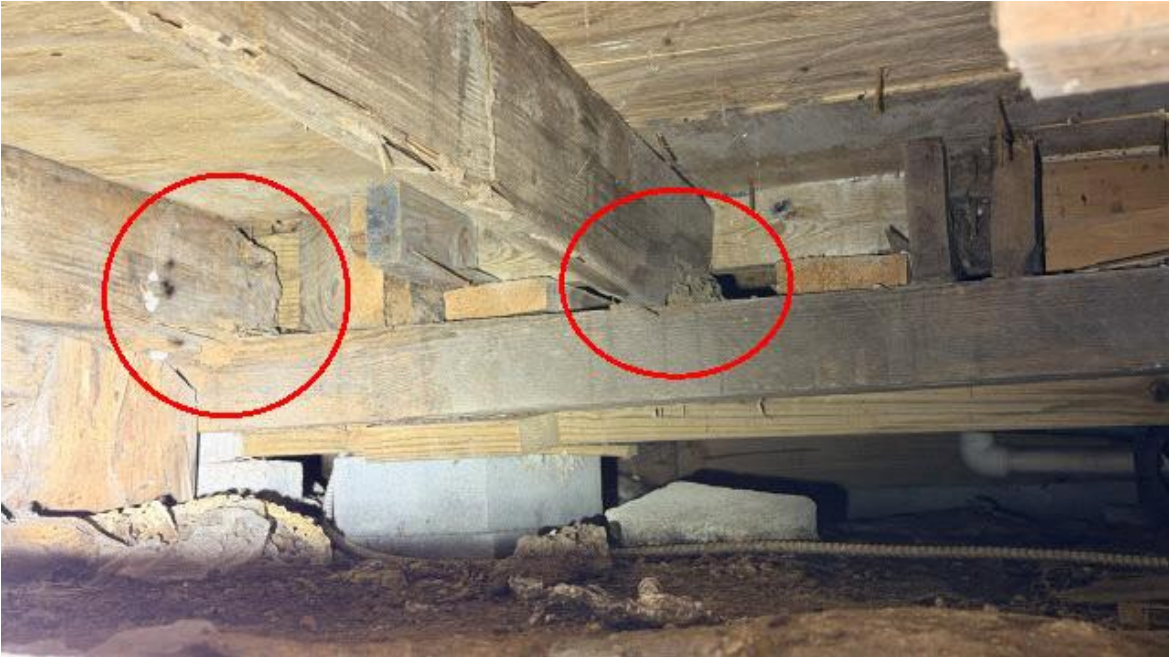
Photo 32

Crawl space view showing advanced wood deterioration (typical).

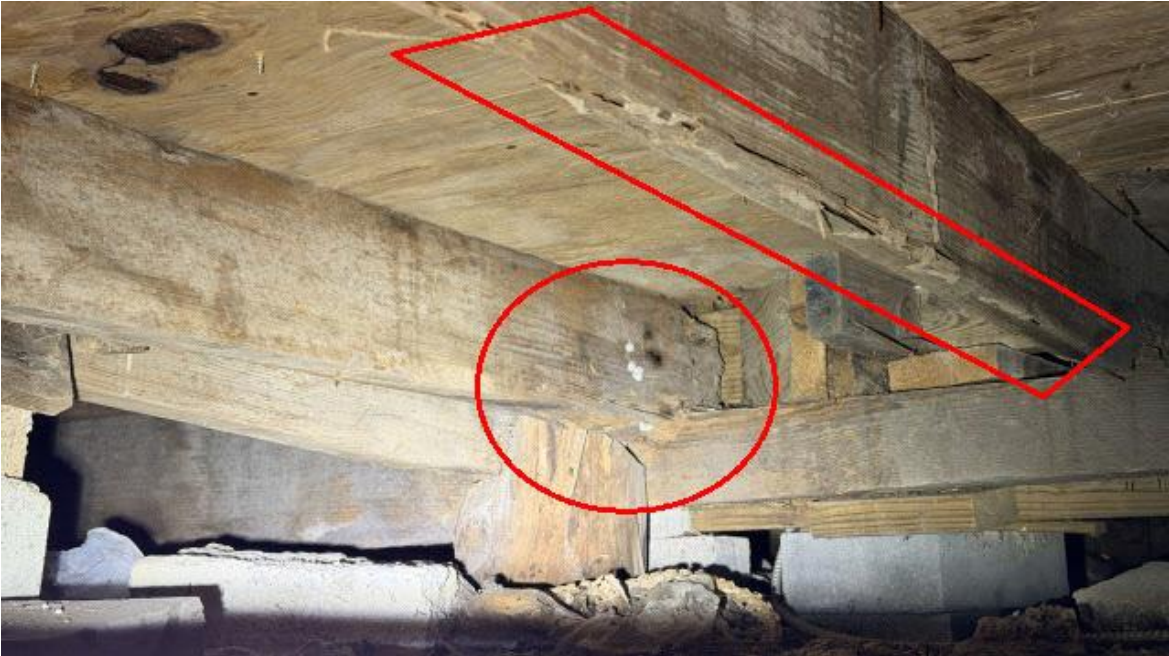
Photo 33

Crawl space view showing advanced wood deterioration (typical).

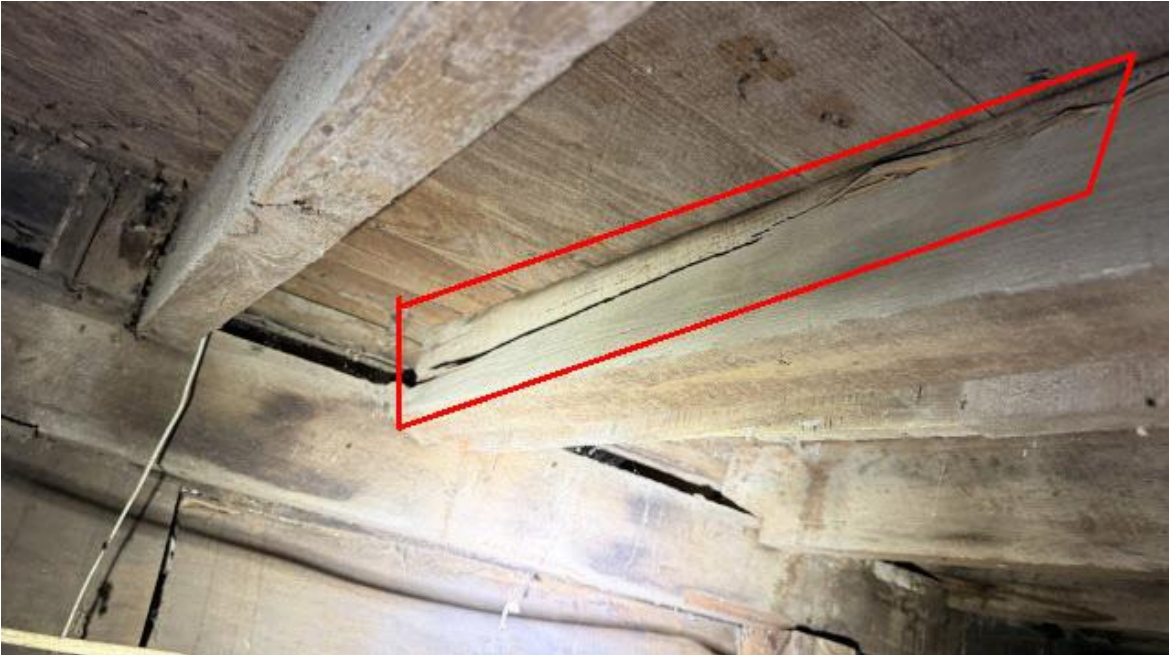
Photo 34

Crawl space view showing broken floor joist.
