**EMMA S. BARRIENTOS**  
**MEXICAN AMERICAN CULTURAL CENTER**  
**Phase 2 Improvements**  
**MACC Advisory Board Update**

**Heidi Tse**  
**Capital Delivery Project Manager**  
**February 4, 2026**

## Heating Hot Water Loop Leak

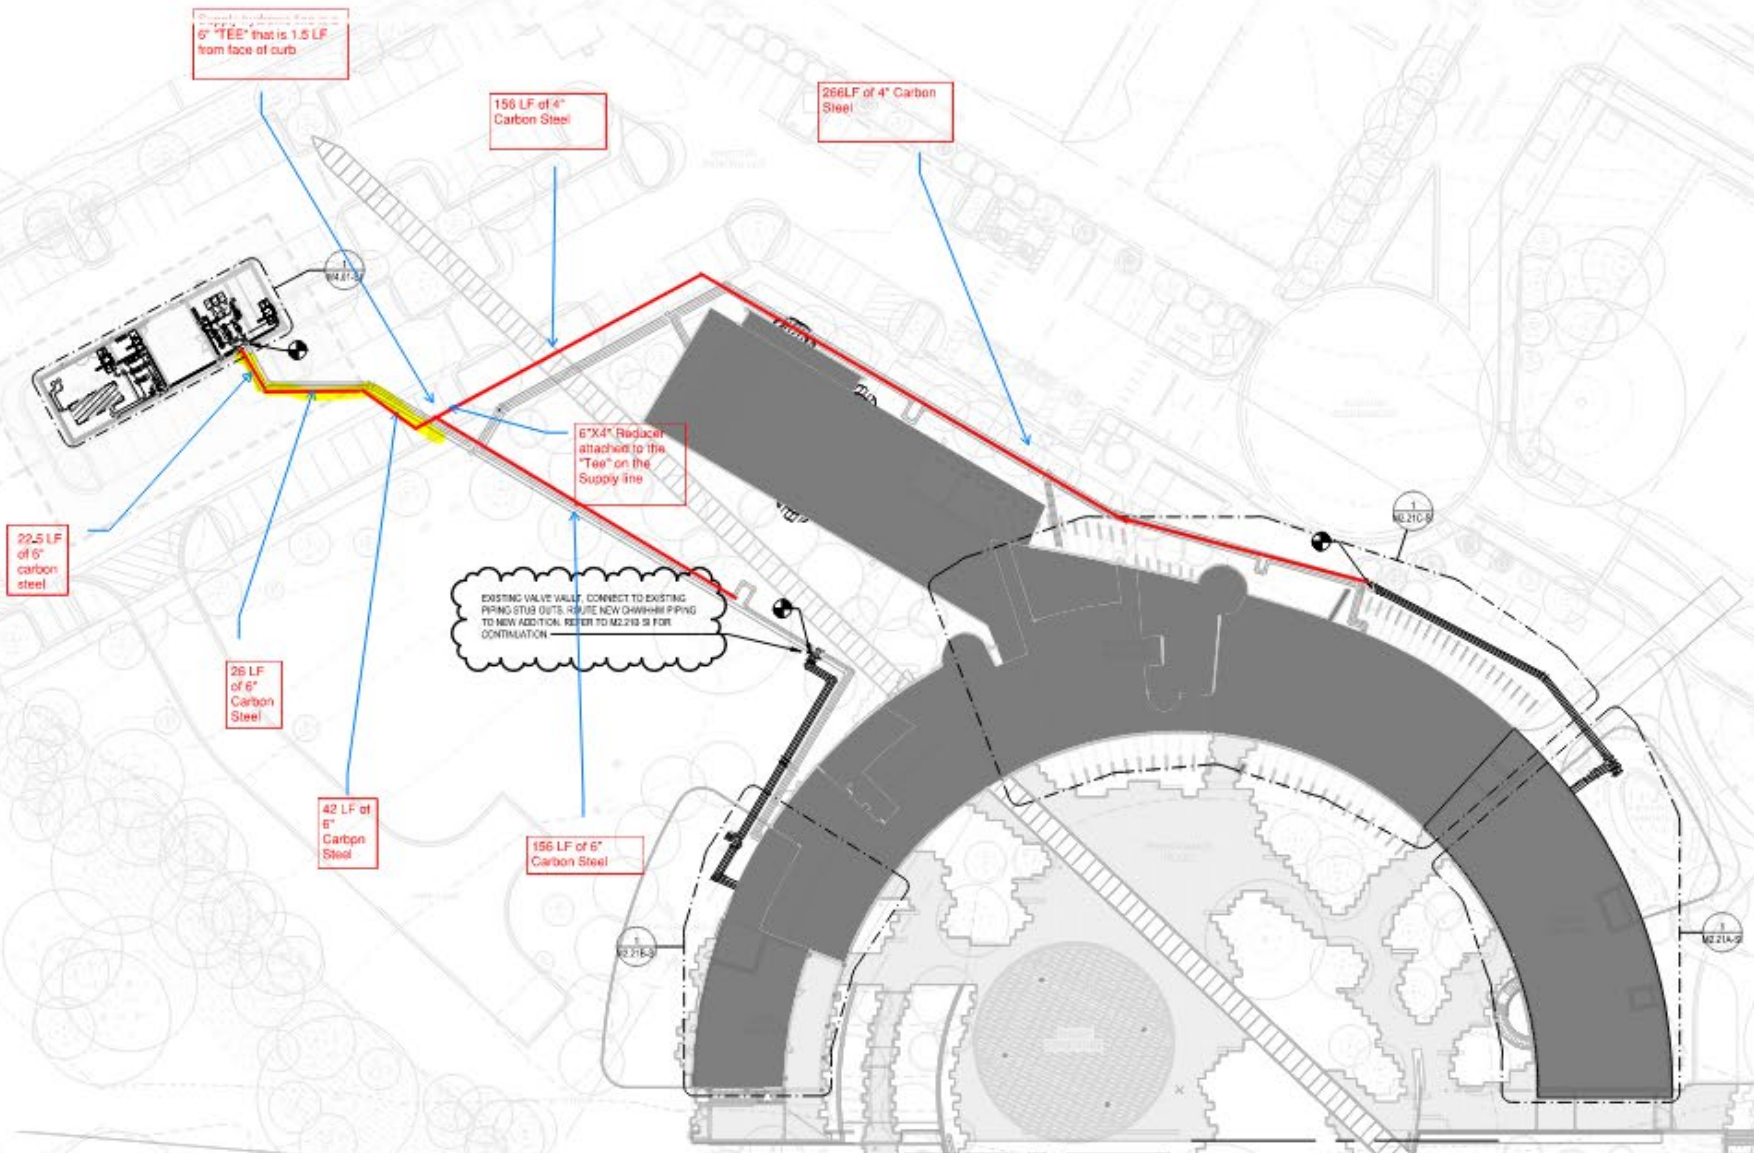
Mechanical Piping Plan shows a diagrammatic location of the existing 2007 piping in light gray. The red lines shows a more accurate layout of the lines. The area tested for the leak is highlighted in yellow.

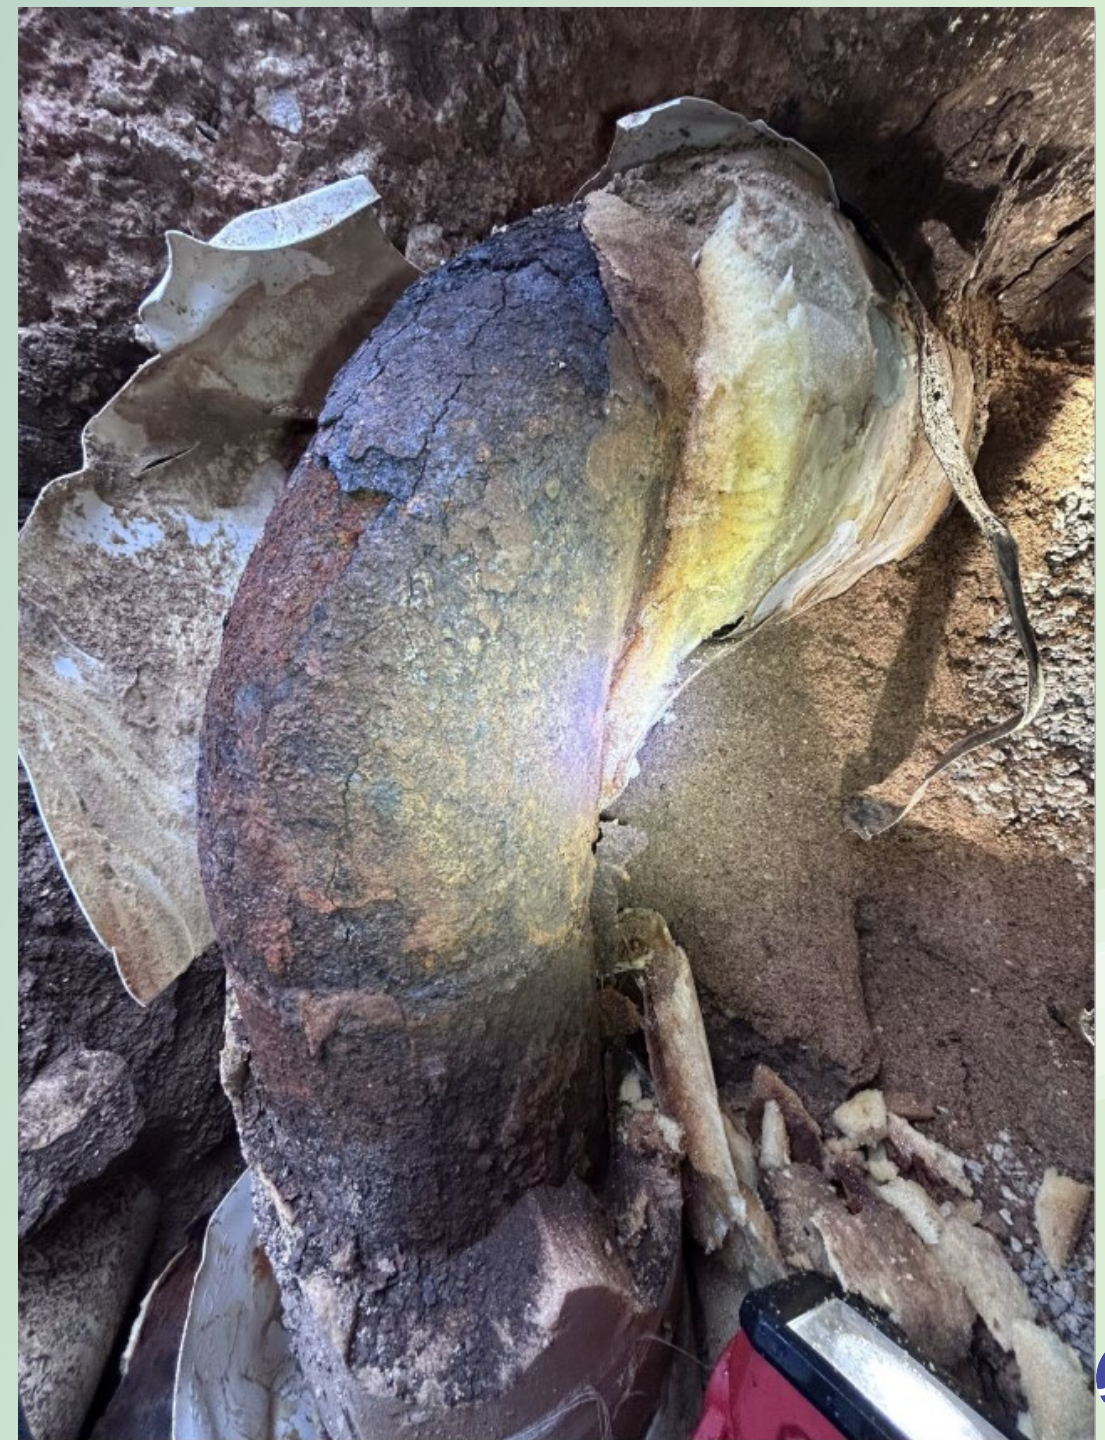
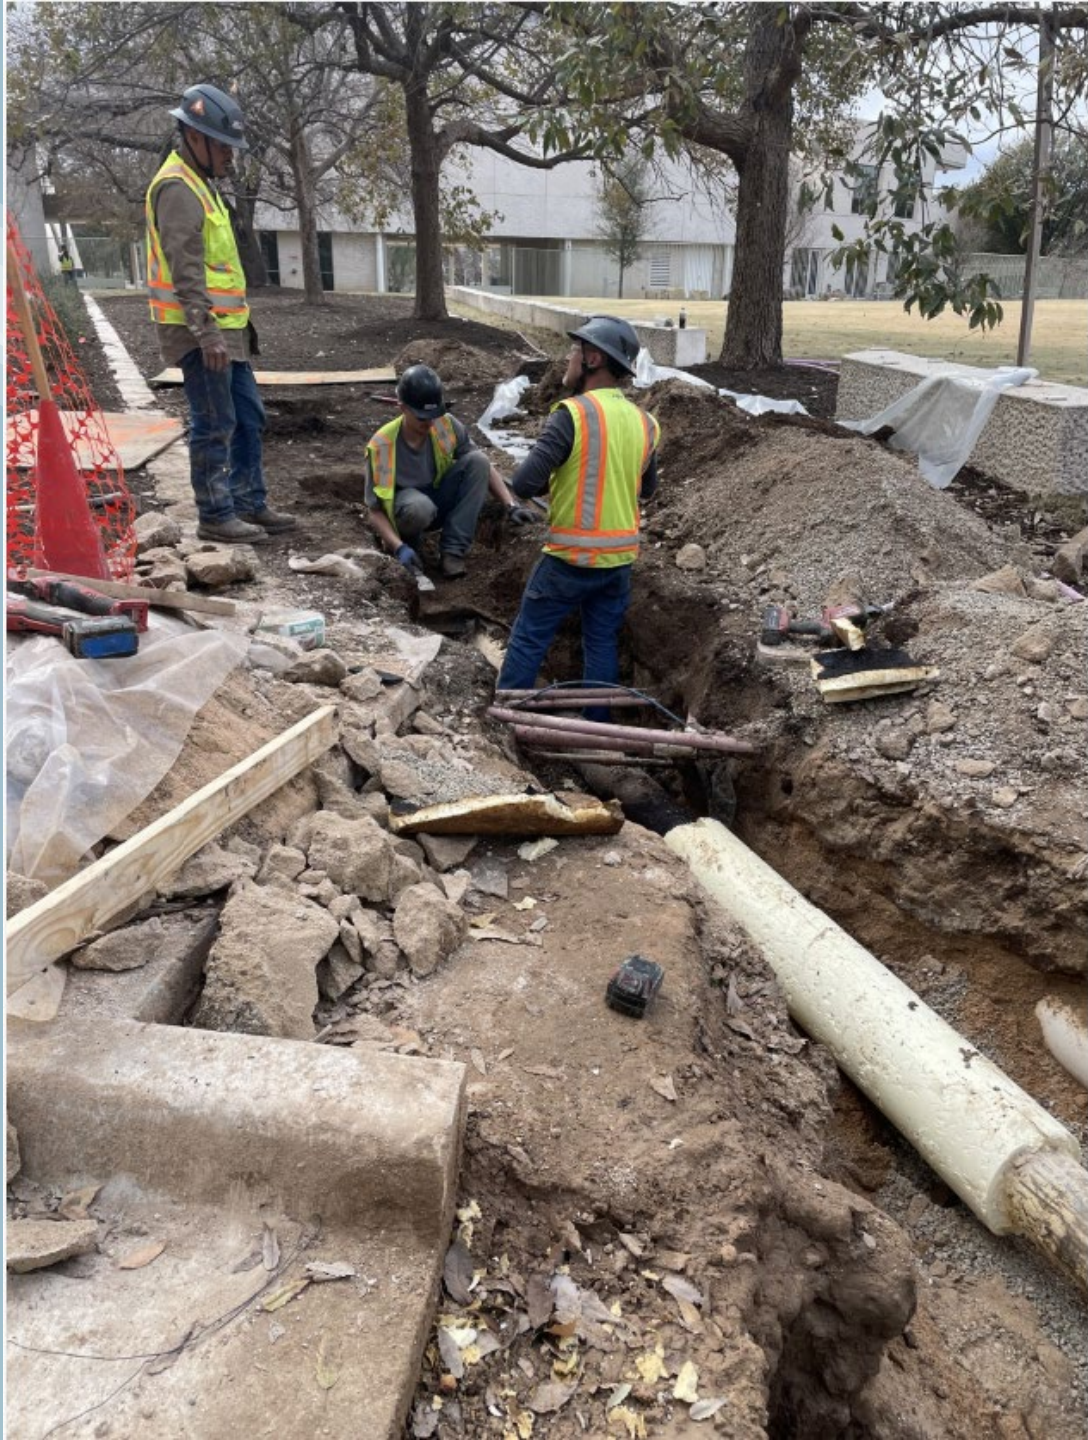
The pipe has deteriorated to the point that 6" steel ductile iron is peeling off as layers with the 2" insulation. The picture indicates rust and stress corrosive cracks (fine brittle cracks formed by combined stress and the corrosive wet environment).

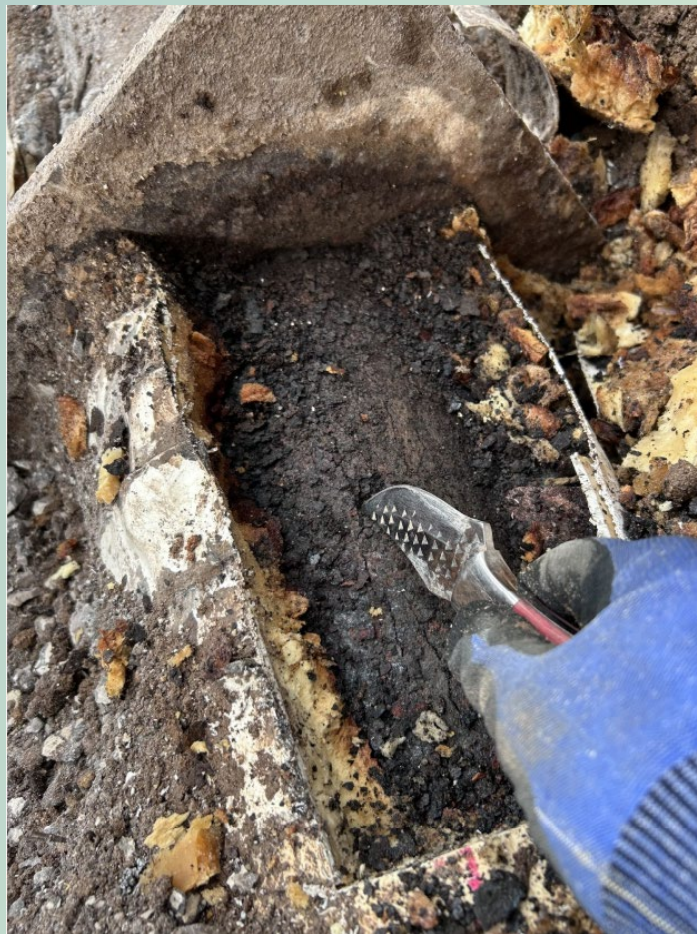
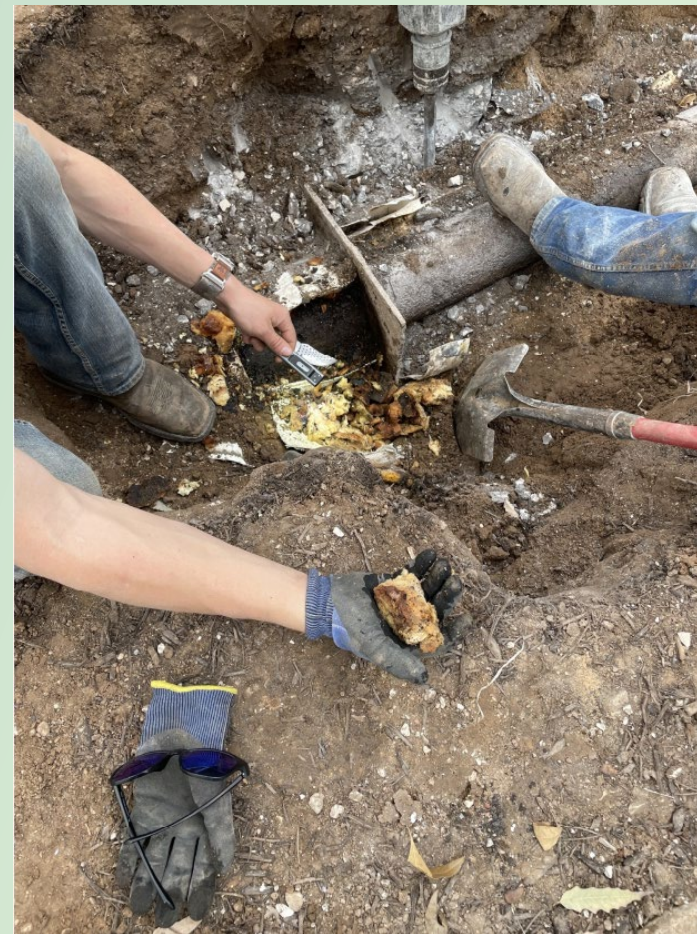
← Excavation in the landscape.

↑ Thrust block with a welded plate. Noticed the insulation is a sponge soaked with water from the leak.

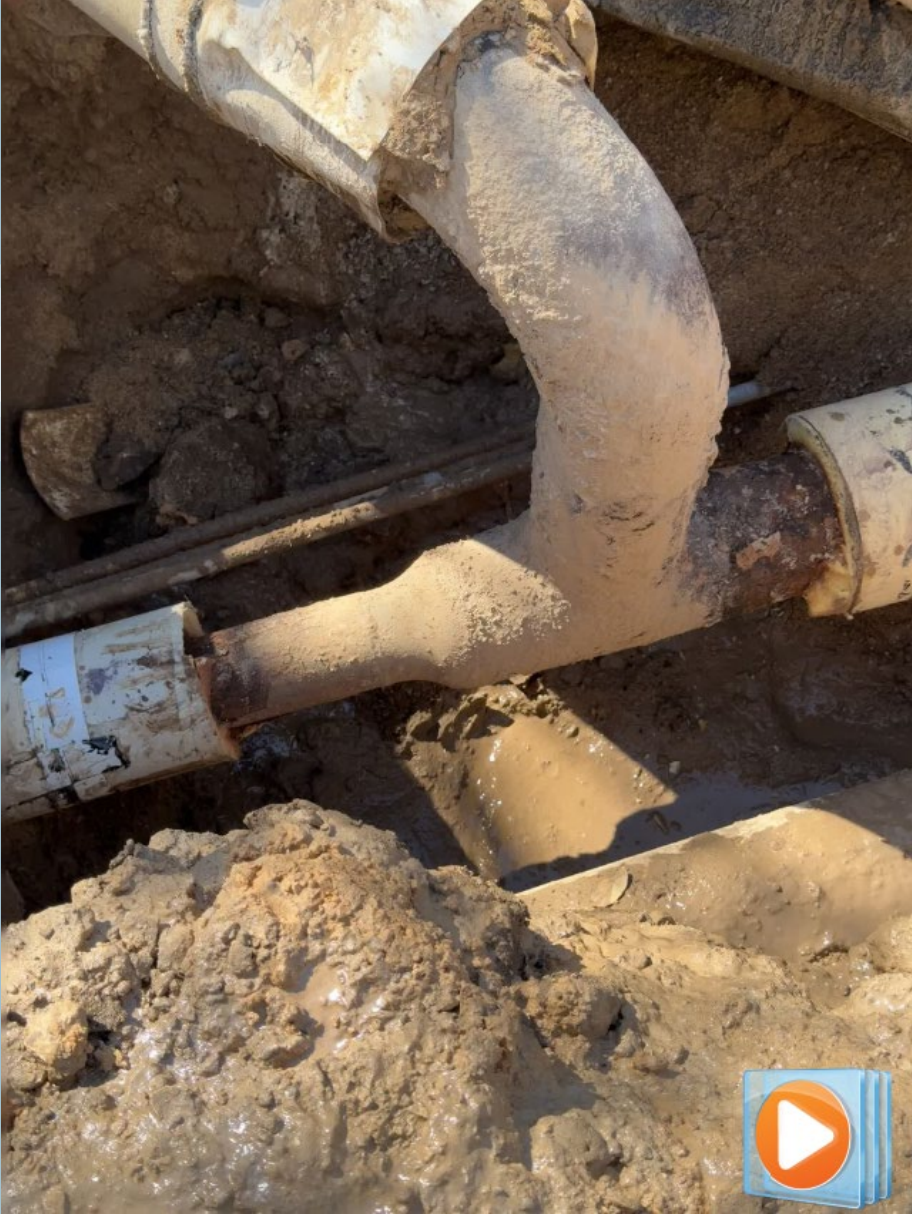
View of leaking “T” intersection and “elbow “with water damaged insulation removed and prepped for re-insulation.

The leak did not originate from here as once thought. The water from the leak has traveled to this low point and saturated the insulated lining and corroded the pipe.
