HLC Review Addendum 07 Oct 2026

4309 Avenue D Item HR-2026-104982

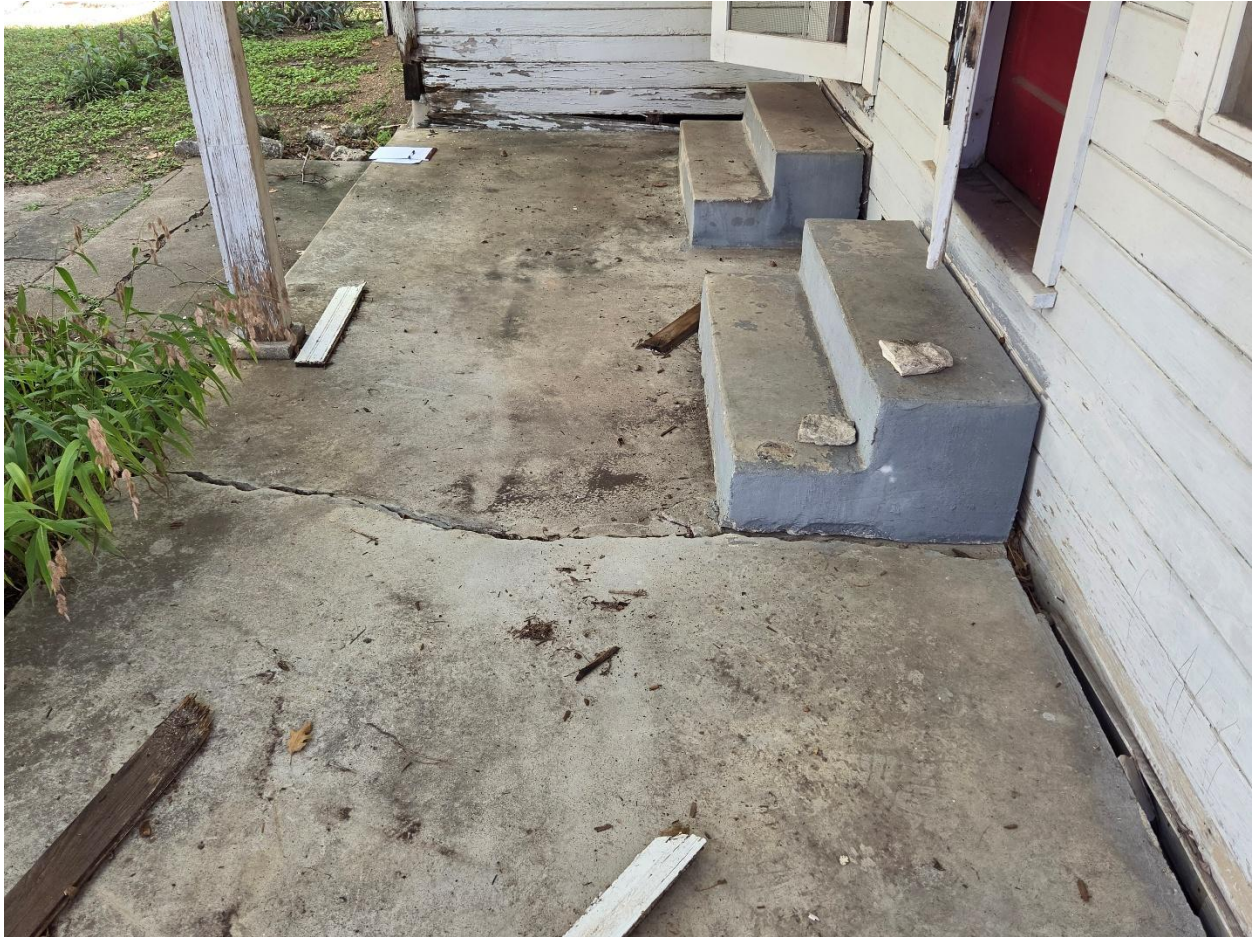
1.2 The concrete pad as front porch is structurally unsound and must be replaced.

The steps outside the primary entry door is not allowed by today's building code.

**Required Egress Doors:** *Must have a flat landing on each side that is at least as wide as the door and extends a minimum of **36 inches** in the direction of travel. The floor or landing cannot be more than **1.5 inches** lower than the top of the threshold for primary egress doors*

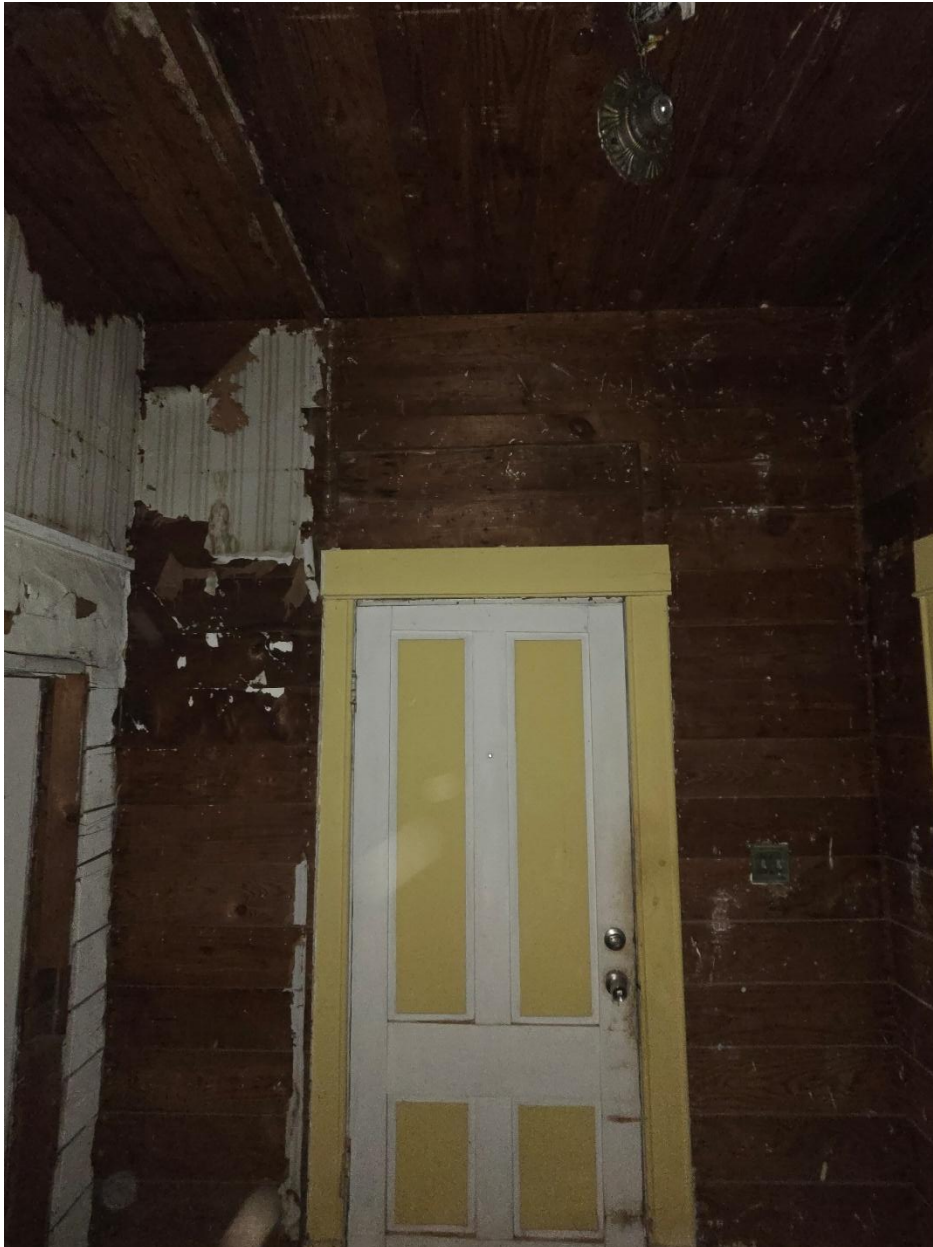
1.2 The second front door is not original to the 1912 home and was added around the time of the Great Depression in 1929. While it is old, it is not original. It enters directly into bedroom and is not in character with the 1912 house Queen Anne-esque house.

Our rehabilitation of this home ( back to single family) includes restoring the original transom in the entry foyer over the original front door. See picture....

The secondary door is a five panel interior non-weather rated door taken from another bedroom. Probably done when Clara Stubbs divided the house for daughter Clara to live there ? There was never a transom over the secondary narrower door.

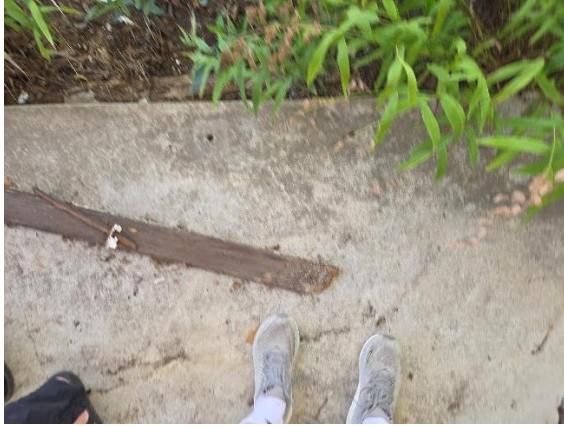
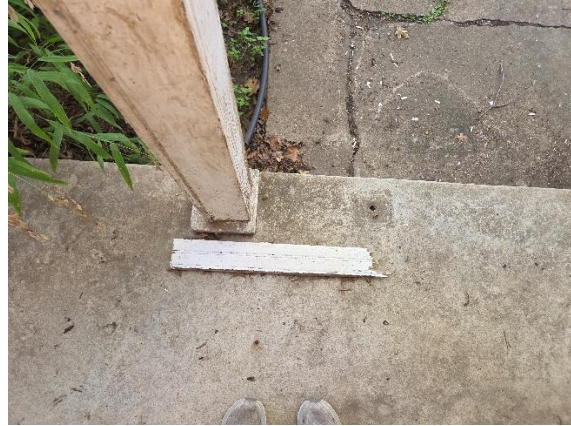
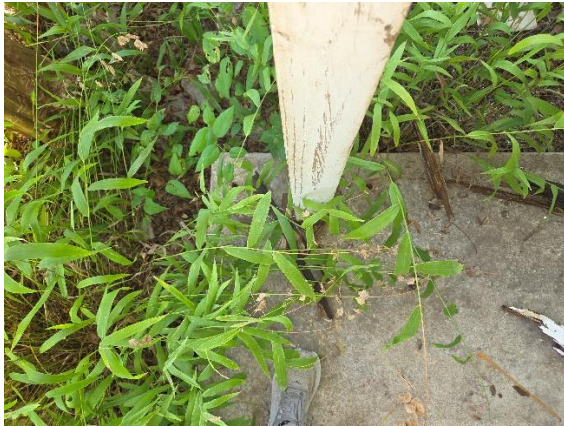
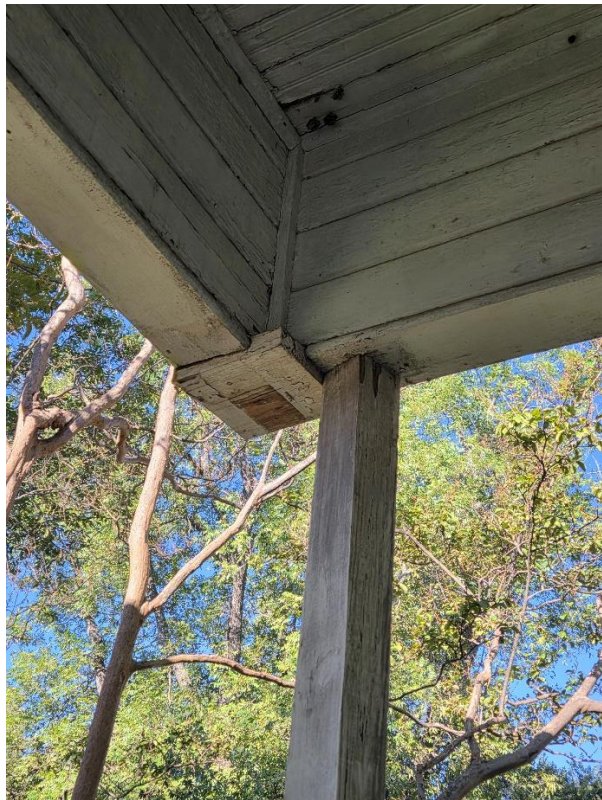
1.2 The current “temporary” front porch posts are not original. Evidence in the slab indicate there may have originally been paired posts – possibly lathe turned like other homes of the 1910’s ??

The columns shown in the proposed front elevation are HBG fiberglass structural columns without direct historical reference to any period. These round columns invoke the past but are also very common in new homes today.

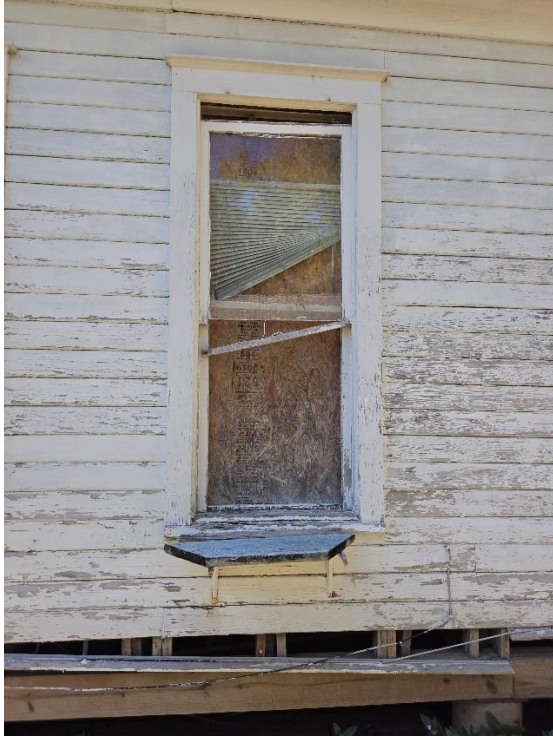
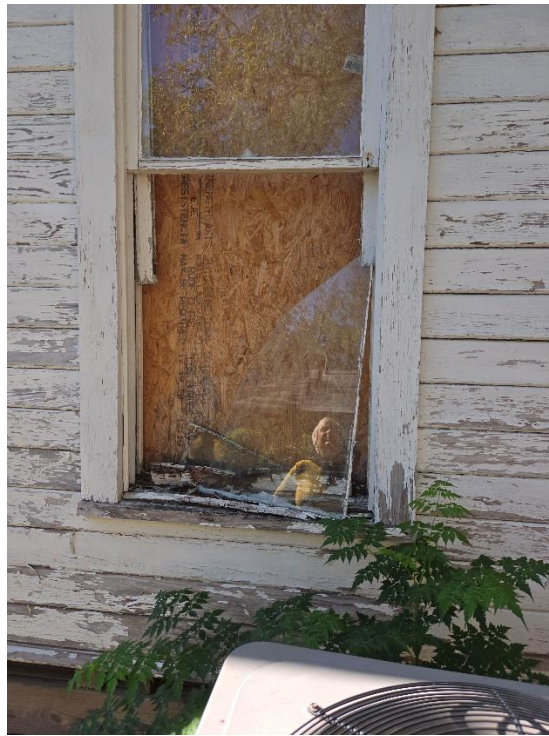
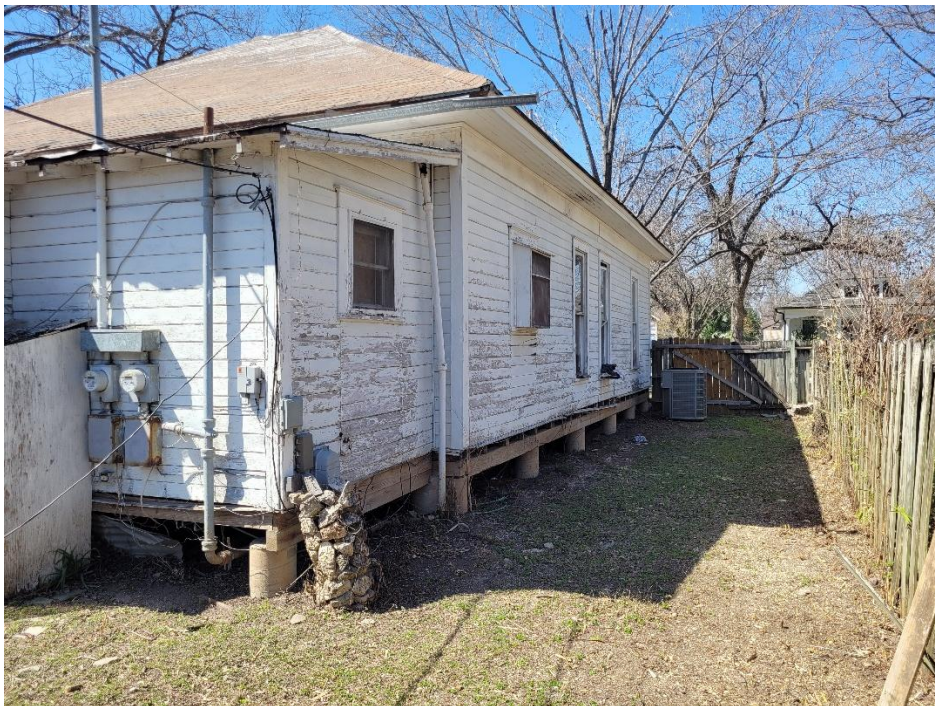
3.1 Restoring windows as possible instead of replacement sounds great and will be our course of action if feasible. Front windows ( as seen from street ) seem easily restorable.

However, the north side ( unseen from street ) seems harder.....
