### **Structural Assessment Letter – Existing Building**

Project: 4113 Guadalupe Renovation (ARE Project No. 26-060-ALA)

Site Address: 4113 Guadalupe St, Austin, TX 78751

Site Visit Date: September 10, 2026

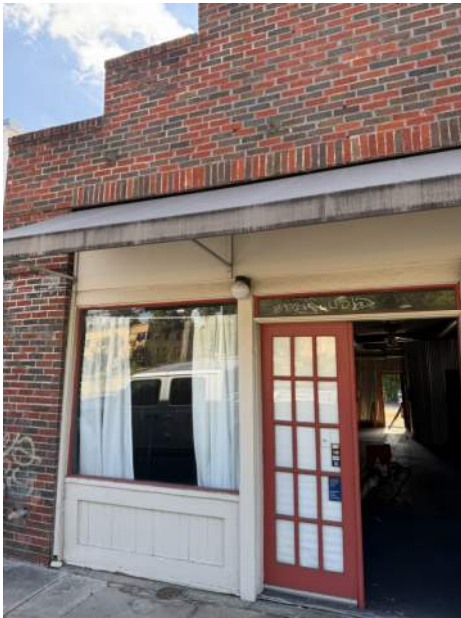
**Figure 1.** Existing front facade at Guadalupe Street – brick facade with storefront; the facade appears to bear on a concrete foundation.

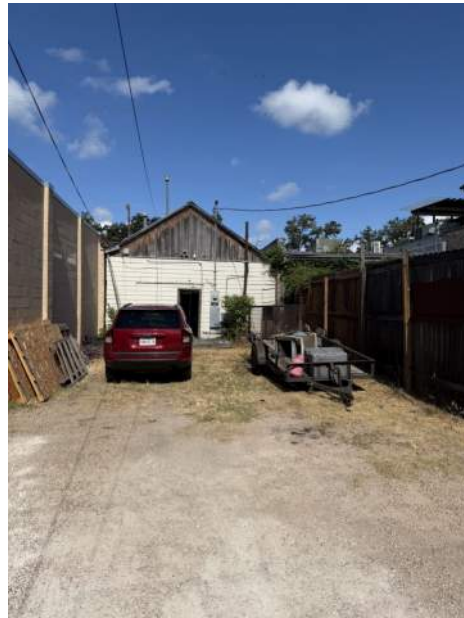
**Figure 2.** Rear of the existing structure – wood-framed building with paneled siding, set between adjacent buildings on each side.

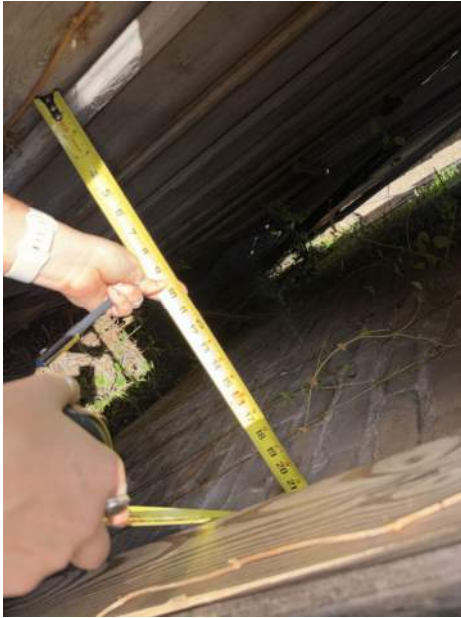
**Figure 3.** Gap between the existing 2x4 north bearing wall and the adjacent building to the north – approximately 21 inches. Water drains through this gap and toward the building.

The floor depression and the differential movement behind the front wall are likely the result of water infiltration at the timber pile foundations. Water currently drains into the gaps between the existing building and the adjacent buildings on the north and south sides, and likely under the building. This allows the soils at the timber piles to soften and the main bearing walls to sink.

The new construction should redirect all water runoff away from the building and prevent water from draining into the gaps between the existing building and the adjacent buildings on the north and south sides. Without correcting the drainage, any foundation repair remains at risk of continued movement.

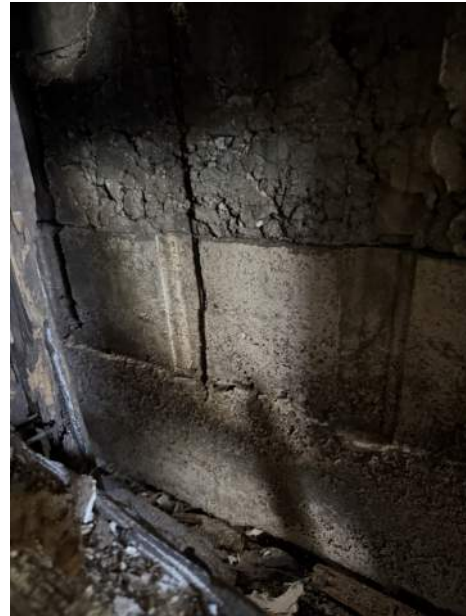
**Figure 4.** Exterior wall of the adjacent building to the south, viewed from the gap between the buildings.

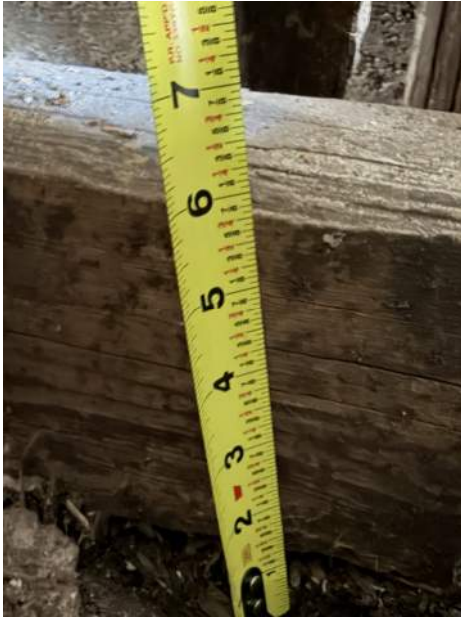
Splitting of the wood was also observed, which may result from non-preservative-treated wood being exposed to the elements. The 4x6 perimeter beam appears to be pressure treated and appears to be in better condition.

**Figure 5.** Existing 4x6 pressure-treated timber beam supporting the floor joists.

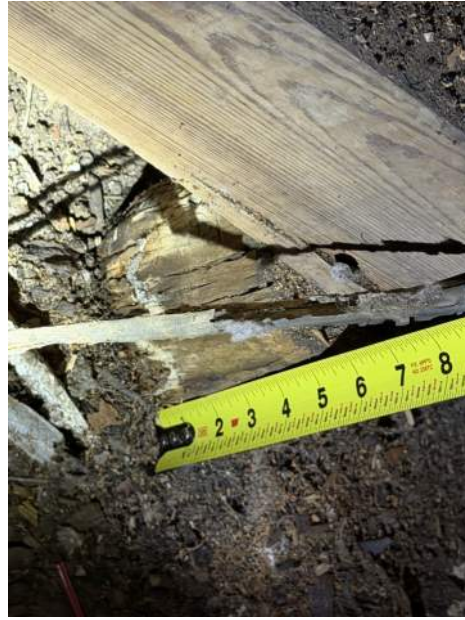
Signs of water damage and water infiltration were observed underneath the building, including water marks on the exposed pile shown in Figure 6. Much of the deterioration of the wood is likely due to water damage.

**Figure 6.** Timber pile foundation supporting the 4x6 timber beam – no concrete support was found.

ARE recommends replacing the timber pile foundations with concrete foundations during construction to provide better bearing and reduce differential settlement. A geotechnical engineer should be retained to evaluate the on-site soils and determine the potential movement of the soils for shallow foundations. Alternatively, driven piles or helical piles may be installed to extend the foundations below the active zone of soil movement.

- Option 1 – New continuous concrete grade beam, 12 inches wide by 24 inches deep, along the perimeter bearing walls.
- Option 2 – Keep the existing 4x6 perimeter timber beam and install new piles at 5 feet 6 inches on center along the beam line, approximately 50 feet long total.
- Option 3 – Remove the existing 4x6 perimeter beam and install new piles spaced further apart with a new rim beam designed to span between them.

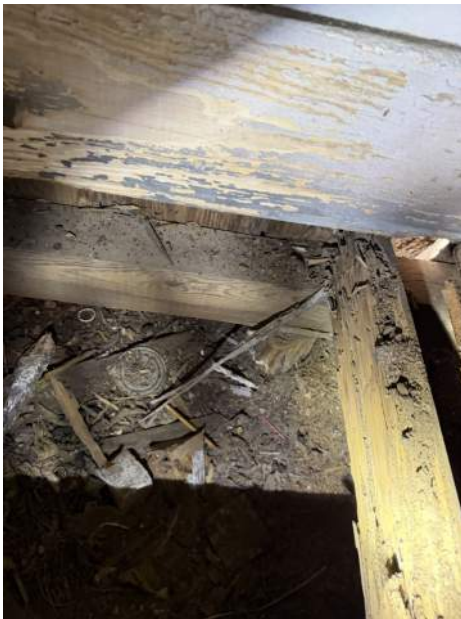
Severe deterioration of the floor joists was observed near the perimeter where the floor was exposed. Many of the joists observed were deteriorated. Further deterioration that is not visible is likely beneath the existing wood decking.

**Figure 7.** Deteriorated 2x6 floor joists at 24 inches on center bearing on the timber beam and pile foundation.

- The maximum span for a 2x6 floor joist at 24 inches on center under the current IBC floor loads (100 psf mercantile live load) is approximately 5 feet 0 inches. The existing joist spans could not be verified, but the floor is sinking and many of the observed joists are deteriorated.

ARE recommends replacing the existing 2x6 floor joists with 2x10 floor joists at 16 inches on center spanning 8 feet 6 inches maximum, in three bays across the width of the building. The existing 2x6 floor joists may be removed once replaced.

Install new interior girders of (4) 2x12 at the third points of the floor, with foundation supports (spread footings or piles) at 9 feet 0 inches on center. With the girders bearing at each end of the building, this is five interior supports plus one at each end – seven supports per girder line over the approximate 50-foot building length.

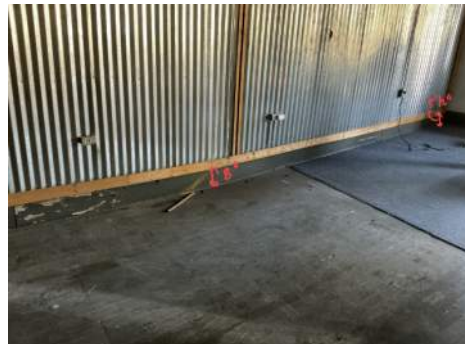
The floor joists bear on the 4x6 pressure-treated timber beam, which spans between timber piles embedded directly in the ground. No concrete footings or piers were found. The floor has a depression of approximately 2 to 4 inches, with the low point near the middle of the floor. The floor level varies across the building.

**Figure 8.** Approximate variation in floor height at the sinking floor – the markup shows the distance from the floor to the horizontal wall member, approximately 8 inches near the middle of the building and approximately 5 inches toward the end of the wall. The difference is the approximate floor depression of 2 to 4 inches.

- The most severe movement is near the middle of the building. As the north and south walls approach the front wall, the movement appears to be more minor, indicating that the middle of the building is sinking the most. There may be a low point in grade near the middle of the building where water cannot escape.

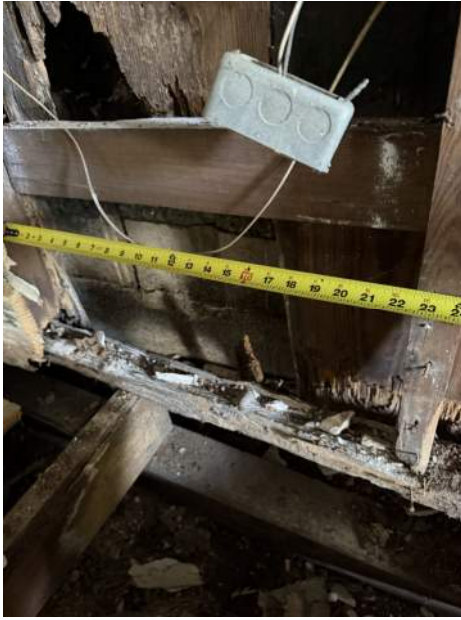
The bottom sill plates and the bases of the 2x4 studs are deteriorated along the exposed portions of the north and south bearing walls. Splits were observed at the base of the wall studs. The wood paneling siding on the side walls has large gaps that allow moisture to infiltrate the wall, which has led to the deterioration of the wood. Splitting of the wall studs was also observed at locations that are not shown in the photographs.

**Figure 9.** Bottom of the existing 2x4 bearing wall with floor joists bearing, adjacent to the neighboring building wall. The sill and stud bases are deteriorated.

The existing 2x4 wall studs should be replaced or lapped at the base, with new sill plates, to restore the original support. ARE recommends replacing the siding with plywood sheathing along the full length of the walls to provide lateral rigidity and a shear wall system, and reinstalling the exterior siding to waterproof the building.

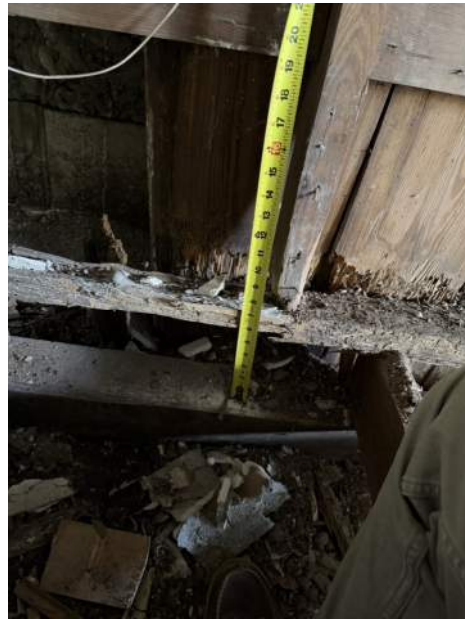
**Figure 10.** South wall – deteriorated wood wall construction. Splits and section loss at the base of the 2x4 studs.

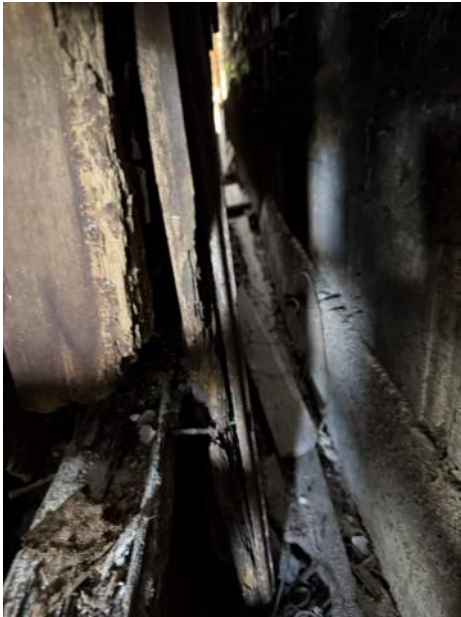
**Figure 11.** South wall base deterioration at the adjacent building – moisture infiltration through the gaps in the siding.

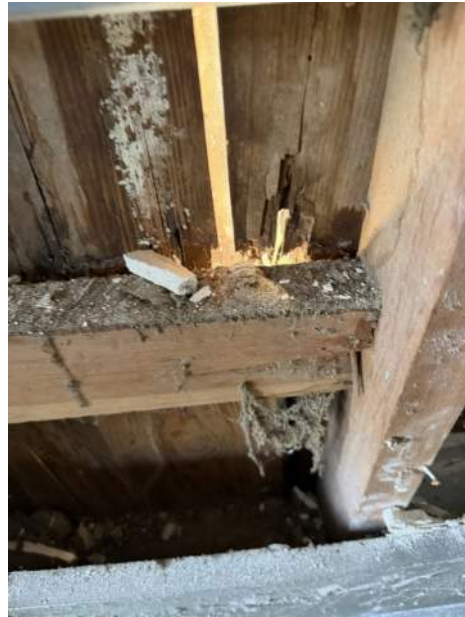
**Figure 12.** North wall – interior deterioration and water damage at the sill and stud bases.

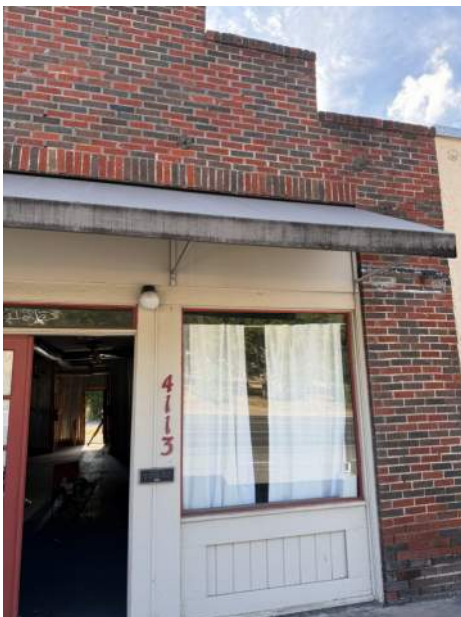
**Figure 13.** Existing front facade – storefront and brick parapet. The historic facade is to remain.

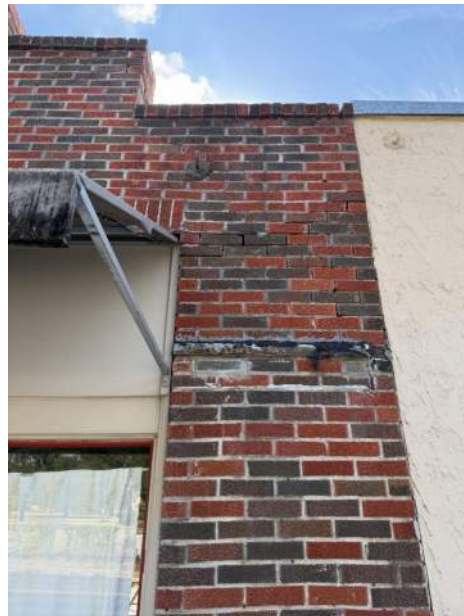
- The front facade appears to show minor movement, resulting in the minor stair-stepping of the brick mortar joints at the facade return shown in Figure 14.

**Figure 14.** Stair-stepped separation at the brick mortar joints at the facade return – minor; possible indication of soil movement. No large cracks were observed in the facade.

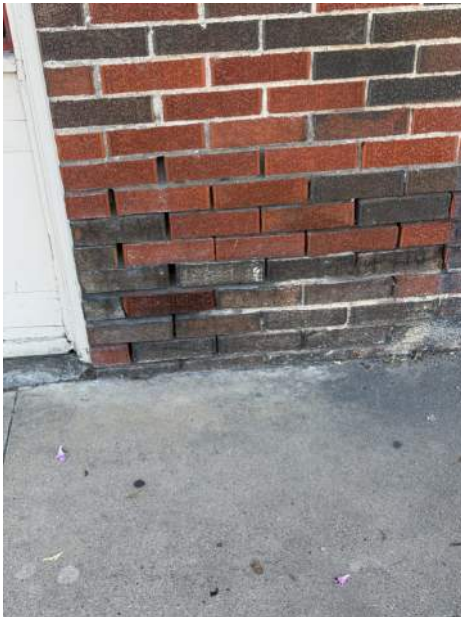
- Gaps were observed in the brick at the base of the facade where the brick meets the concrete foundation (Figure 15), and the sidewalk has separated from the front foundation (Figure 16).

**Figure 15.** Gaps in the brick at the base of the facade where the brick meets the concrete foundation.

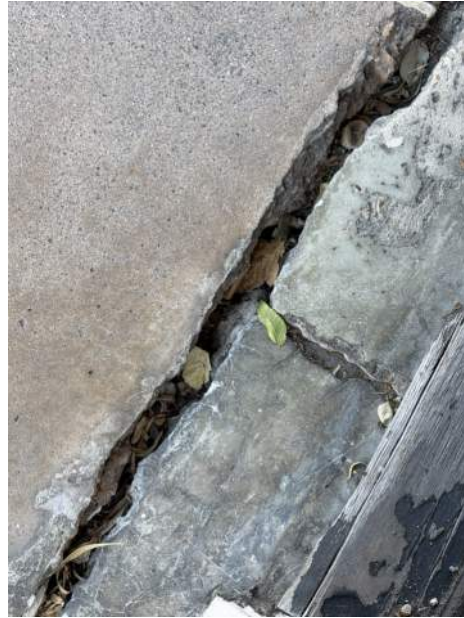
- There is a crack in the front wall foundation at the doorway (Figure 16), indicating that the front concrete foundation is not completely stable. The magnitude of movement appears to be much less severe than in the timber-pile-supported portions of the building (the north and south walls).

**Figure 16.** Crack in the front wall foundation at the doorway, and separation between the sidewalk and the front foundation.
