## STRUCTURAL PROPERTY CONDITION ASSESSMENT

1005 East 8<sup>th</sup> St.  
AUSTIN, TEXAS 78702

Gregor Property  
1005 East 8th Street  
Austin, Texas 78702

Re: Building Inspection  
USAA  
9800 Fredericksburg Road  
San Antonio, Texas 78288

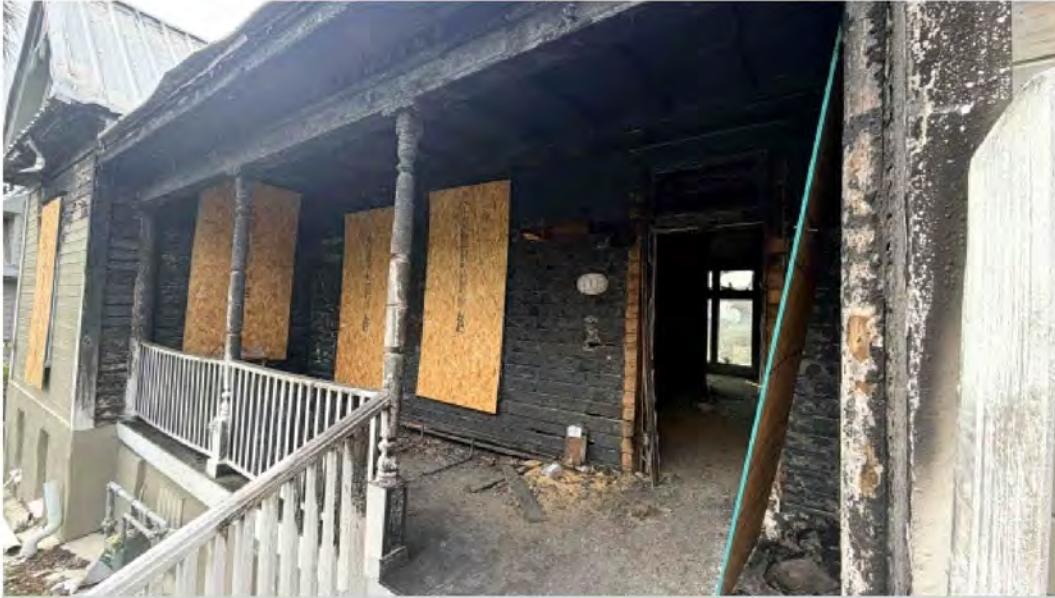
Photo 5

Front elevation view. Note fire impact at the front porch area.

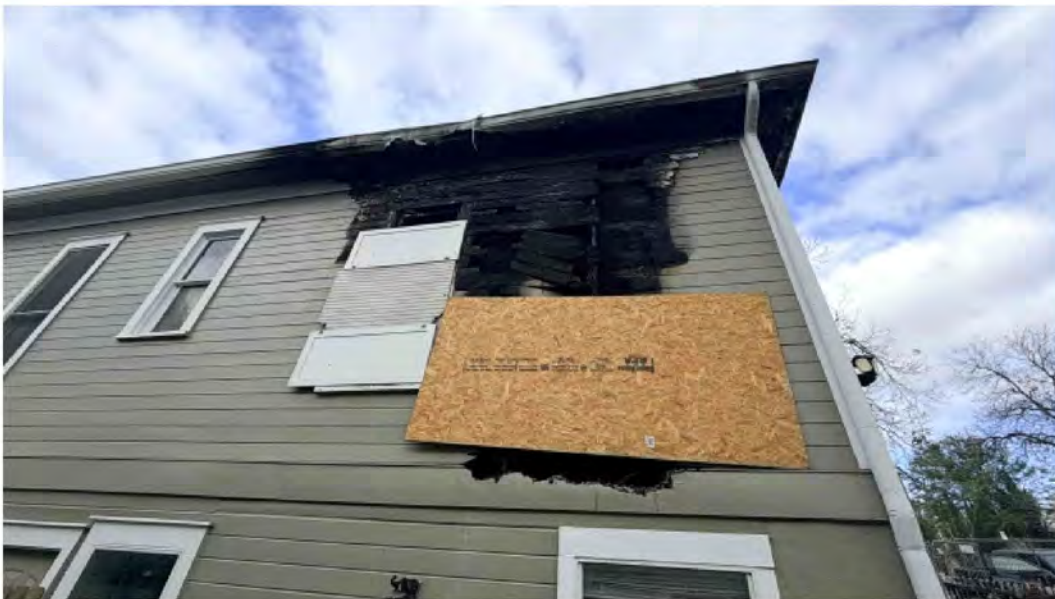
Photo 6

Left elevation view. Note fire impact along the siding.

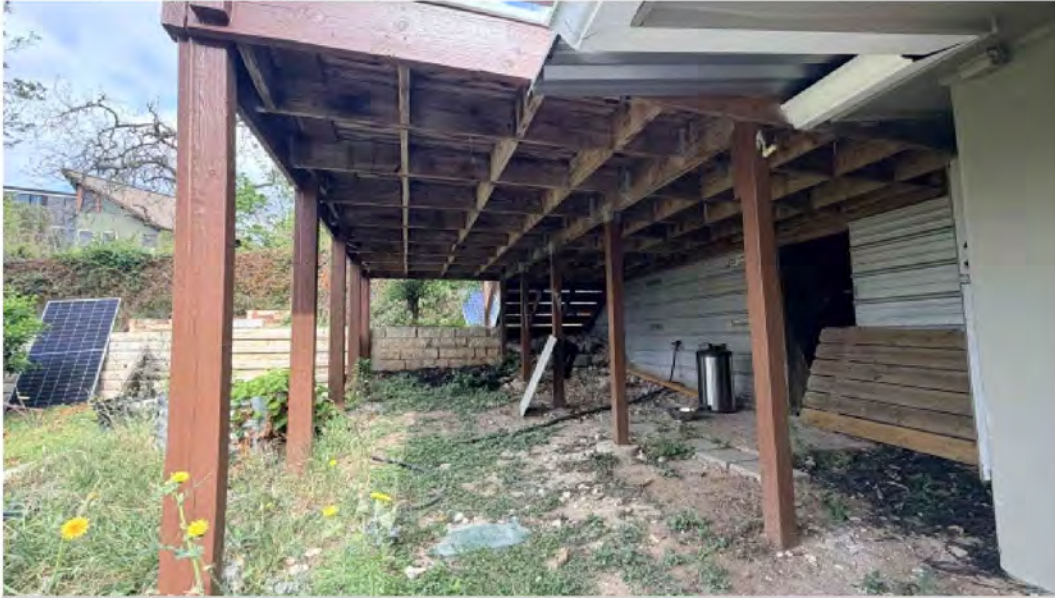
Photo 7

Rear view. No fire impacted area was observed at the back deck.

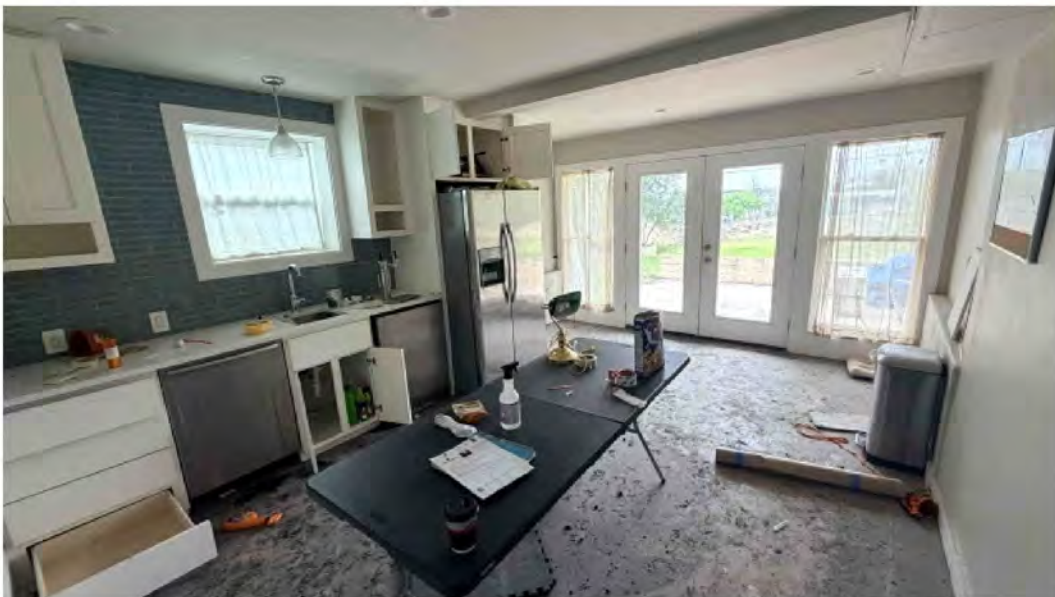
Photo 8

Lower level living room view. No fire impacted area was observed.

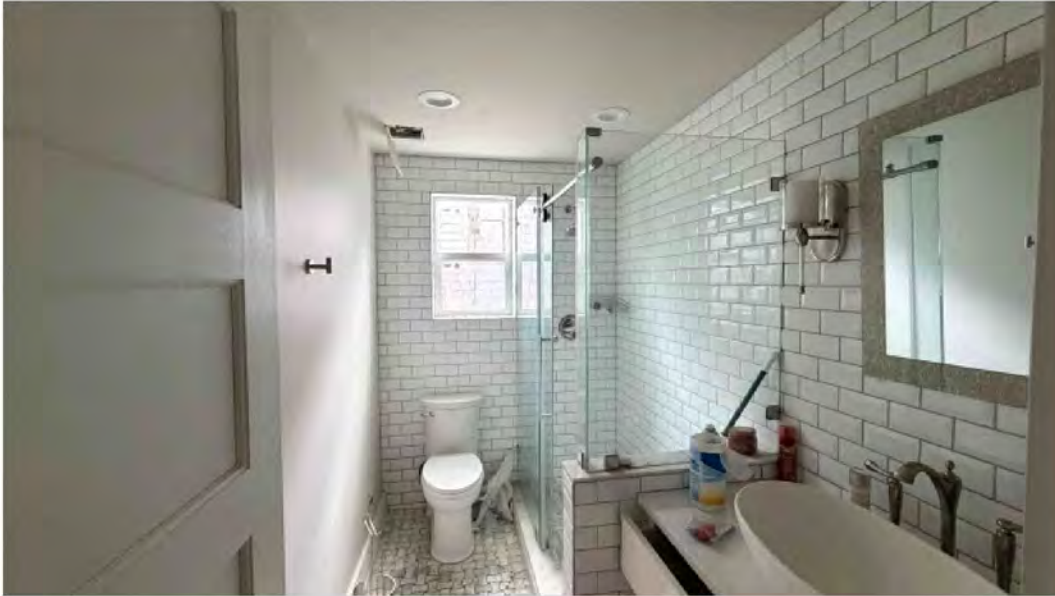
Photo 9

Lower level bathroom view. No fire impacted area was observed.

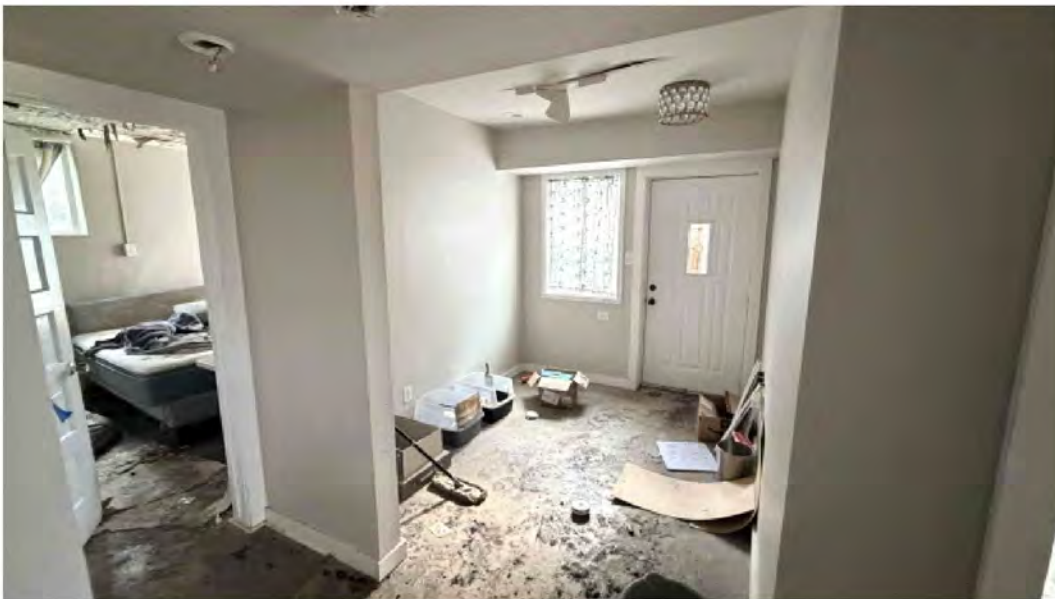
Photo 10

Lower level entrance area view. No fire impacted area was observed.

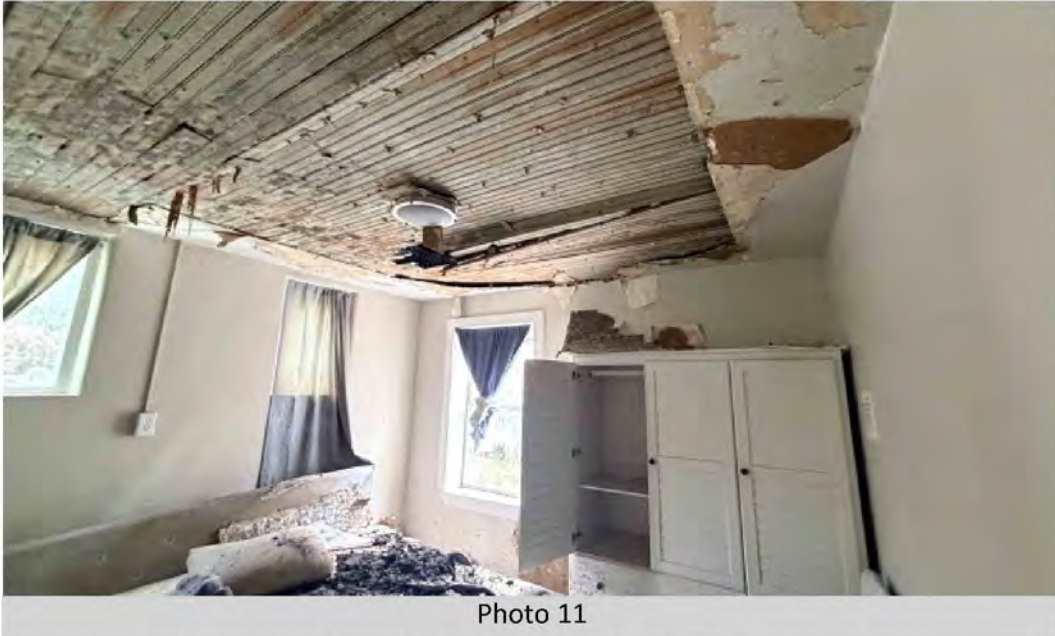
Photo 11

Lower level bedroom view. Note compromised ceiling due to fire.

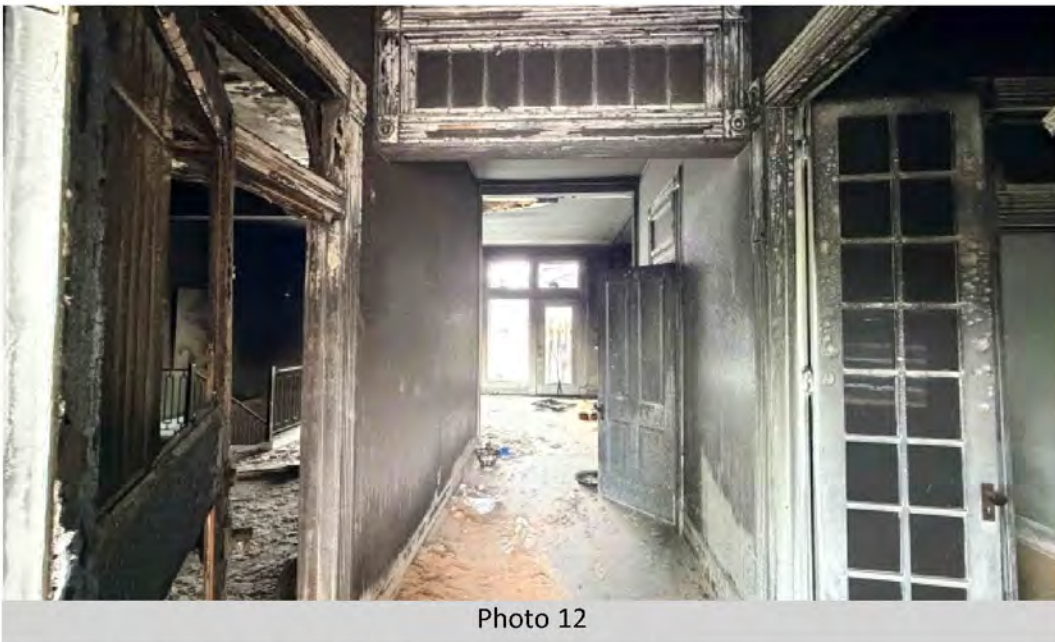
Photo 12

Upper level entrance view. Note fire impacted areas.

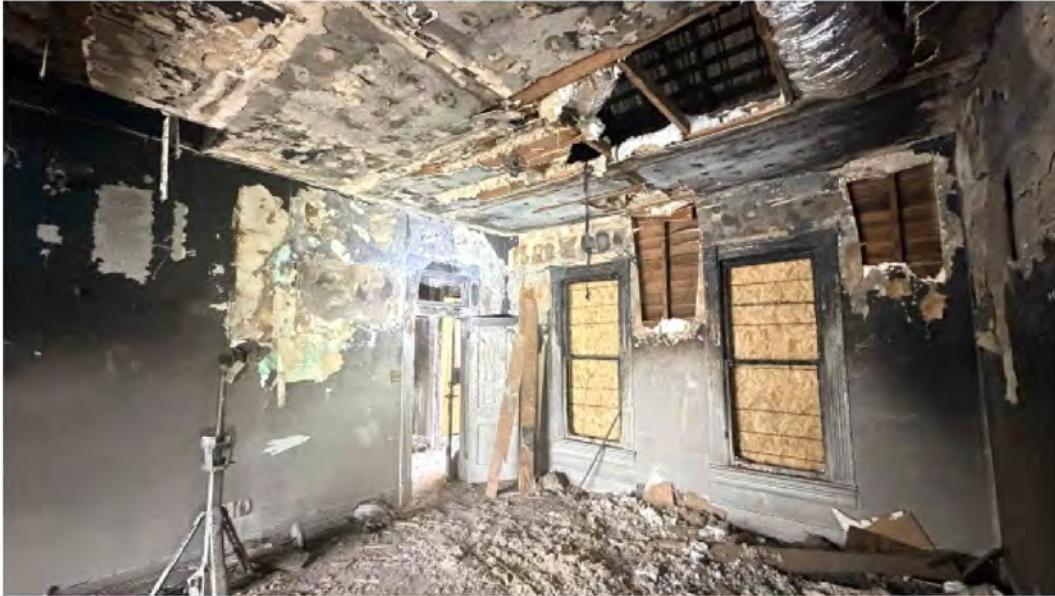
Photo 13

Upper level living room view. Note fire impacted areas.

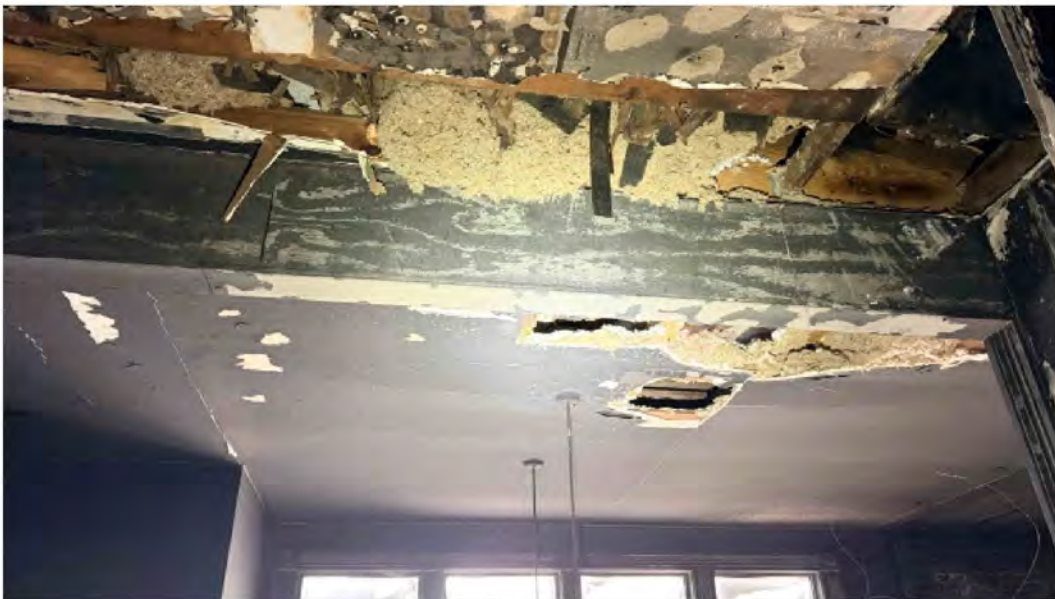
Photo 14

Upper level living room view. Note fire impacted ceiling beam.

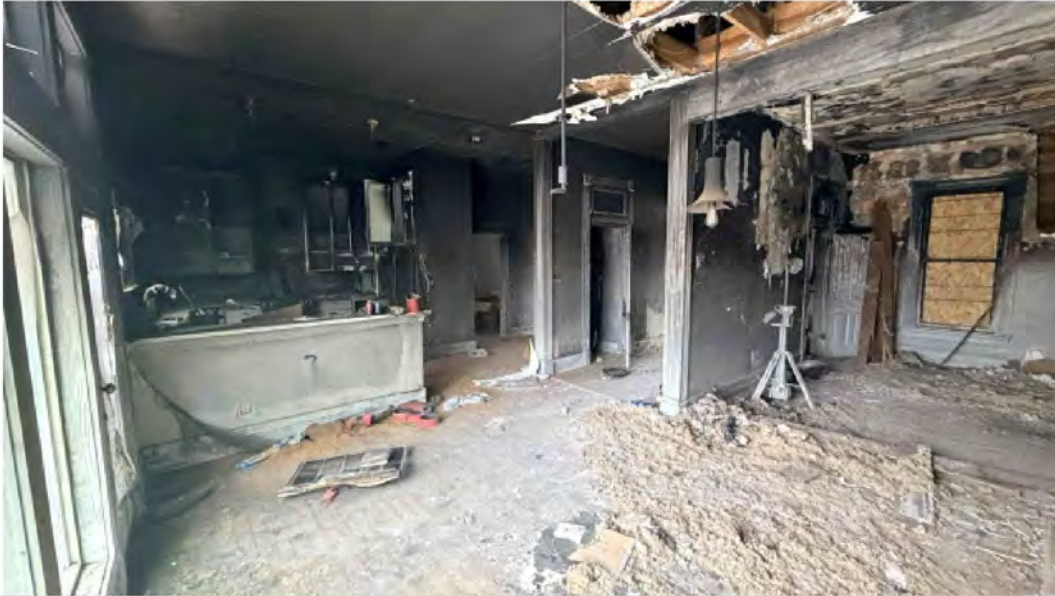
Photo 15

Upper level living room view. Note fire impacted areas.

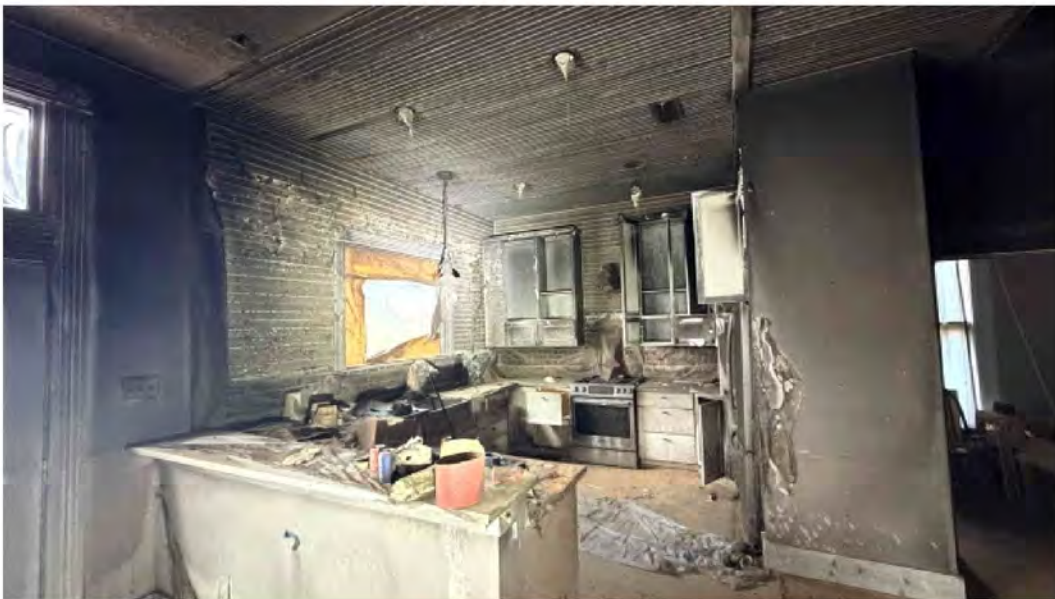
Photo 16

Upper level kitchen view. Note fire impacted areas.

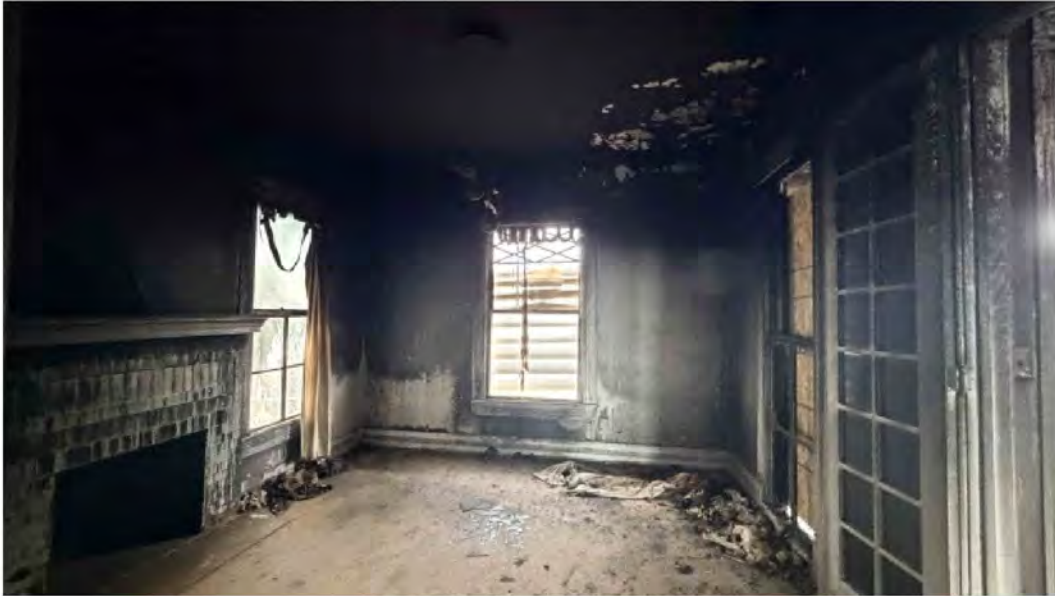
Photo 17

Upper level family room view. Note fire impacted areas.

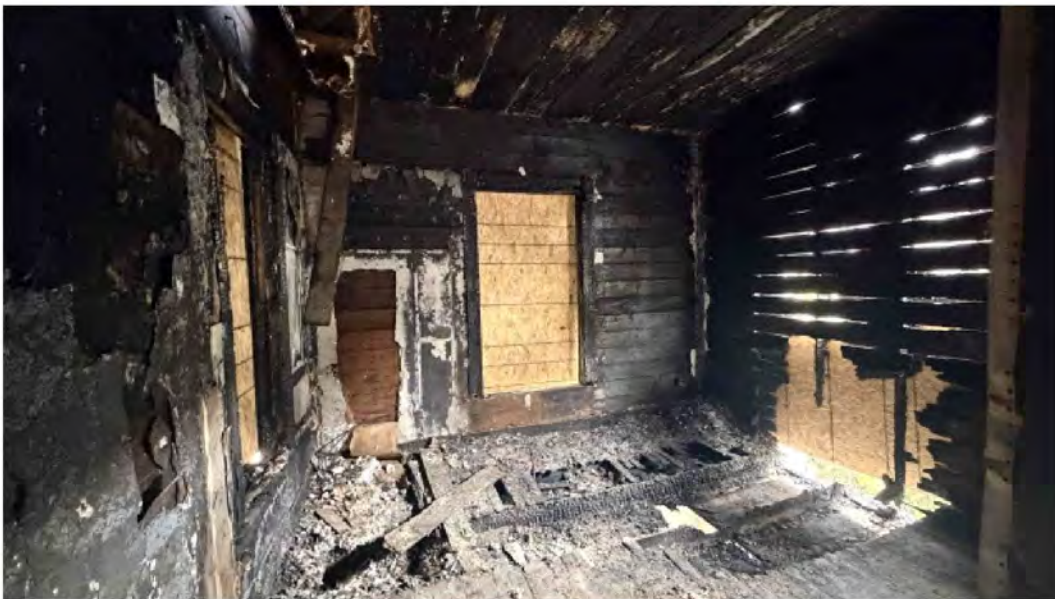
Photo 18

Upper level front bedroom view where fire allegedly originated. Note fire affected areas.

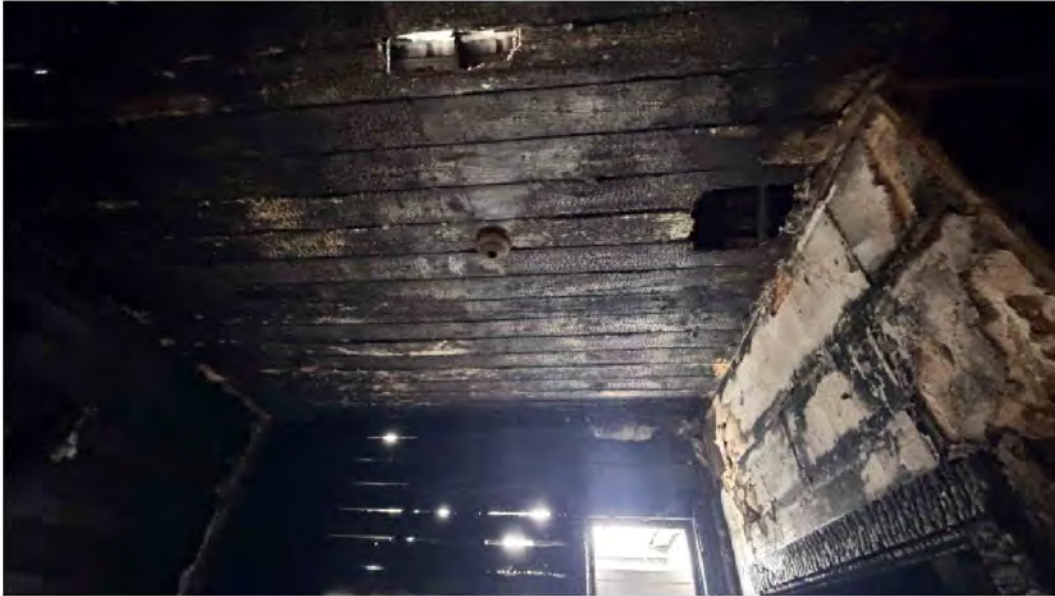
Photo 19

Upper level front bedroom view. Note fire affected areas.

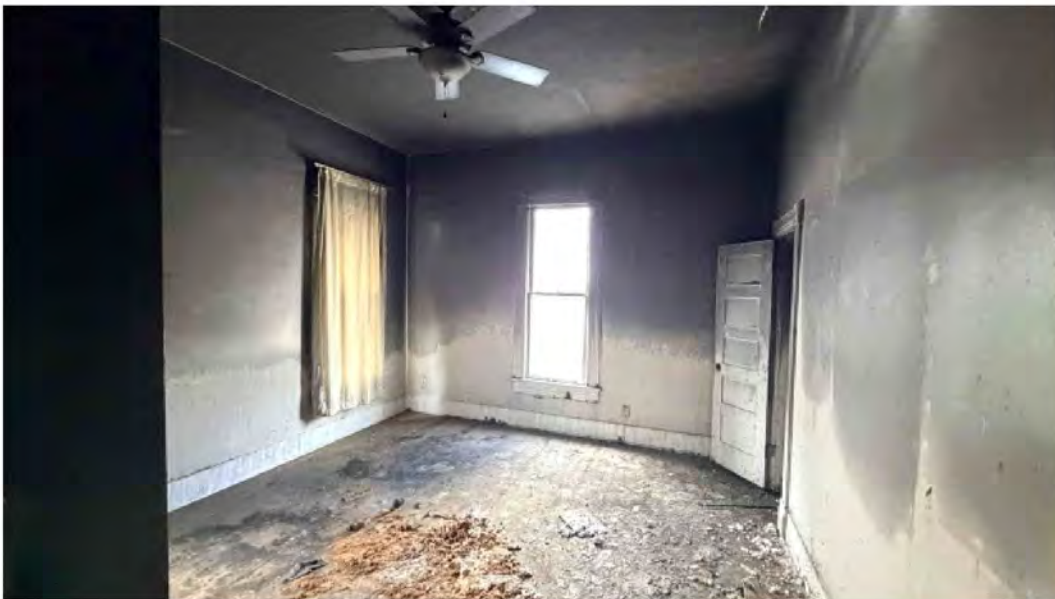
Photo 20

Upper level rear bedroom view. No fire impacted area was observed.

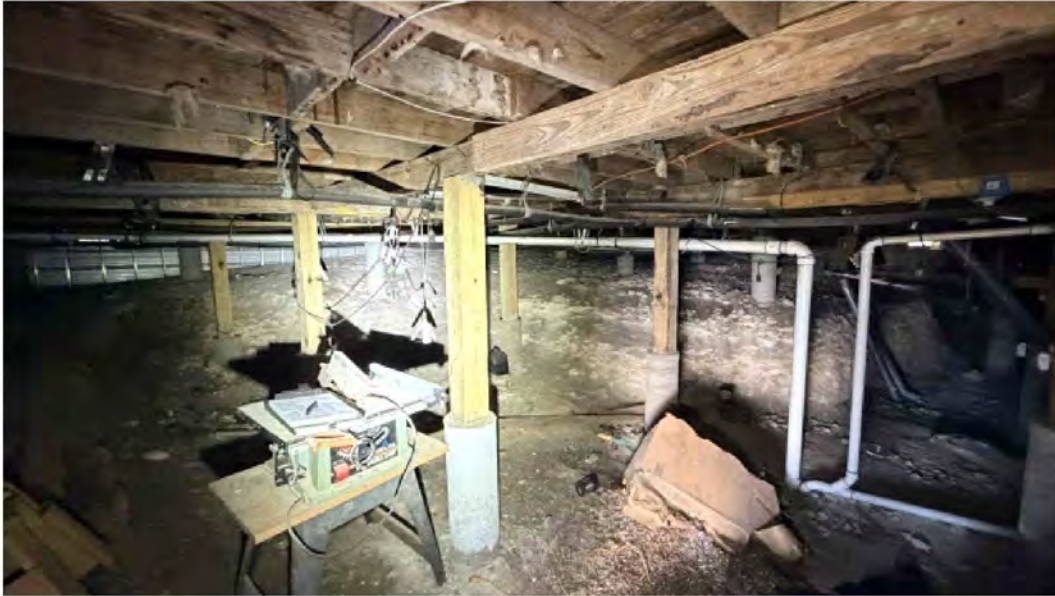
Photo 21

Crawl space view. No fire impacted area was observed.

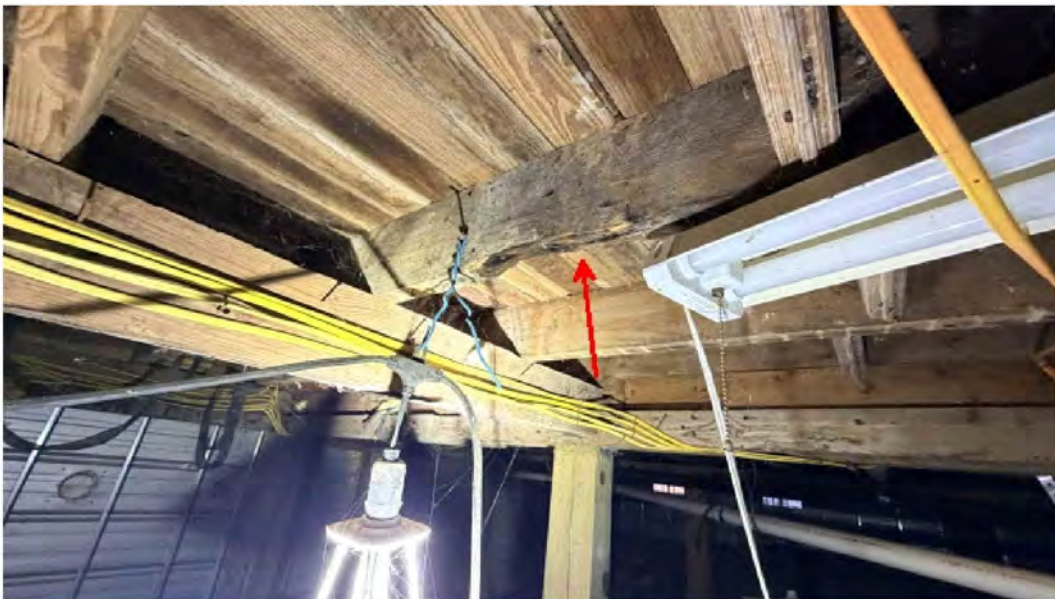
Photo 22

Crawl space view. Deteriorated wood members were observed.

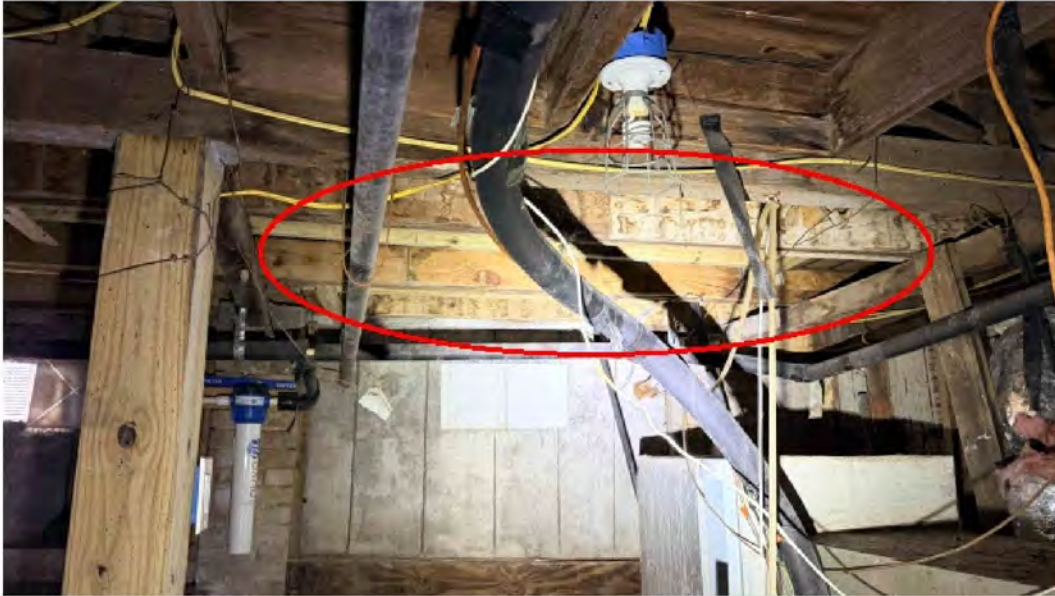
Photo 23

Crawl space view. Deteriorated and/or previously repaired wood members were observed.

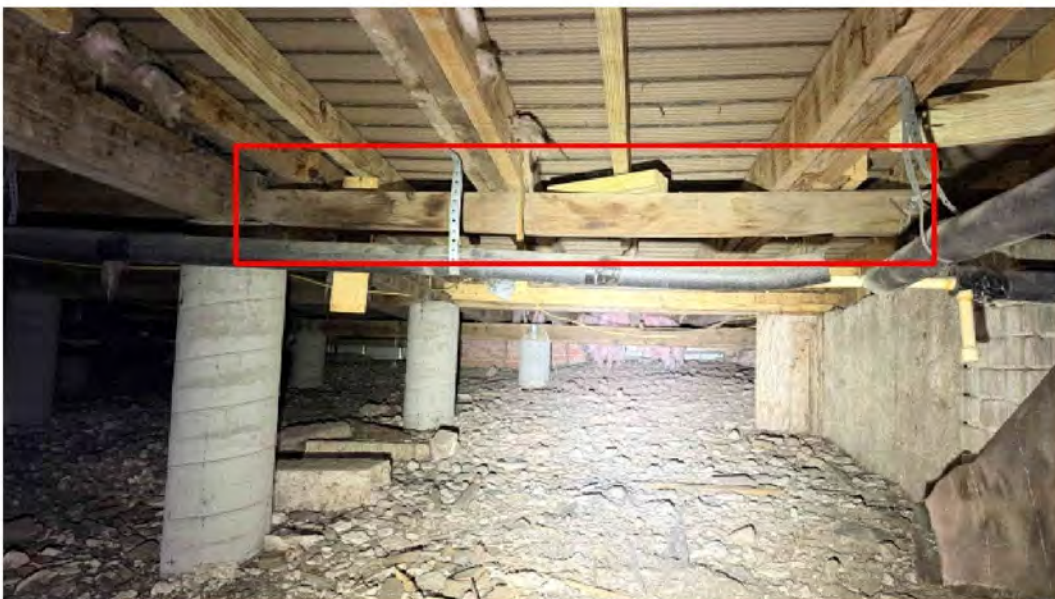
Photo 24

Crawl space view. Note deflected wood beam.

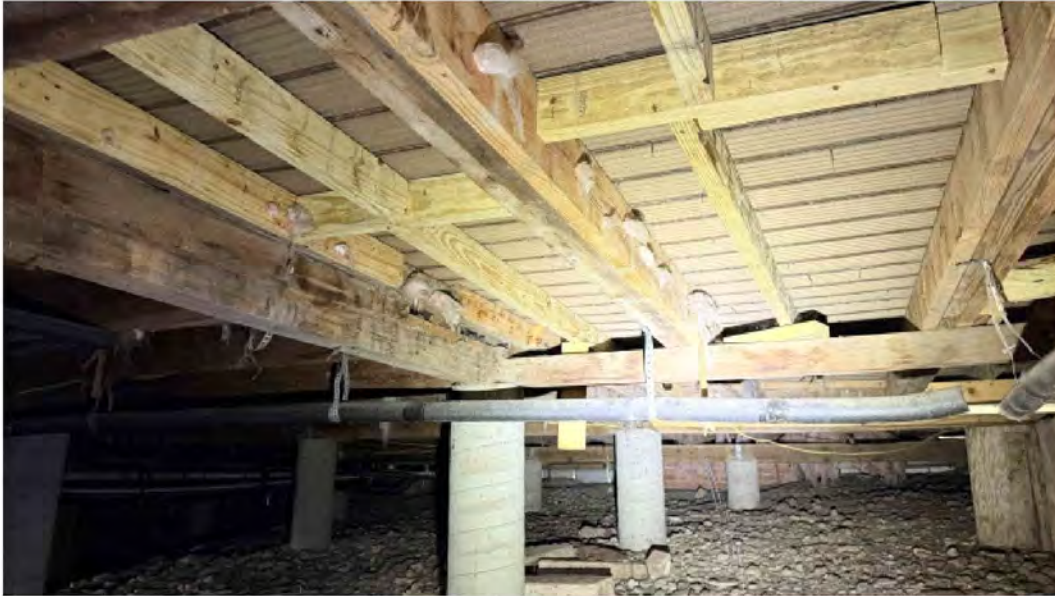
Photo 25

Crawl space view. Undersized and improperly repaired wood members were observed.

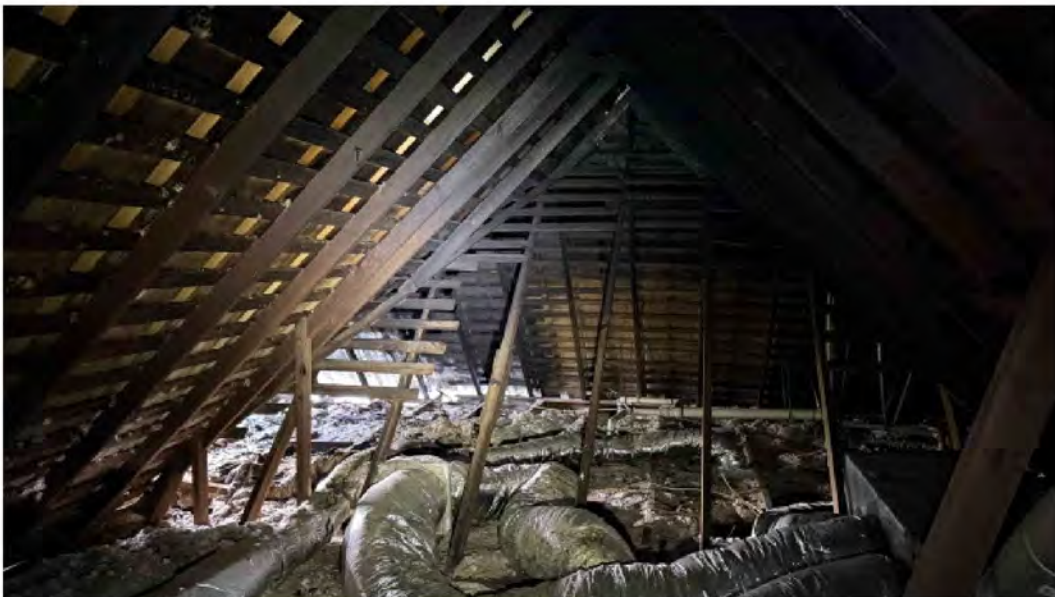
Photo 26

Attic view. Note fire affected roof members.

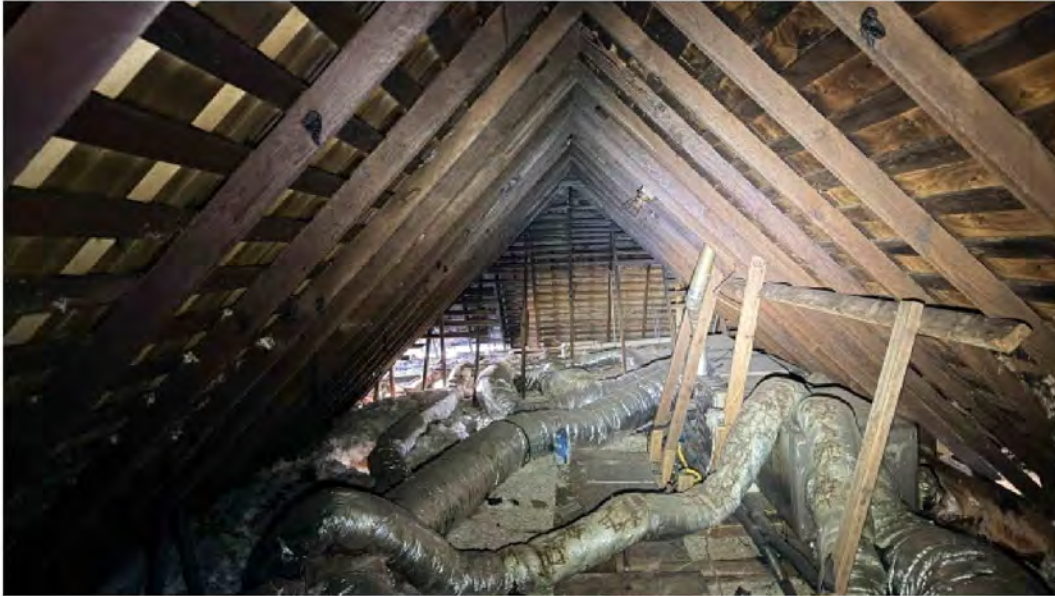
Photo 27

Attic view. Note fire affected roof members.

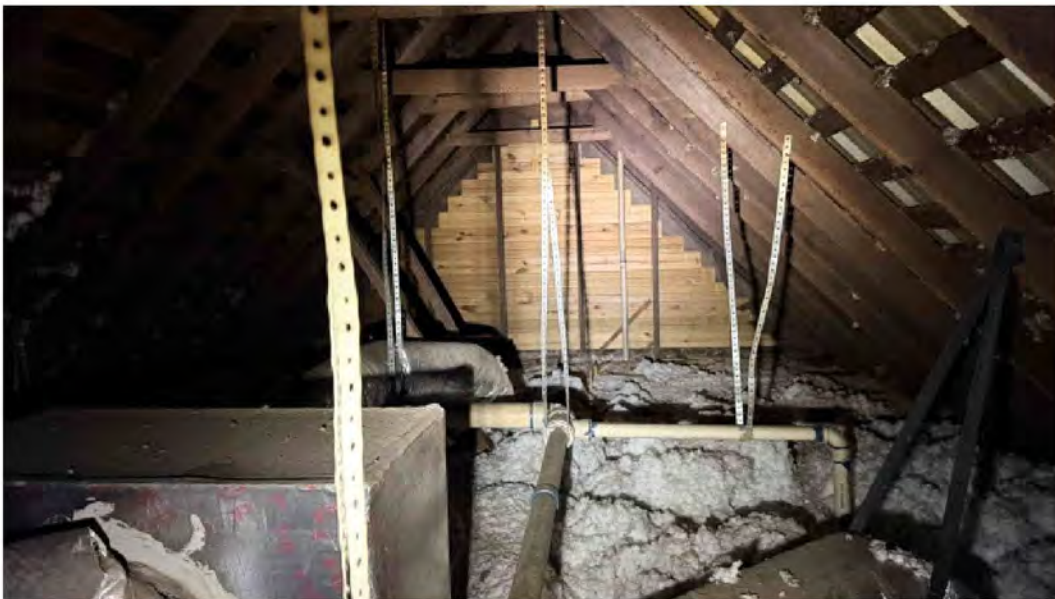
Photo 28

Attic view. No fire impacted members were noted above the kitchen area.
