MEMORANDUM

SUBJECT: Life Safety and Permitting Issues at Nixta Taqueria

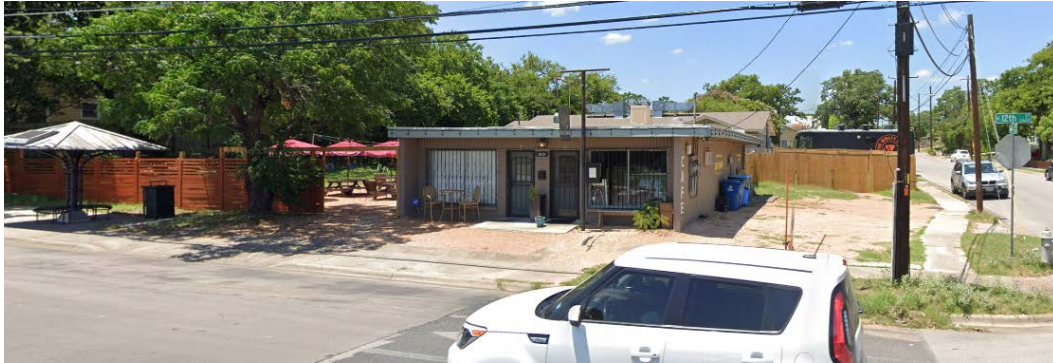
June 2018 - Privacy fence and outdoor seating added. Still operating as Cultivo.

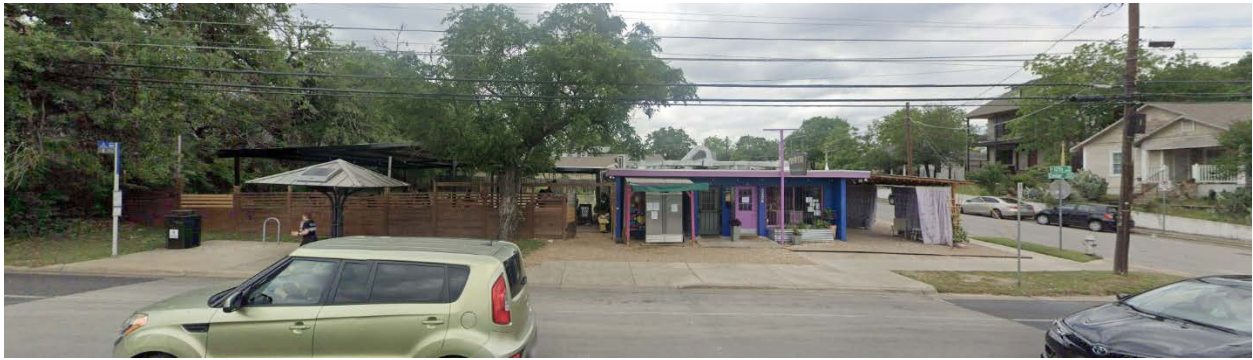
- **Fire safety due to outdoor expansion.** When the roof was extended to build an unpermitted outdoor area, the meters became enclosed under the roof extension and no longer meet safety clearance requirements. The Austin Fire Department needs to conduct an inspection to determine any changes to occupancy because of the outdoor expansion. Additional fire safety equipment may be required and another fire exit may need to be added.

April 2022 – To right of building, outdoor covered seating and lighting added. To left of building, outdoor bar and more seating added – both covered by a structure connected to the main building.

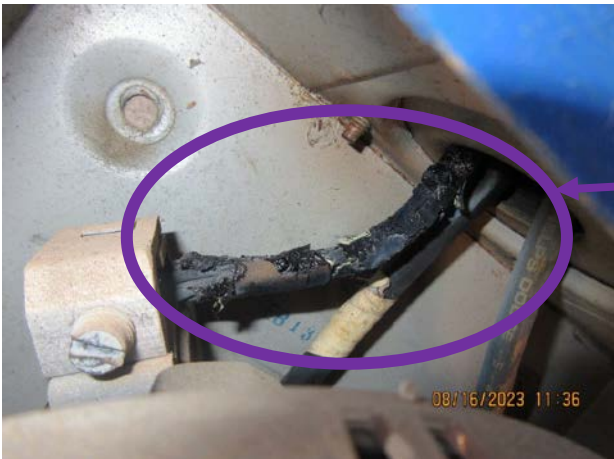
On August 16, 2023, an Austin Energy (AE) high heat alarm was triggered because an electric meter overheated at Nixta Taqueria. The building is divided into two suites and utilizes two meters. The AE technician found burned wires on the business owners' side of the meter and determined that the business was using too much amperage. This presents a severe risk of fire or explosion and a threat to public safety. Therefore, AE disabled one of the meters and left a Notice of Electrical Hazard with the business owner.

August 16, 2023 – An Austin Energy (AE) high heat alarm was triggered because an electric meter overheated at Nixta Taqueria. Upon arrival, the AE technician found melted and frayed wires causing a threat to public health, safety, and property, which resulted in AE removing the meter.

Burned wires.
