**ITEM FOR ZONING AND PLATTING COMMISSION AGENDA**

**PROJECT NAME:** Woodlawn Baptist Church

**SITE PLAN:** SP-2010-0158C

**SUBJECT:** Woodlawn Baptist Church  
SP-2010-0158C

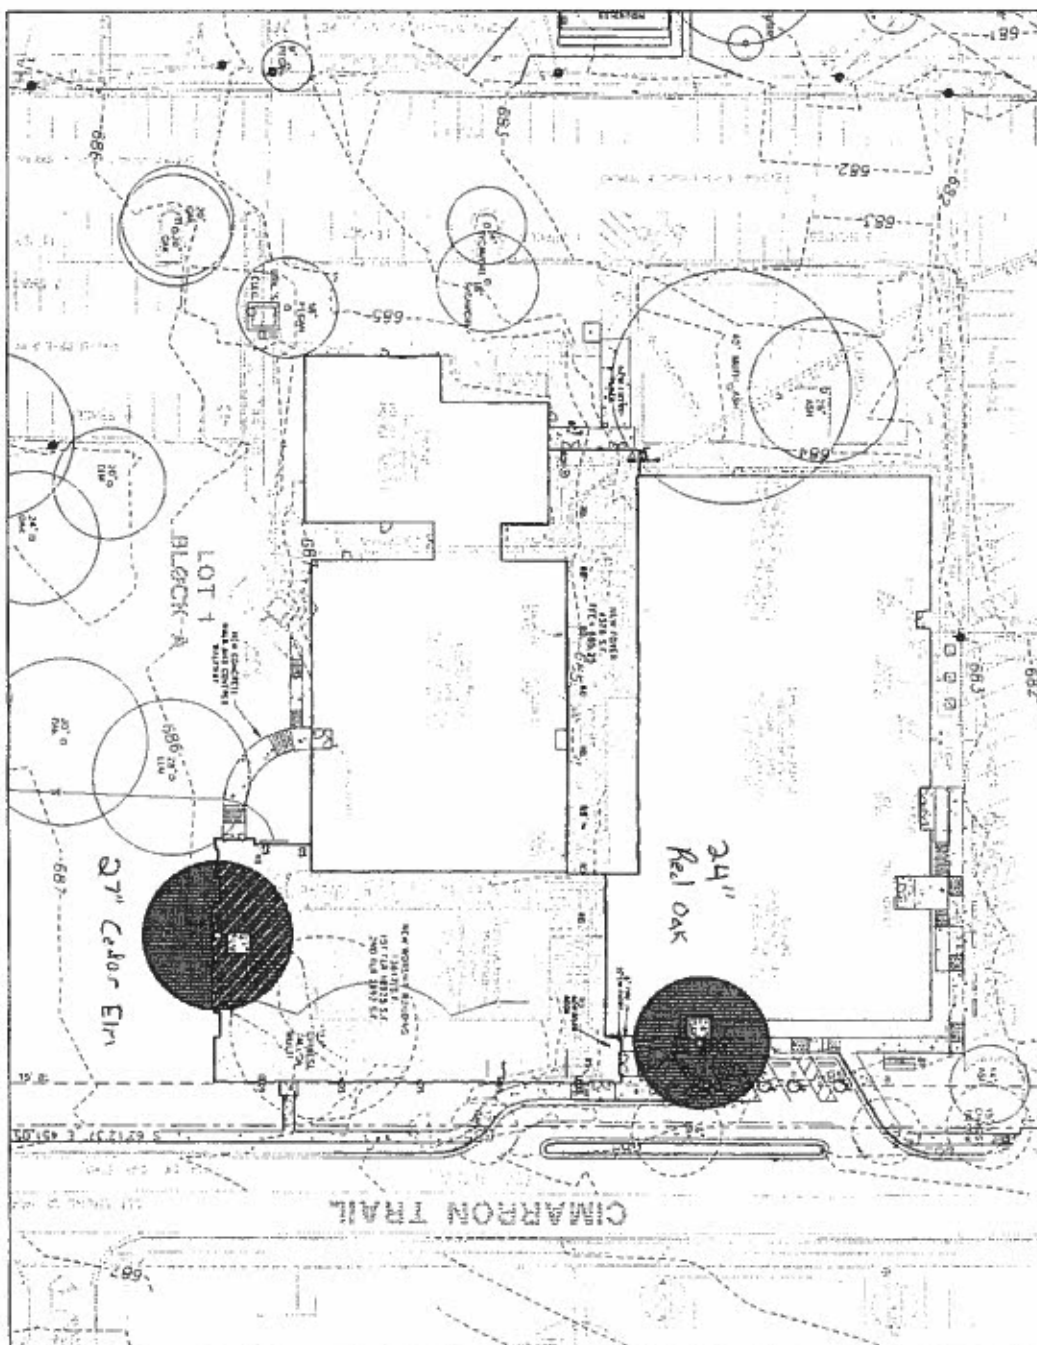
Exhibit # 1

Two heritage size trees are proposed to be removed. The subject trees are a 27" dbh Cedar Elm (*Ulmus crassifolia*) located just within the footprint of the proposed worship hall and a 24" non-native Red Oak (*Quercus spp.*) located within the footprint of the proposed parking spaces (Exhibit 1).

HERITAGE TREE EXHIBIT - 24" <sup>Red</sup> OAK AND 27" ELM  
(LOCATIONS SHOWN IN RED)

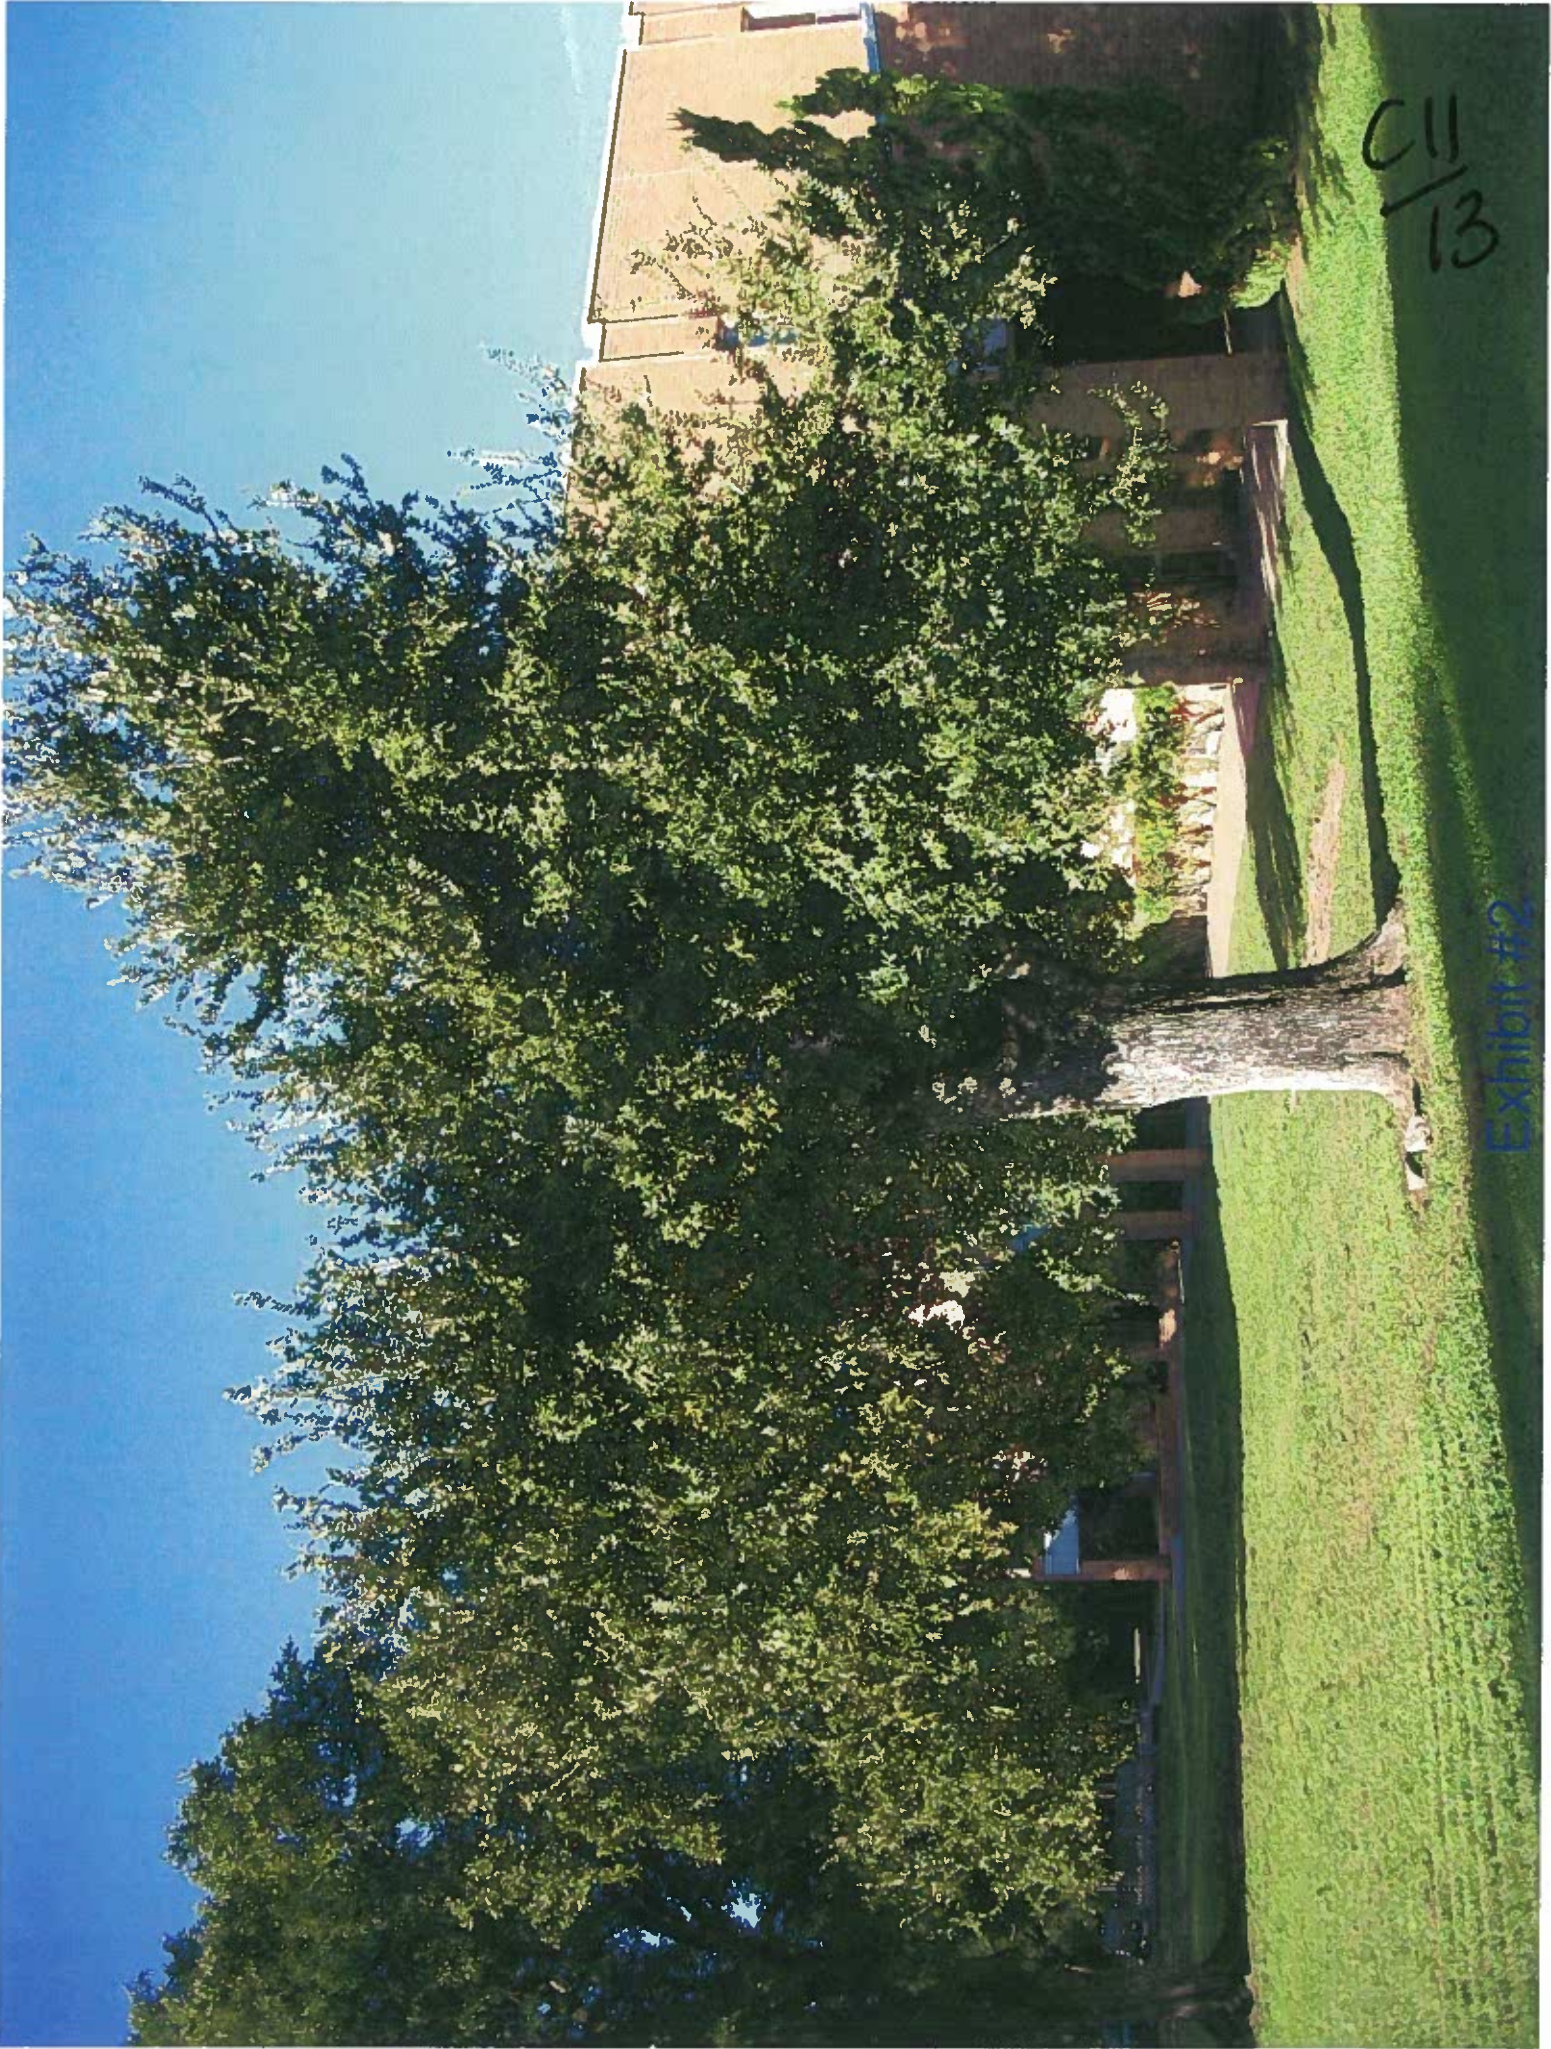
Based on a September 28, 2010, tree assessment, the 27" Cedar Elm displays severe structural defects. The main leader of the subject tree is no longer present (Exhibit 2). This defect is likely due to either storm damage or improper pruning. Further, at some point in the past the subject tree likely had two stems, possibly codominate. One of the stems is no longer present (Exhibit 3). This defect is also likely due to either storm damage or improper pruning. The absence of a main leader has resulted in lateral bud growth and an imbalanced canopy (Exhibit 4). This has further exacerbated the structural weakness of the tree already weakened by decay and poorly attached adventitious stems (Exhibit 5).

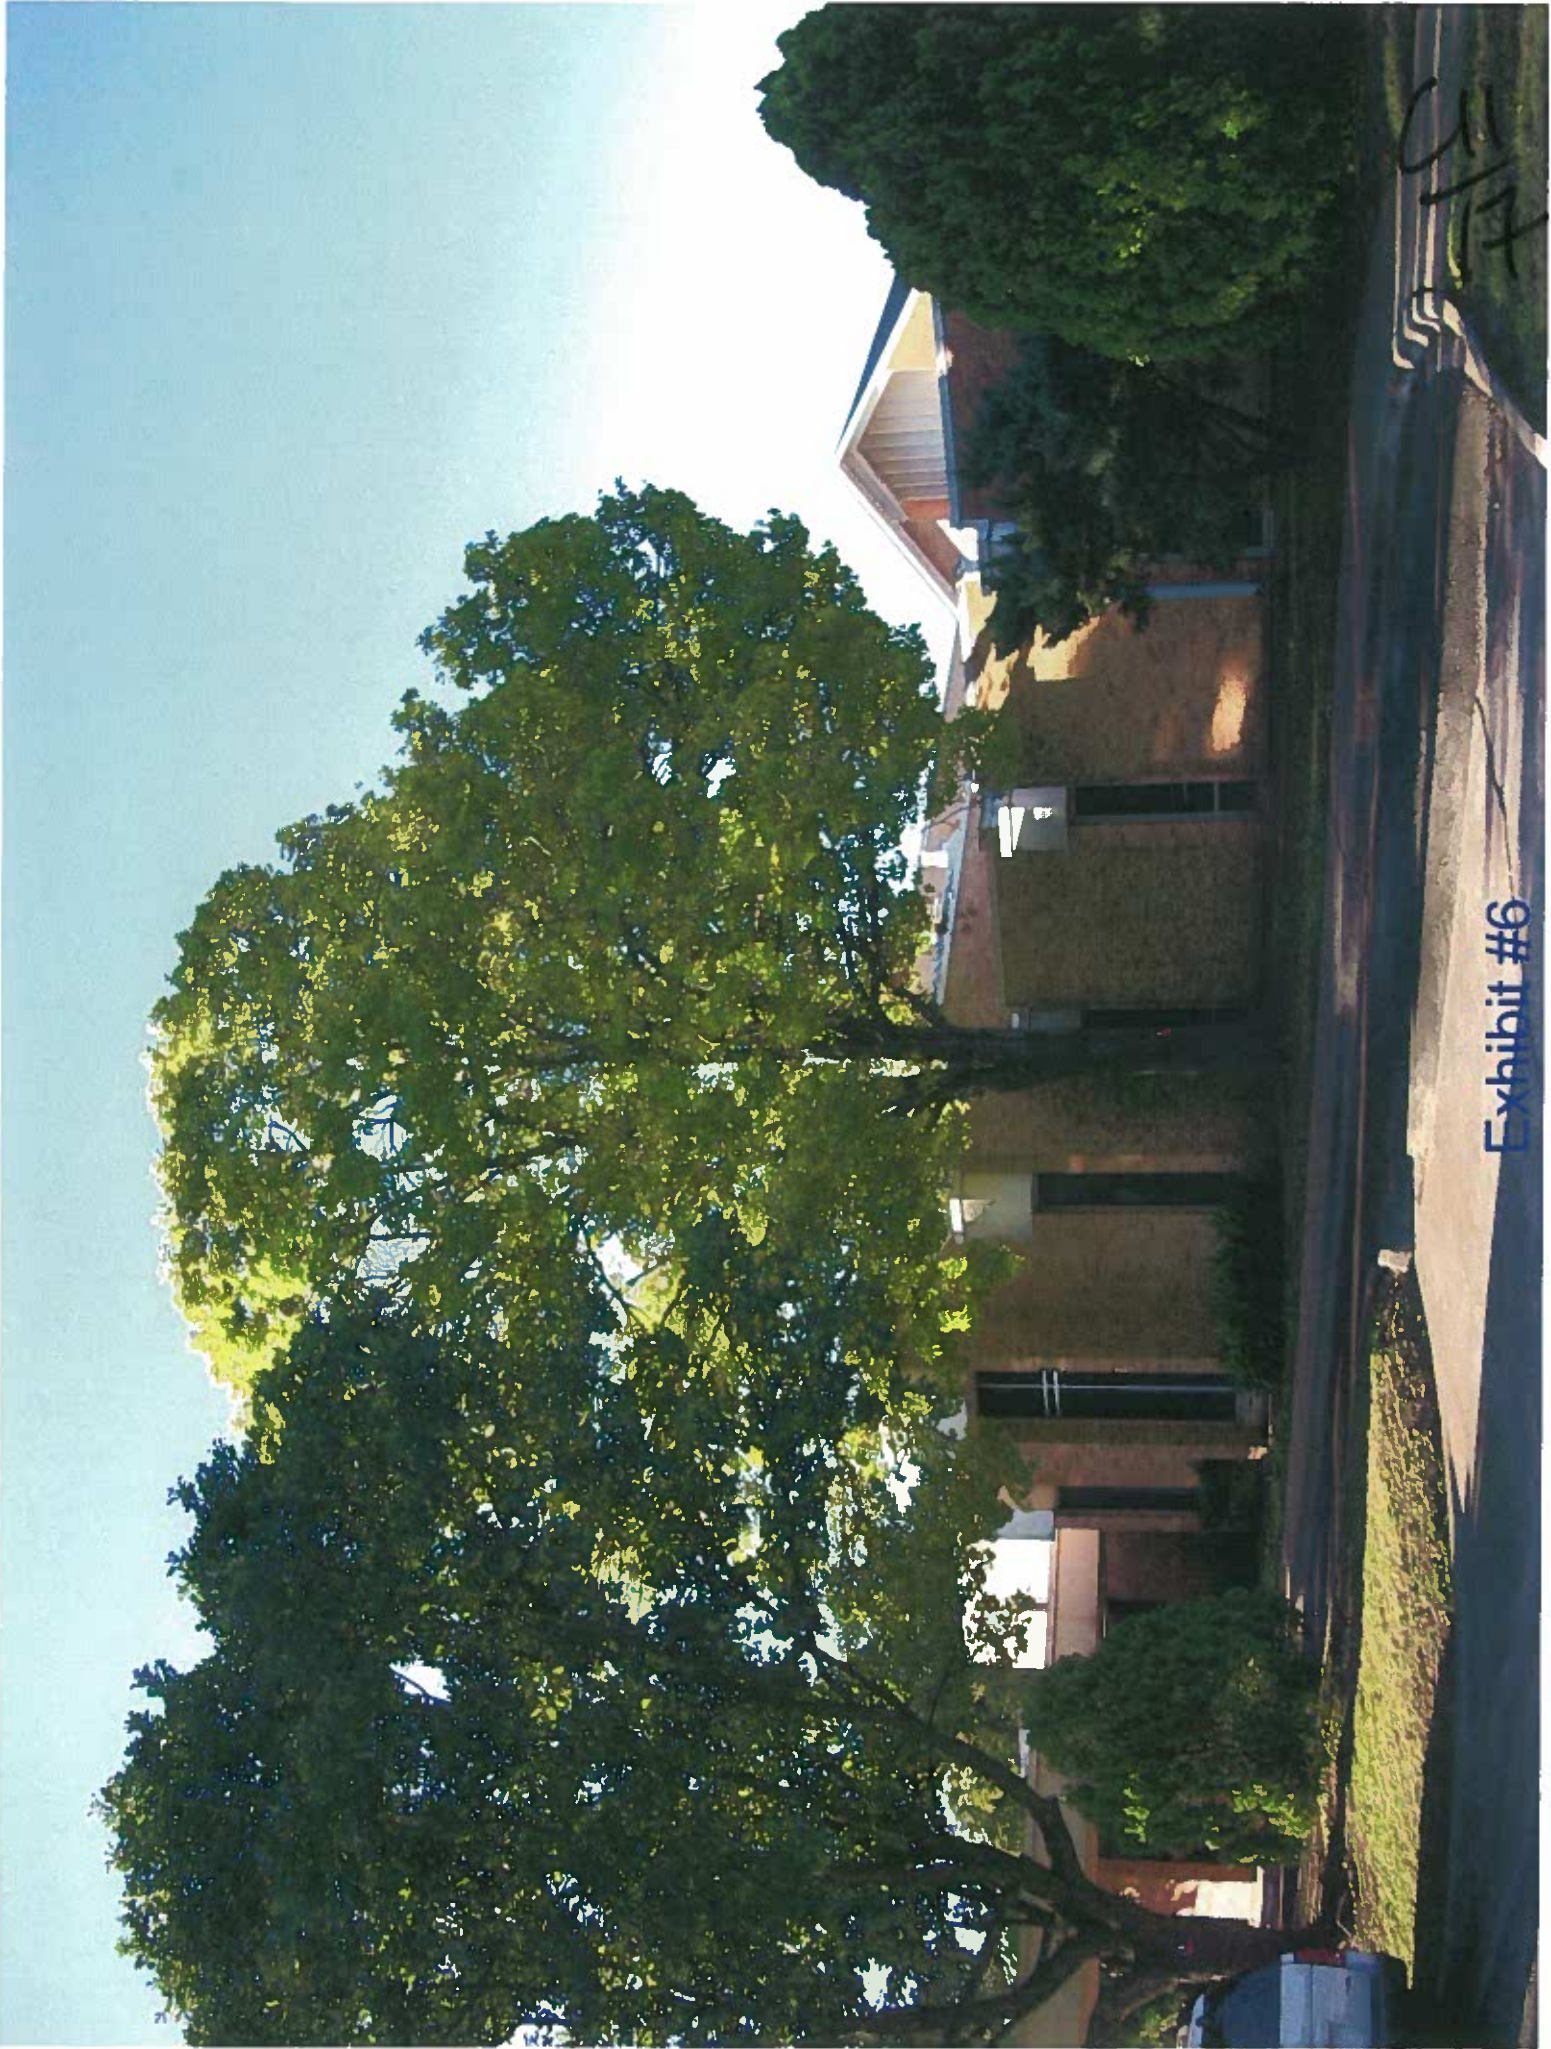
Exhibit #6

Based on a September 28, 2010, tree assessment the 24" Red Oak (*Quercus spp.*) was identified as a Red Oak displaying severe symptoms of foliar chlorosis (Exhibit 6). This tree has likely suffered from chronic chlorosis due in part to soil compaction (Exhibit 7) and calcareous soils, but more so from a poor choice in species selection as this species or cultivar of Red Oak does not appear to be a native species based on analysis of the leaf morphology. The subject tree appears to be either (1) a cultivar of *Quercus shumardii* or (2) a species of red oak from the southeastern United States. Either way, the tree species is likely adapted to more acidic soils than the existing soil conditions.

Chlorosis, which is the loss or reduced development of chlorophyll, is typically due to a micronutrient deficiency in iron, manganese, and/or zinc. These minerals are essential to chlorophyll production. In turn, chlorophyll is necessary for photosynthesis. In soils with a pH greater than 6.5 these minerals may be present, but may not be readily available for uptake by the plant. The resulting symptom of this soil condition is displayed by intervenial chlorosis in the foliage (Exhibit 8). In this case, long-term treatment of chlorotic leaves or modifying the soil conditions surrounding the tree are not feasible options to correct this condition. These options are costly, timely, and unlikely to correct the chlorosis. Foliar sprays only provide temporary results as they treat the leaves not the soil. Injections into the vascular tissue of the tree only provide temporary results as well. Soil treatments attempt to lower the soil pH though this depends on the soil chemistry, depth of treatment, and other factors that may not be able to be adequately modified to address the chlorotic conditions of the tree.
