MEMORANDUM

SUBJECT: Investigation of Bull Creek Tributary 4 near Spicewood Springs Road

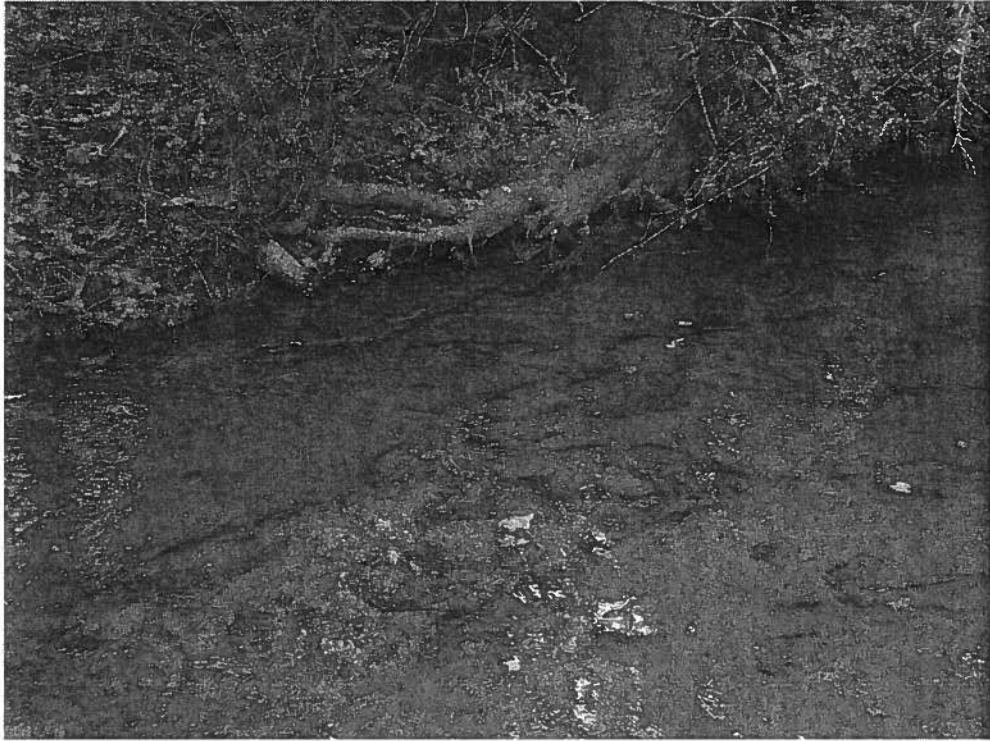
Several interesting features were identified in this creek reach. A zone of maidenhair fern was observed on the east bank of the channel (Photo 2) about midway downstream of the culvert. Water was pooled on the bedrock surface but no flowing water was seen. This feature probably qualifies as a Critical Environmental Feature by City of Austin standards. A knob of rock on the west bank adjacent to a plunge pool about 20 feet downstream may indicate seepage from the west bank at the same horizon but does not appear to qualify as a CEF.

Photo 2. Seepage horizon on east side of Tributary 4.

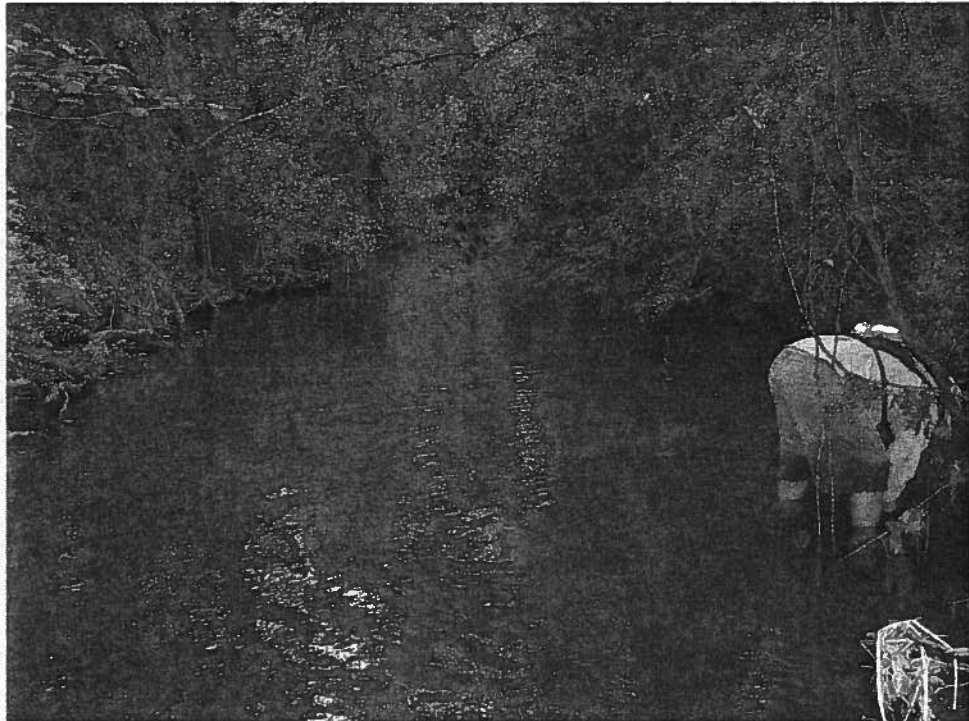
Photo 3. Tributary 4 channel showing pits in limestone bedrock.

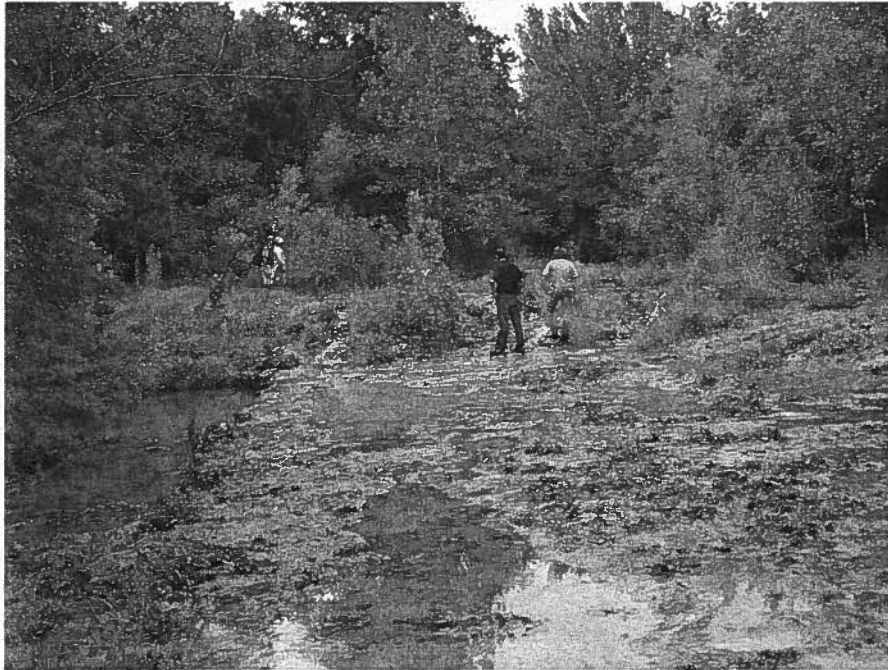
Photo 4. Watershed staff checking pit areas in channel bedrock for salamanders.

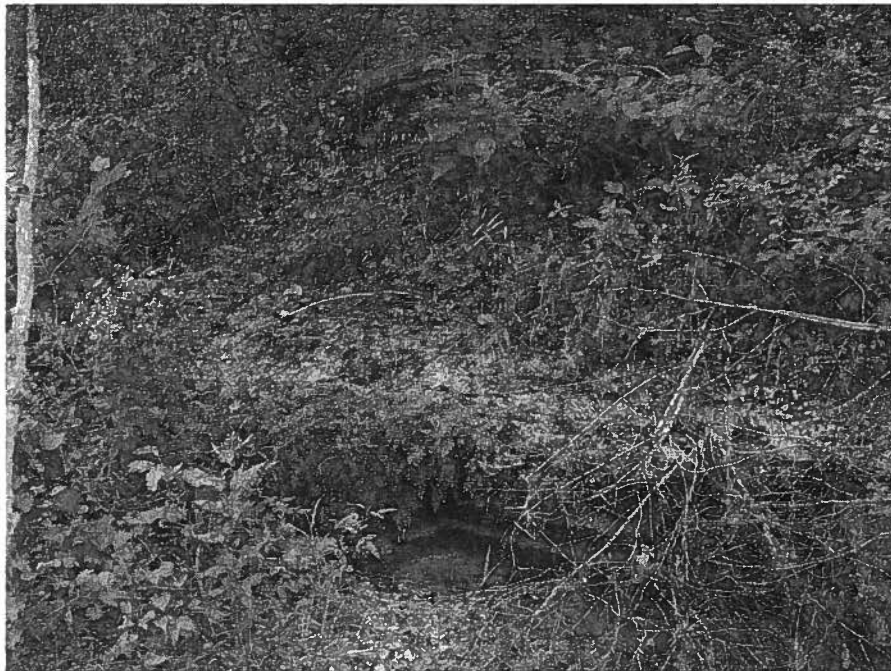
A second zone of potential seepage was identified further in a shallow pool downstream (Photo 1) on the west bank consisting of an alluvial bank with maidenhair and wood ferns with an overhanging bank at the water level. The channel floor was relatively flat bedrock with local tight fractures trending N33°E and numerous pits (Photo 3). Elevation of the channel here is approximately 712 ft. This area is similar in appearance to a site in Balcones Canyonlands Preserve with a significant spring containing salamanders. No water was discharging and no salamanders were observed (Photo 4). This bedrock character extended to the confluence with Bull Creek. The two channels contained numerous small travertine dams at the confluence (Photo 5). The zone of ferns is likely a CEF but the channel pits do not appear to be at this time.

Photo 5. Confluence of Tributary 4 on right with Bull Creek at center and left.

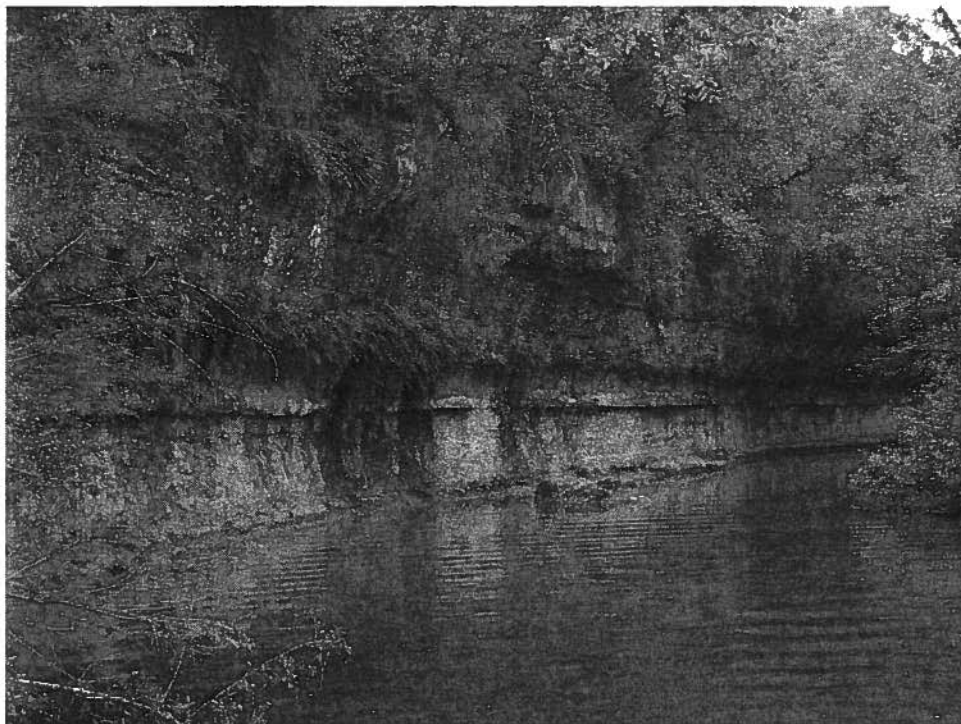
A small spring was identified on the west bank about 100 feet downstream of the stream confluence characterized by maidenhair fern, travertine deposition and a small amount of water dripping off the ledge (Photo 6). This spring qualifies as a CEF. The spring appears to originate from a burrowed layer of limestone about 2 ft thick. A bluff about 100 ft downstream shows the same intervals seen in the tributary channel with two zones of seepage highlighted by ferns (Photo 7). The lower zone appears to correspond to the small spring and the upper zone with the seepage area first seen downstream of the culvert. A description of a core taken from hole JT-120 at the intersection of Spicewood Springs Rd and Old Lampasas Trail between 300-800 ft away from the seepage locations (Photo 1) encountered burrowed dolomitic limestone and dolomite beginning at an elevation of 712.2 ft, about the same elevation as the creek channels. This boring also noted a water table at an elevation of 706.8 ft which could be the same zone as the springs and seeps are located in.

Photo 6. Small spring on west bank of Bull Creek downstream of confluence.
