ITEM FOR ENVIRONMENTAL BOARD AGENDA

PROJECT NAME: Block at 26th Street

SUBJECT: Block at 26th Street
SP-2011-0032C.SH

Re: Block at 26th Street (SP-2011-0032C.SH) – Tree Variance Request

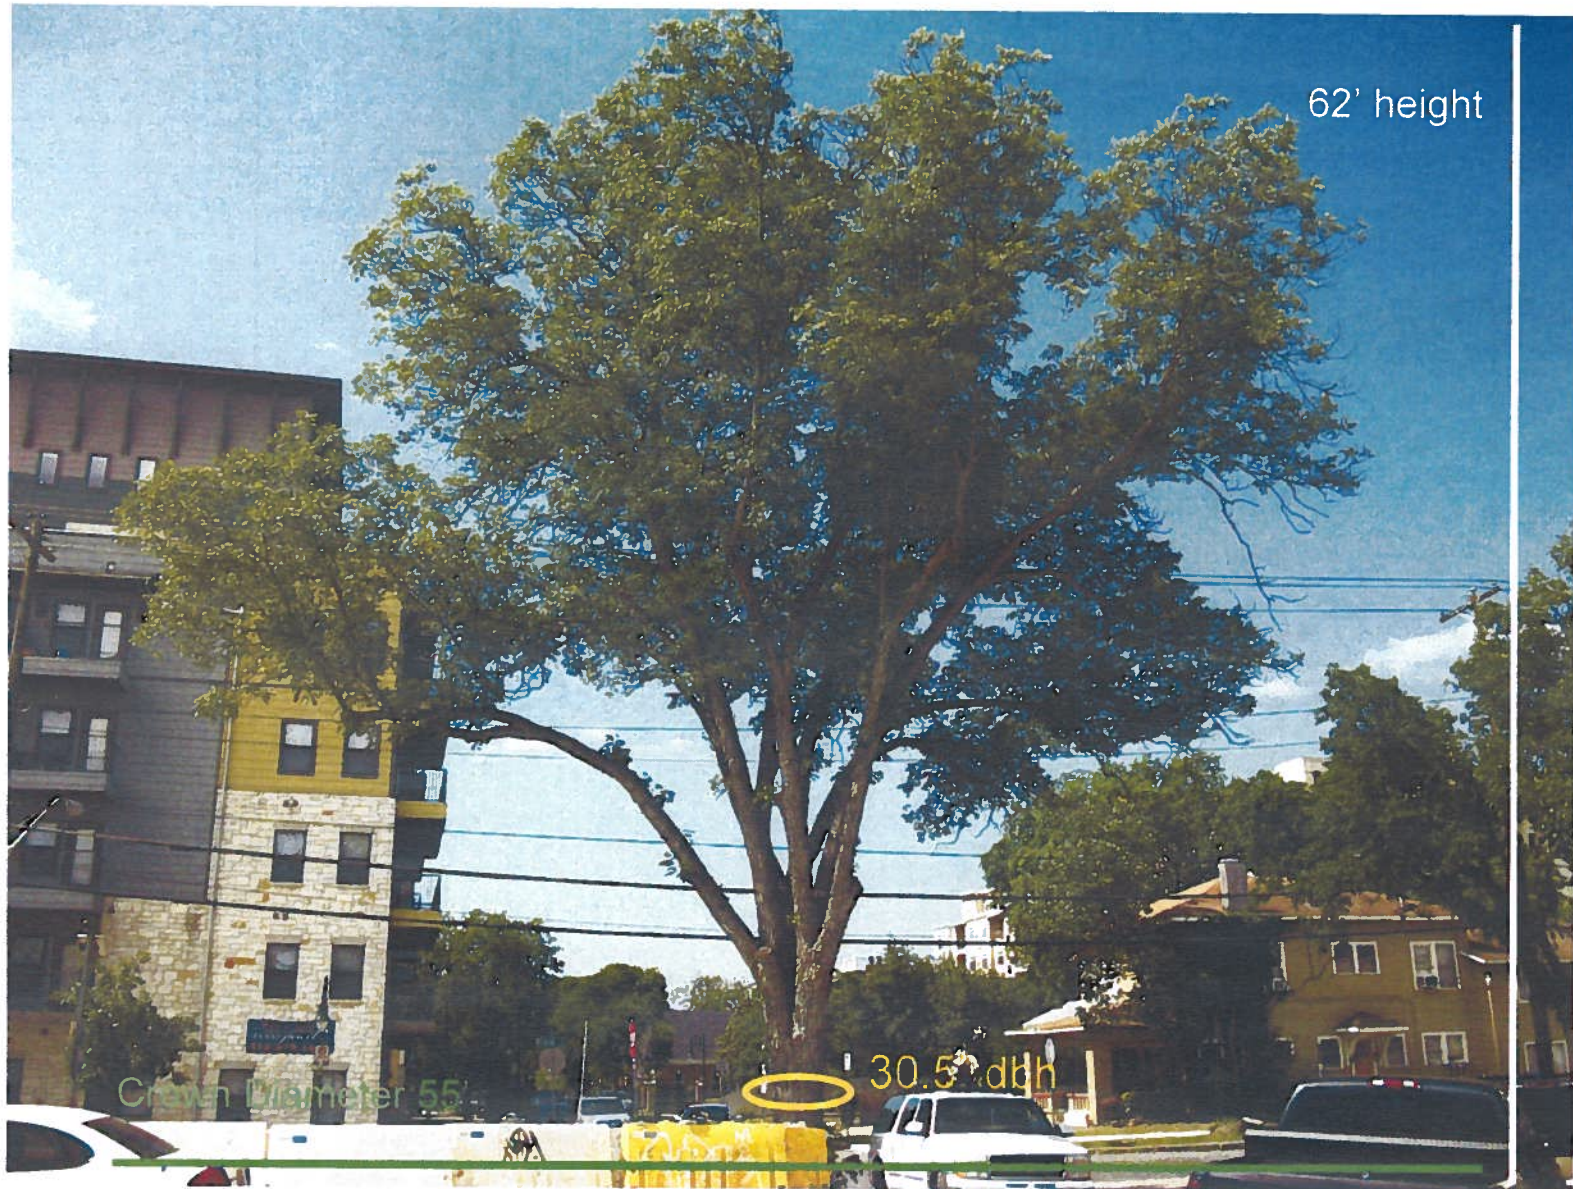
Exhibit #2

The subject tree is a 30.5 inch diameter at breast height (dbh) Pecan (*Carya illinoensis*). The tree height is 63 feet and the canopy spread is 55 feet (Exhibit 2). The trunk bifurcates into two co-dominate stems at eight feet above grade (Exhibit 3). Storm damage is evident by the presence of broken stems, though no noticeable decay or structural weaknesses are present (Exhibit 4). Minor pruning has occurred for utility clearing and likely from storm damage. There is minor deadwood and tip dieback in the crown though this is not uncommon in *Carya illinoensis* (Exhibit 5). This condition is likely exacerbated by poor soil and extensive compaction in the critical root zone (Exhibit 6). Given the aforementioned conditions, the subject tree is rated 'good' per the City Arborist tree evaluation (Exhibit 7).
