**Table of Contents for Block at 26<sup>th</sup> street**  
**Heritage Tree Variance Package**

**PROJECT NAME:** Block at 26<sup>th</sup> Street

**SITE PLAN:** SP-2011-0032C.SH

**SUBJECT:** Block at 26<sup>th</sup> Street  
SP-2011-0032C.SH

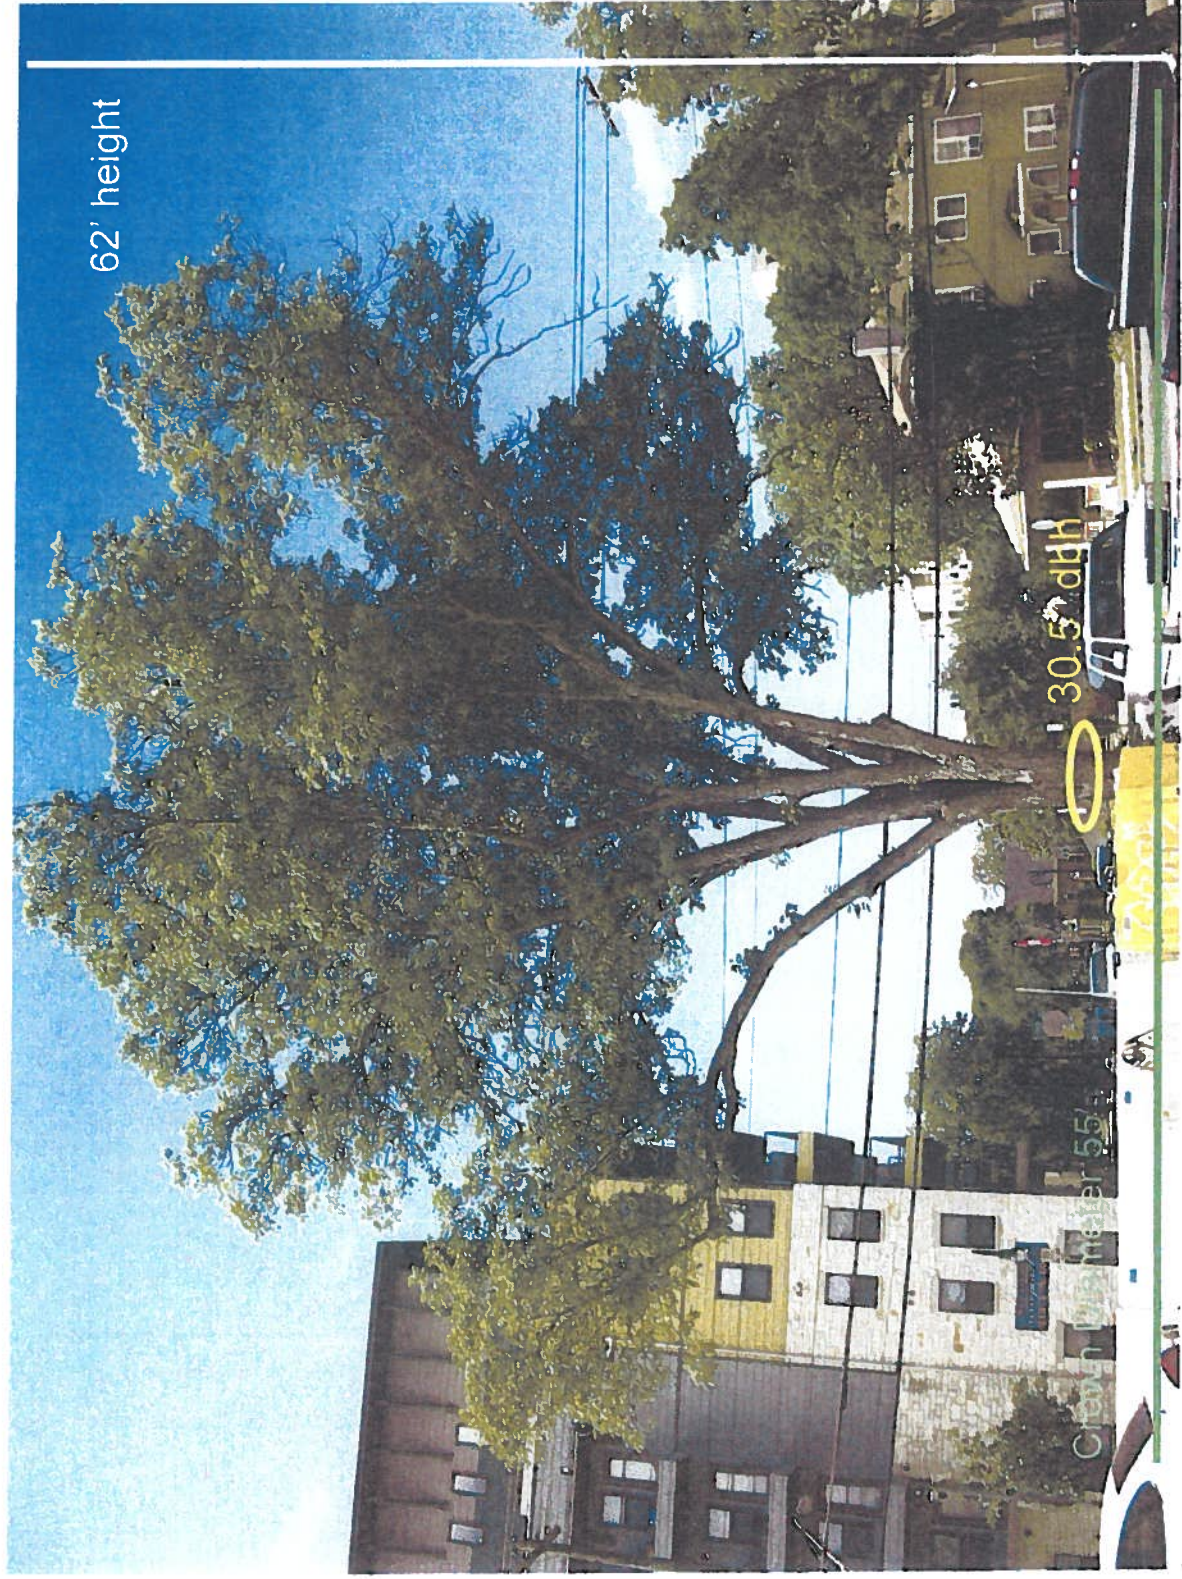
Exhibit #2

The subject tree is a 30.5 inch diameter at breast height (dbh) Pecan (*Carya illinoensis*). The tree height is 63 feet and the canopy spread is 55 feet (Exhibit 2). The trunk bifurcates into two co-dominate stems at eight feet above grade (Exhibit 3). Storm damage is evident by the presence of broken stems, though no noticeable decay or structural weaknesses are present (Exhibit 4). Minor pruning has occurred for utility clearing and likely from storm damage. There is minor deadwood and tip dieback in the crown though this is not uncommon in *Carya illinoensis* (Exhibit 5). This condition is likely exacerbated by poor soil and extensive compaction in the critical root zone (Exhibit 6). Given the aforementioned conditions, the subject tree is rated 'good' per the City Arborist tree evaluation (Exhibit 7).

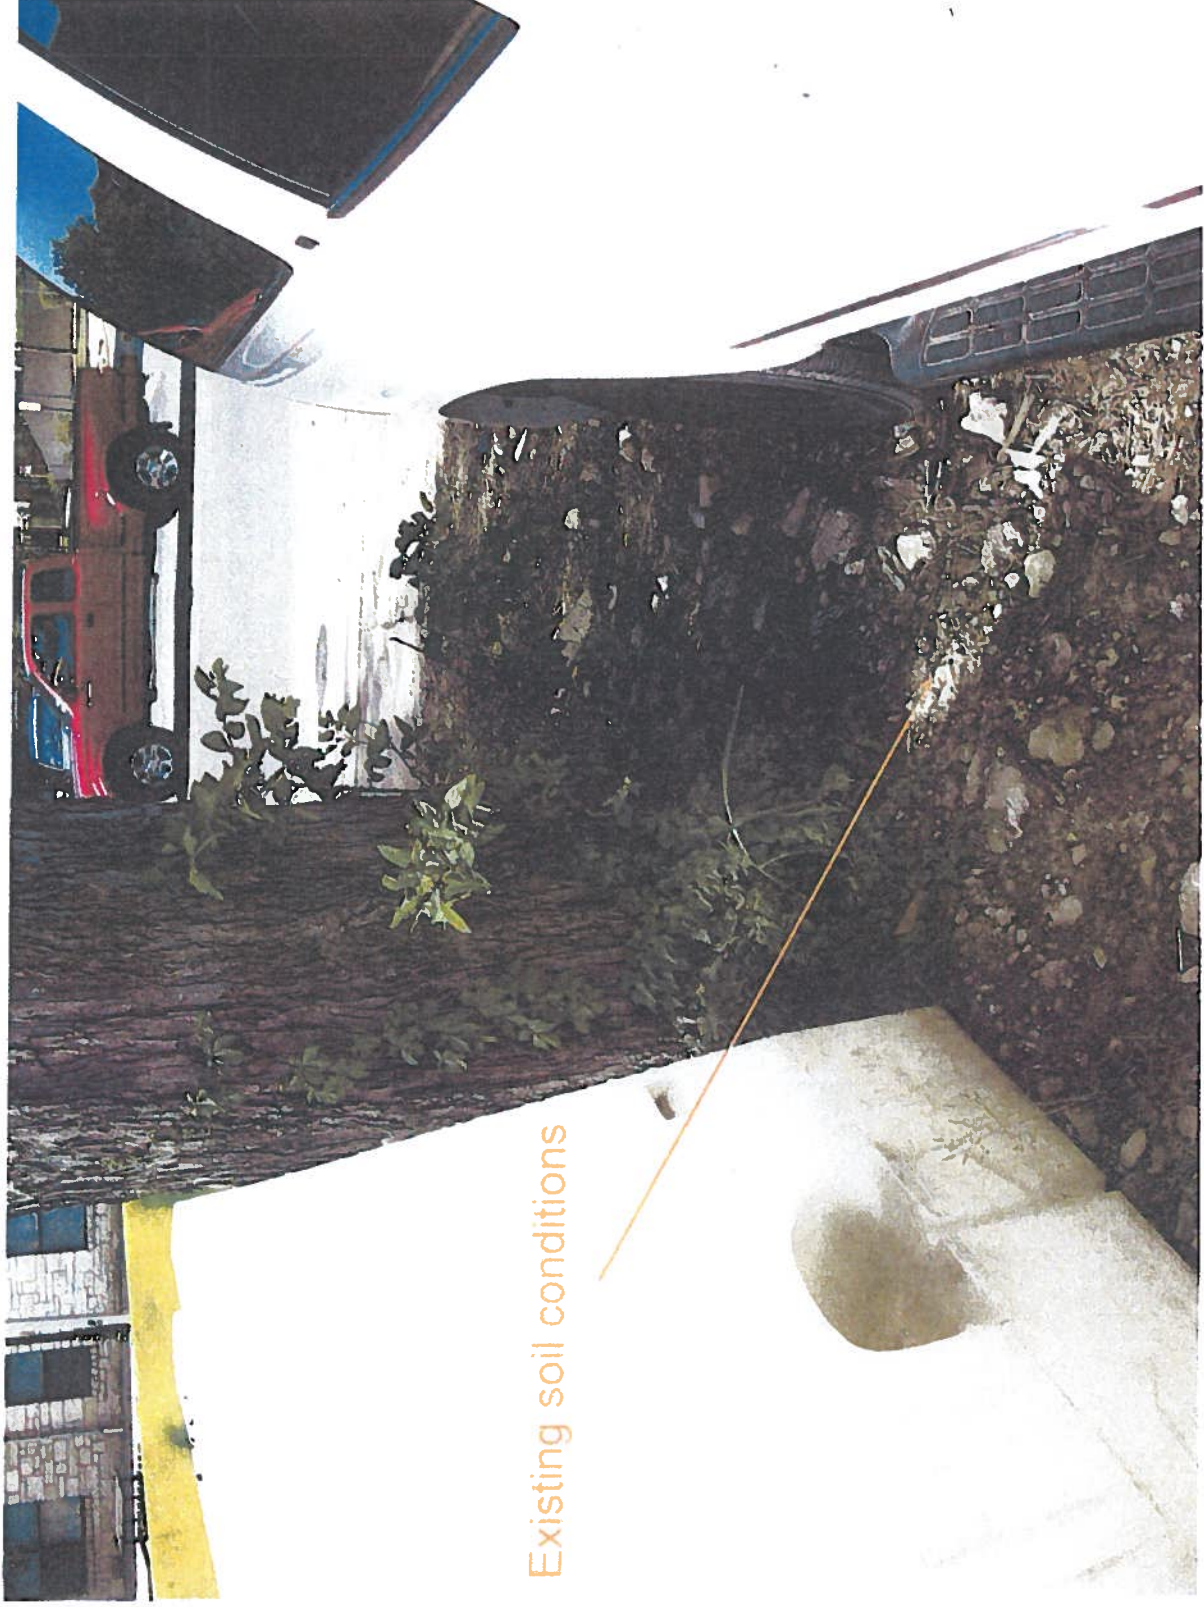
Exhibit #6

Existing soil conditions

- 300 percent mitigation.
- Applicant is to work with the Parks and Recreation Department to develop a tree care and/or tree planting program on public property within Shoal Creek Watershed.
- Tree care is provided by a certified arborist for the existing rights-of-way trees to remain onsite. Existing planter beds should also be expanded and soil conditions improved.
