### ITEM FOR ENVIRONMENTAL BOARD AGENDA

Block at 26th Street

SP-2011-0032C.SH

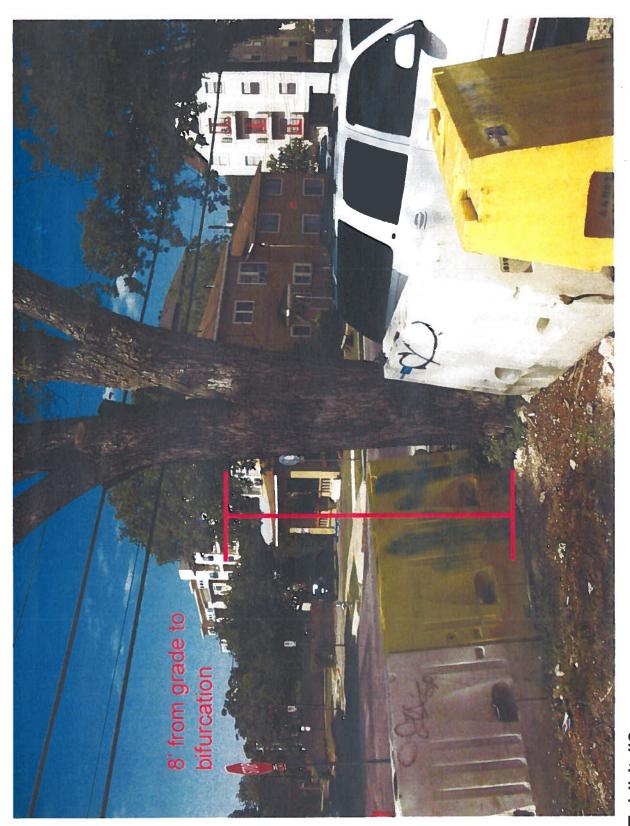
Exhibit #3

The subject tree is a 30.5 inch diameter at breast height (dbh) Pecan (Carya illinoensis). The tree height is 63 feet and the canopy spread is 55 feet (Exhibit 2). The trunk bifurcates into two co-dominate stems at eight feet above grade (Exhibit 3). Storm damage is evident by the presence of broken stems, though no noticeable decay or structural weaknesses are present (Exhibit 4). Minor pruning has occurred for utility clearing and likely from storm damage. There is minor deadwood and tip dieback in the crown though this is not uncommon in Carya illinoensis (Exhibit 5). This condition is likely exacerbated by poor soil and extensive compaction in the critical root zone (Exhibit 6). Given the aforementioned conditions, the subject tree is rated 'good' per the City Arborist tree evaluation (Exhibit 7).
