Table of Contents for Bowie Street Tree Permit
Heritage Tree Variance Package

PROJECT NAME: 311,313,315 Bowie Street

TREE PERMIT: 10617196

Tree Assessment Report

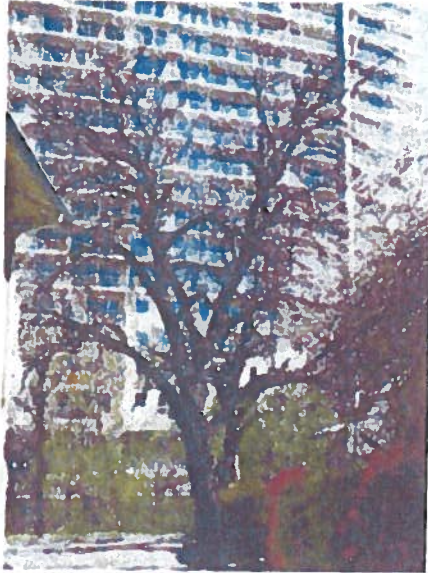
Located at the right rear of the Consort office, this tree stands approximately 60 feet in height. The stem leans 5 degrees toward the north, but the tree architecture is balanced. The crown is medium for stem size and has approximately 5% dead branches with a maximum size of 5 inches. The branch ends are dense and heavy. Two abrupt bends and a sweep are visible in the scaffold branches. A previous failure of a 6-inch limb is visible. The root flare is mostly exposed, and no evidence of root decay was visible upon excavating the south and east sides of the root collar. The root space is limited.

Tree #6805 is a stable, attractive tree with minor flaws that are typical of older pecans in urban settings. One question on the property is the suitability of this tree to be transplanted. In our experience, large pecan trees are not good candidates for relocation. As pecan is a bona-fide tap root species, transplanting large specimens in deep soils will sever this large root and eventually lead to decay and tree failure. This is due to the difficulty in capturing a deep enough root ball and the associated weight of the transplant.

Left photo – structure of Tree #6805.

Tree #6805, however, is a quality tree in good condition. Relocation of this tree is problematic due to the depth of the root ball needed for a successful transplant and the urban nature of the site. Unless an unusually large root zone were left for this tree, development around this large riparian tree would likely cause enough site disturbance and internal soil drainage changes to cause the tree to decline.

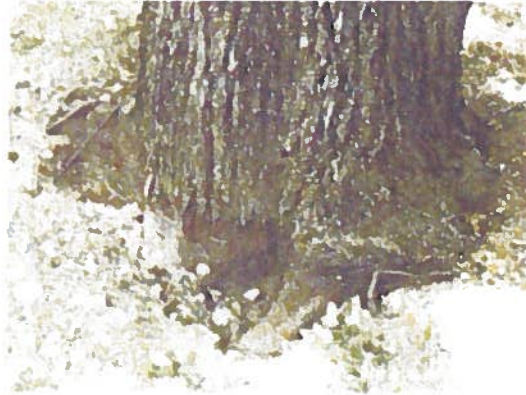
Photo above – root collar of Tree #6805.

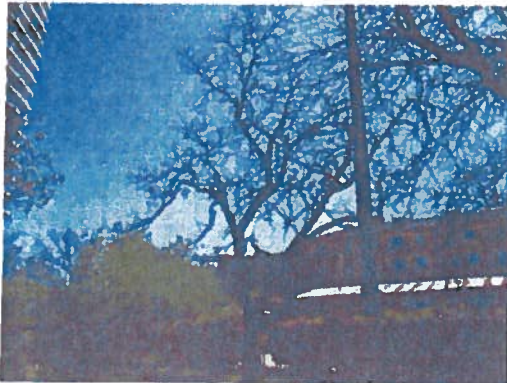
This tree is located at the right rear of the Consort parking lot and stands approximately 55 feet in height. The crown is medium for stem size, and the tree architecture is balanced. About one percent of the branches in the crown are dead with a maximum size of 3 inches. Branch ends are dense and heavy. Five abrupt bends and several previous branch failures are visible. This tree has a codominant-stem structure with a crotch at 8 feet. The codominant stems measure each approximately 19 and 24 inches in diameter. The stem growing to the west displays a 9-inch cavity just above the crotch, and the stem growing east displays a decay column of approximately 12 feet in length and up to 8 inches wide. A crack and borer gallery extend the length of the decay column. A 2" x 10" cavity appears at approximately 4.5 feet on the main stem. Excavation of the south and east sides of the root crown revealed that the root flare is buried with 32 inches of rocky fill, stone, and brick. The excavation did not reveal evidence of decay in the area excavated. The root space is very limited.

Tree #6806 displays numerous problems. Although the canopy gives the appearance of a healthy tree, the structure of the tree has fundamental problems. The east stem is decayed and cracked and highly likely to fail. Abrupt bends in the scaffold branches, previous failures, persistent dead wood and cavities add to the declining and hazardous condition of this tree. The buried root collar and limited root space have likely contributed to the declining condition of the tree and would likely contribute to further decline of this tree over time.

Left photo – structure of Tree #6806.

With regard to tree # 6806, incumbent decay, root collar disorders, and accumulated stress coupled with high traffic in this area and high pedestrian presence make this tree an unreasonable hazard. Removal of this tree is the recommended before development.

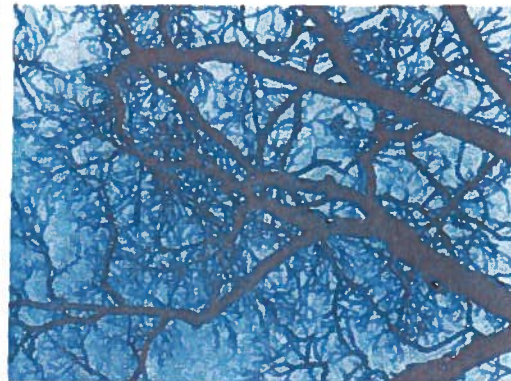
Right photo – abrupt bend in the crown of Tree #6806.

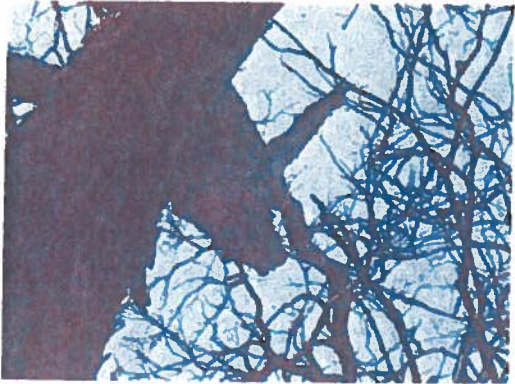
Left photo – decayed east stem and previous storm damage on Tree #6806.

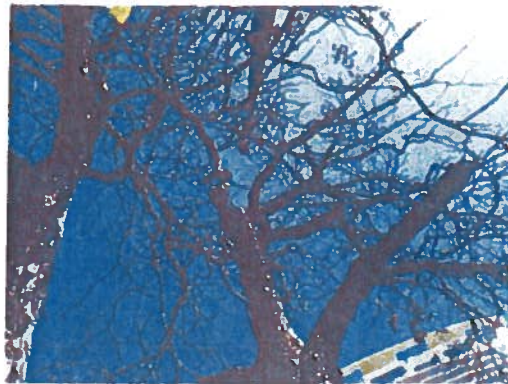
Right photo – broken stubs in Tree #6806 from previous storm damage.

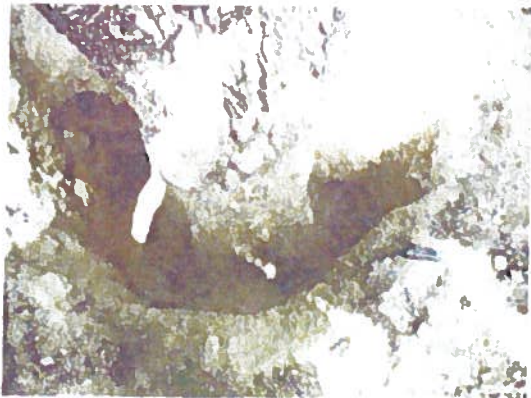
Left photo – view of exposed root collar on the south side of Tree #6806.

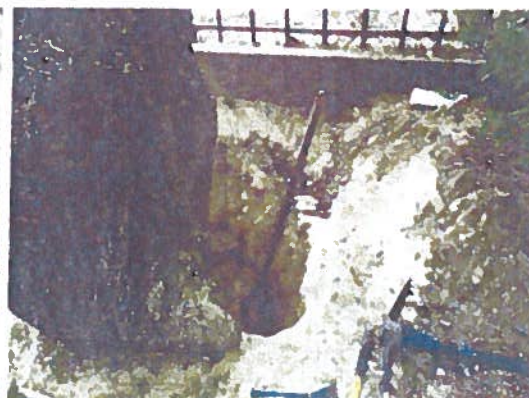
Right photo – view of fill depth (32 inches) over the root collar of Tree #6806.

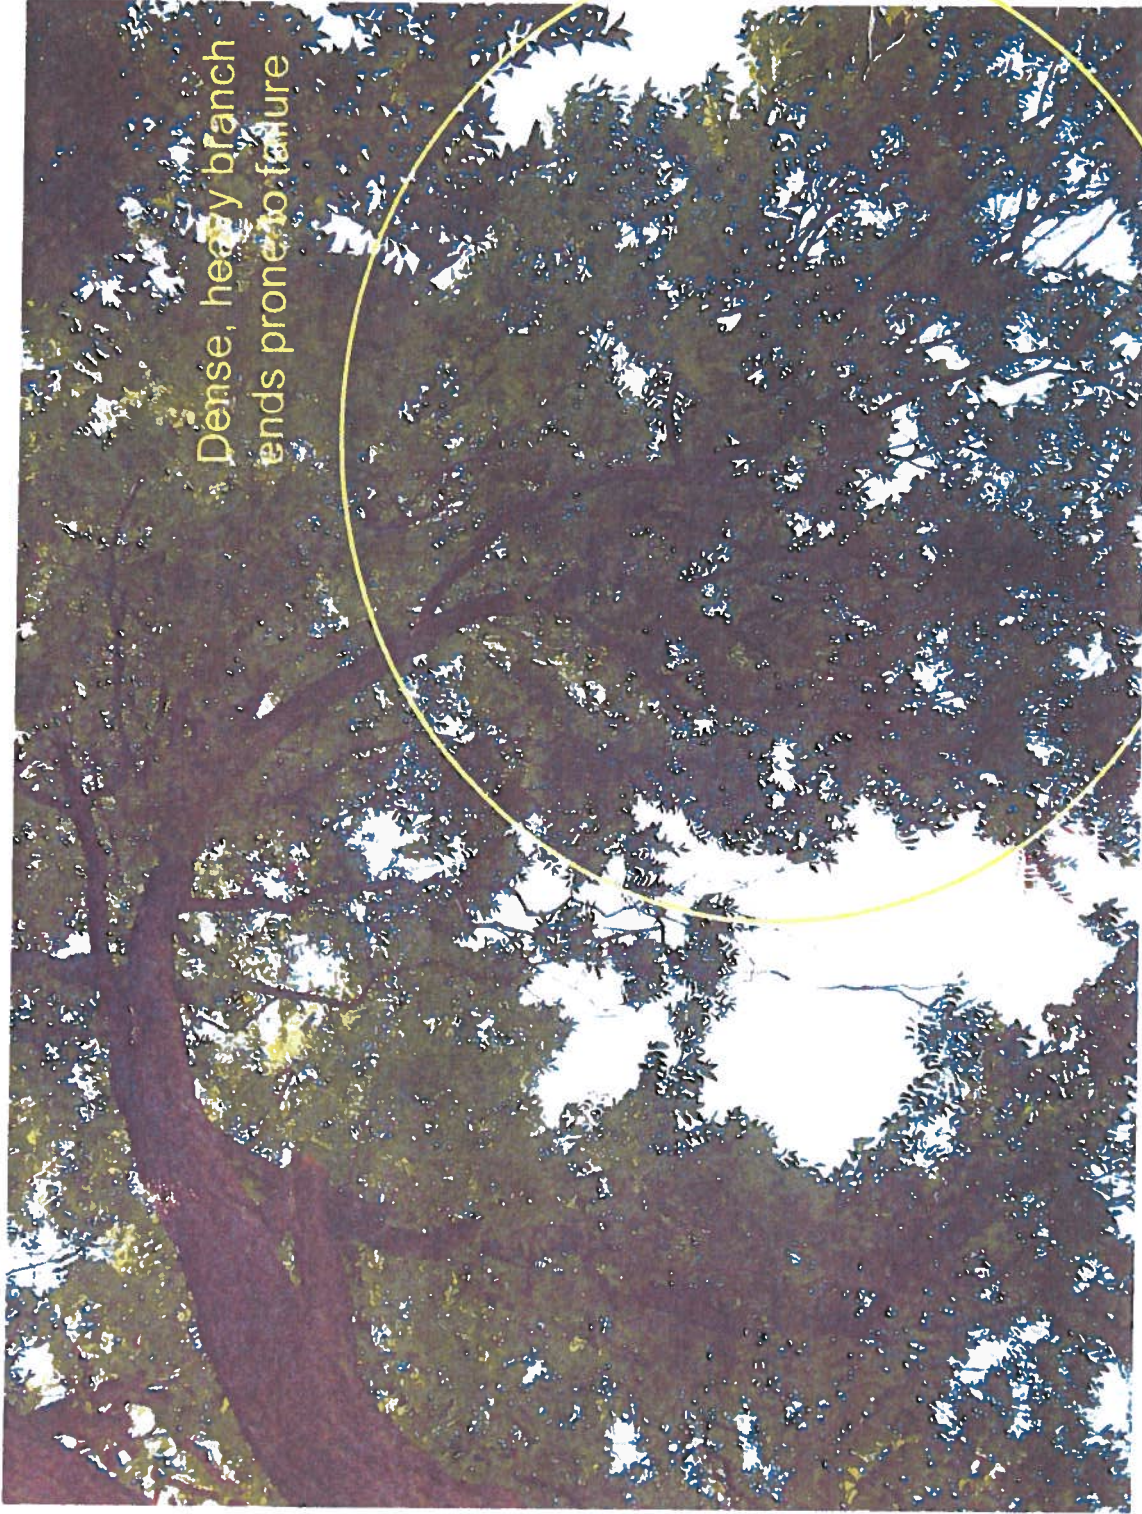
Exhibit 2

The subject tree is a 32.0 inch diameter at breast height (dbh) Pecan (*Carya illinoensis*). The tree height is 57 feet and the canopy spread is 55 feet (Exhibit 2). The canopy is generally symmetrical exhibiting less than five percent deadwood with minimal structural defects (Exhibit 2). Dense, heavy branch ends appear to be the only visible evidence for potential branch failure (Exhibit 3). Storm damage is evident by the presence of broken stems, though no noticeable decay or structural weaknesses are present (Exhibit 4). Subsurface conditions are characterized by greater than 90 percent impervious cover over the root system, compacted and consolidated soil, and fill material that has partially buried the root flare (Exhibit 5). Rainfall catchment area is limited by the extent of impervious cover though it is likely shallow groundwater is influencing soil moisture in the rhizosphere (interface between root system and soil). Decay is not apparent and unlikely since the soil is principally composed of abiotic minerals as opposed to organic soils. Given the aforementioned conditions, the subject tree is rated 'good' per the City Arborist tree evaluation (Exhibit 6).

Dense, heavy branch
ends prone to failure

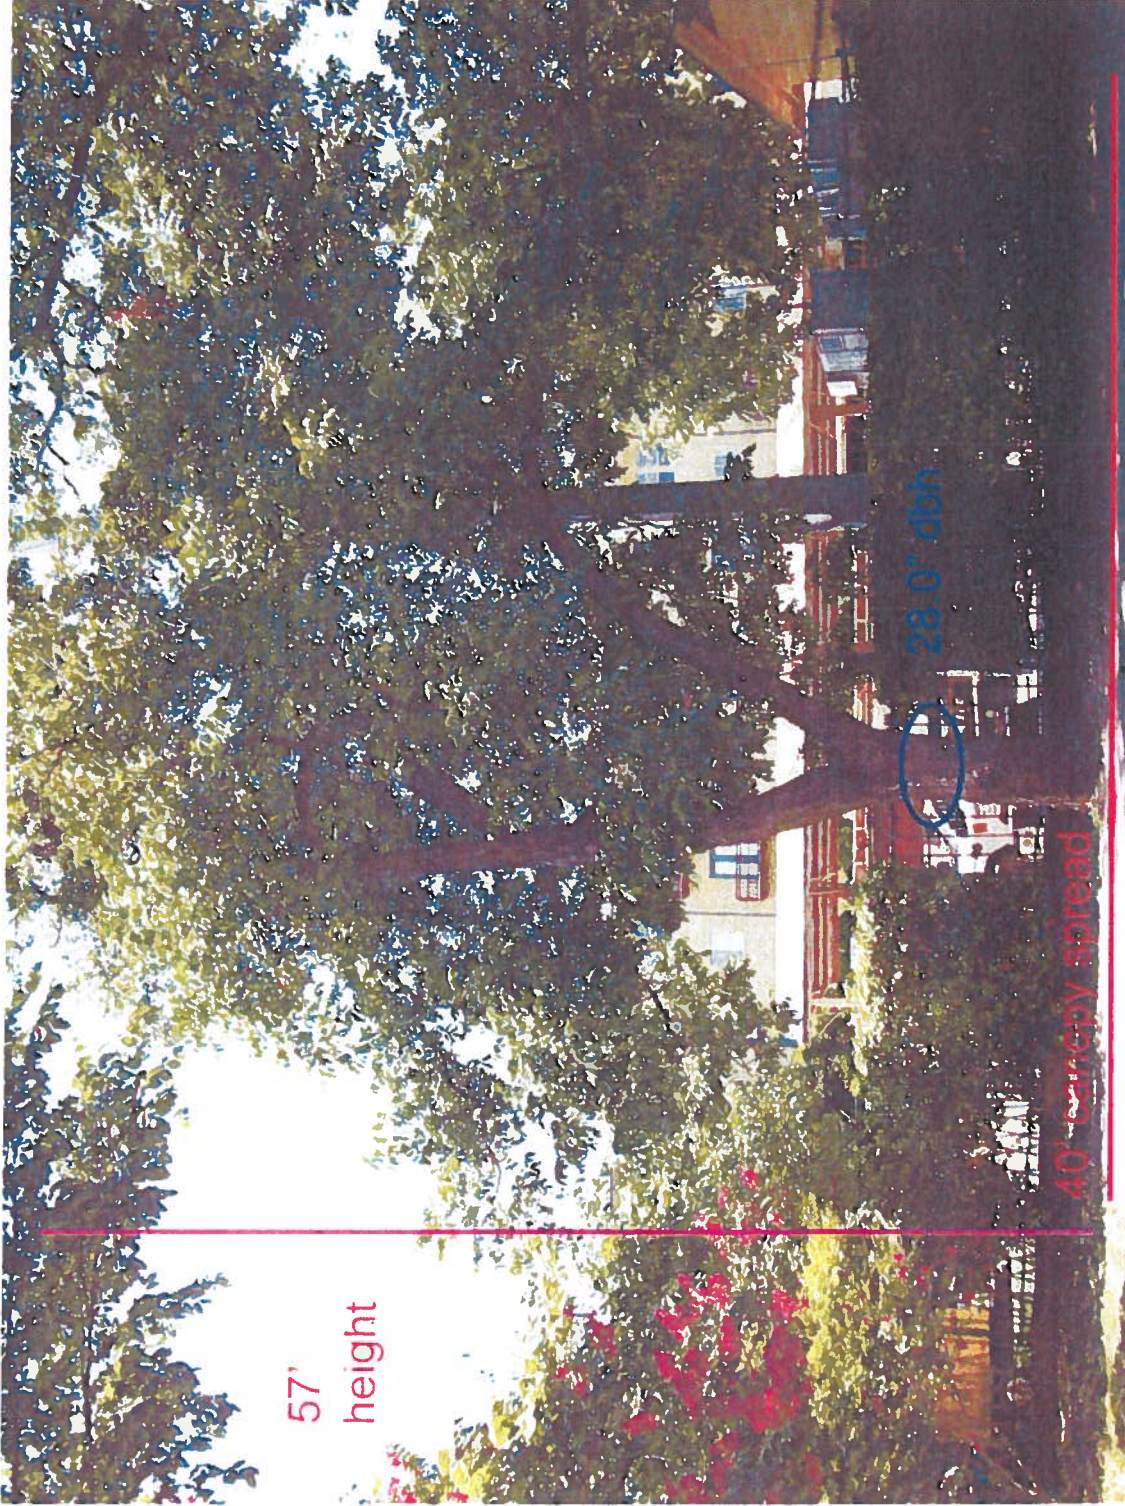
Exhibit 7

There is also a 28.0 inch diameter Pecan onsite that is proposed to be removed (Exhibit 7). This tree displays severe structural defects. There is a 2" x 10" cavity that exhibits

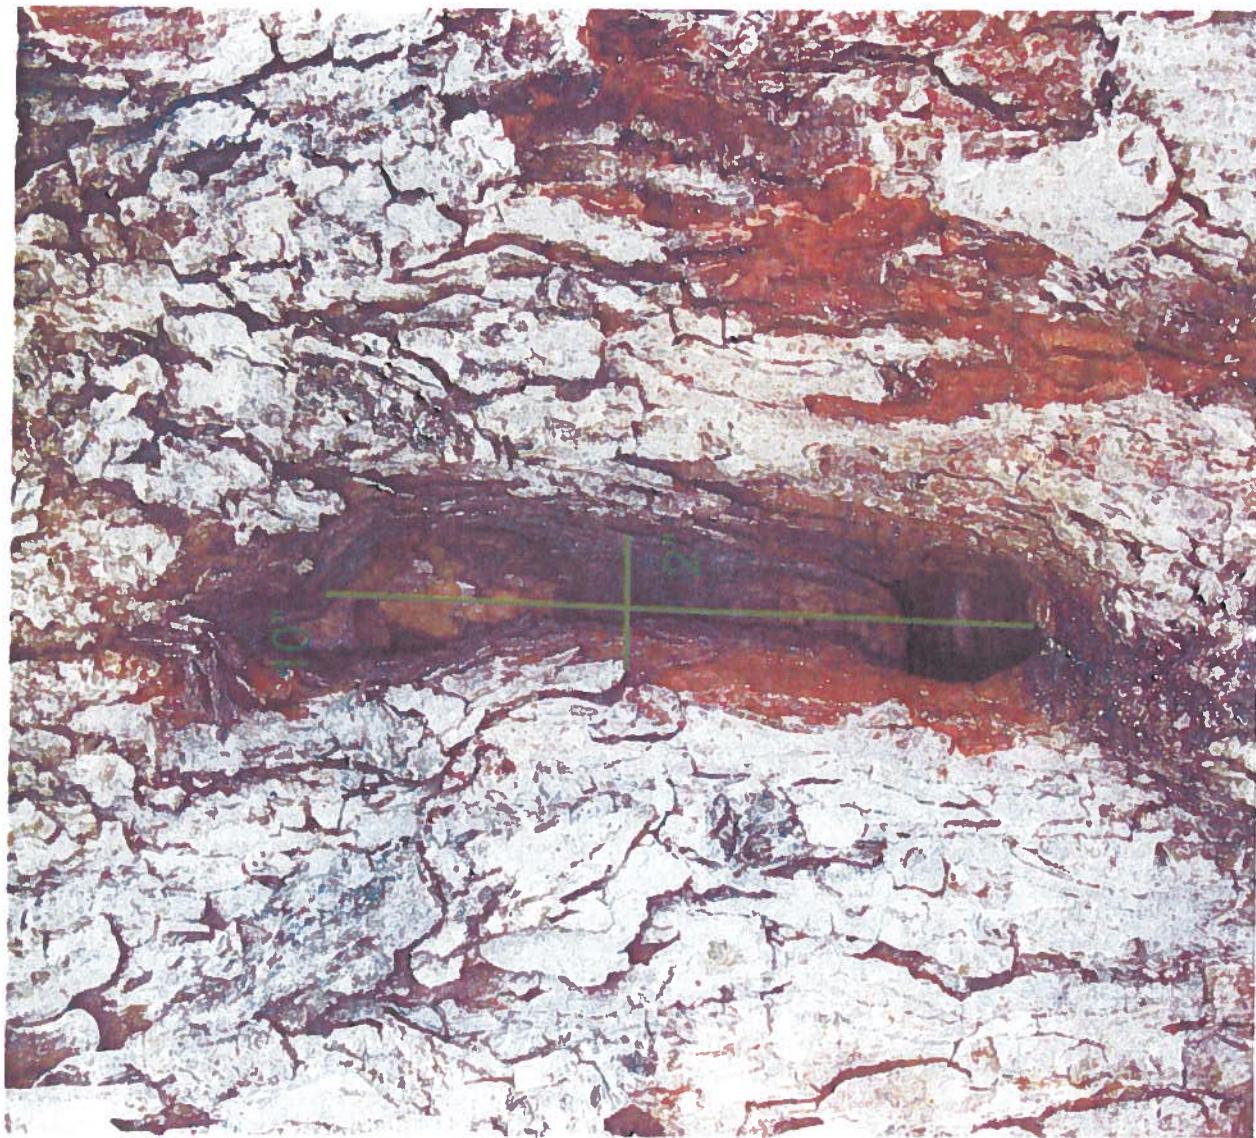
Exhibit 8

significant decay as evidenced by the ~200 in³ of void space (Exhibit 8). There is also a 8" x 12" decay column in the east stem (Exhibit 9). Further, the root flare has been buried 32 inches with rock, fill, stone, and brick (Exhibit 10) per the Bartlett assessment included in the applicant's memorandum. Given the aforementioned reasons both the City Arborist's assessment (Exhibit 11) and the Bartlett assessment concur that the subject tree is hazardous. The subject tree meets the criteria for administrative criteria for removal per both LDC 25-8-624(5)(a), diseased and restoration is not practicable, and LDC 25-8-624(A)(3) imminent hazard; thus the City Arborist will allow the subject tree to be removed and is not considered part of the variance request before the Environmental Board and Planning Commission.

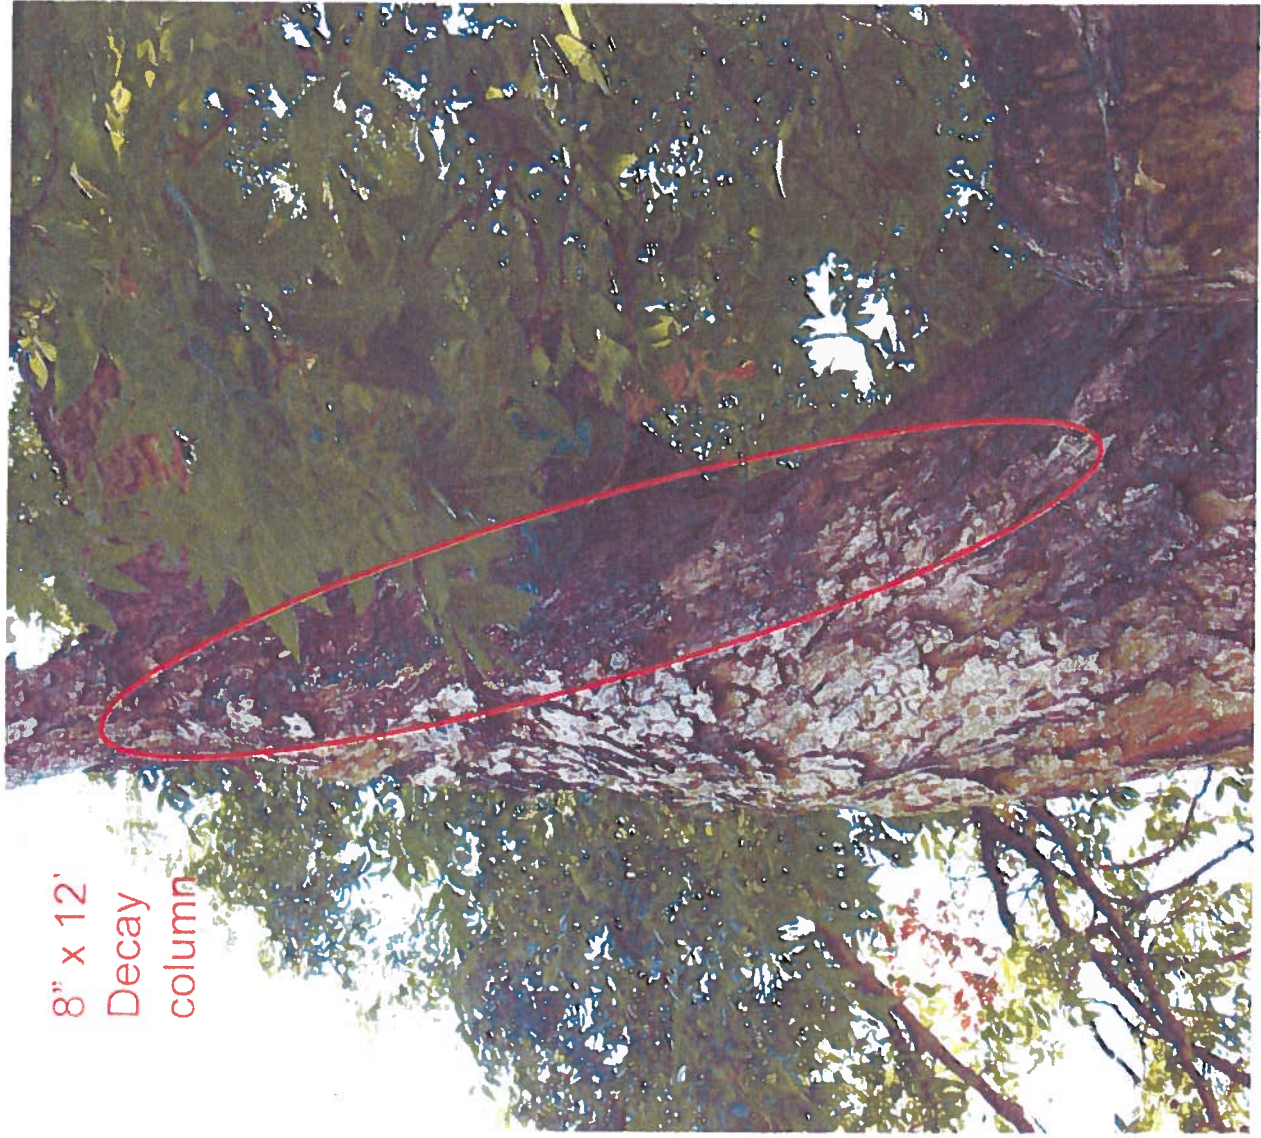
8" x 12'
Decay
column
