Table of Contents for Block at 26th street
Heritage Tree Variance Package

PROJECT NAME: Block at 26th Street

SITE PLAN: SP-2011-0032C.SH

SUBJECT: Block at 26th Street
SP-2011-0032C.SH

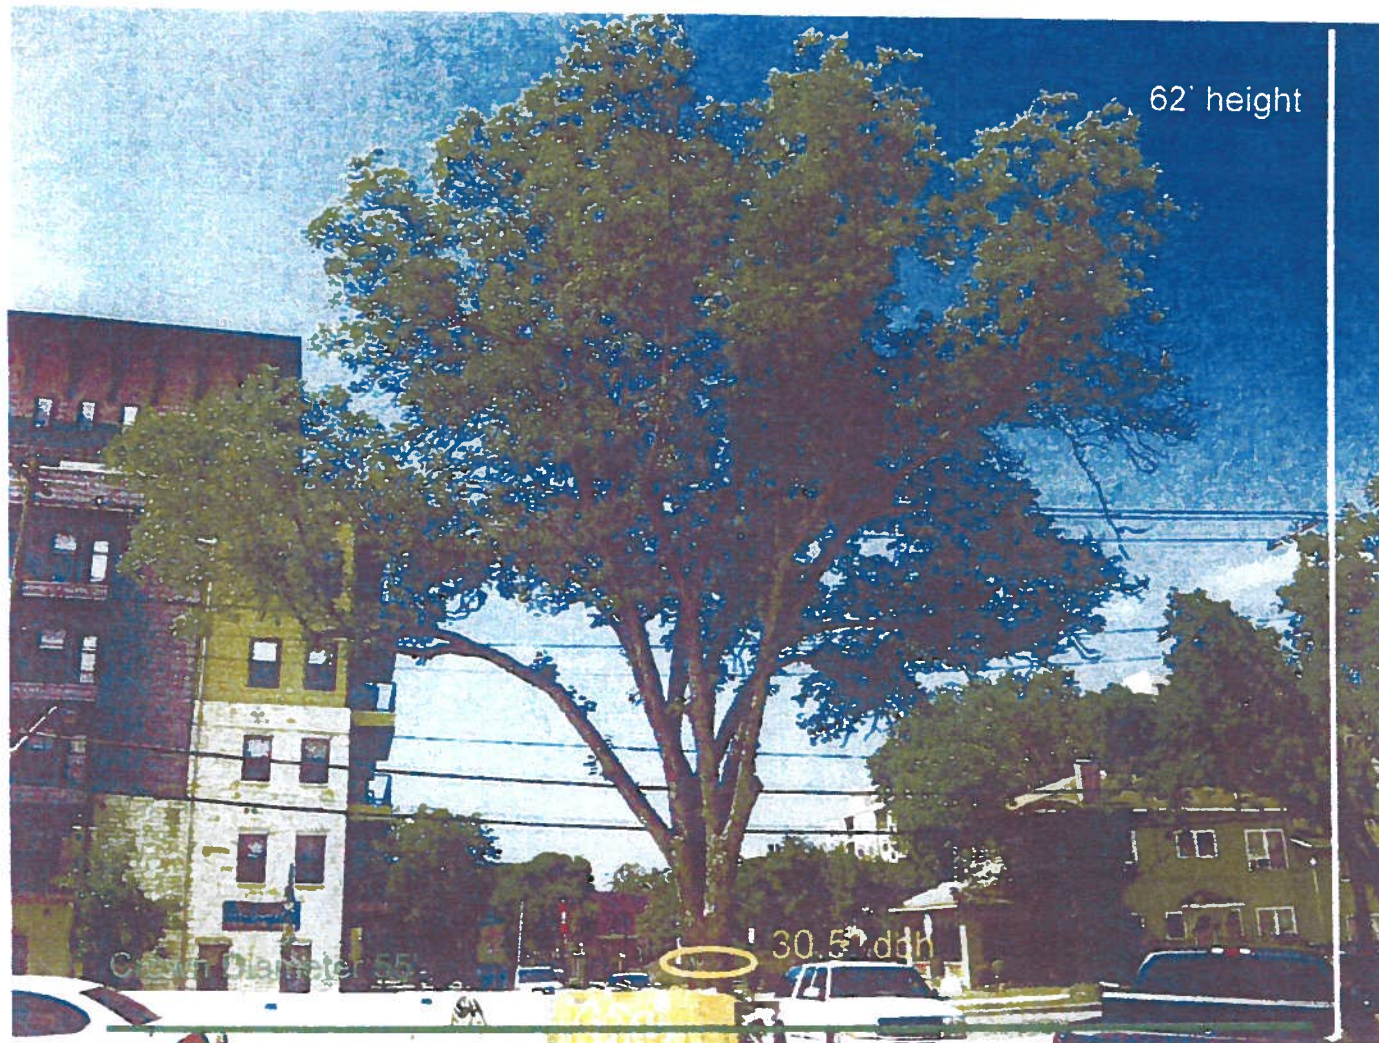
Exhibit #2

The subject tree is a 30.5 inch diameter at breast height (dbh) Pecan (*Carya illinoensis*). The tree height is 63 feet and the canopy spread is 55 feet (Exhibit 2). The trunk bifurcates into two co-dominate stems at eight feet above grade (Exhibit 3). Storm damage is evident by the presence of broken stems, though no noticeable decay or structural weaknesses are present (Exhibit 4). Minor pruning has occurred for utility clearing and likely from storm damage. There is minor deadwood and tip dieback in the crown though this is not uncommon in *Carya illinoensis* (Exhibit 5). This condition is likely exacerbated by poor soil and extensive compaction in the critical root zone (Exhibit 6). Given the aforementioned conditions, the subject tree is rated 'good' per the City Arborist tree evaluation (Exhibit 7).
