Table of Contents for Bowie Street Tree Permit
Heritage Tree Variance Package

PROJECT NAME: 311,313,315 Bowie Street

Tree Assessment Report

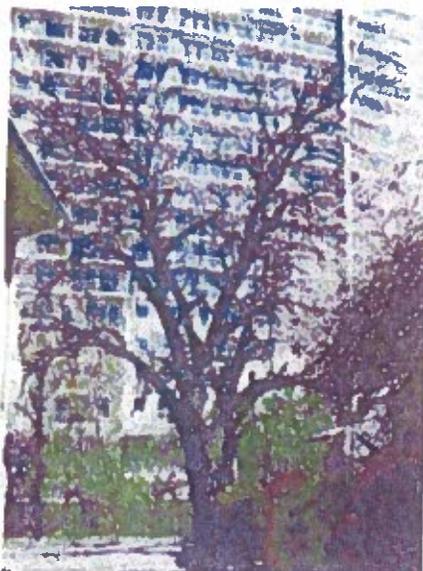
Tree #6805 is a stable, attractive tree with minor flaws that are typical of older pecans in urban settings. One question on the property is the suitability of this tree to be transplanted. In our experience, large pecan trees are not good candidates for relocation. As pecan is a bona-fide tap root species, transplanting large specimens in deep soils will sever this large root and eventually lead to decay and tree failure. This is due to the difficulty in capturing a deep enough root ball and the associated weight of the transplant.

Left photo – structure of Tree #6805

Tree #6805, however, is a quality tree in good condition. Relocation of this tree is problematic due to the depth of the root ball needed for a successful transplant and the urban nature of the site. Unless an unusually large root zone were left for this tree, development around this large riparian tree would likely cause enough site disturbance and internal soil drainage changes to cause the tree to decline.

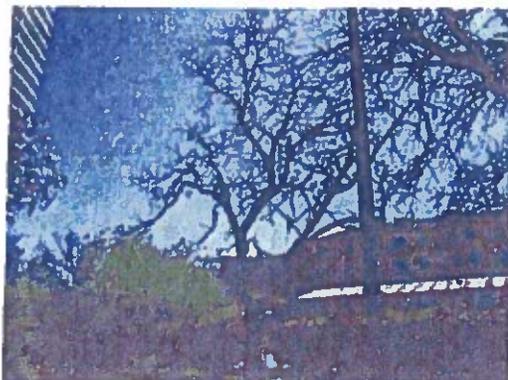
Left photo – structure of Tree #6806

With regard to tree # 6806, incumbent decay, root collar disorders, and accumulated stress coupled with high traffic in this area and high pedestrian presence make this tree an unreasonable hazard. Removal of this tree is the recommended before development.

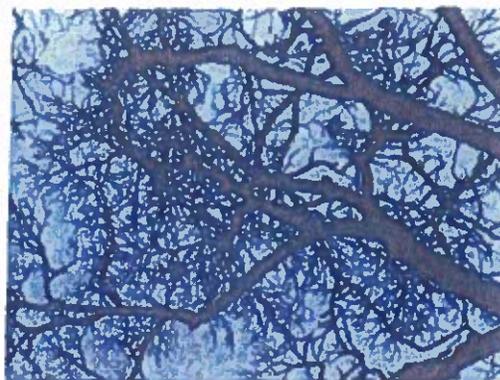
Tree #6806 displays numerous problems. Although the canopy gives the appearance of a healthy tree, the structure of the tree has fundamental problems. The east stem is decayed and cracked and highly likely to fail. Abrupt bends in the scaffold branches, previous failures, persistent dead wood and cavities add to the declining and hazardous condition of this tree. The buried root collar and limited root space have likely contributed to the declining condition of the tree and would likely contribute to further decline of this tree over time.

Right photo – abrupt bend in the crown of Tree #6806

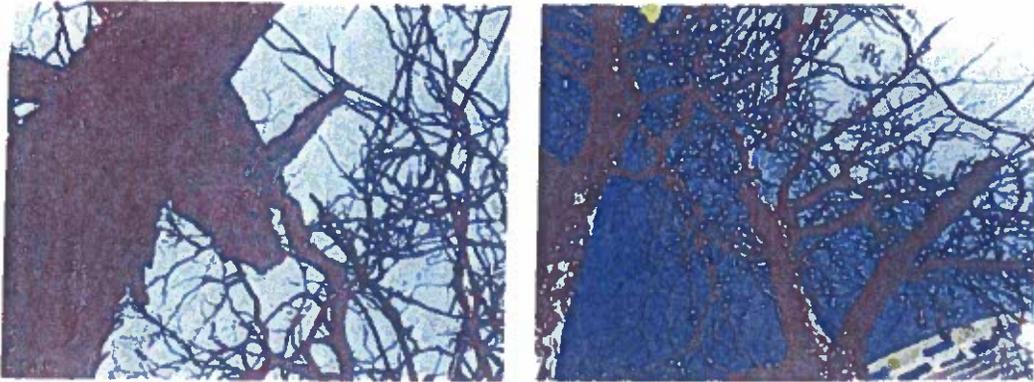
Left photo – decayed east stem and previous storm damage on Tree #6806.
Right photo – broken stubs in Tree #6806 from previous storm damage.

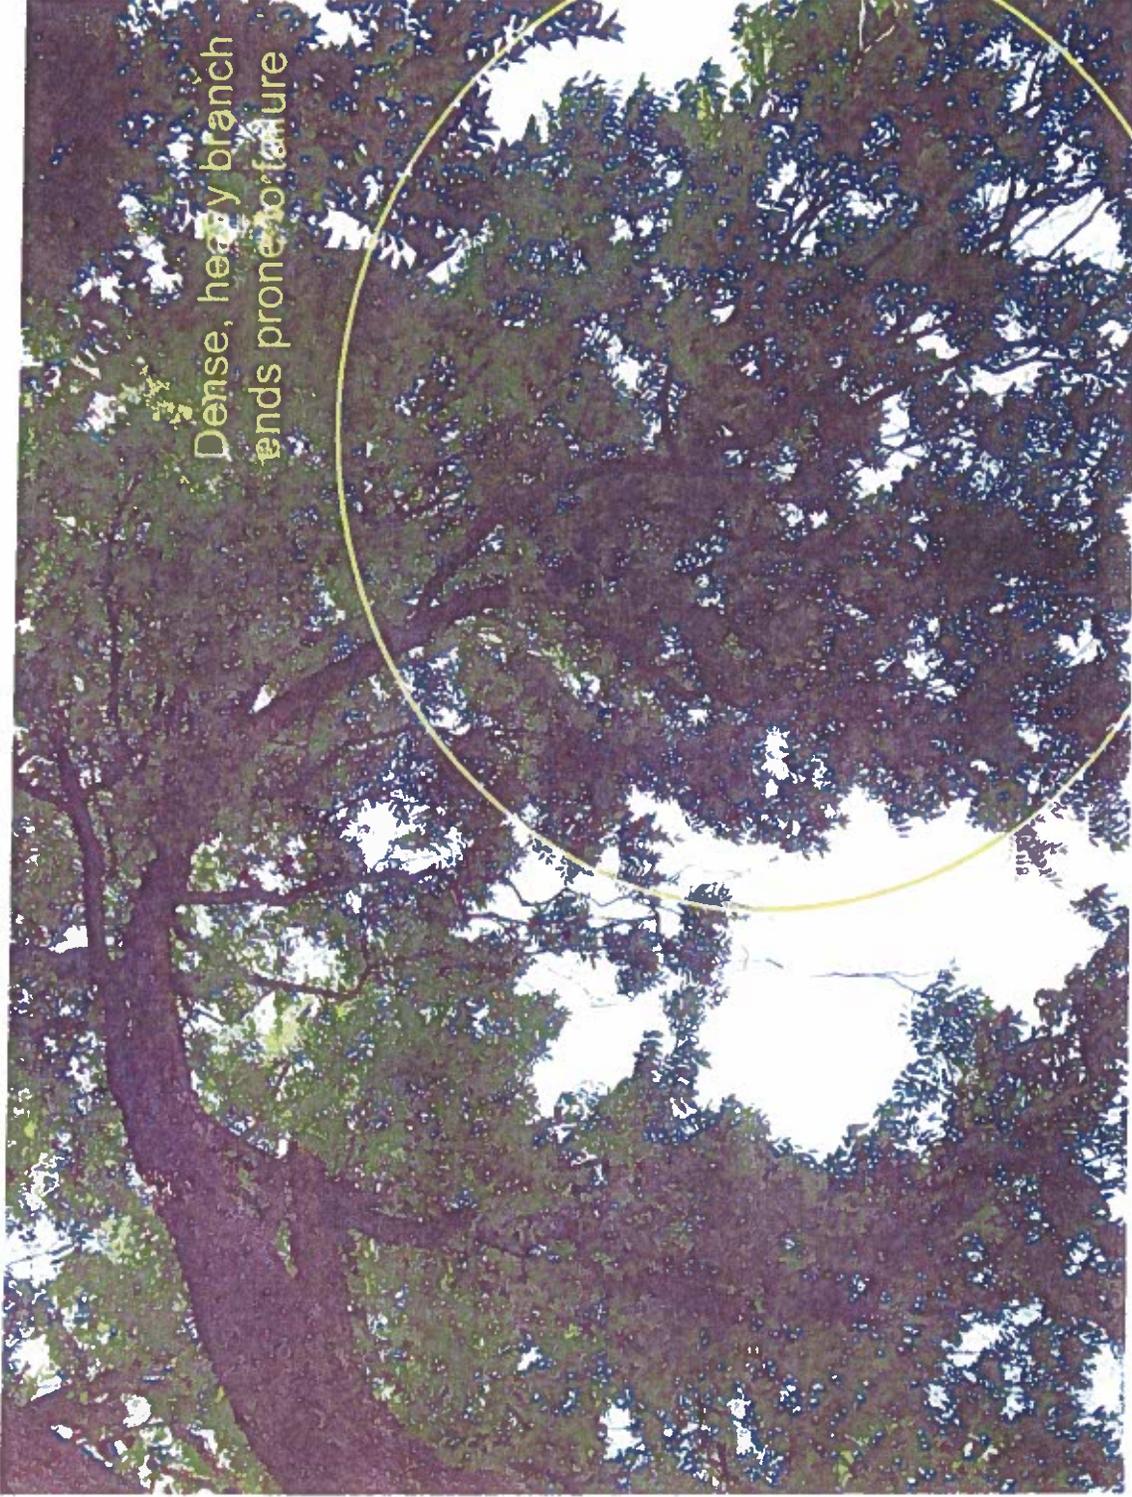
Exhibit 2

Dense, heavy branch
ends prone to failure

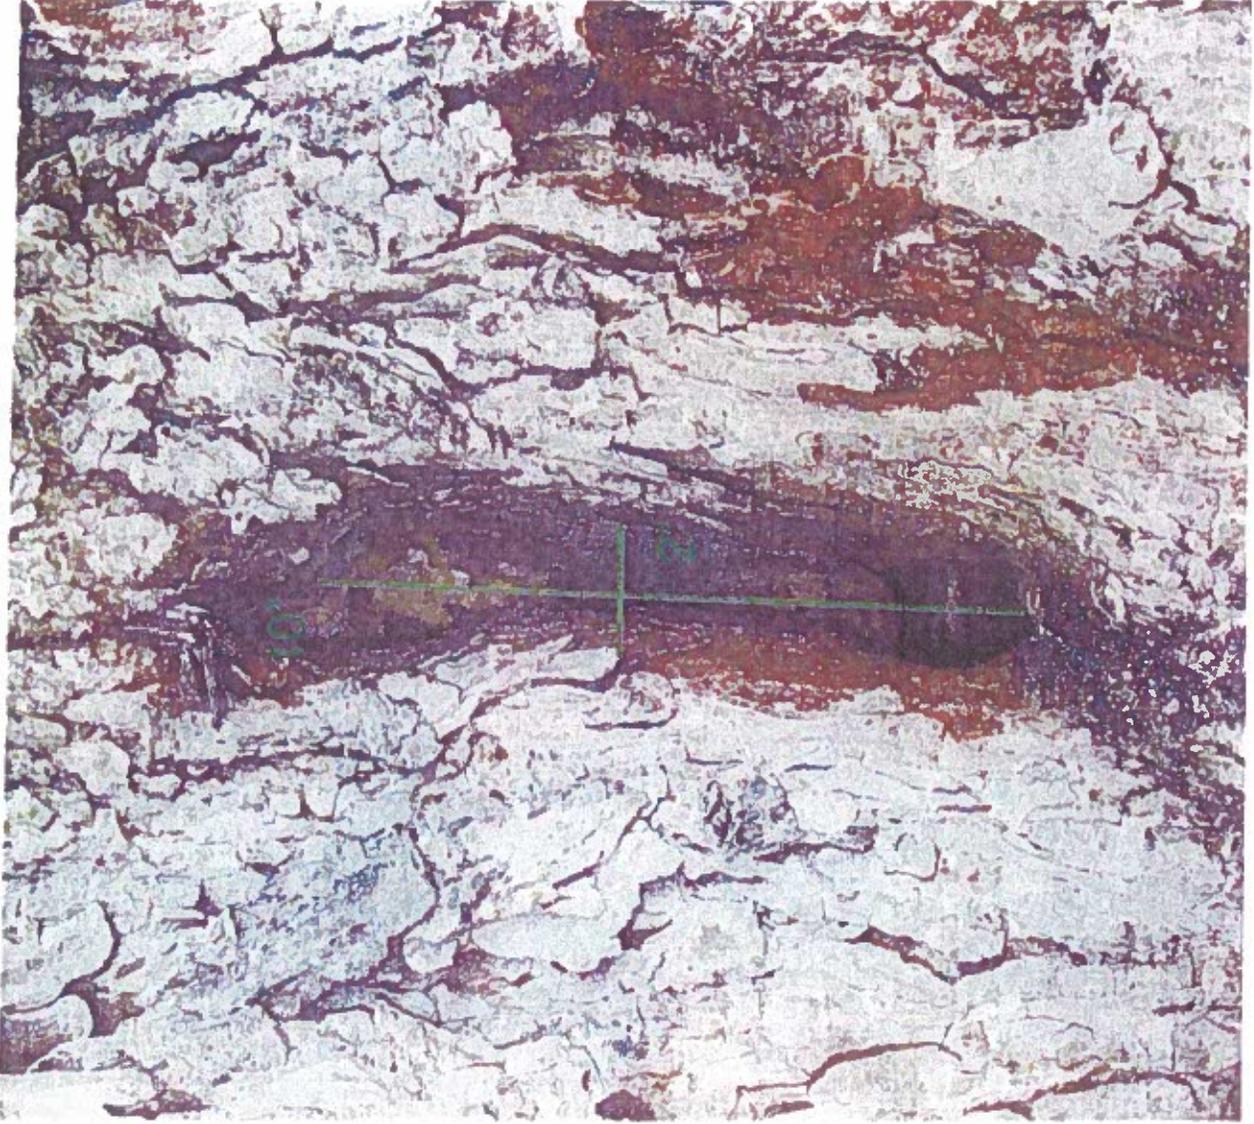
Exhibit 8

There is also a 28.0 inch diameter Pecan onsite that is proposed to be removed (Exhibit 7). This tree displays severe structural defects. There is a 2" x 10" cavity that exhibits

significant decay as evidenced by the ~200 in¹ of void space (Exhibit 8). There is also a 8" x 12" decay column in the east stem (Exhibit 9). Further, the root flare has been buried 32 inches with rock, fill, stone, and brick (Exhibit 10) per the Bartlett assessment included in the applicant's memorandum. Given the aforementioned reasons both the City Arborist's assessment (Exhibit 11) and the Bartlett assessment concur that the subject tree is hazardous. The subject tree meets the criteria for administrative criteria for removal per both LDC 25-8-624(5)(a), diseased and restoration is not practicable, and LDC 25-8-624(A)(3) imminent hazard; thus the City Arborist will allow the subject tree to be removed and is not considered part of the variance request before the Environmental Board and Planning Commission.

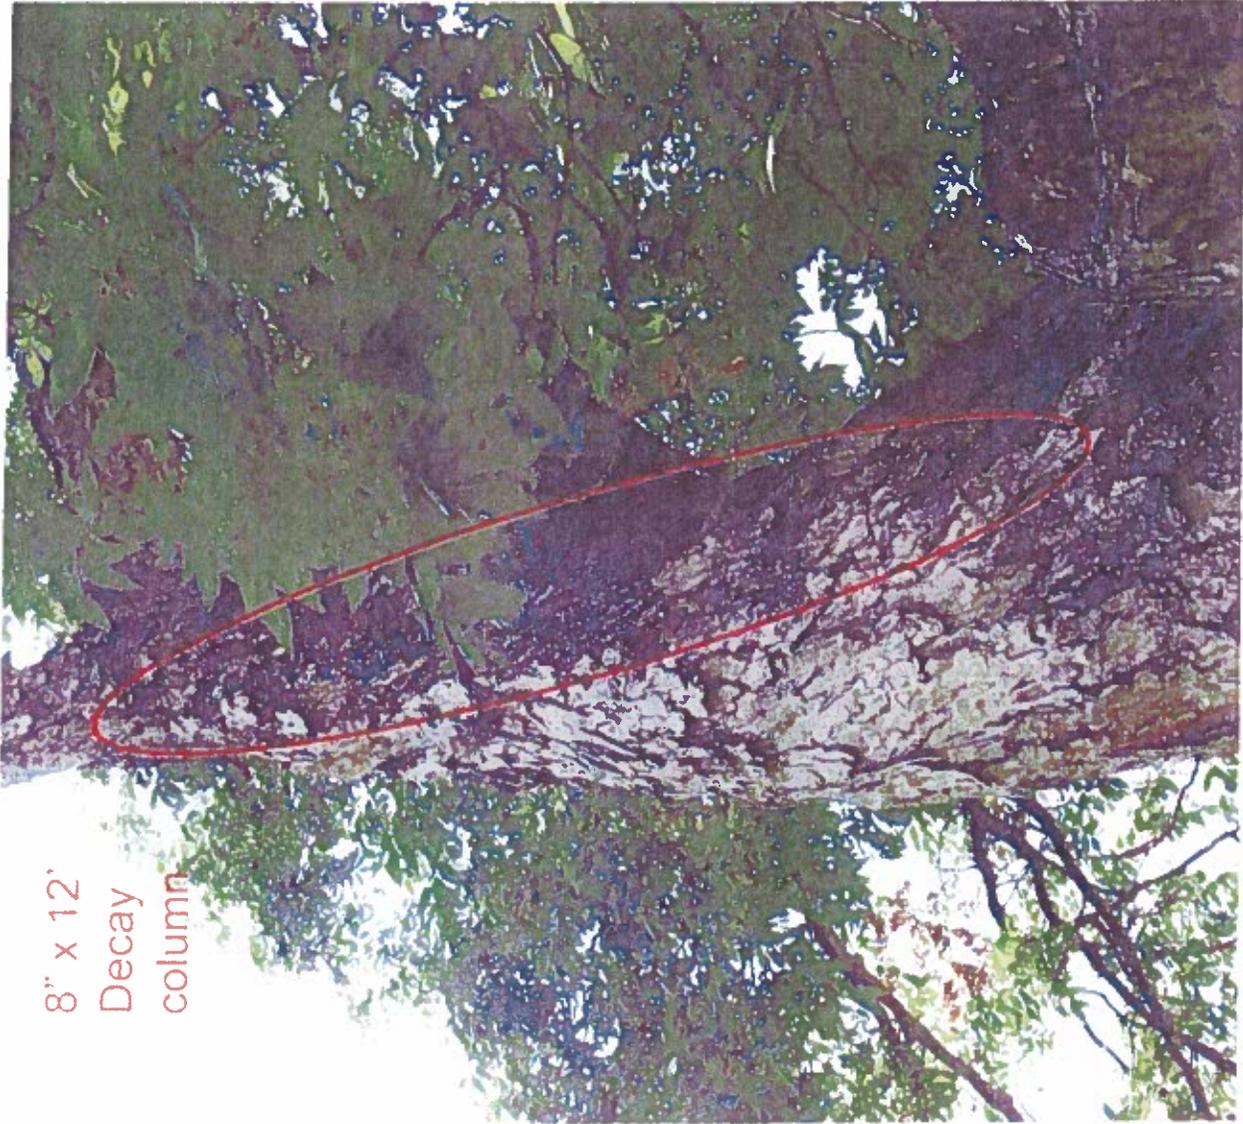
Exhibit 9

8" x 12'
Decay
column
