**Table of Contents for Bowie Street Tree Permit**  
**Heritage Tree Variance Package**

**PROJECT NAME:** 311,313,315 Bowie Street

**TREE PERMIT:** 10617196

## Tree Assessment Report

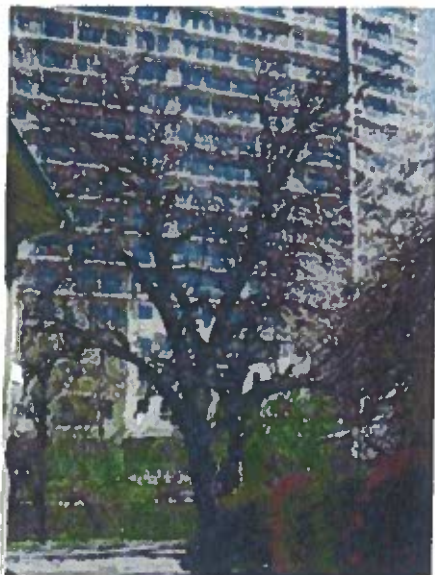
Located at the right rear of the Consort office, this tree stands approximately 60 feet in height. The stem leans 5 degrees toward the north, but the tree architecture is balanced. The crown is medium for stem size and has approximately 5% dead branches with a maximum size of 5 inches. The branch ends are dense and heavy. Two abrupt bends and a sweep are visible in the scaffold branches. A previous failure of a 6-inch limb is visible. The root flare is mostly exposed, and no evidence of root decay was visible upon excavating the south and east sides of the root collar. The root space is limited.

Left photo – structure of Tree #6805.

Tree #6805, however, is a quality tree in good condition. Relocation of this tree is problematic due to the depth of the root ball needed for a successful transplant and the urban nature of the site. Unless an unusually large root zone were left for this tree, development around this large riparian tree would likely cause enough site disturbance and internal soil drainage changes to cause the tree to decline.

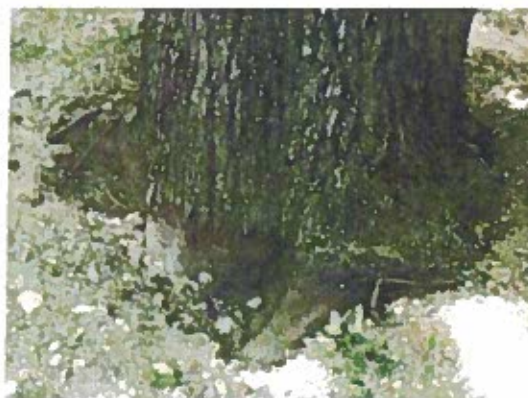
Photo above – root collar of Tree #6805.

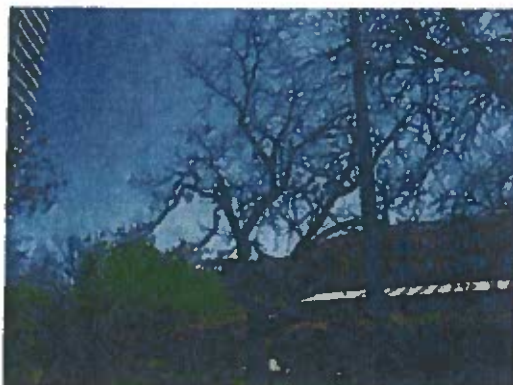
This tree is located at the right rear of the Consort parking lot and stands approximately 55 feet in height. The crown is medium for stem size, and the tree architecture is balanced. About one percent of the branches in the crown are dead with a maximum size of 3 inches. Branch ends are dense and heavy. Five abrupt bends and several previous branch failures are visible. This tree has a codominant-stem structure with a crotch at 8 feet. The codominant stems measure each approximately 19 and 24 inches in diameter. The stem growing to the west displays a 9-inch cavity just above the crotch, and the stem growing east displays a decay column of approximately 12 feet in length and up to 8 inches wide. A crack and borer gallery extend the length of the decay column. A 2" x 10" cavity appears at approximately 4.5 feet on the main stem. Excavation of the south and east sides of the root crown revealed that the root flare is buried with 32 inches of rocky fill, stone, and brick. The excavation did not reveal evidence of decay in the area excavated. The root space is very limited.

Left photo – structure of Tree #6806.

With regard to tree # 6806, incumbent decay, root collar disorders, and accumulated stress coupled with high traffic in this area and high pedestrian presence make this tree an unreasonable hazard. Removal of this tree is the recommended before development.

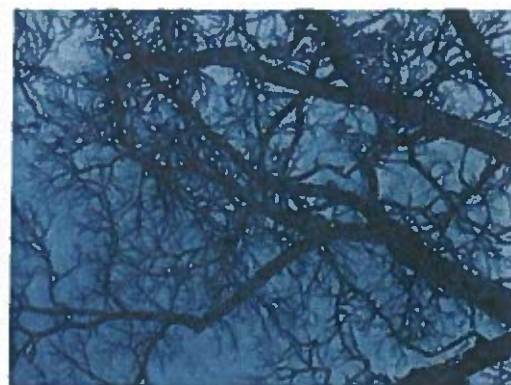
Right photo – abrupt bend in the crown of Tree #6806.

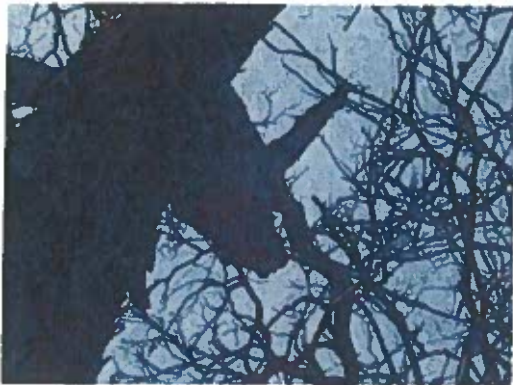
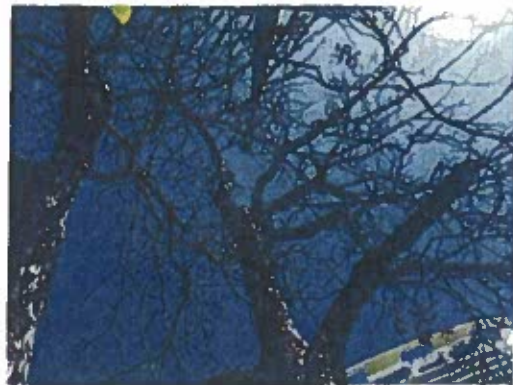
Tree #6806 displays numerous problems. Although the canopy gives the appearance of a healthy tree, the structure of the tree has fundamental problems. The east stem is decayed and cracked and highly likely to fail. Abrupt bends in the scaffold branches, previous failures, persistent dead wood and cavities add to the declining and hazardous condition of this tree. The buried root collar and limited root space have likely contributed to the declining condition of the tree and would likely contribute to further decline of this tree over time.

Left photo – decayed east stem and previous storm damage on Tree #6806.  
Right photo – broken stubs in Tree #6806 from previous storm damage.

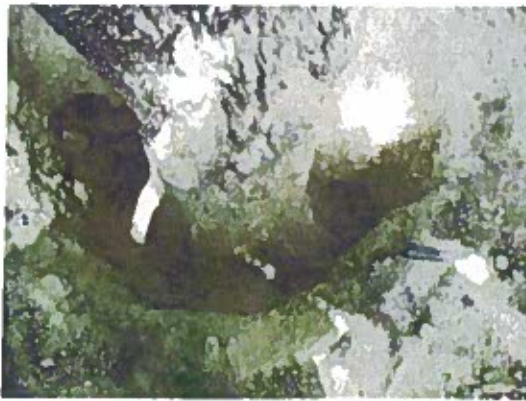
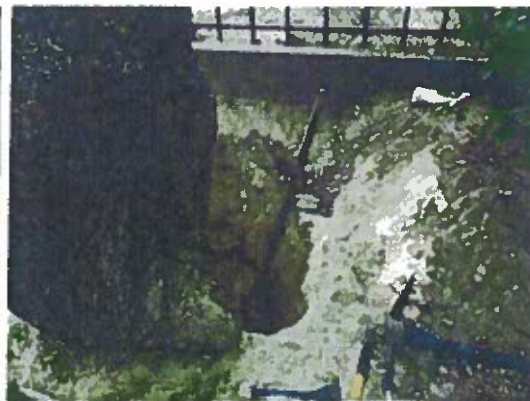
Left photo – view of exposed root collar on the south side of Tree #6806.  
Right photo – view of fill depth (32 inches) over the root collar of Tree #6806.

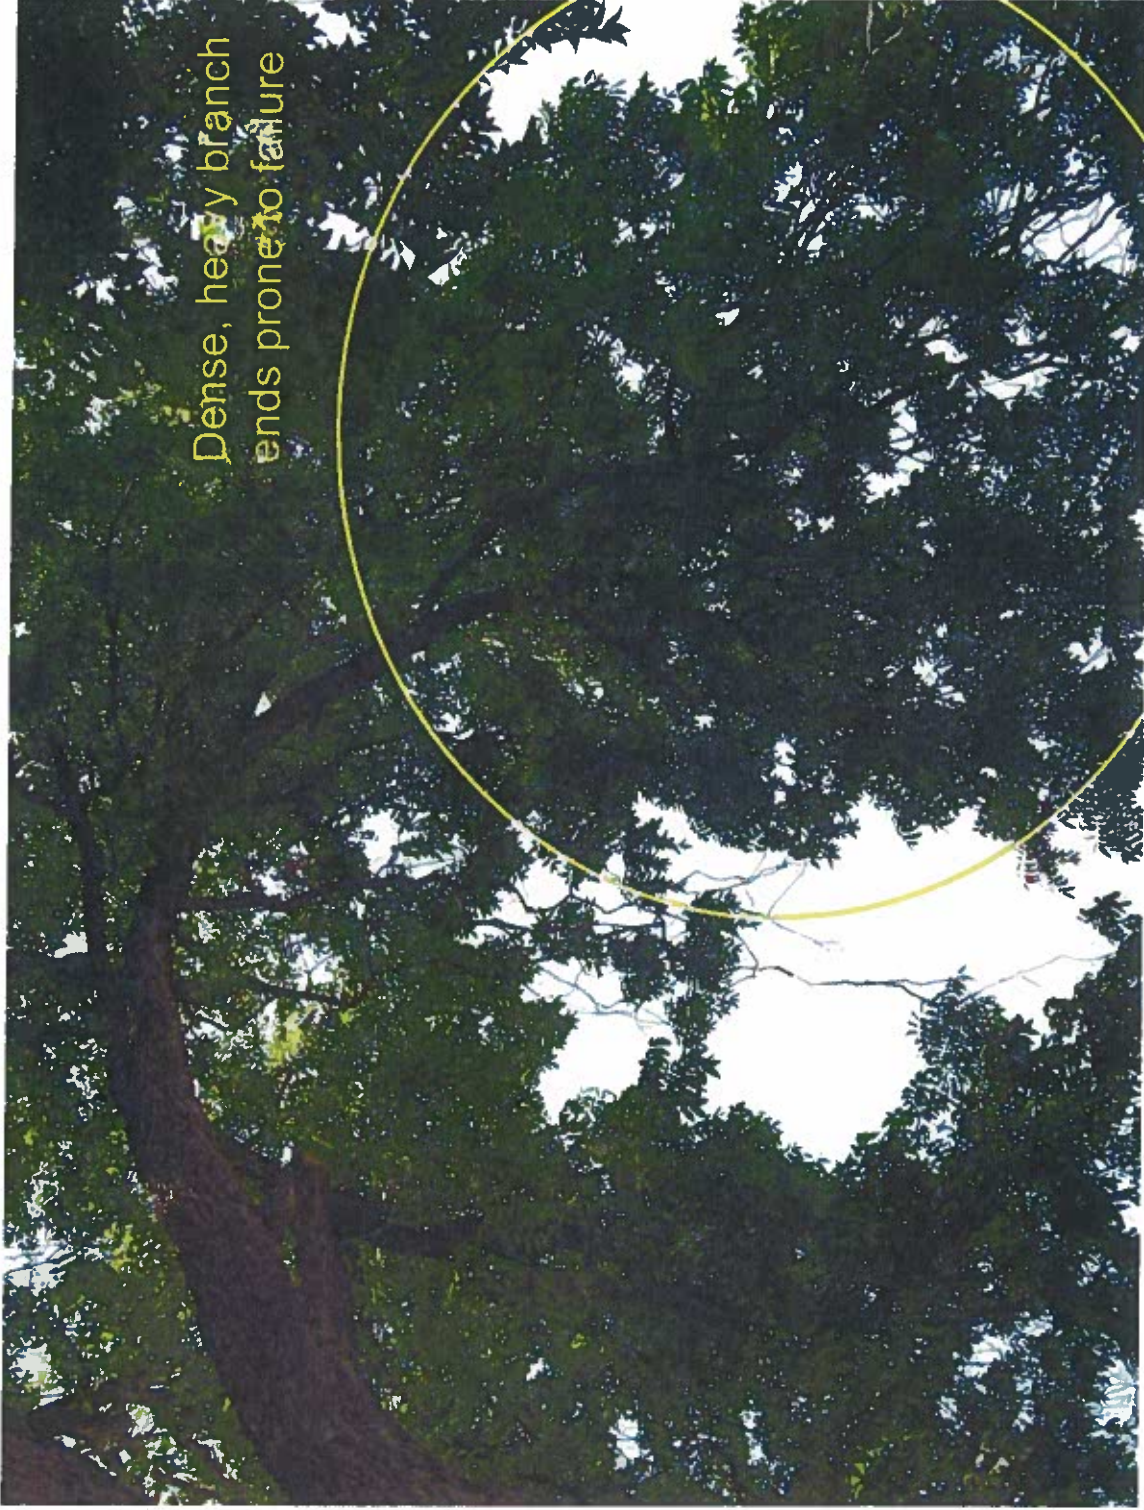
Exhibit 2

Dense, heavy branch  
ends prone to failure

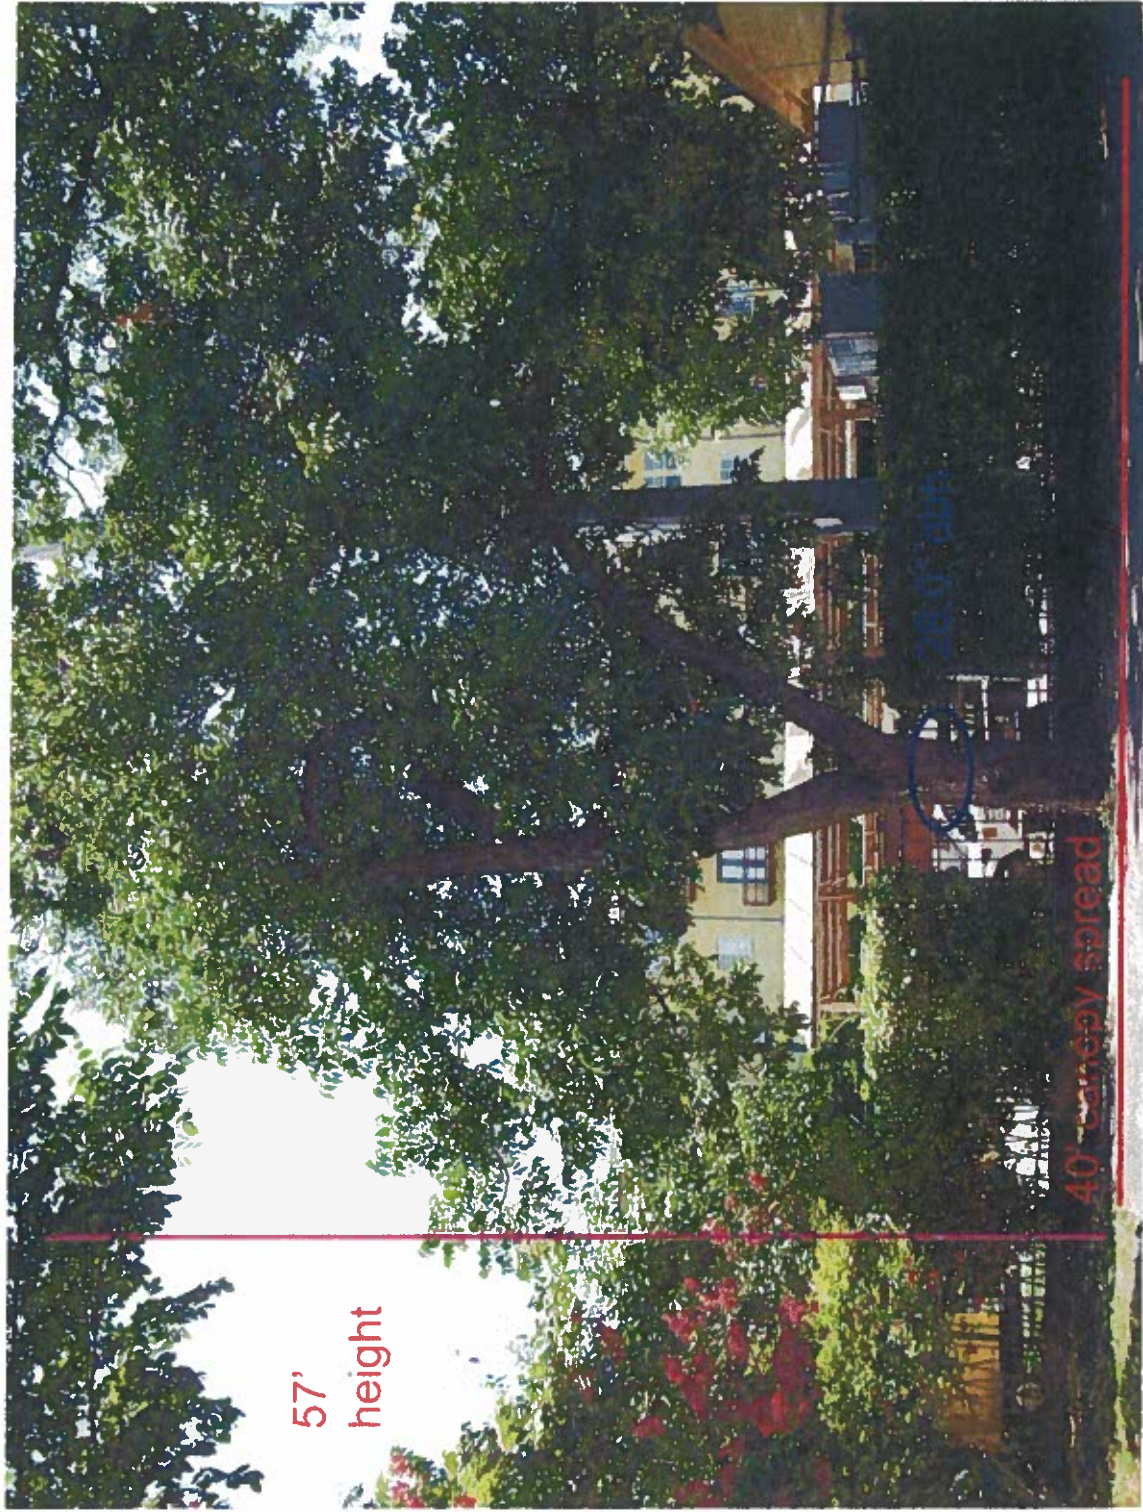
Exhibit 7

There is also a 28.0 inch diameter Pecan onsite that is proposed to be removed (Exhibit 7). This tree displays severe structural defects. There is a 2" x 10" cavity that exhibits

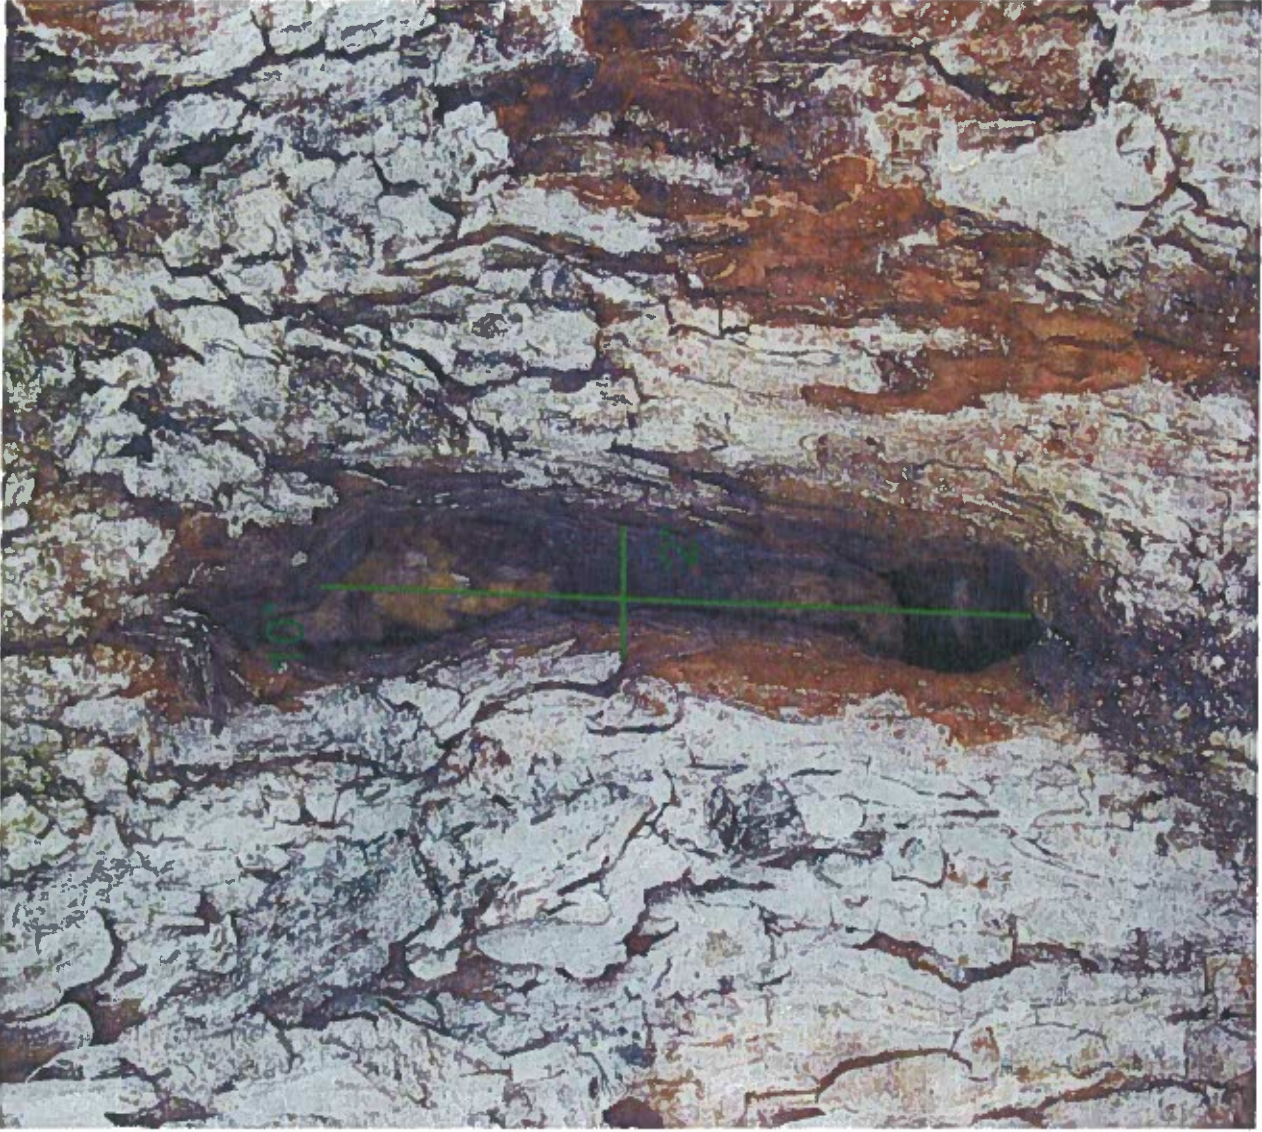
Exhibit 8

significant decay as evidenced by the ~200 in<sup>3</sup> of void space (Exhibit 8). There is also a 8" x 12' decay column in the east stem (Exhibit 9). Further, the root flare has been buried 32 inches with rock, fill, stone, and brick (Exhibit 10) per the Bartlett assessment included in the applicant's memorandum. Given the aforementioned reasons both the City Arborist's assessment (Exhibit 11) and the Bartlett assessment concur that the subject tree is hazardous. The subject tree meets the criteria for administrative criteria for removal per both LDC 25-8-624(5)(a), diseased and restoration is not practicable, and LDC 25-8-624(A)(3) imminent hazard; thus the City Arborist will allow the subject tree to be removed and is not considered part of the variance request before the Environmental Board and Planning Commission.

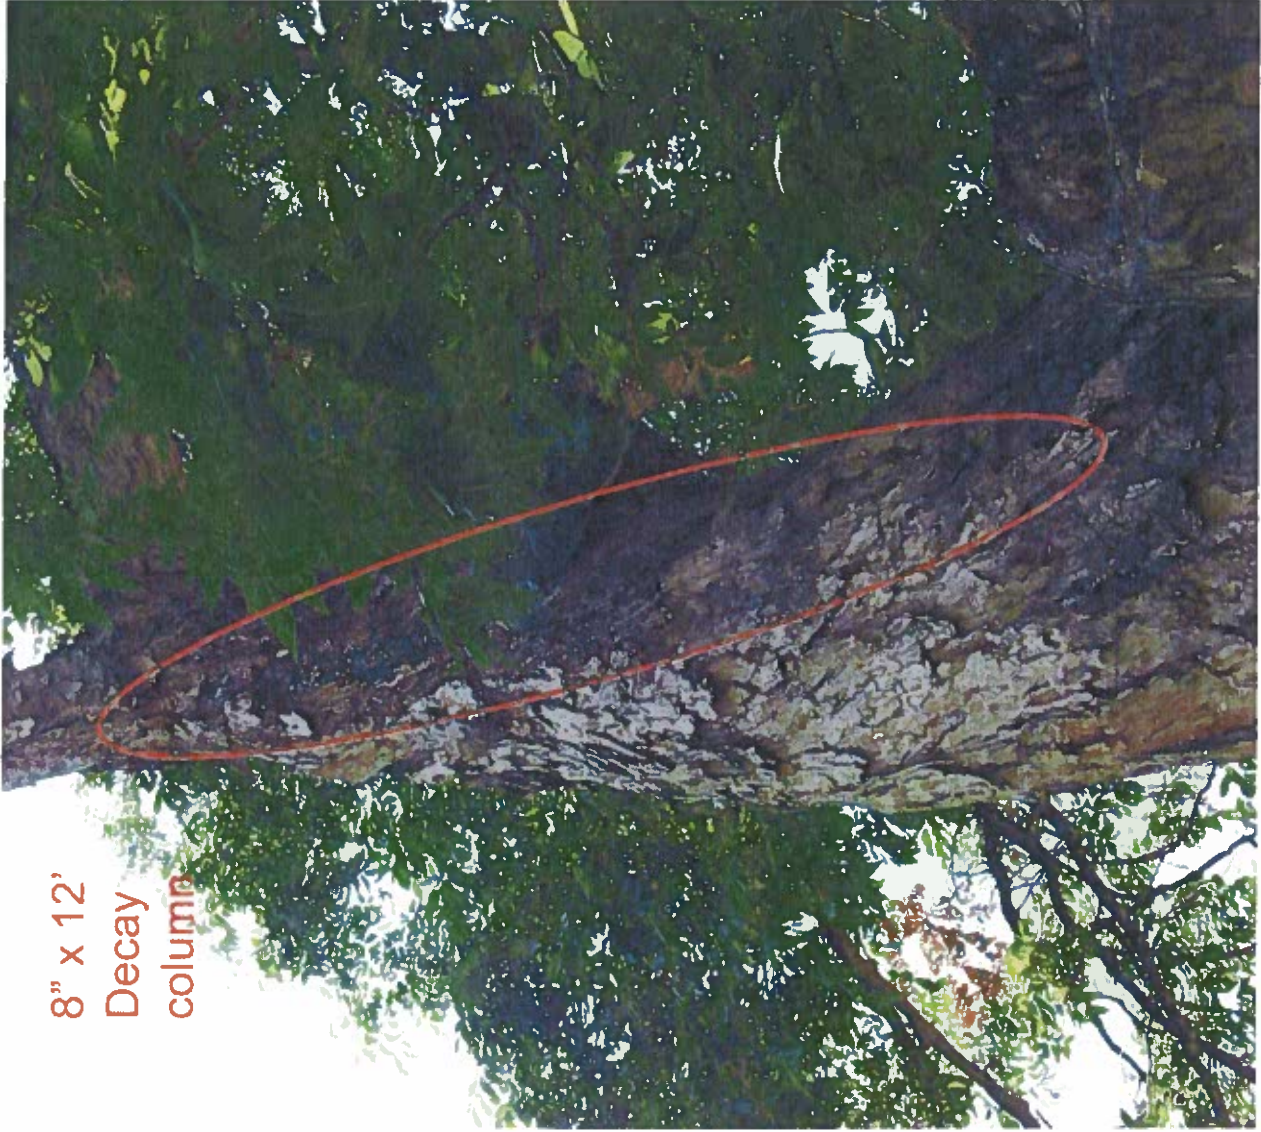
Exhibit 9

8" x 12'  
Decay  
column
