Table of Contents for Bowie Street Tree Permit
Heritage Tree Variance Package

PROJECT NAME: 311,313,315 Bowie Street

TREE PERMIT: 10617196

Tree Assessment Report

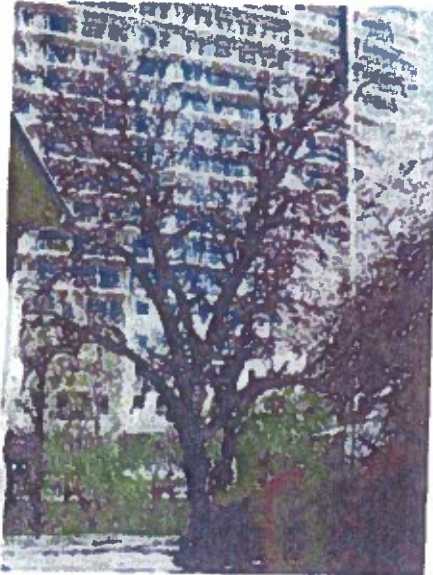
Located at the right rear of the Consort office, this tree stands approximately 60 feet in height. The stem leans 5 degrees toward the north, but the tree architecture is balanced. The crown is medium for stem size and has approximately 5% dead branches with a maximum size of 5 inches. The branch ends are dense and heavy. Two abrupt bends and a sweep are visible in the scaffold branches. A previous failure of a 6-inch limb is visible. The root flare is mostly exposed, and no evidence of root decay was visible upon excavating the south and east sides of the root collar. The root space is limited.

Tree #6805 is a stable, attractive tree with minor flaws that are typical of older pecans in urban settings. One question on the property is the suitability of this tree to be transplanted. In our experience, large pecan trees are not good candidates for relocation. As pecan is a bona-fide tap root species, transplanting large specimens in deep soils will sever this large root and eventually lead to decay and tree failure. This is due to the difficulty in capturing a deep enough root ball and the associated weight of the transplant.

Left photo – structure of Tree #6805.

Tree #6805, however, is a quality tree in good condition. Relocation of this tree is problematic due to the depth of the root ball needed for a successful transplant and the urban nature of the site. Unless an unusually large root zone were left for this tree, development around this large riparian tree would likely cause enough site disturbance and internal soil drainage changes to cause the tree to decline.

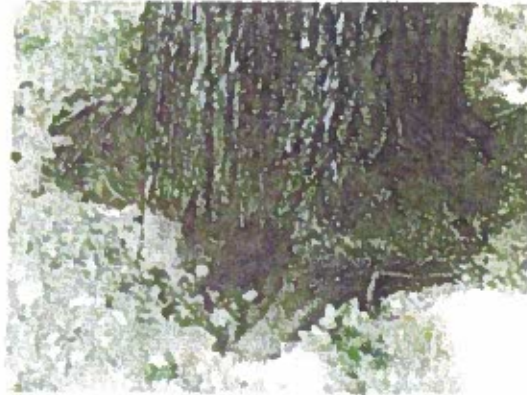
Photo above – root collar of Tree #6805

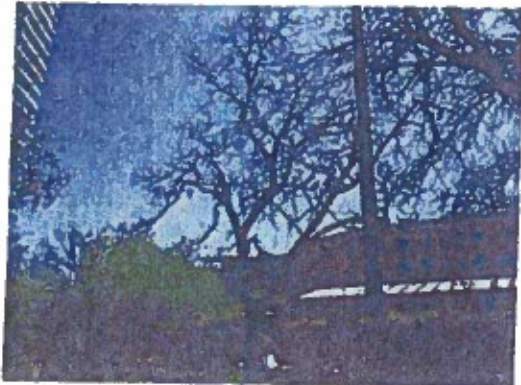
This tree is located at the right rear of the Consort parking lot and stands approximately 55 feet in height. The crown is medium for stem size, and the tree architecture is balanced. About one percent of the branches in the crown are dead with a maximum size of 3 inches. Branch ends are dense and heavy. Five abrupt bends and several previous branch failures are visible. This tree has a codominant-stem structure with a crotch at 8 feet. The codominant stems measure each approximately 19 and 24 inches in diameter. The stem growing to the west displays a 9-inch cavity just above the crotch, and the stem growing east displays a decay column of approximately 12 feet in length and up to 8 inches wide. A crack and borer gallery extend the length of the decay column. A 2" x 10" cavity appears at approximately 4.5 feet on the main stem. Excavation of the south and east sides of the root crown revealed that the root flare is buried with 32 inches of rocky fill, stone, and brick. The excavation did not reveal evidence of decay in the area excavated. The root space is very limited.

Tree #6806 displays numerous problems. Although the canopy gives the appearance of a healthy tree, the structure of the tree has fundamental problems. The east stem is decayed and cracked and highly likely to fail. Abrupt bends in the scaffold branches, previous failures, persistent dead wood and cavities add to the declining and hazardous condition of this tree. The buried root collar and limited root space have likely contributed to the declining condition of the tree and would likely contribute to further decline of this tree over time.

Left photo – structure of Tree #6806.

With regard to tree # 6806, incumbent decay, root collar disorders, and accumulated stress coupled with high traffic in this area and high pedestrian presence make this tree an unreasonable hazard. Removal of this tree is the recommended before development.

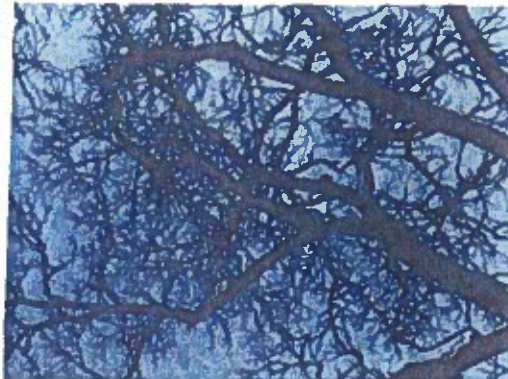
Right photo – abrupt bend in the crown of Tree #6806.

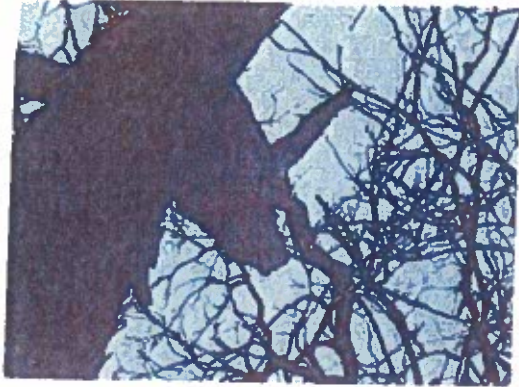
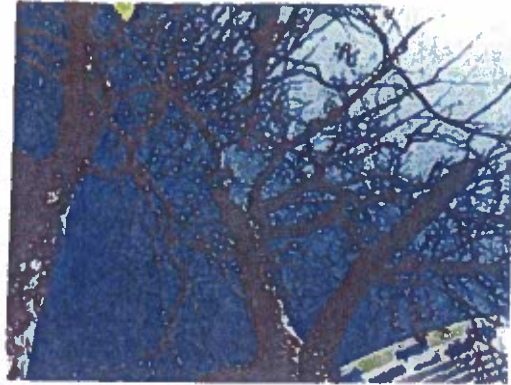
Left photo – decayed east stem and previous storm damage on Tree #6806.
Right photo – broken stubs in Tree #6806 from previous storm damage.

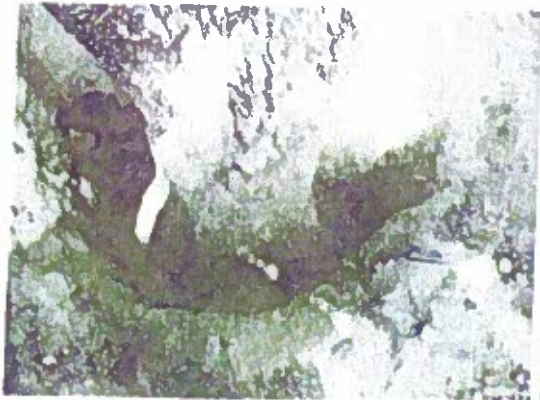
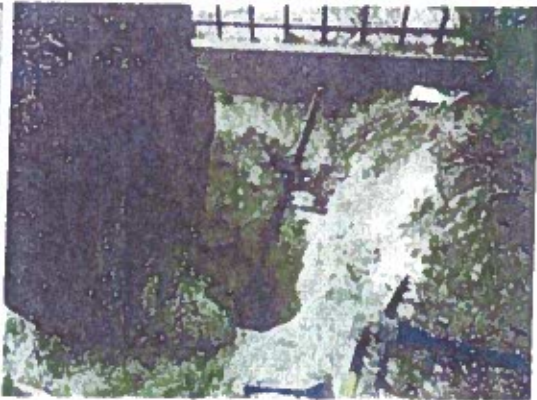
Left photo – view of exposed root collar on the south side of Tree #6806.
Right photo – view of fill depth (32 inches) over the root collar of Tree #6806.

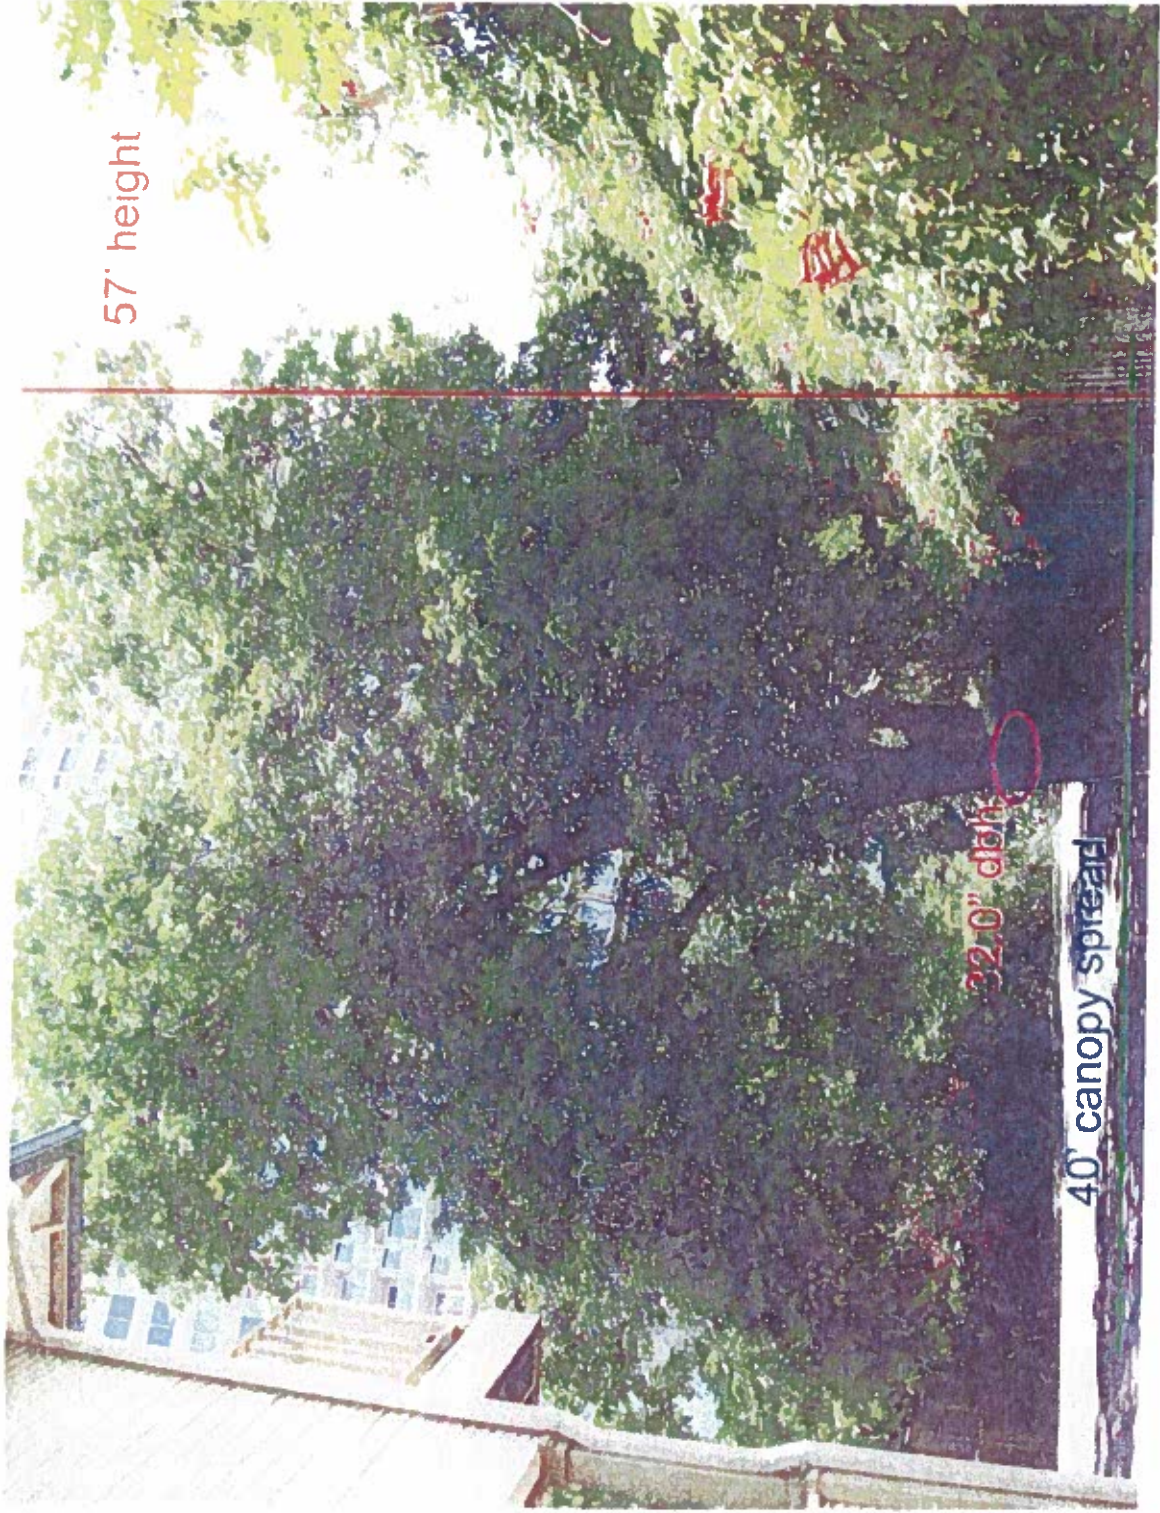
Exhibit 2

The subject tree is a 32.0 inch diameter at breast height (dbh) Pecan (*Carya illinoensis*). The tree height is 57 feet and the canopy spread is 55 feet (Exhibit 2). The canopy is generally symmetrical exhibiting less than five percent deadwood with minimal structural defects (Exhibit 2). Dense, heavy branch ends appear to be the only visible evidence for potential branch failure (Exhibit 3). Storm damage is evident by the presence of broken stems, though no noticeable decay or structural weaknesses are present (Exhibit 4). Subsurface conditions are characterized by greater than 90 percent impervious cover over the root system, compacted and consolidated soil, and fill material that has partially buried the root flare (Exhibit 5). Rainfall catchment area is limited by the extent of impervious cover though it is likely shallow groundwater is influencing soil moisture in the rhizosphere (interface between root system and soil). Decay is not apparent and unlikely since the soil is principally composed of abiotic minerals as opposed to organic soils. Given the aforementioned conditions, the subject tree is rated 'good' per the City Arborist tree evaluation (Exhibit 6).

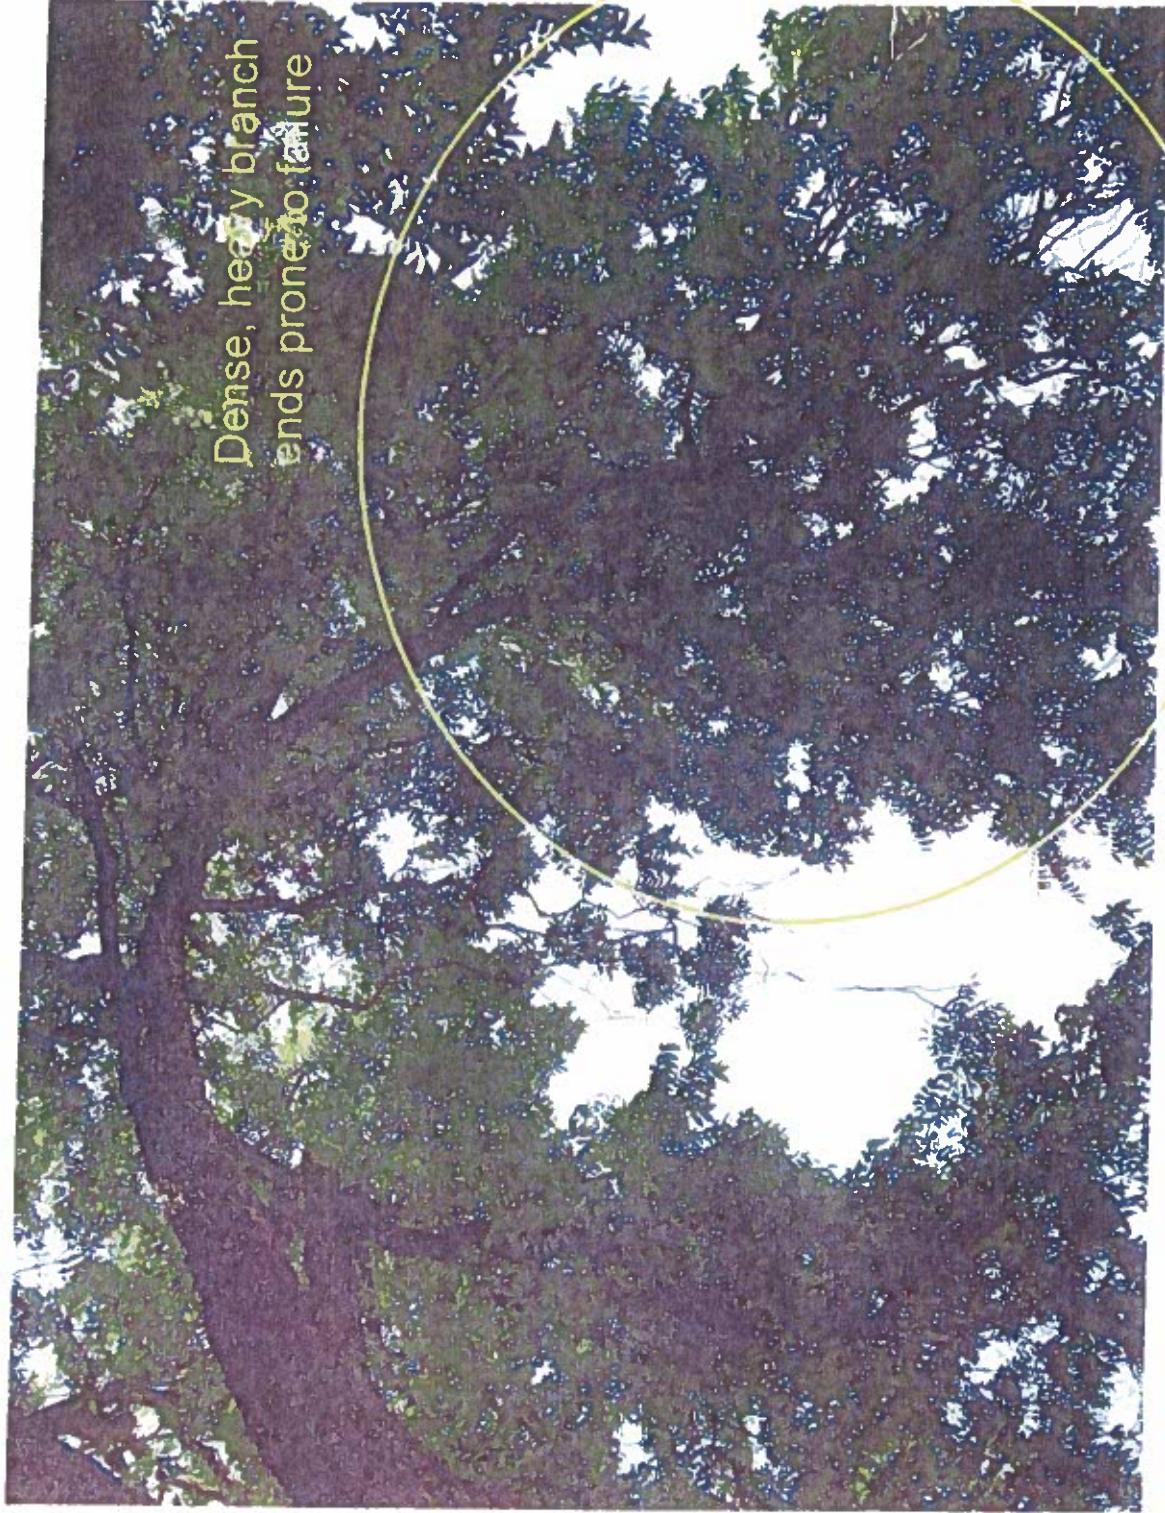
Exhibit 3

Dense, heavy branch
ends prone to failure

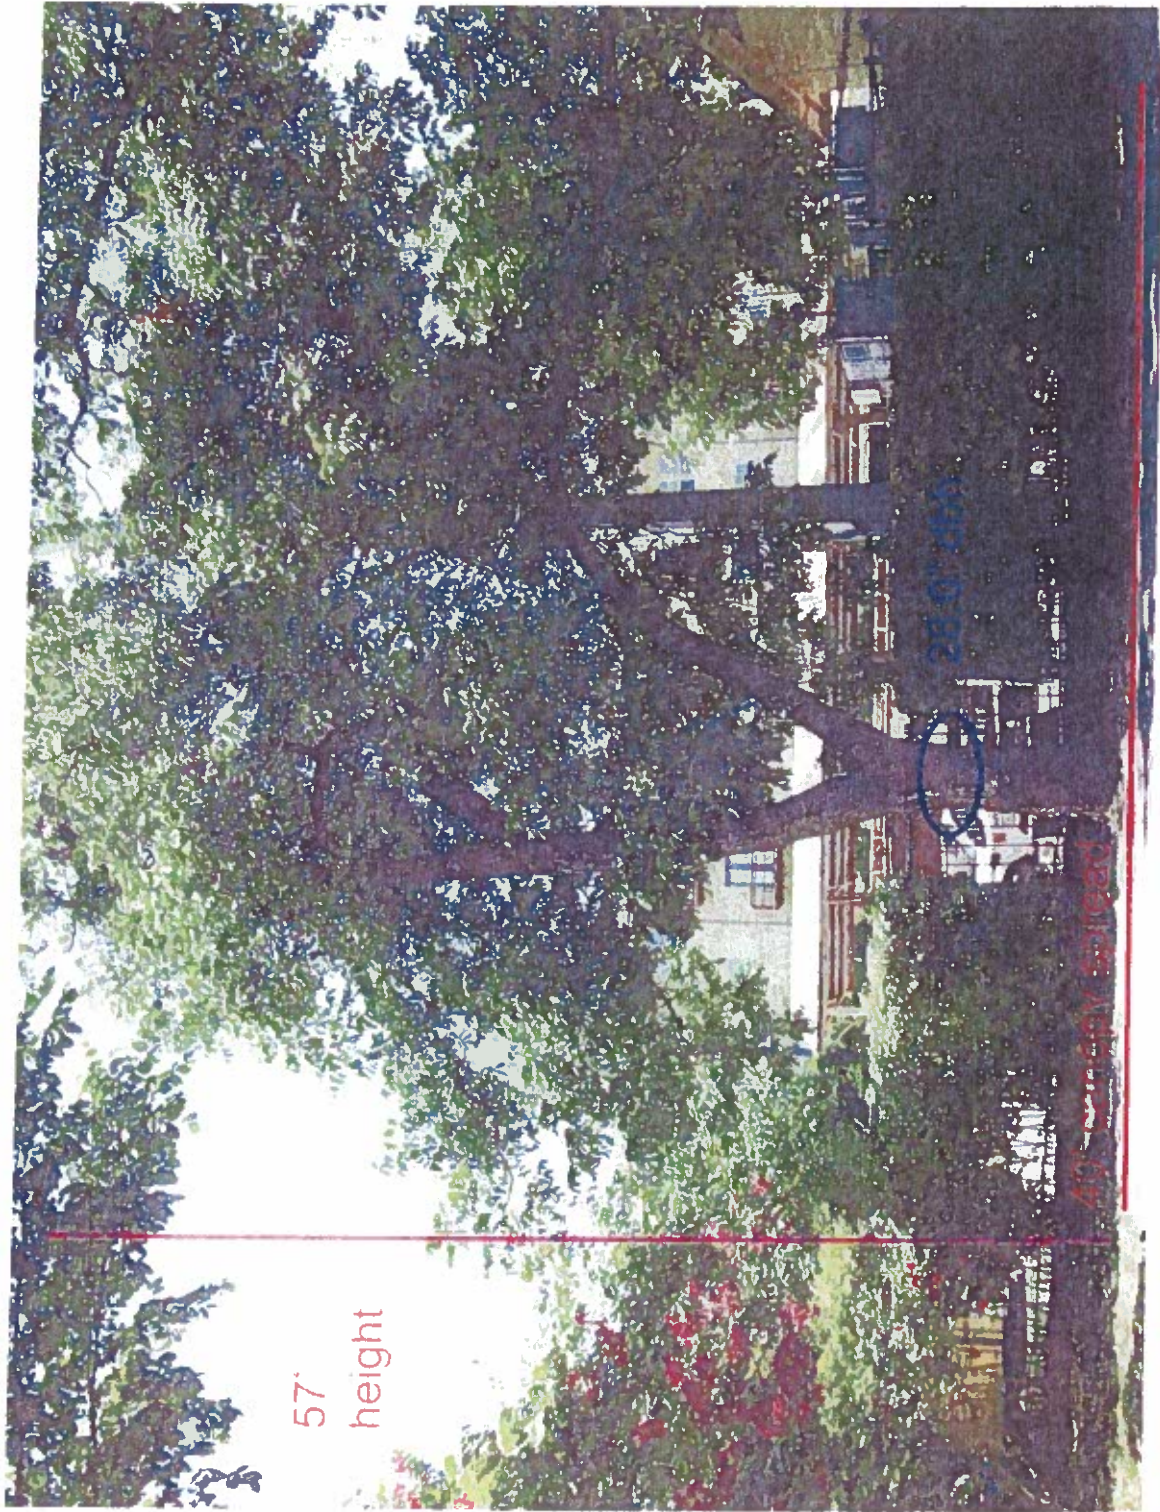
Exhibit 7

There is also a 28.0 inch diameter Pecan onsite that is proposed to be removed (Exhibit 7). This tree displays severe structural defects. There is a 2" x 10" cavity that exhibits

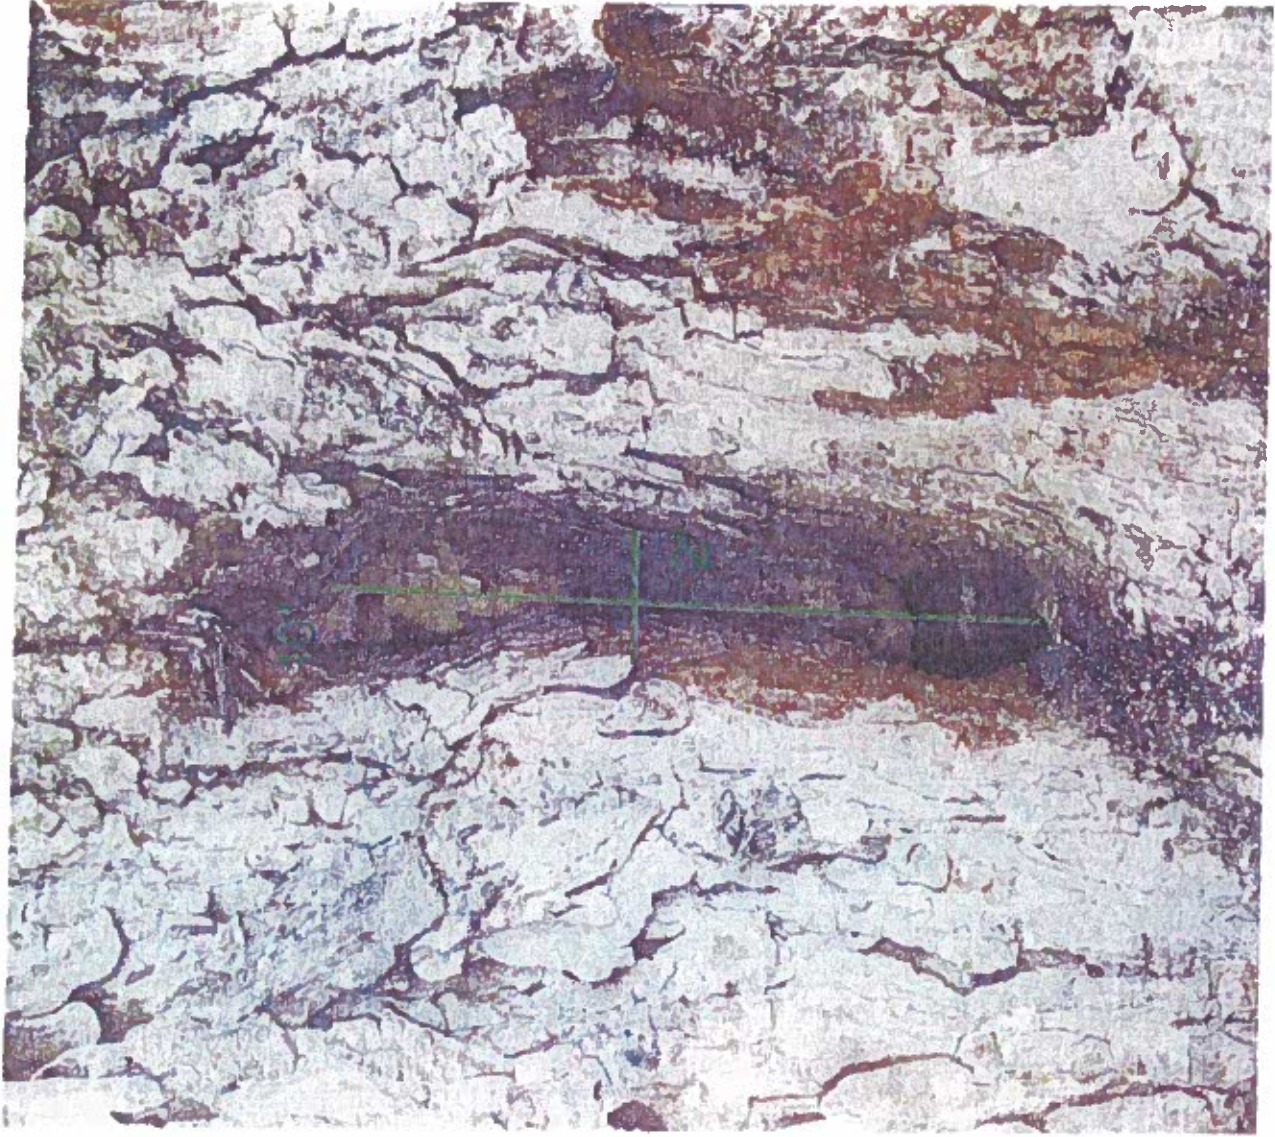
Exhibit 8

significant decay as evidenced by the -200 in³ of void space (Exhibit 8). There is also a 8" x 12' decay column in the east stem (Exhibit 9). Further, the root flare has been buried 32 inches with rock, fill, stone, and brick (Exhibit 10) per the Bartlett assessment included in the applicant's memorandum. Given the aforementioned reasons both the City Arborist's assessment (Exhibit 11) and the Bartlett assessment concur that the subject tree is hazardous. The subject tree meets the criteria for administrative criteria for removal per both LDC 25-8-624(5)(a), diseased and restoration is not practicable, and LDC 25-8-624(A)(3) imminent hazard; thus the City Arborist will allow the subject tree to be removed and is not considered part of the variance request before the Environmental Board and Planning Commission.

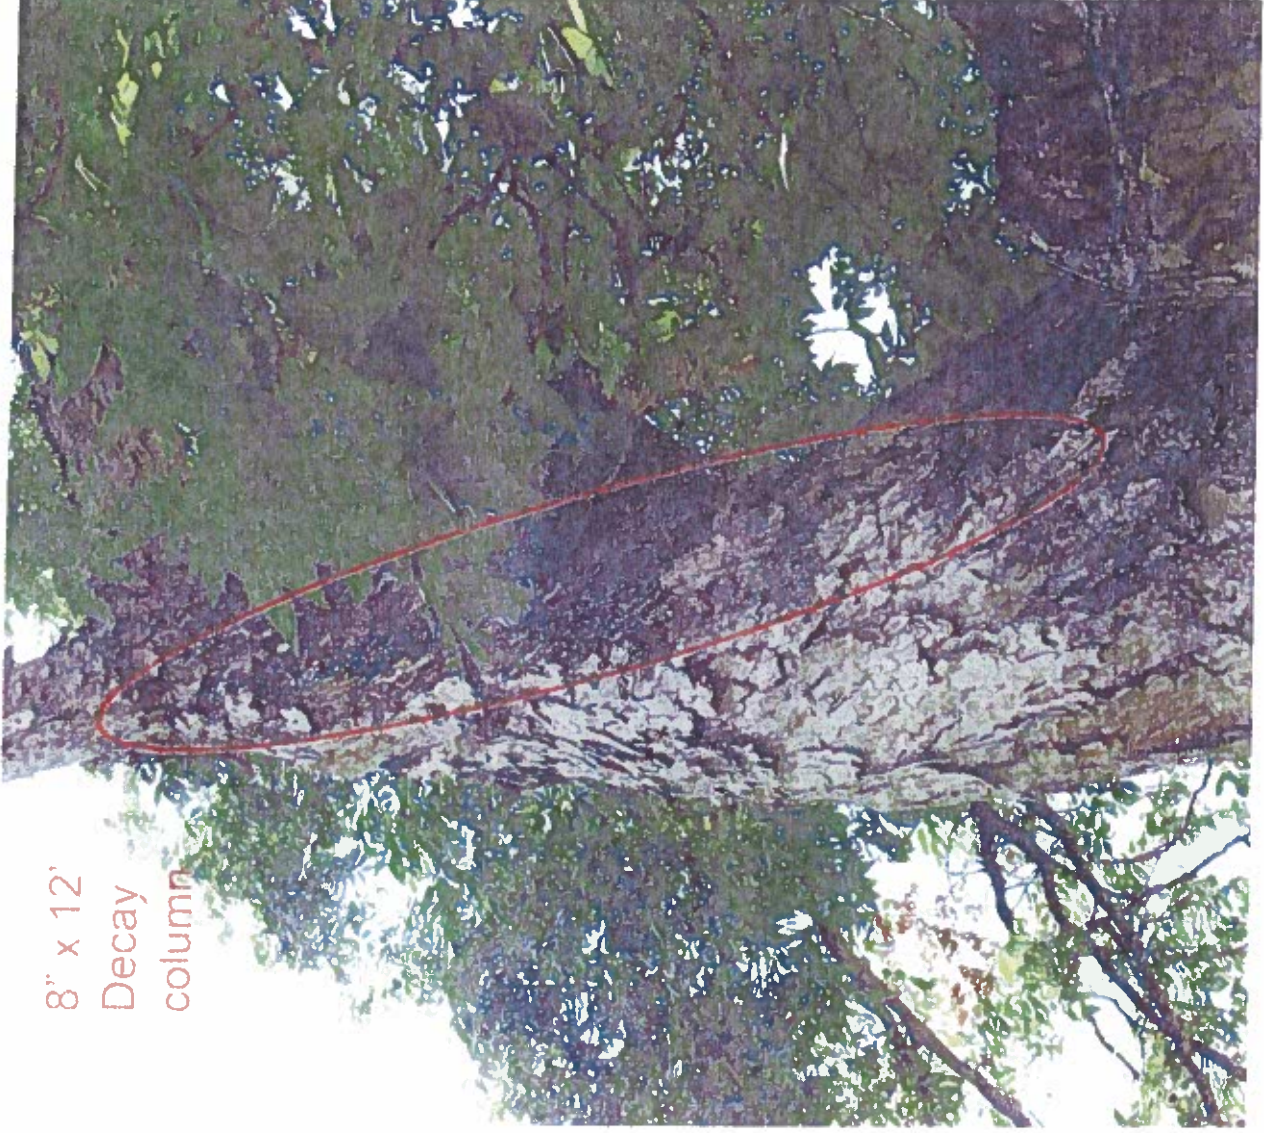
Exhibit 9

8" x 12'
Decay
column
