HISTORIC LANDMARK COMMISSION
OCTOBER 22, 2012
CERTIFICATE OF APPROPRIATENESS
LHD-2012-0031
4406 Avenue F
Hyde Park Local Historic District

Demolish a c. 1945 contributing house to allow for construction of a new house.

STRUCTURAL INSPECTION REPORT

Location of Property: 4406 Avenue F, Austin, TX

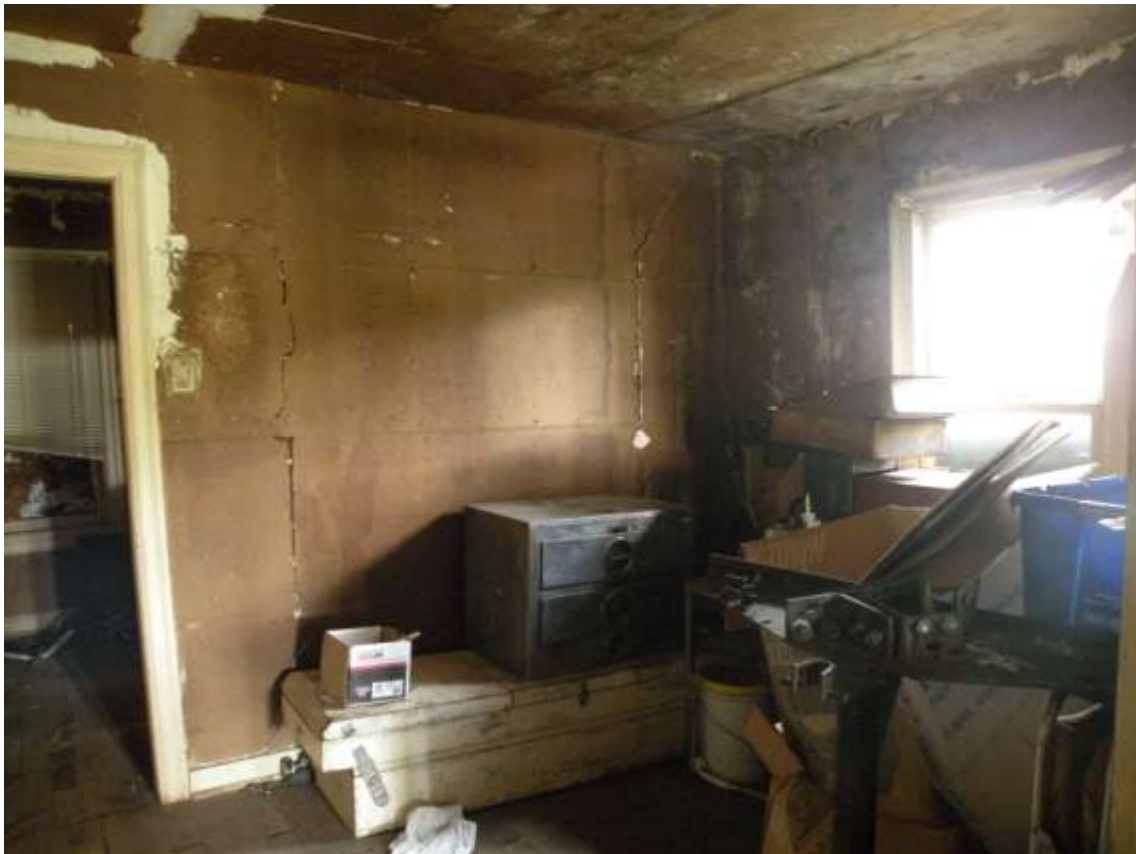
Interior conditions

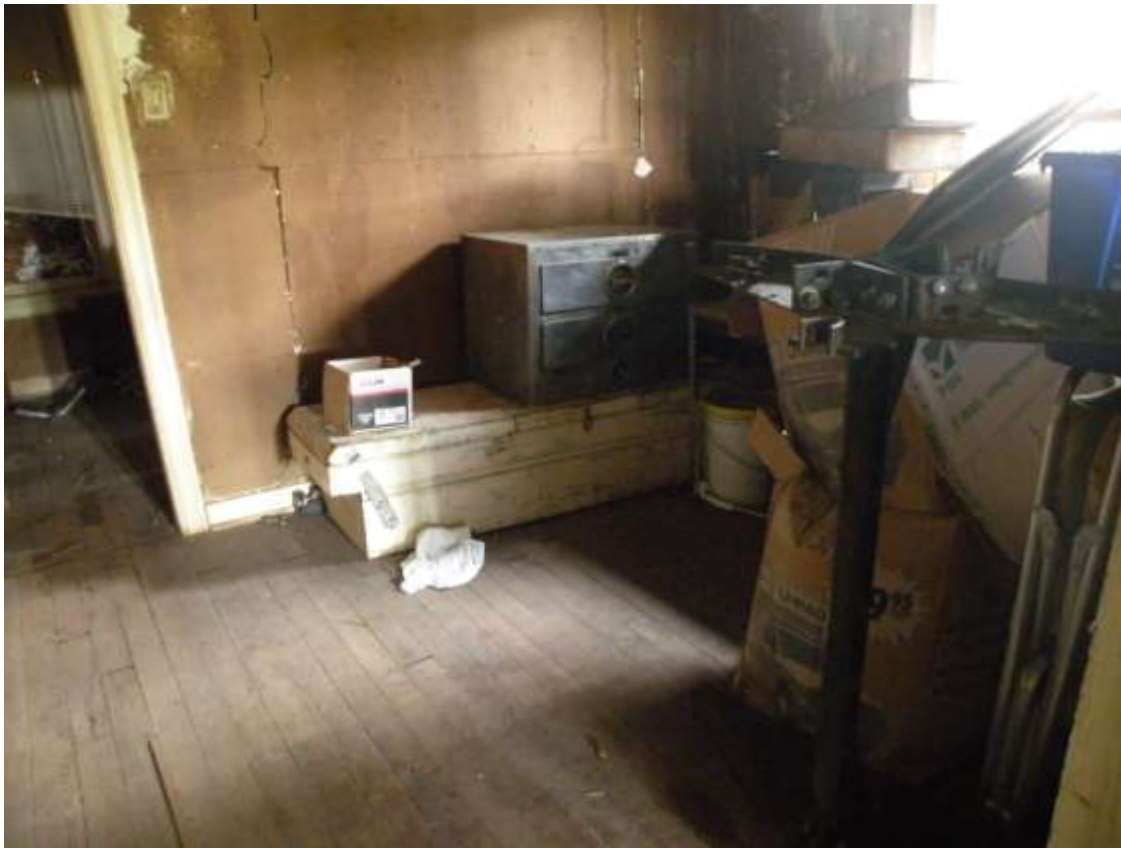
Interior conditions

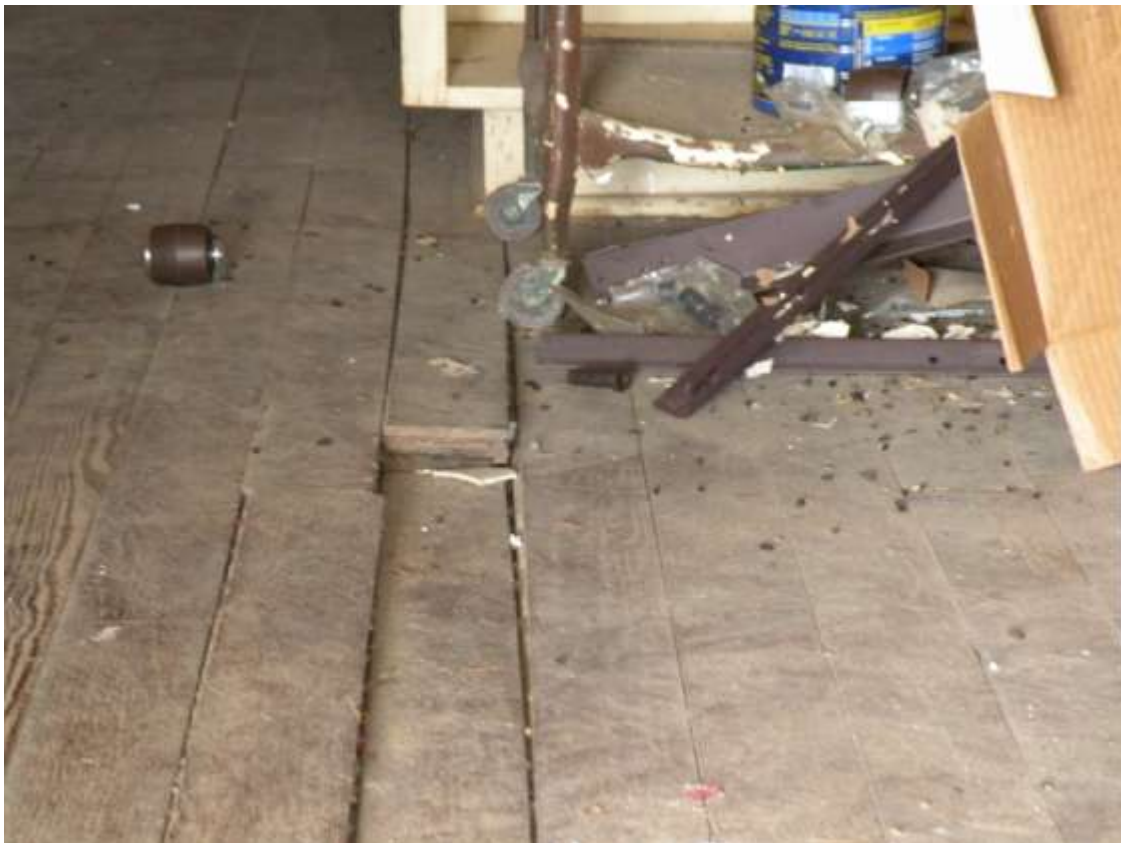
Interior conditions
