HISTORIC LANDMARK COMMISSION  
 NOVEMBER 26, 2012  
 CERTIFICATE OF APPROPRIATENESS  
 LHD-2012-0031  
 4406 Avenue F  
 Hyde Park Local Historic District

**STRUCTURAL INSPECTION REPORT**

Location of Property: 4406 Avenue F, Austin, TX

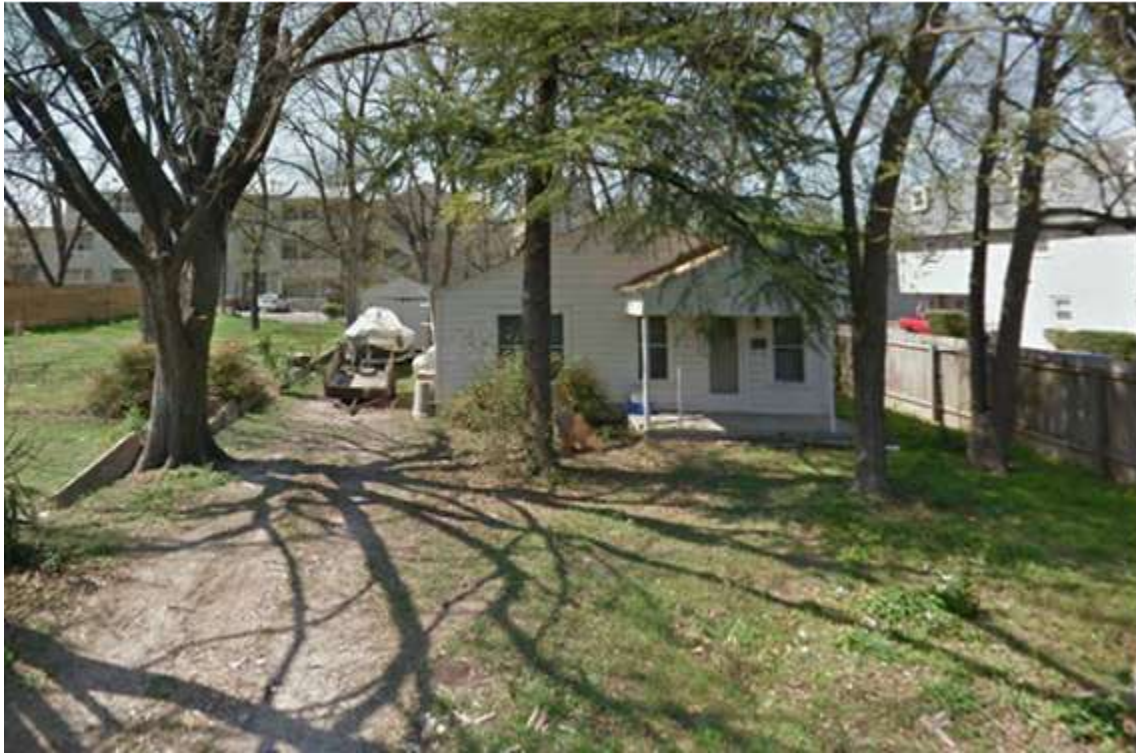
Exterior front façade of 4406 Avenue F

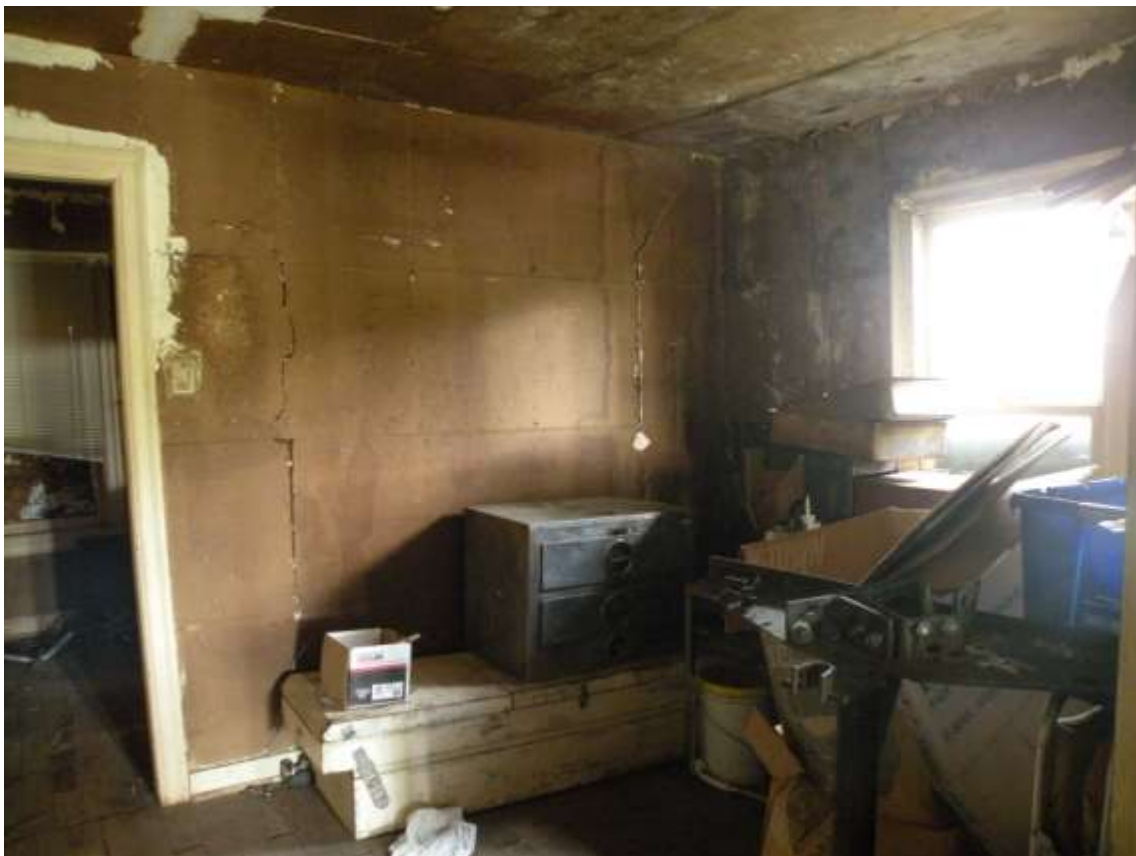
The existing house is in poor condition with visible deficiencies such as sloping floors, evidence of moisture intrusion on the interior ceilings, floors boards that have deteriorated to the point of breaking, and openings in the wall that have required patching. The city cited the property for code violations in 2008 and again in 2011 due to the house being open and accessible, and there is evidence that vagrants may still be gaining access to the house. According to City permit records repairs were made in 2008 to meet minimum code standards including repairing siding, windows, roofing, and joists.

Interior conditions

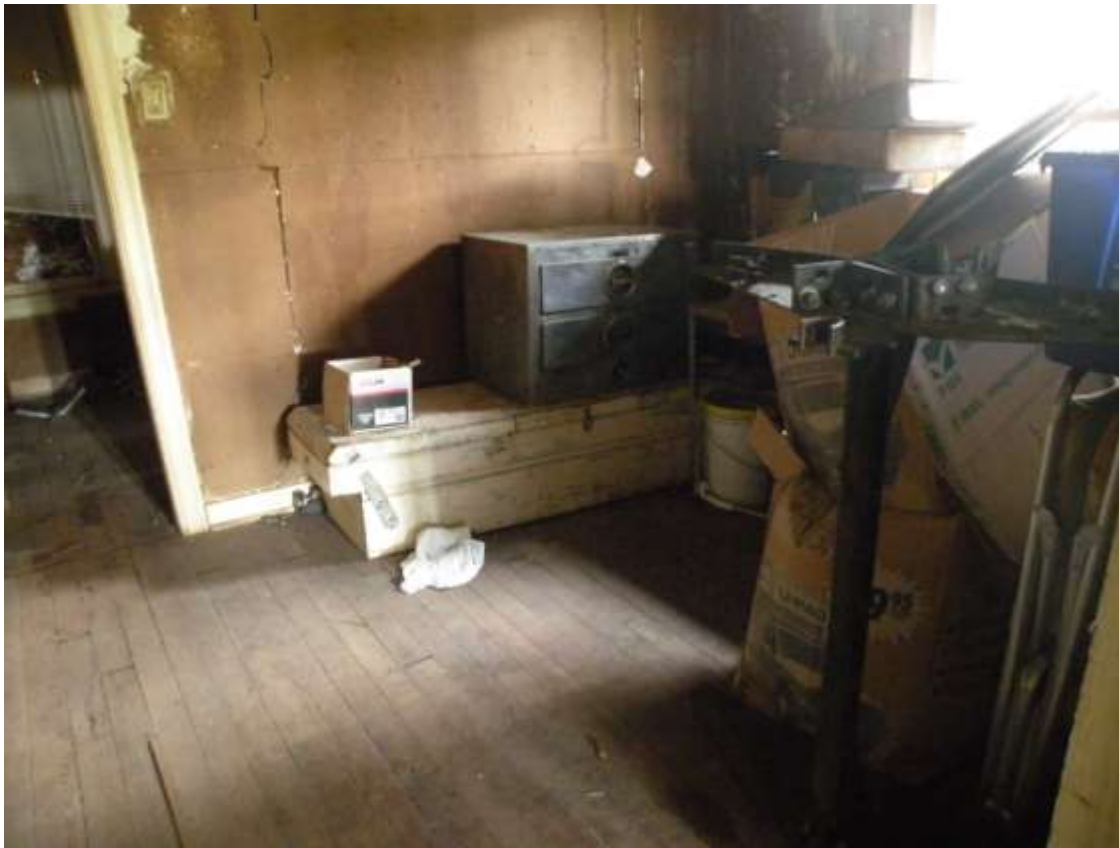
Interior conditions

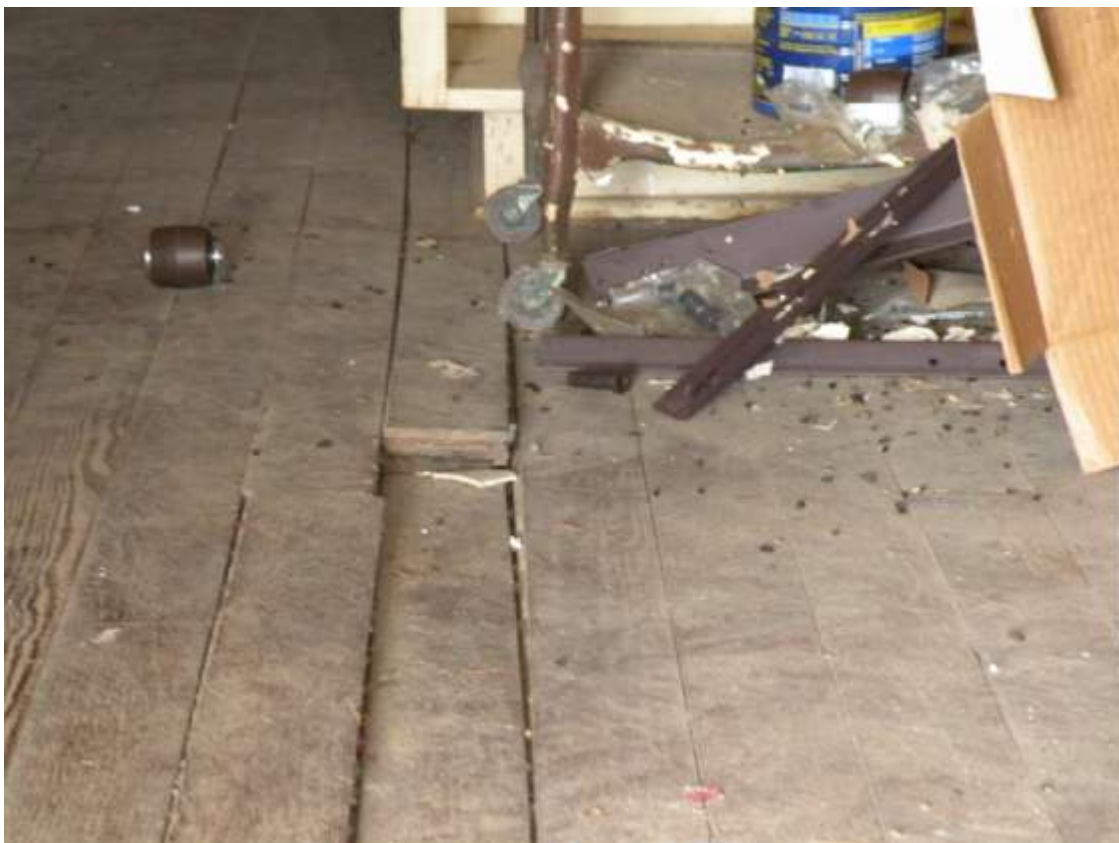
Interior conditions

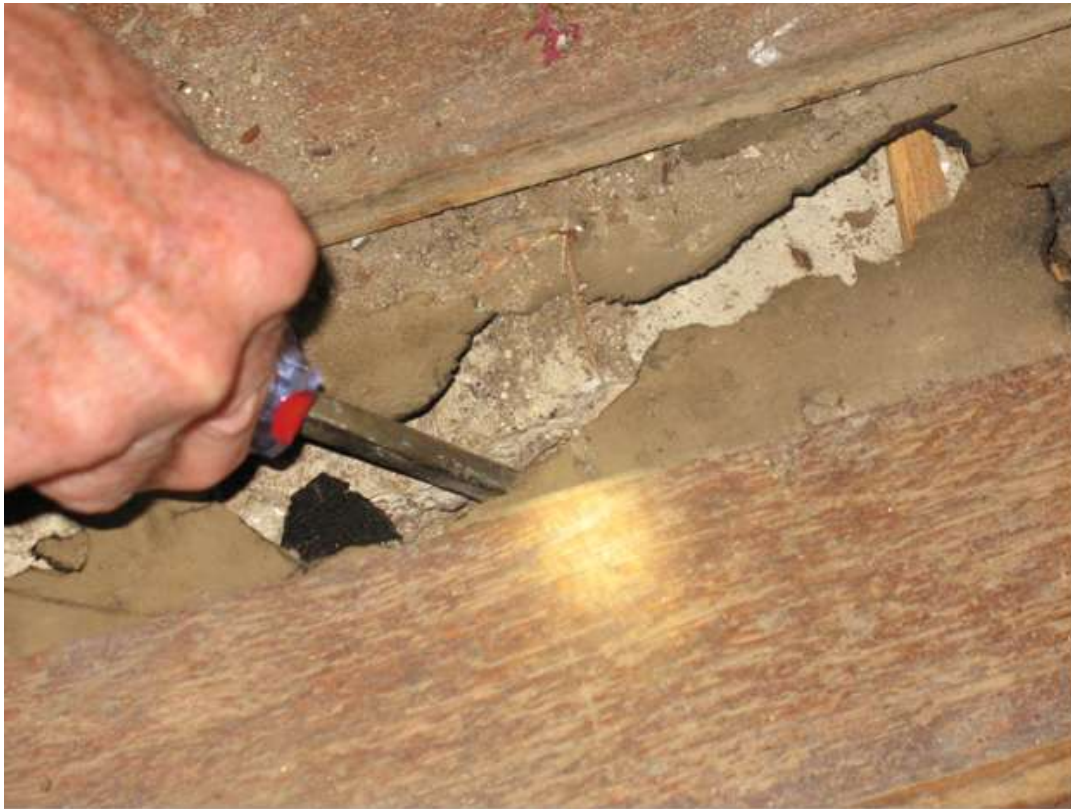
Crack in slab foundation under existing floor boards.

**Foundation:** The concrete slab was covered with hardwood flooring. A portion of this flooring was pulled up in the living room, revealing a two-inch wide crack in the concrete slab. The original slab was capped with 1-1/2 inches of concrete at that point. There was no steel reinforcing observed in the crack in the concrete.

**Foundation:** It is my opinion, based on experience, that an un-reinforced concrete slab is irreparable. I would not be involved in any attempt to repair this slab with piers. I recommend that the house, including the concrete slab, be torn down. I have only recommended that one other house be demolished and re-built in my twenty-five year career in the Austin area and that was because the slab was un-reinforced.

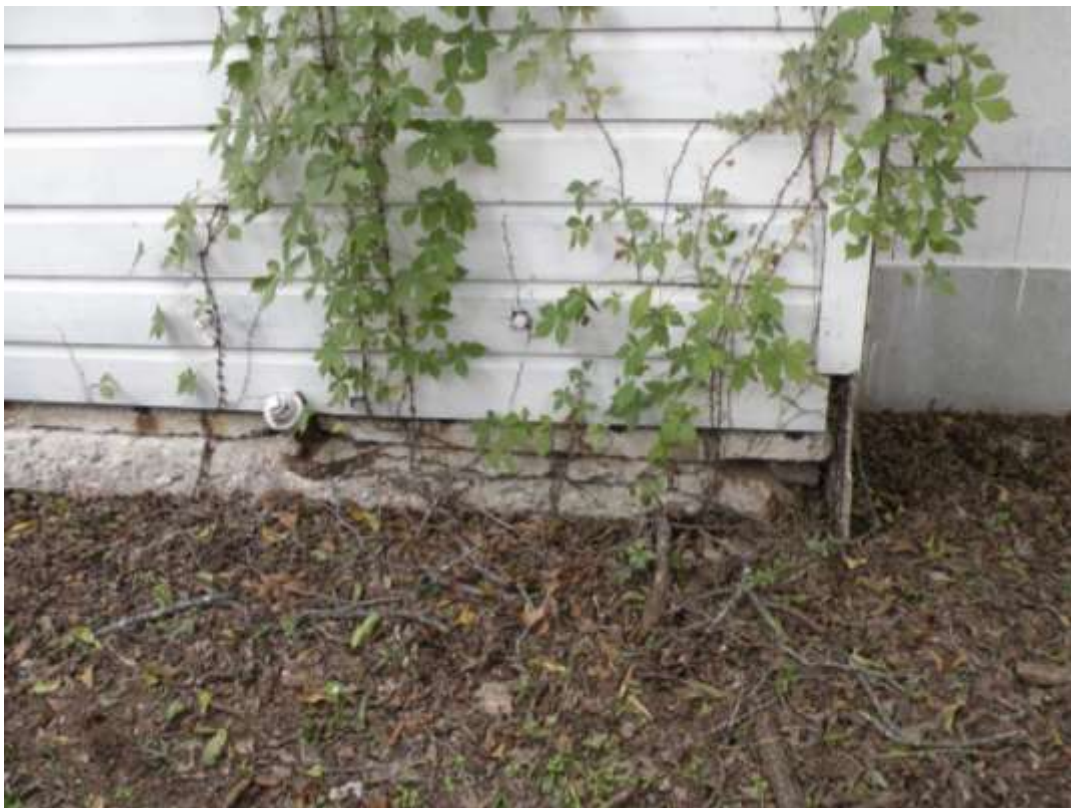
Foundation conditions of 4406 Avenue F

The foundation sloped down at the right end about six inches and down at the left end about three inches.

The foundation at the above address was evaluated on 11/5/2012. The home has experienced significant foundation displacement and damage, most notably along the right side. The portions of the foundation that were visible, are constructed with non-traditional methods. There appear to be concrete slabs poured on top of each other, up to the height of the wooden beams and flooring. This type of construction is not repairable by any foundation repair techniques that we use. I cannot perceive how this home could be lifted and/or the foundation repaired.

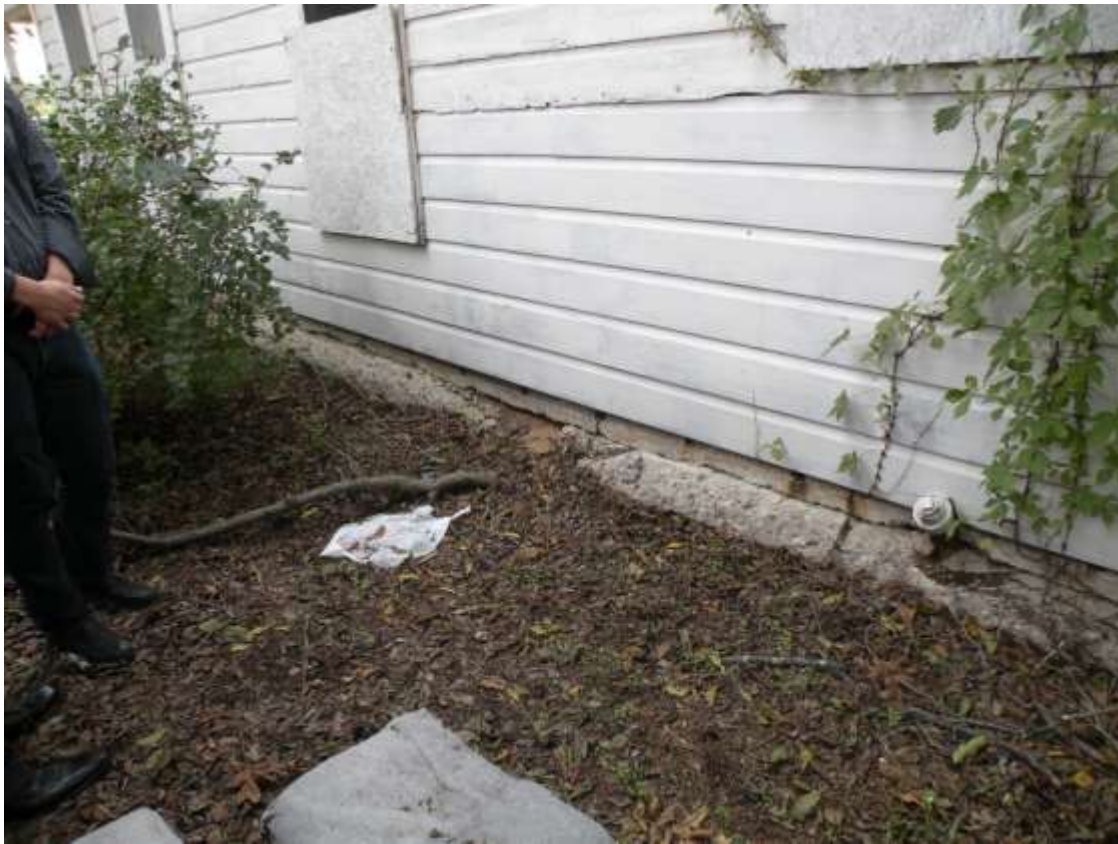
Foundation conditions of 4406 Avenue F

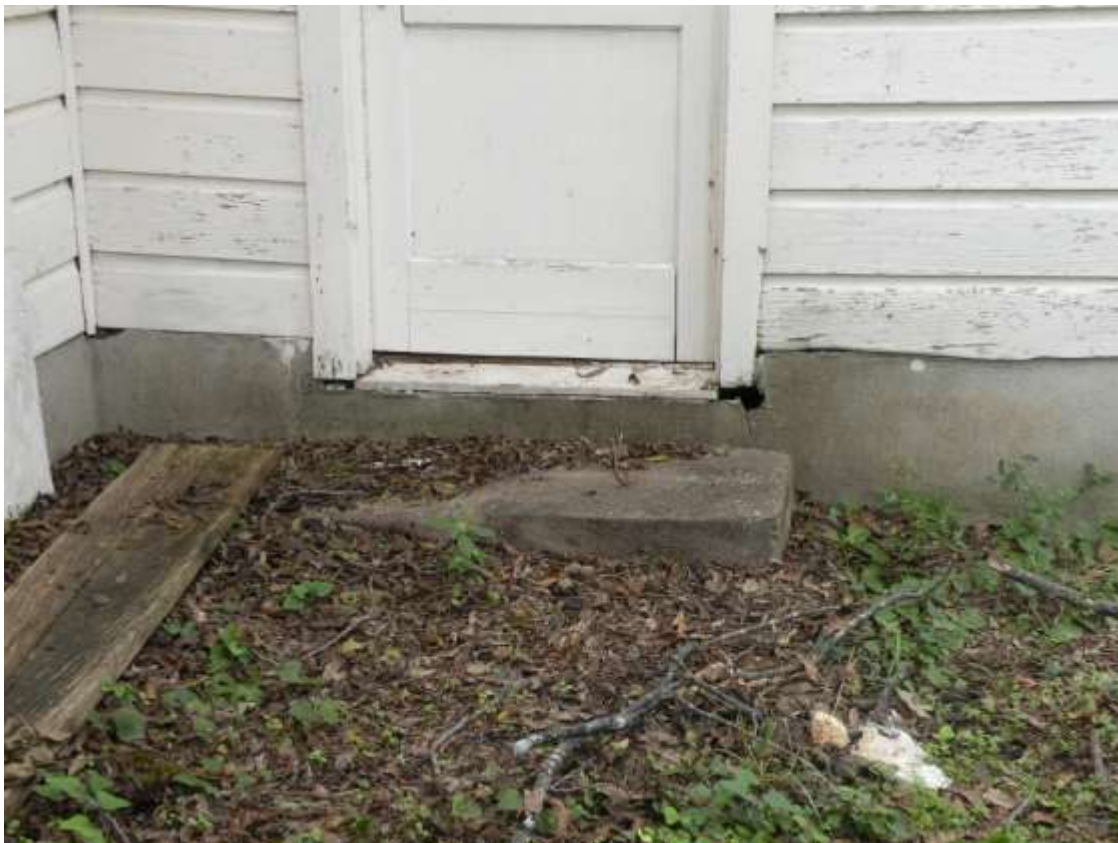
Foundation conditions of 4406 Avenue F
