**Table of Contents for 2818 Rio Grande Tree Permit**  
**Heritage Tree Variance Package**

**PROJECT NAME:** 2818 Rio Grande

**TREE PERMIT #:** 10827869

**SUBJECT:** 2818 Rio Grande

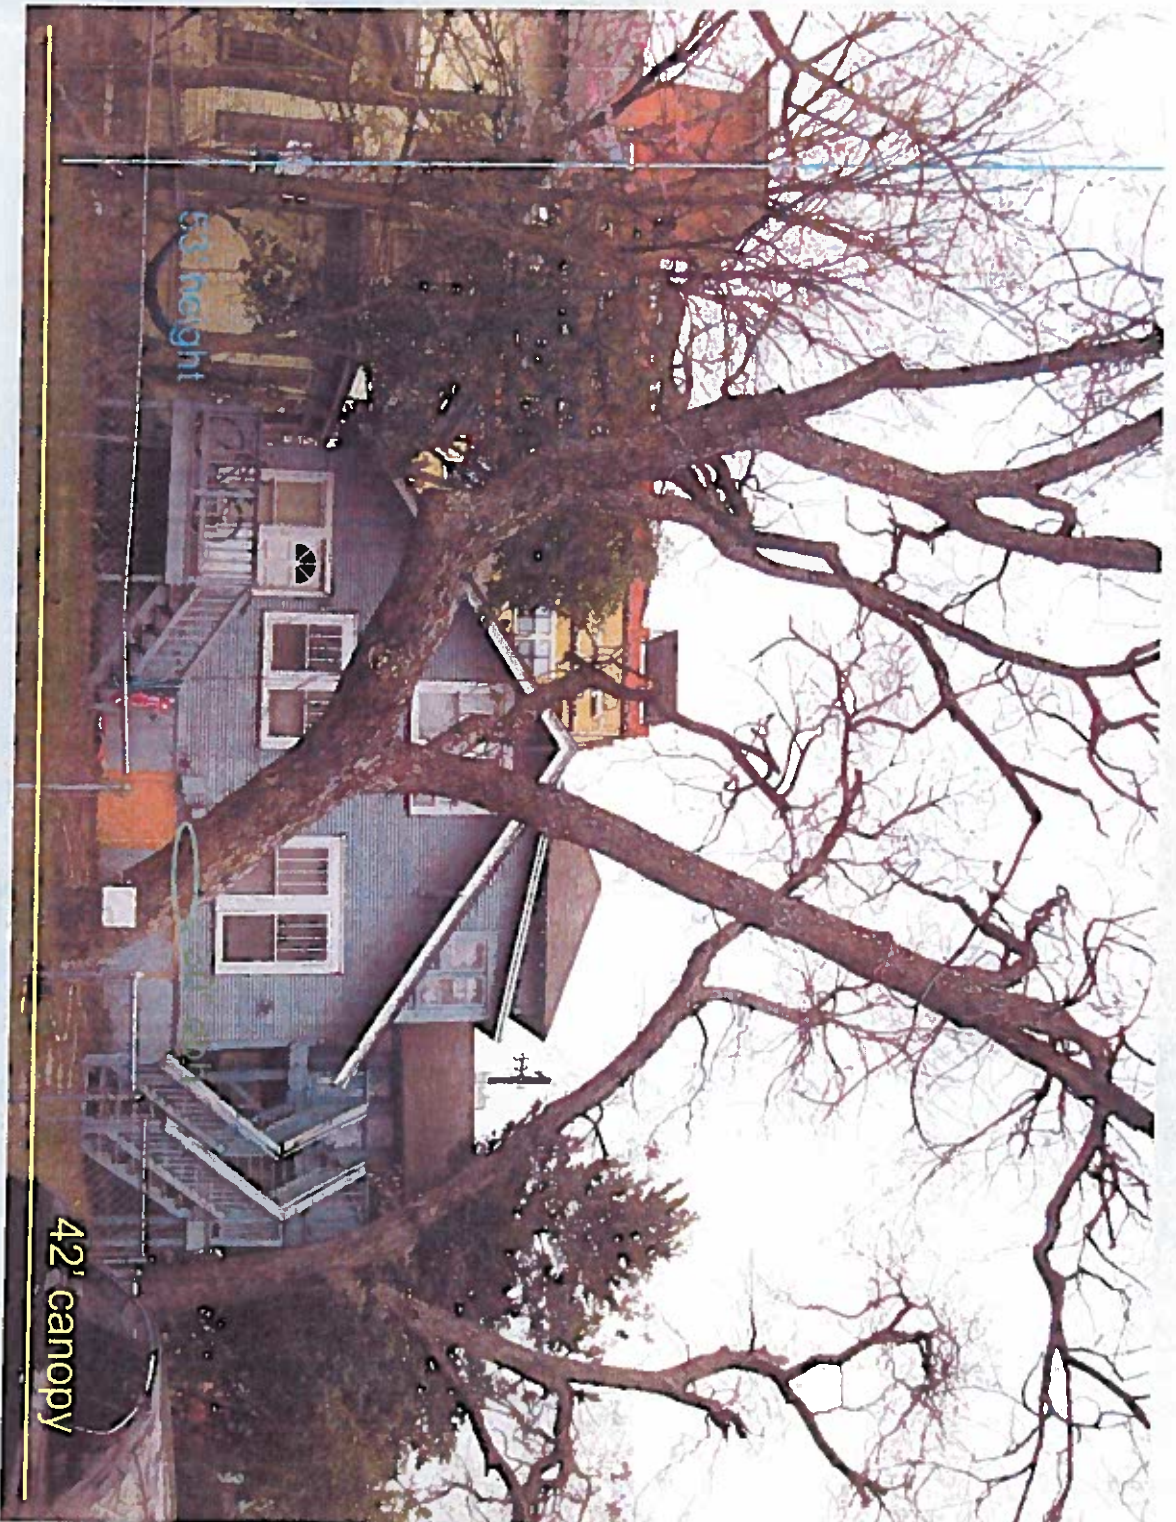
Exhibit 3

The subject tree is a 30.0 inch diameter at breast height (dbh) Pecan (*Carya illinoensis*). The tree height is 53 feet and the canopy spread is 42 feet (Exhibit 3). The tree has a 45 degree lean from vertical with no evidence of root decay or soil heaving (Exhibit 4).

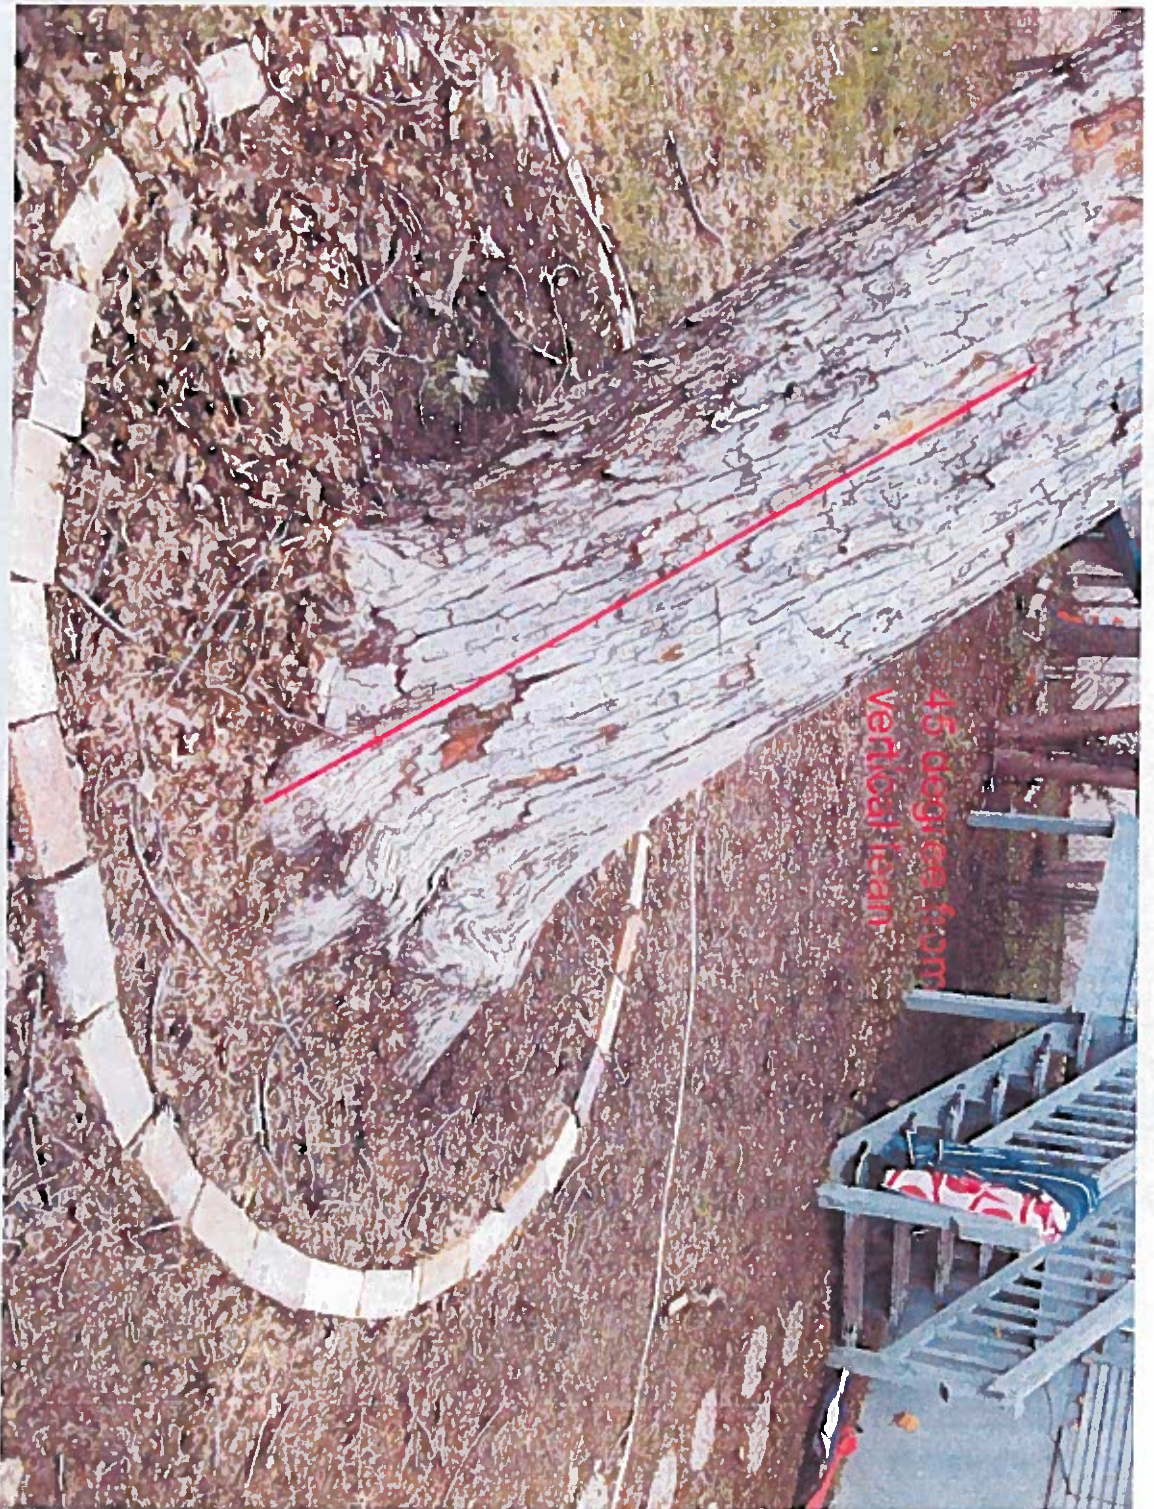
Exhibit 4

Lean: 45° degrees from vertical natural or unnatural      Soil heaving: Y / (N)  
 Decay in plane of lean: Y / (N)      Roots exposed: Y / (N)      Soil cracking: Y / (N)  
 Lean severity: S / (M) / L      Compounding factors: imbalanced canopy  
 Suspect root rot: Y / (N)      Mushroom/conk present: Y / (N) ID: \_\_\_\_\_  
 Exposed roots: S / M / L      Undermined: S / M / L  
 Root pruned: \_\_\_\_\_ feet from trunk      Root area affected: \_\_\_\_\_%      Buttress wounded: Y / (N)  
 Restricted root area: S / M / L      Potential for root failure: S / (M) / L

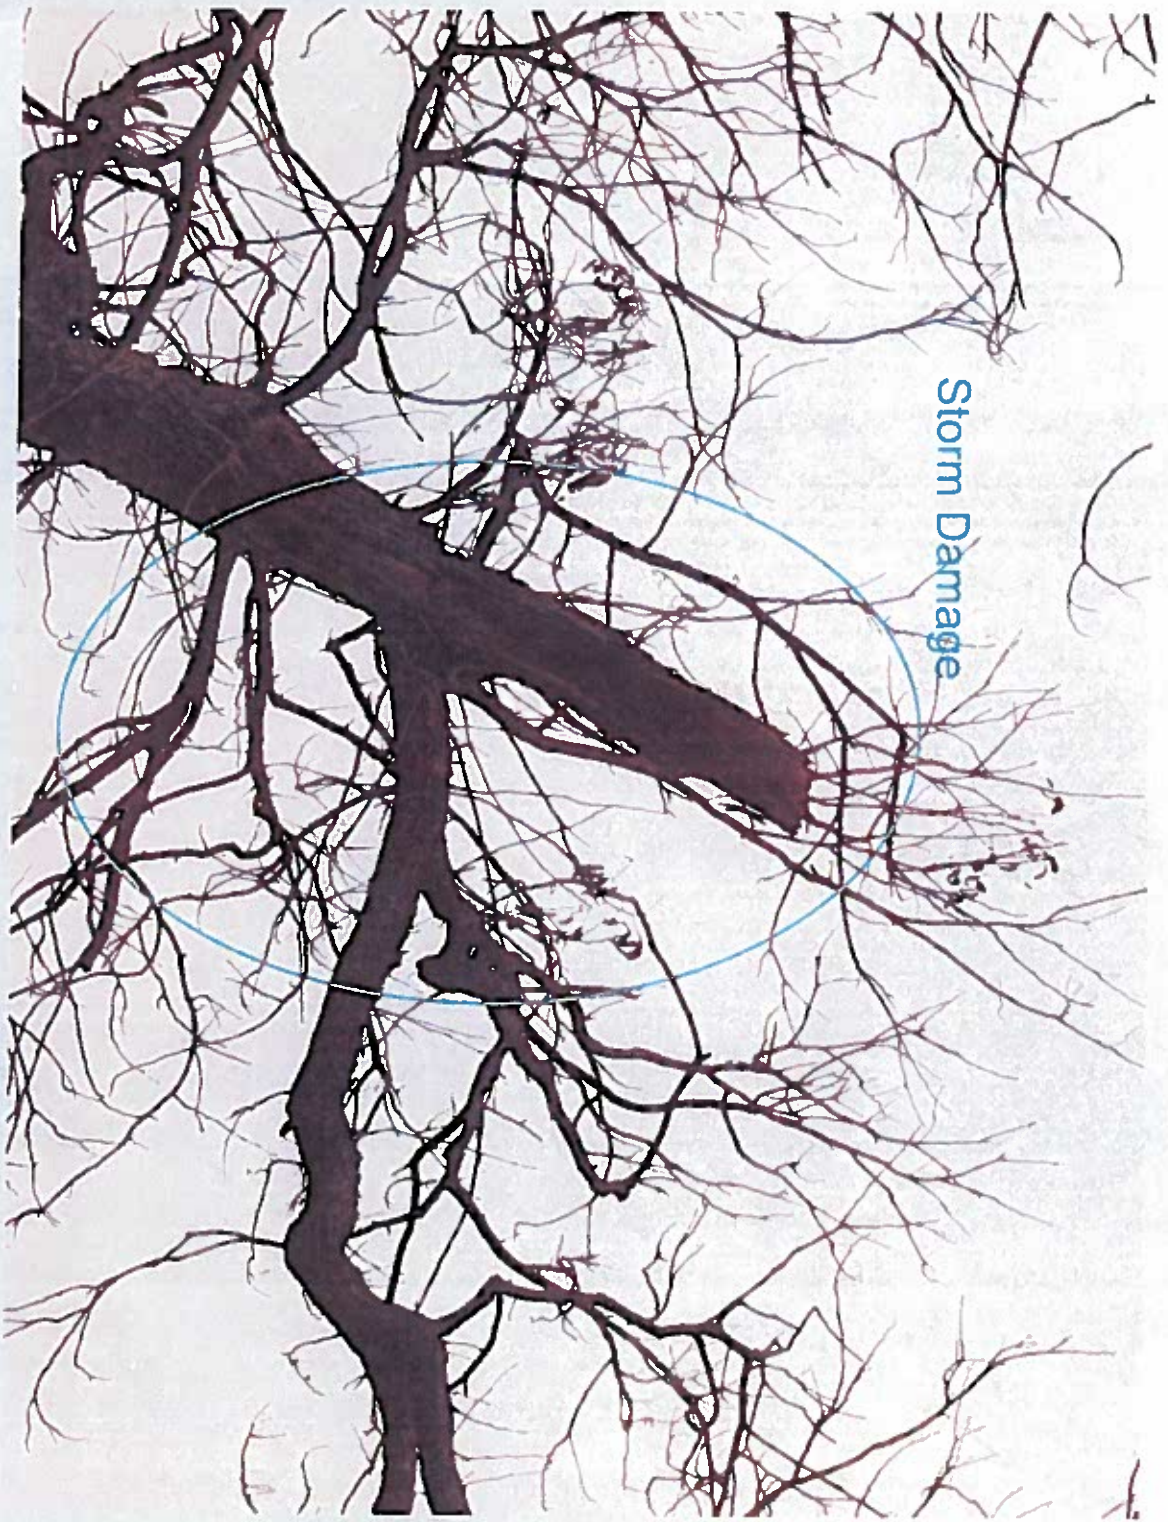
Exhibit 5

The canopy has major asymmetry, extensive storm damage, and moderate decay. Storm damage is evident by the presence of multiple broken stems and subsequent decay (Exhibits 5, 6, 7 and 8).

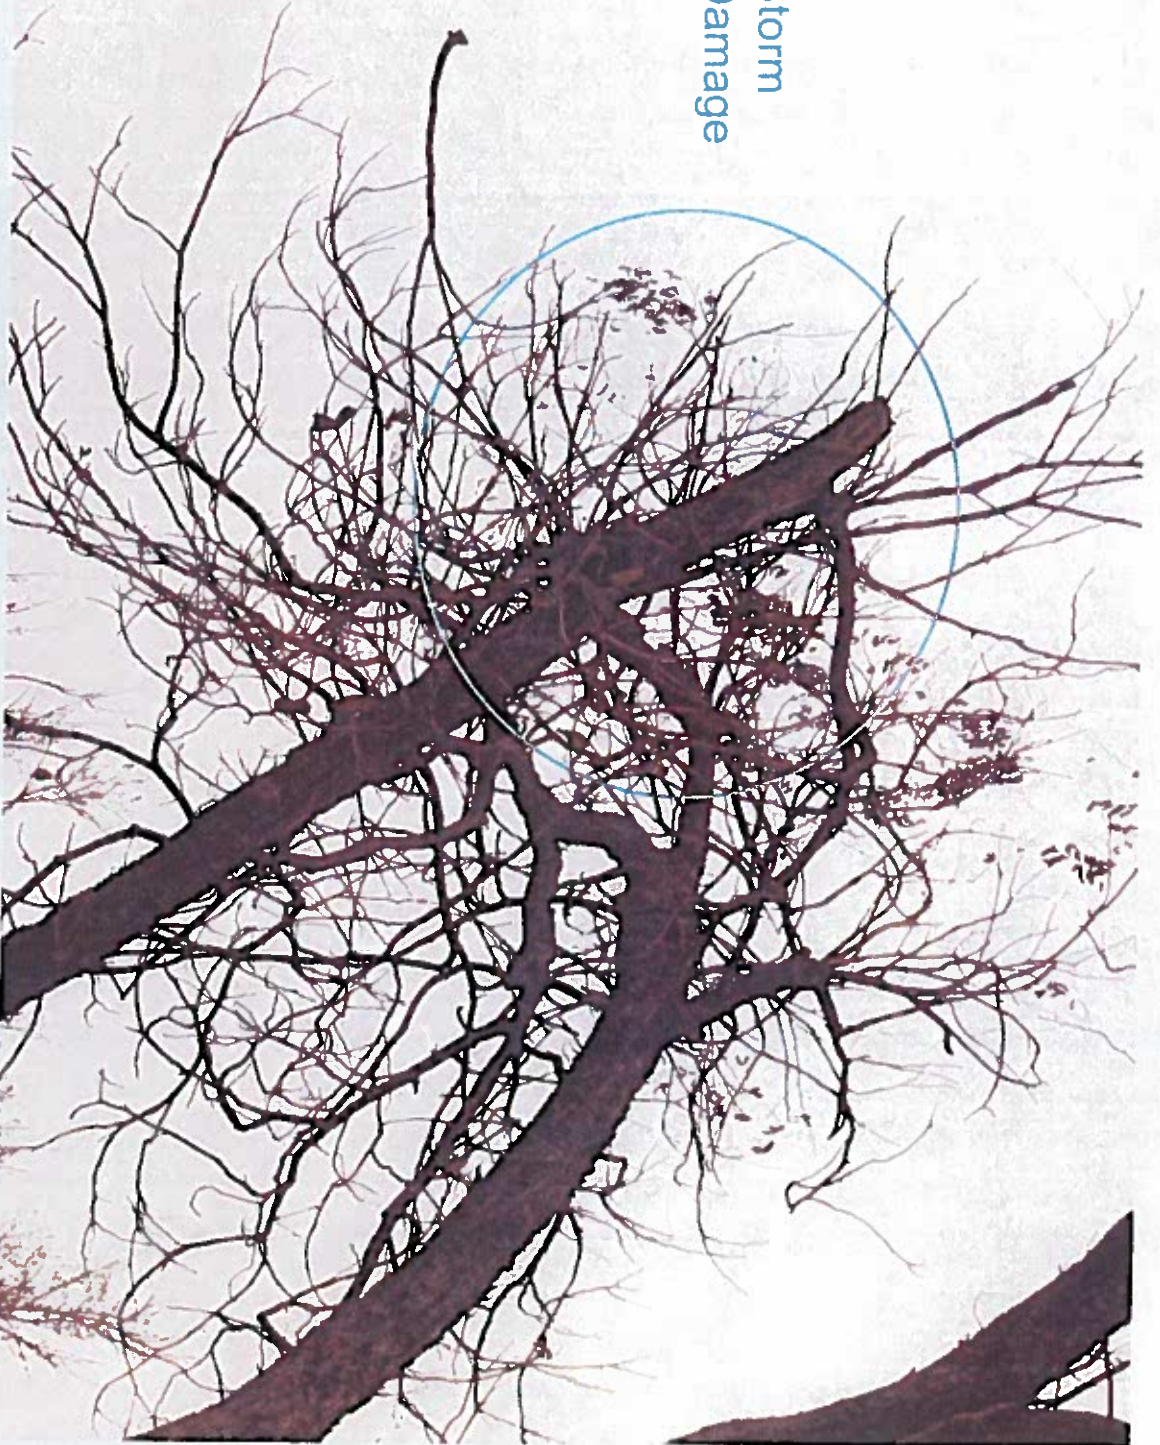
Exhibit 6

Storm  
Damage

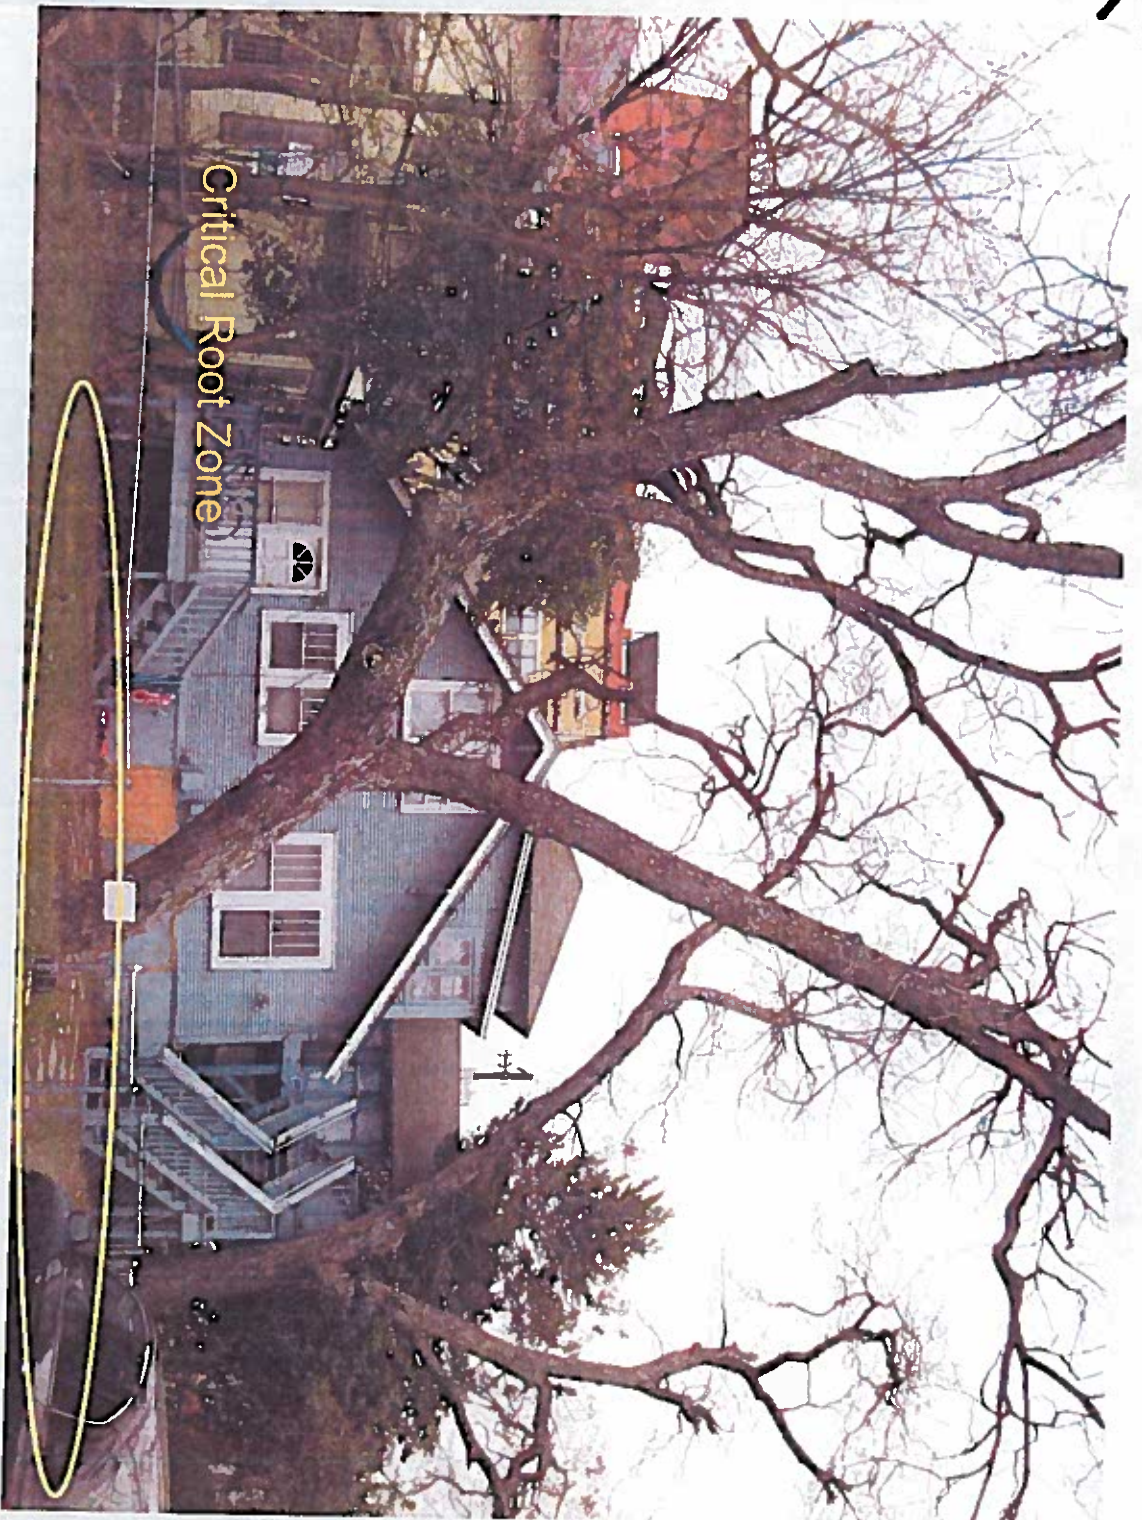
Exhibit 9

Critical root zone conditions are characterized by compacted turf grass and bare soil, base material serving as a parking lot, and a housing structure (Exhibit 9). Root flare is present with no signs of wounding or decay.
