Table of Contents for 507 W. 23rd Street Tree Permit
Heritage Tree Variance Package

**ADDRESS
OF PROPERTY:** 507 W. 23rd Street

SUBJECT: 507 W. 23rd Street Heritage Tree Removal

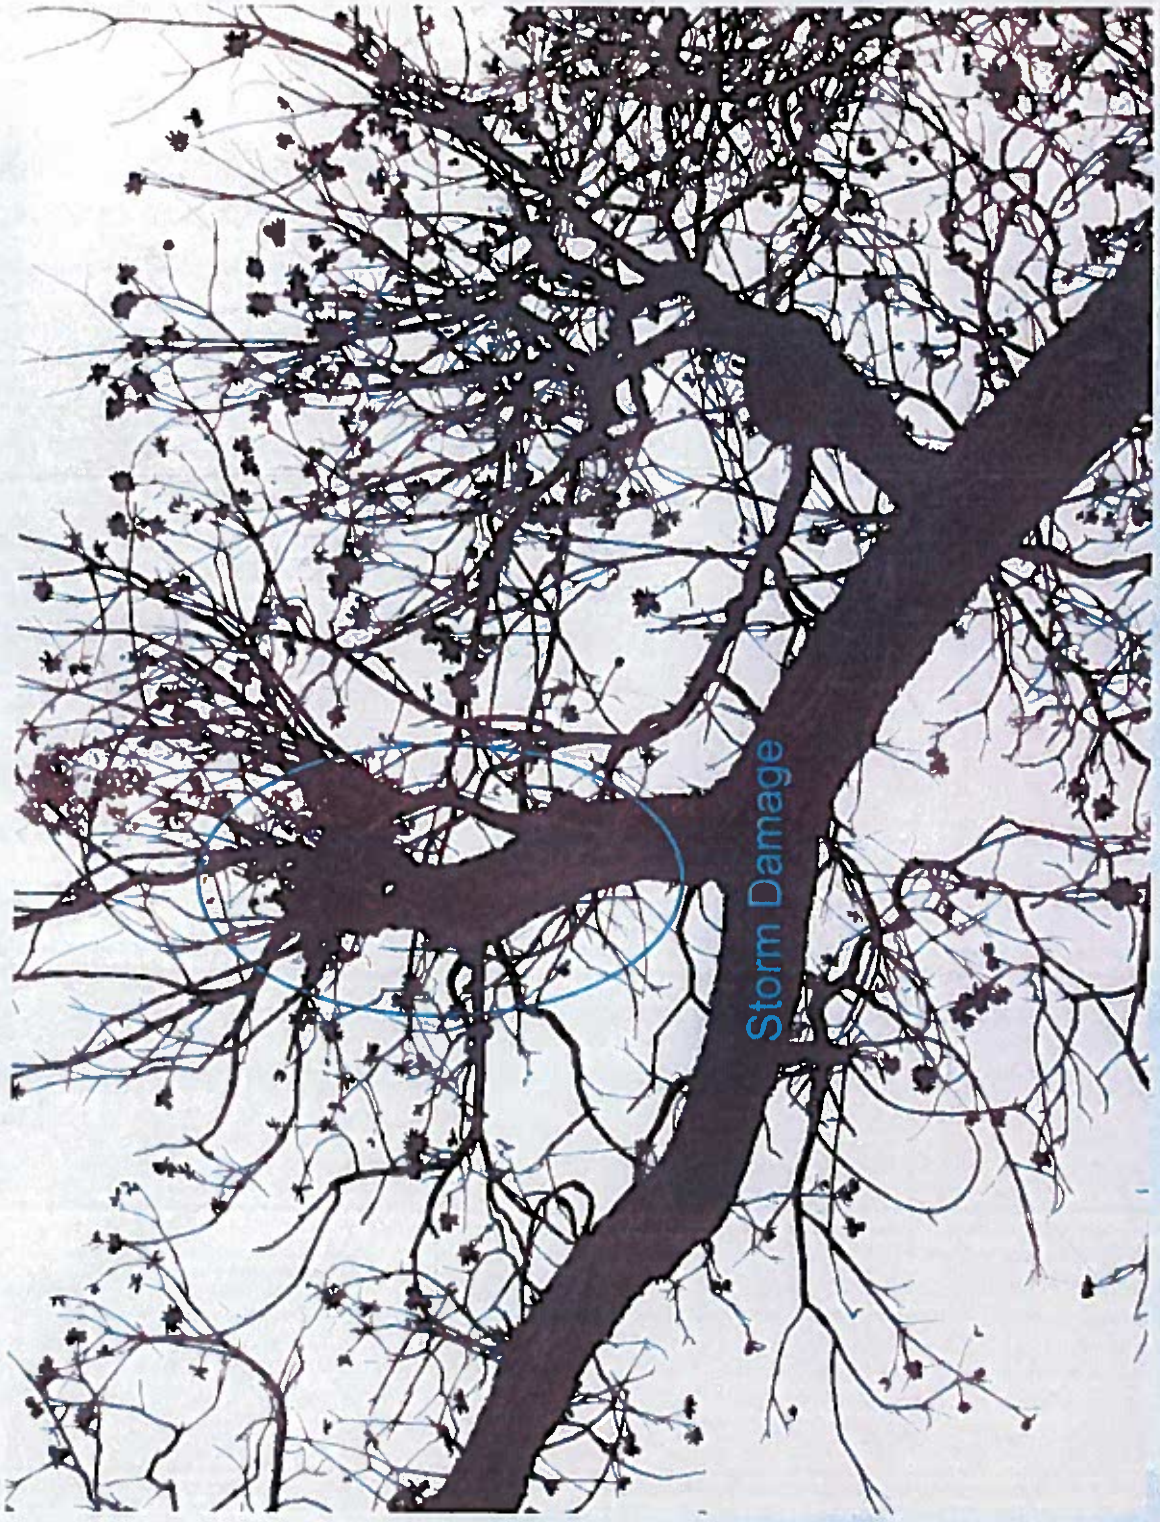
Exhibit 4

The canopy architecture displays minor asymmetry. Storm damage is evident by the presence of broken stems in the canopy (Exhibit 4). Minor cavities, wounds, and previous stem failures are apparent (Exhibit 5).

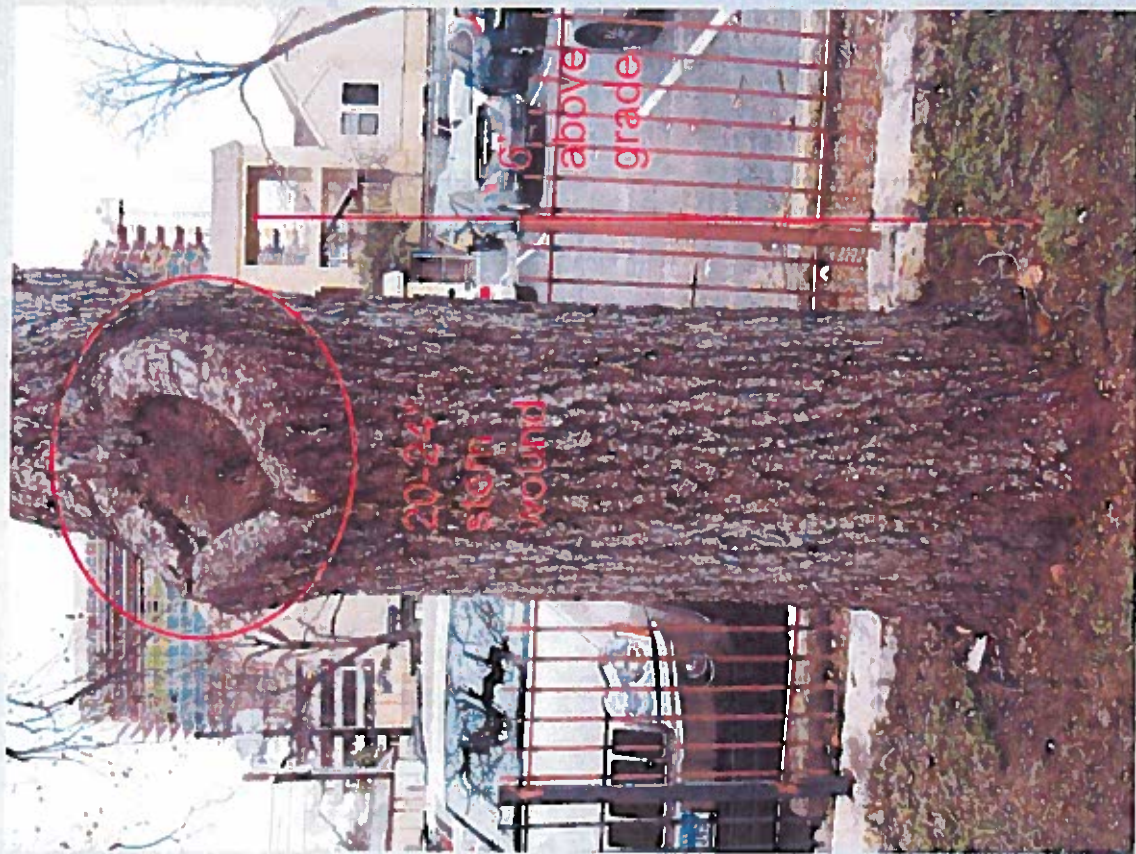
Exhibit 6

A major stem (20-24") wound occurs ~6' above grade (Exhibit 6). Callousing of the wound has occurred and minimal decay detected.

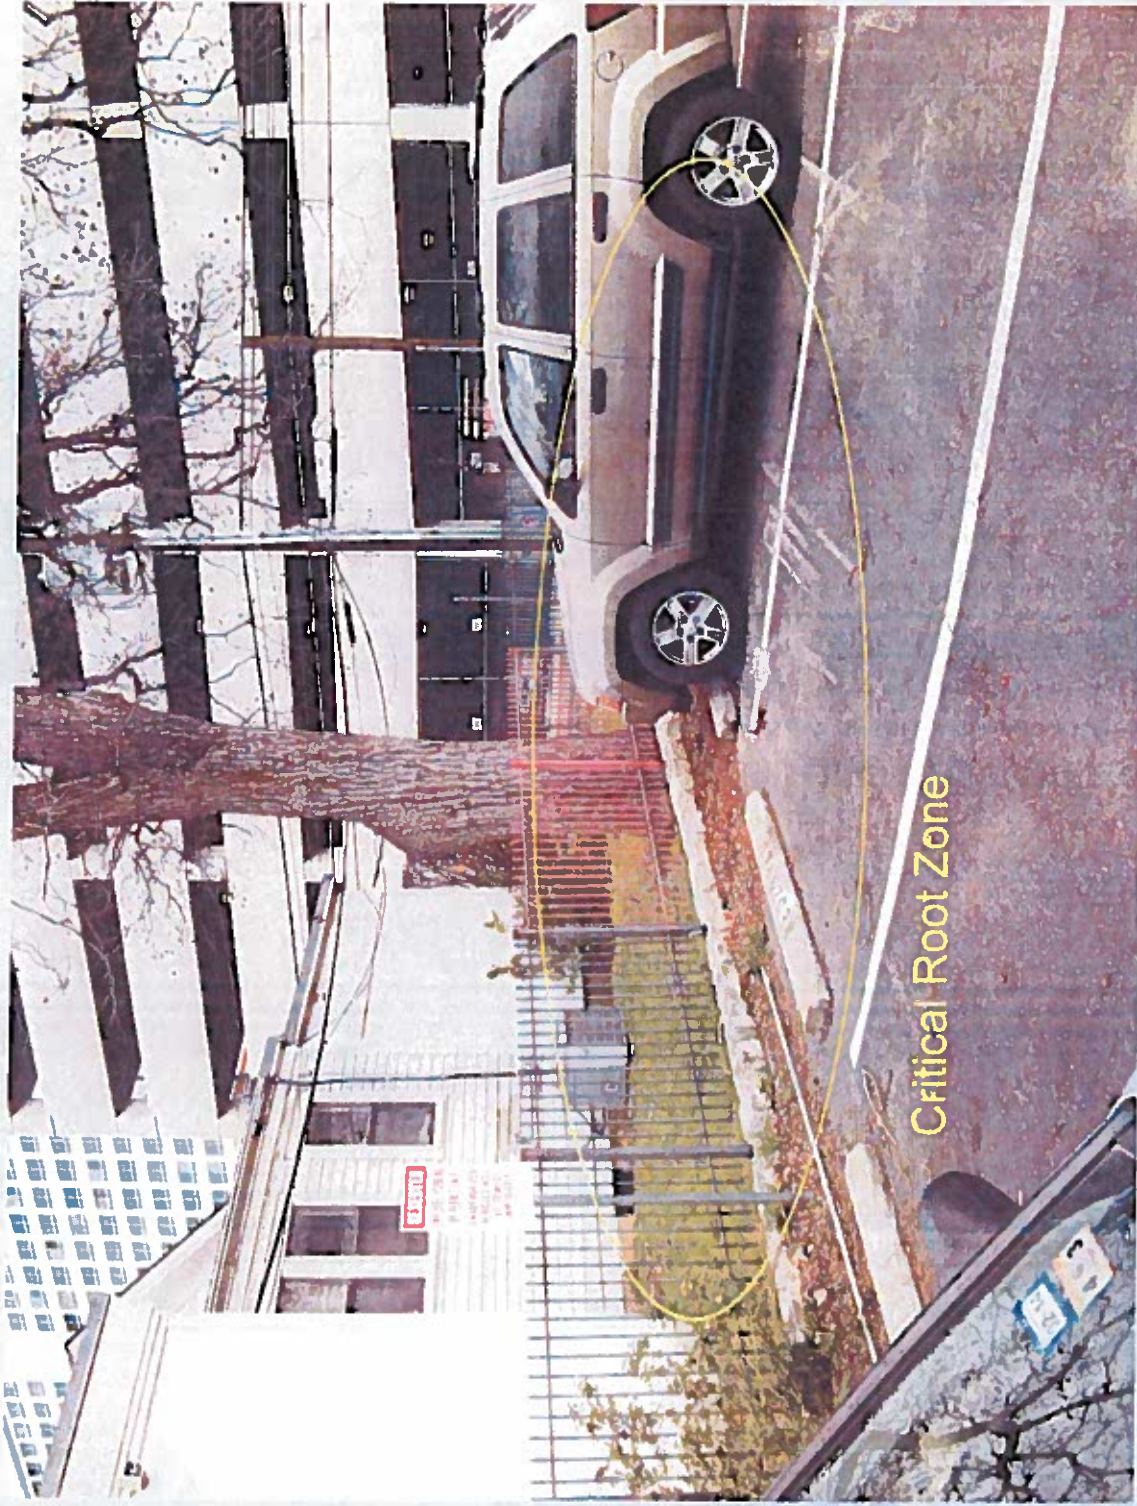
Exhibit 7

Root flare is apparent at grade. No defects are apparent. Critical root zone conditions are characterized by a 6" wall abutting the root flare, asphalt parking, turfgrass, and a

building structure (Exhibit 7). The depth of the wall is unknown. Surface and subsurface conditions in the critical root zone are poor due to compaction and impervious cover.

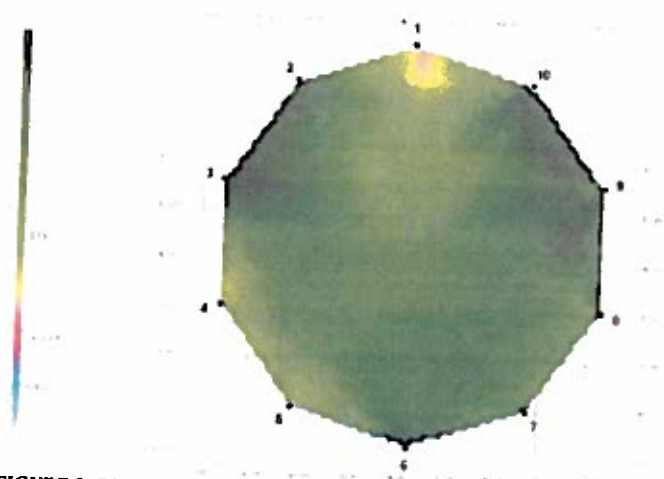
We performed sound-wave readings at approximately 16 inches above grade and 63 inches above grade. The higher reading was located just below the stem wound described above. This would provide a better indication of internal decay that might be present in the stem, including toward the tree base, a location more vulnerable to failure risk. The results revealed zero percent decay at the lower location (Figure 2) and one percent decay at the upper location (Figure 3).

Regarding the sound-wave images, the results indicated near-complete absence of decay. This suggests that the wound directly above the upper reading is effectively walling off movement of decay, especially in a vertical direction, downward. The absence of decay at the lower reading, combined with the good appearance of the buttress roots, suggests that the tree has good strength at a critical area - where the stem and support roots connect.

FIGURE 3: SONIC TOMOGRAPH AT 63 INCHES ABOVE GRADE SHOWING ONE PERCENT DECAY

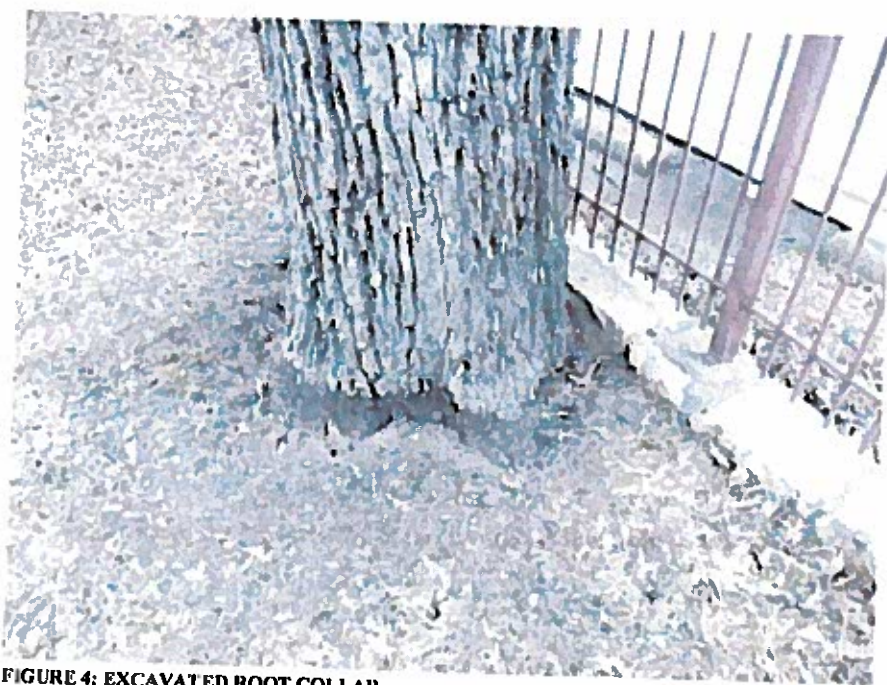
Using the compressed-air tool, we excavated the root collar to about eight inches to expose more area of the buttress roots. No defects were visible based on this examination (Figures 4 and 5).

FIGURE 4: EXCAVATED ROOT COLLAR

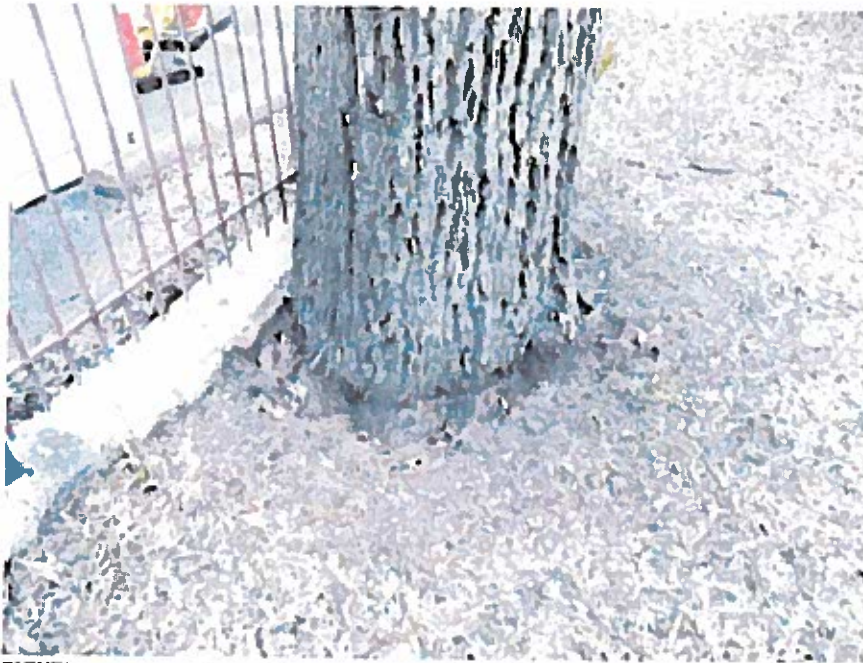
FIGURE 5: EXCAVATED ROOT COLLAR, OPPOSITE VIEW

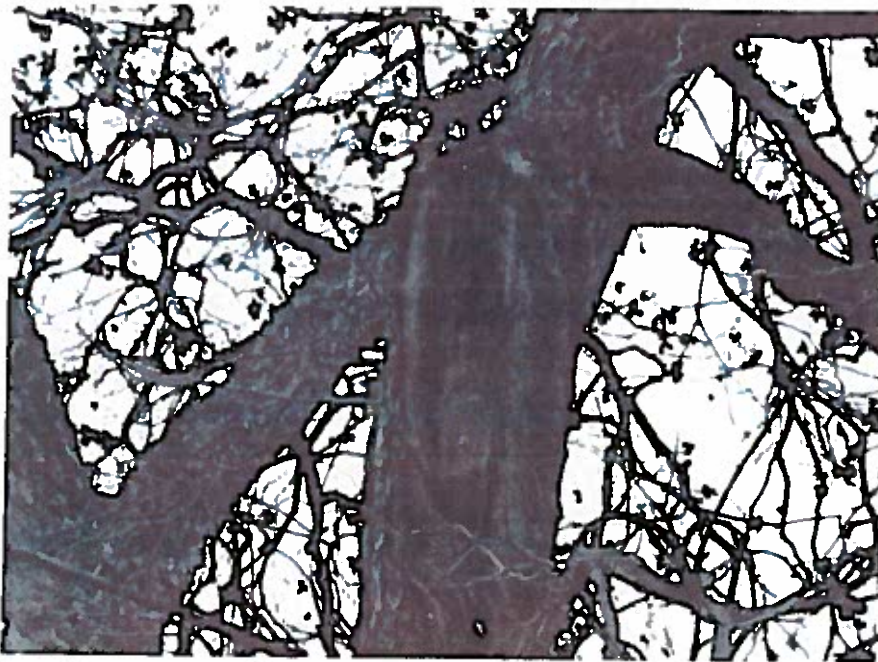
FIGURE 6: WOUND ON WESTERN MOST SCAFFOLD BRANCH

Our inspections show the subject tree to be healthy with good structure and enough vigor to resist the impacts of wounding. To err on the side of caution, I do recommend that the western most scaffold branch have weight-reduction pruning to reduce risk of failure, given the wound that we observed on this limb.

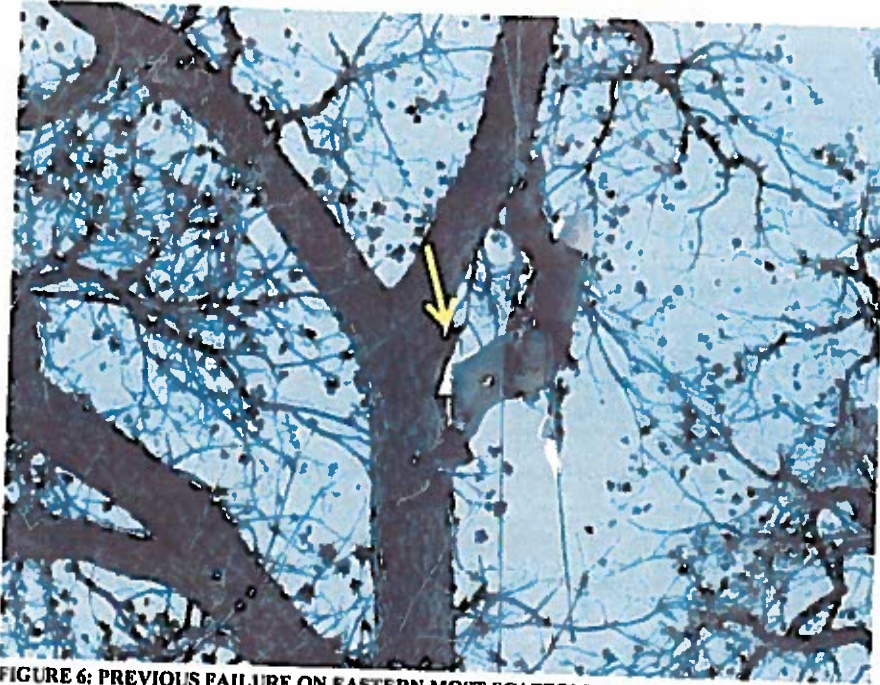
The second wound is located on the eastern most scaffold branch and was caused by a previous branch failure (Figure 7). No cavity or decay is visible on the wound.

FIGURE 6: PREVIOUS FAILURE ON EASTERN MOST SCAFFOLD BRANCH

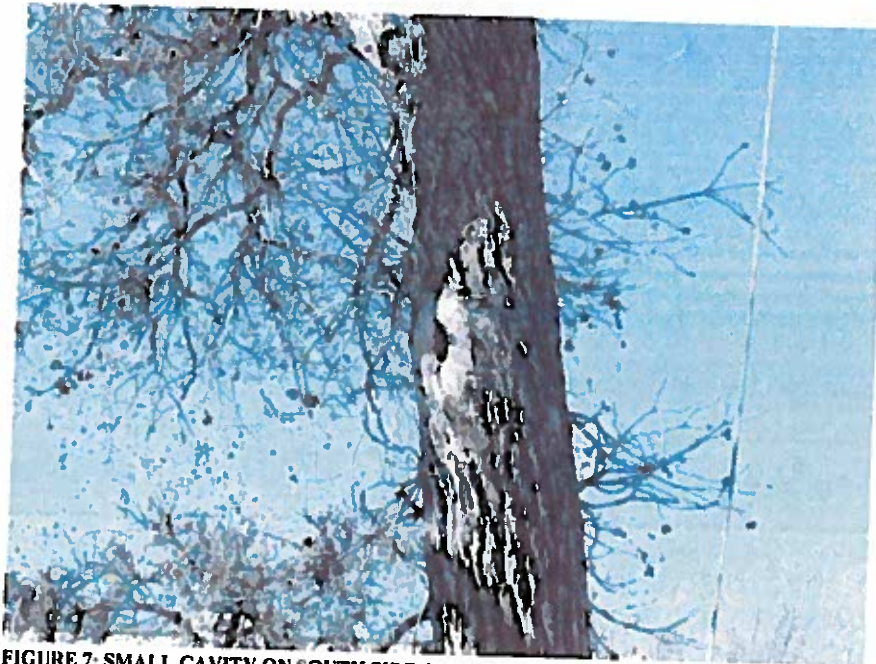
FIGURE 7: SMALL CAVITY ON SOUTH SIDE OF STEM
