**Table of Contents for 507 W. 23<sup>rd</sup> Street Tree Permit**  
**Heritage Tree Variance Package**

**ADDRESS  
OF PROPERTY:** 507 W. 23<sup>rd</sup> Street

**TREE PERMIT #:** 10884861

**SUBJECT:** 507 W. 23<sup>rd</sup> Street Heritage Tree Removal

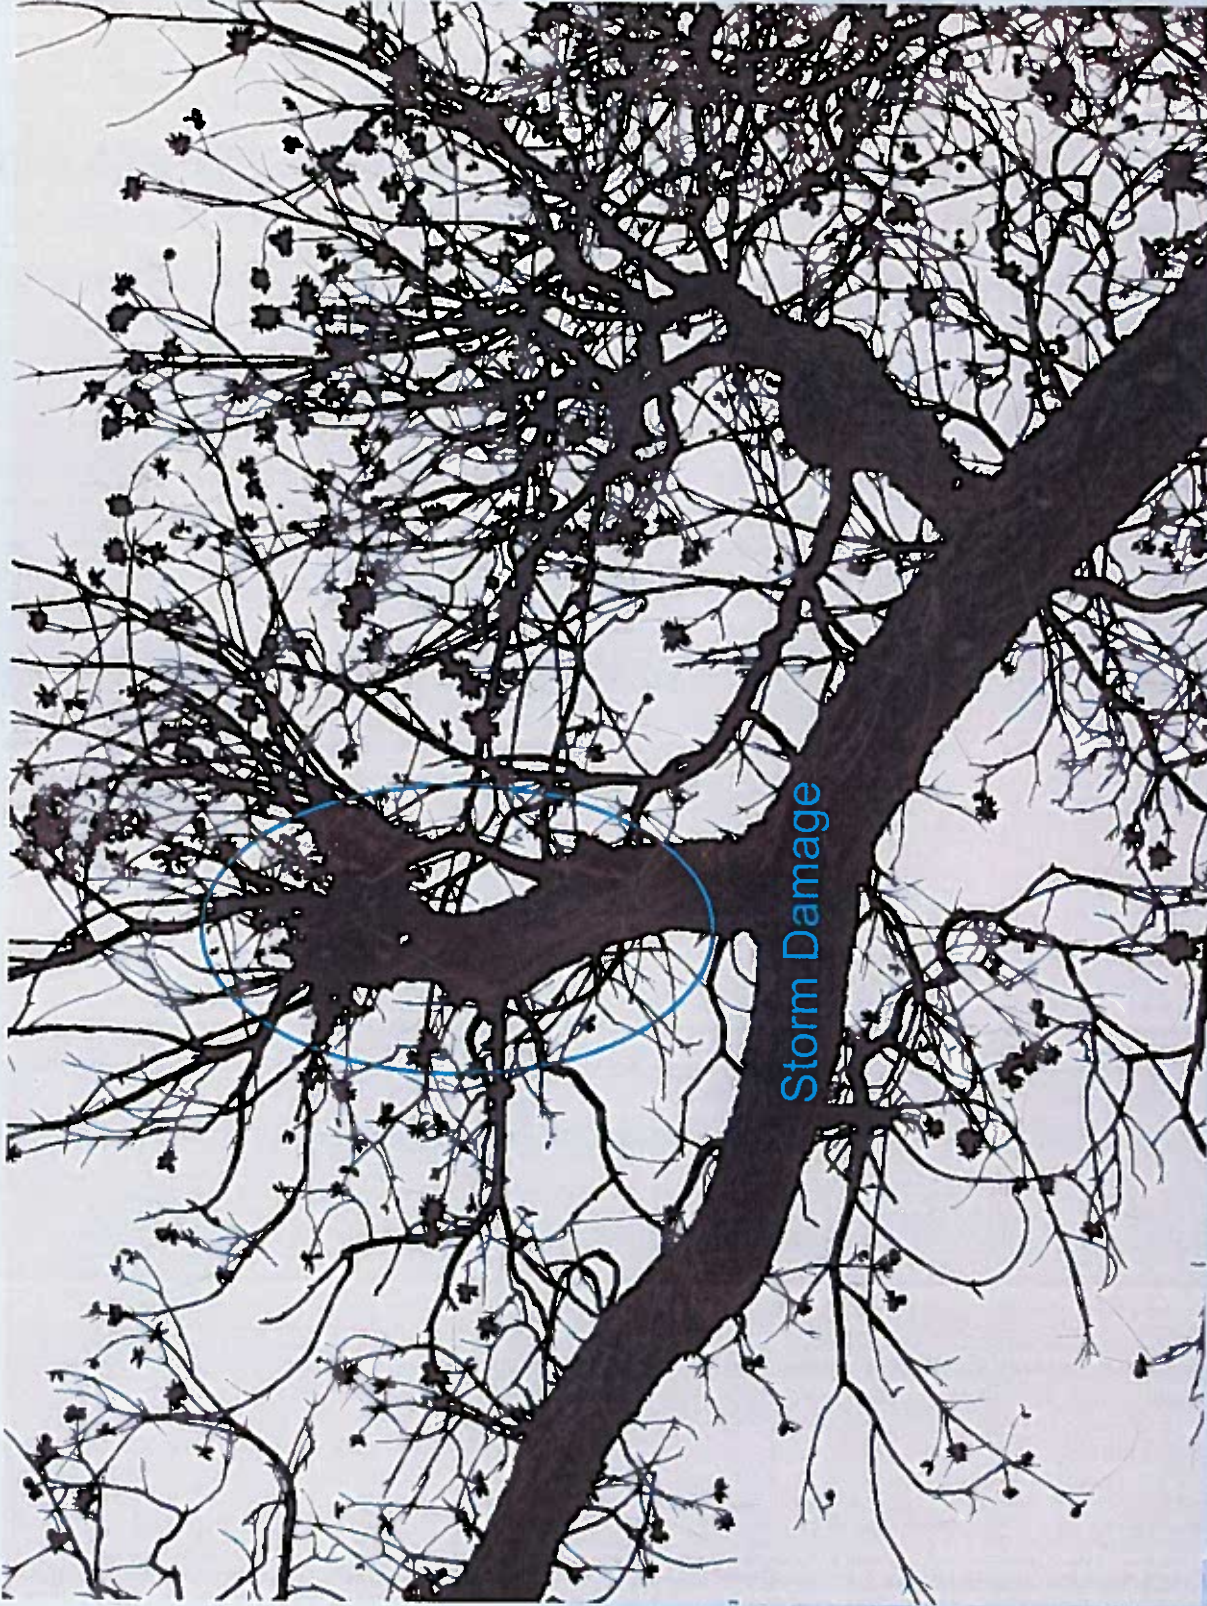
Exhibit 4

The canopy architecture displays minor asymmetry. Storm damage is evident by the presence of broken stems in the canopy (Exhibit 4). Minor cavities, wounds, and previous stem failures are apparent (Exhibit 5).

Storm Damage,  
callousing, and cavity

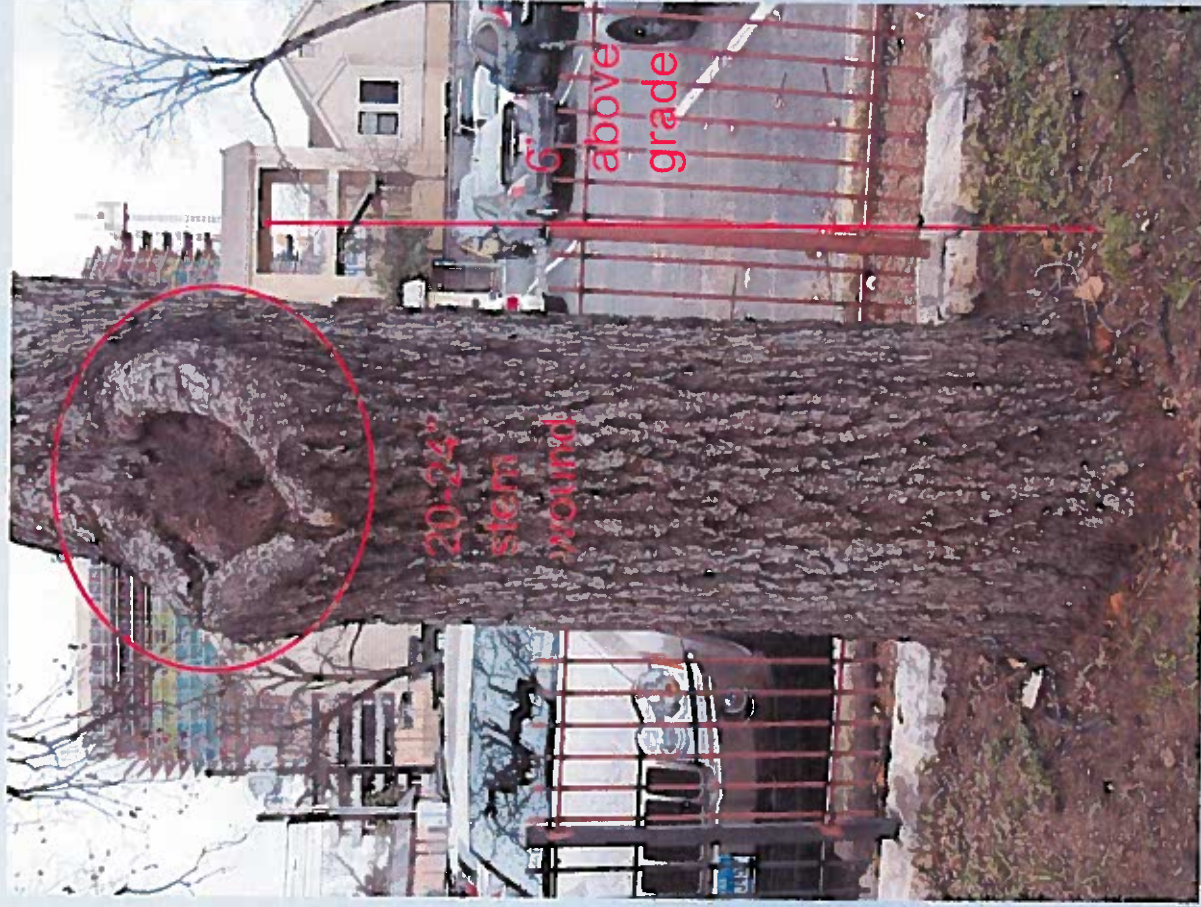
Exhibit 6

A major stem (20-24") wound occurs ~6' above grade (Exhibit 6). Callousing of the wound has occurred and minimal decay detected.

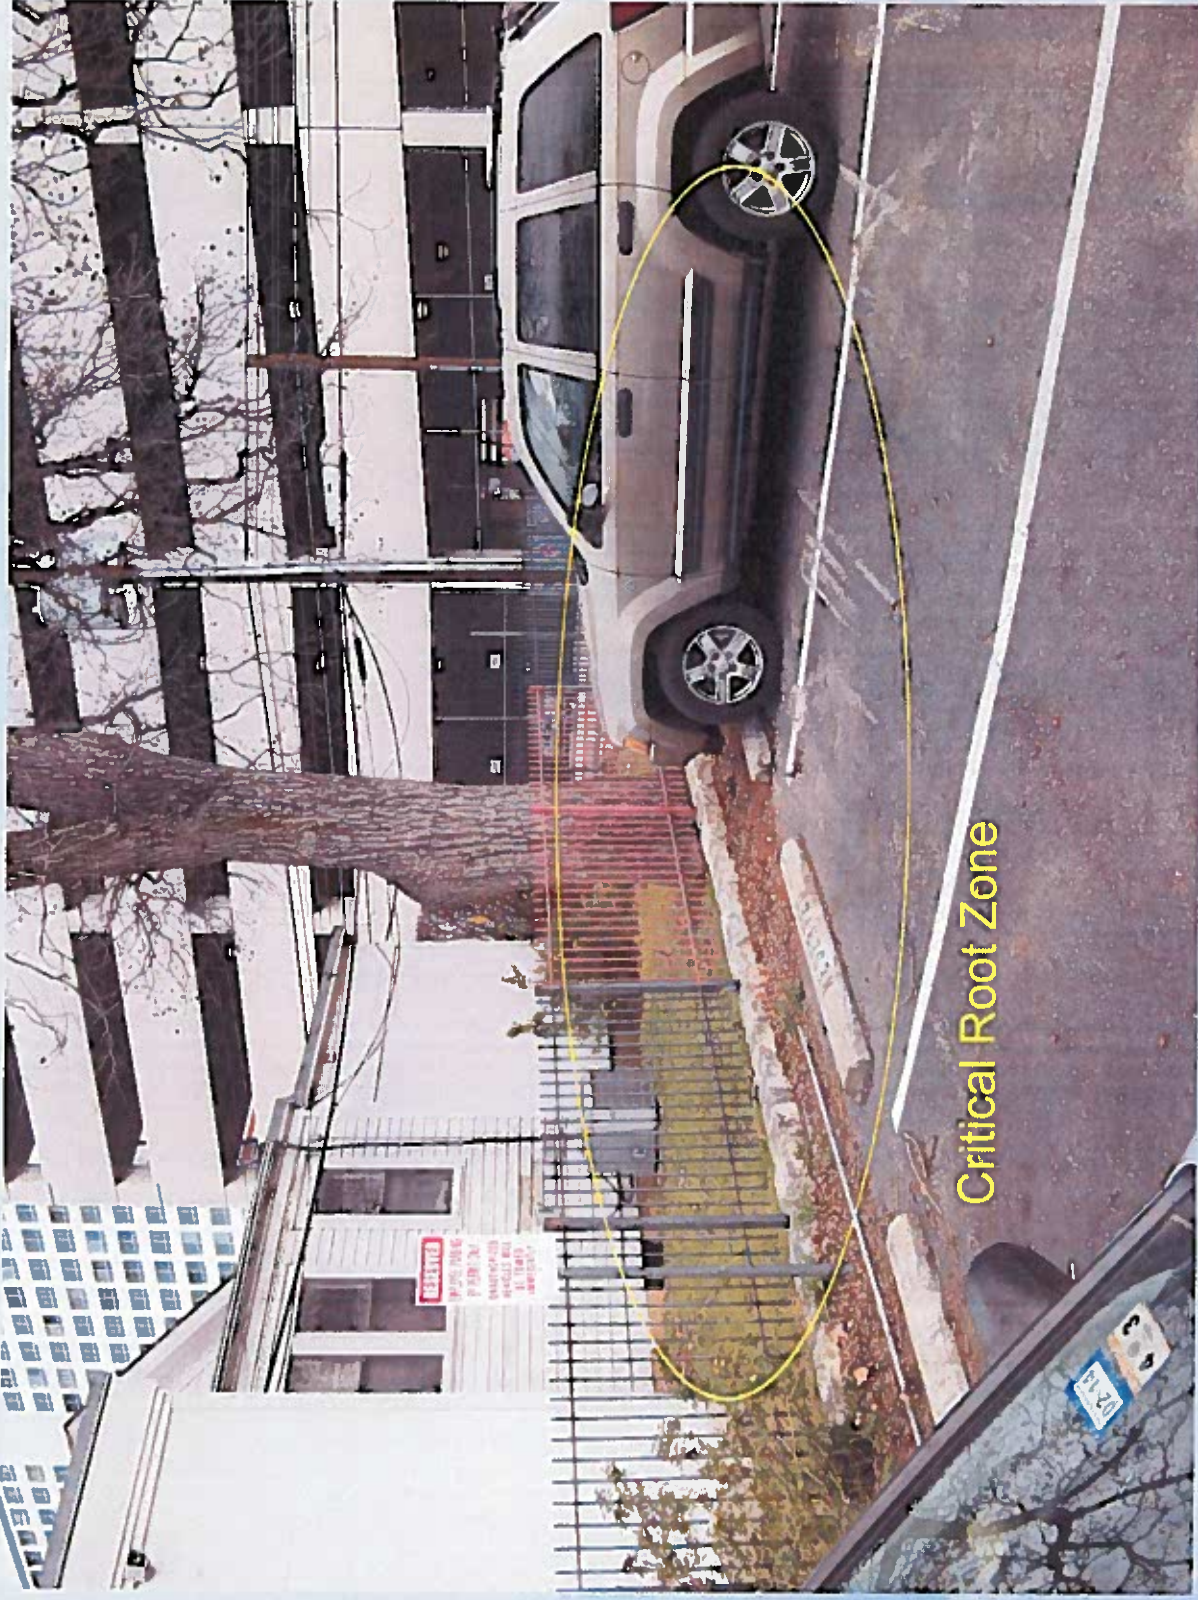
Exhibit 7

Root flare is apparent at grade. No defects are apparent. Critical root zone conditions are characterized by a 6" wall abutting the root flare, asphalt parking, turfgrass, and a

building structure (Exhibit 7). The depth of the wall is unknown. Surface and subsurface conditions in the critical root zone are poor due to compaction and impervious cover.

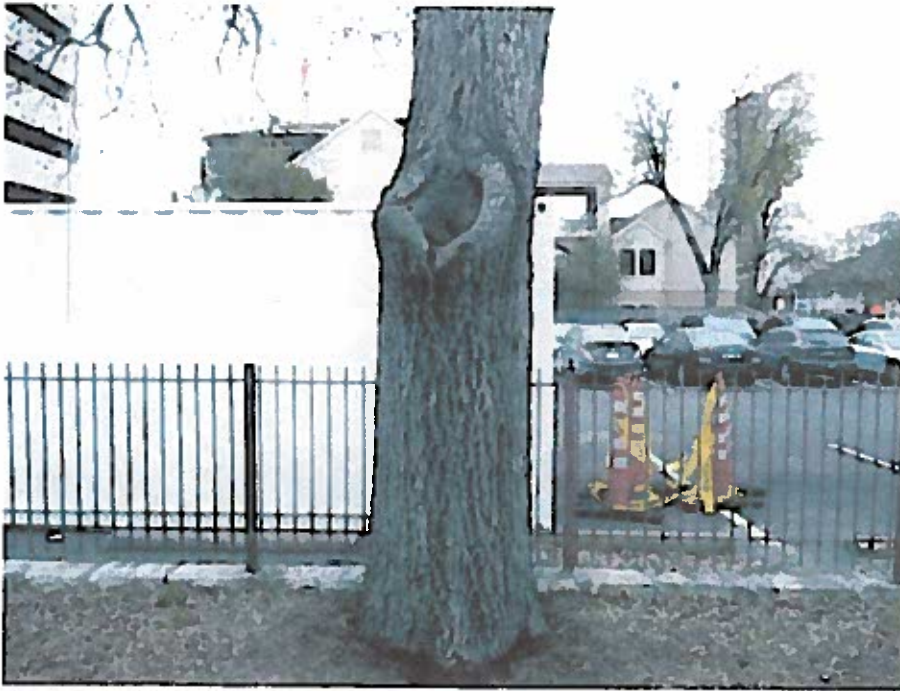
My initial observation was that the subject tree was sound-looking. The tree architecture was desirable with good balance and structure. Although the leaves had fallen due to the season, the crown area appeared healthy, with little dead wood apparent. Many pecans were still visible in the crown. At about six feet above grade, a wound was visible on the stem where a branch had been previously removed. Some decay was present in this area (Figure 1). The tree's root flare was visible.

Wounding in trees is common. Wounds occur from pruning cuts, failures from storm damage and heavy branch ends, mechanical damage, and other reasons. Whether these are significantly harmful to trees depends on a variety of factors such as wound number and severity; tree species, age, and vigor; and the tree's ability to compartmentalize the wound. When a tree becomes wounded, it doesn't heal; it attempts to wall off the wound by producing chemical and physical boundaries that act to limit the spread of disease and decay organisms<sup>1</sup>. This process, called compartmentalization, is often very successful, and new, healthy wood will form around the wound to strengthen that area over time. The subject tree appears to have effectively compartmentalized the wounds that we observed.

FIGURE 1: STEM WOUND AT APPROXIMATELY SIX FEET ABOVE GRADE

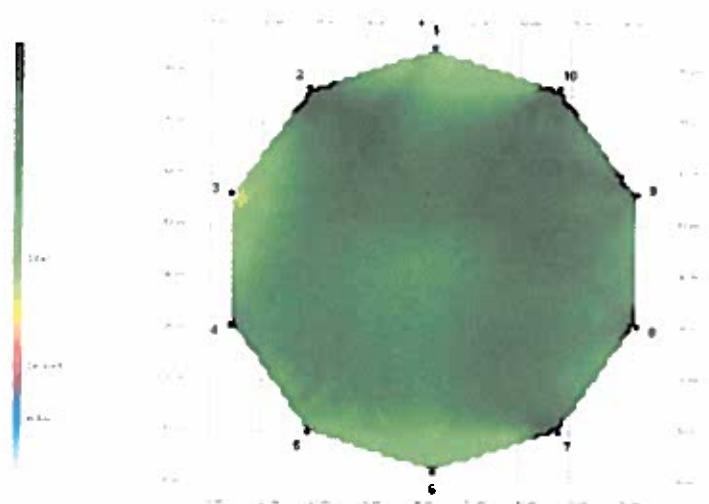
We performed sound-wave readings at approximately 16 inches above grade and 63 inches above grade. The higher reading was located just below the stem wound described above. This would provide a better indication of internal decay that might be present in the stem, including toward the tree base, a location more vulnerable to failure risk. The results revealed zero percent decay at the lower location (Figure 2) and one percent decay at the upper location (Figure 3).

FIGURE 2: SONIC TOMOGRAPH AT 16 INCHES ABOVE GRADE SHOWING ZERO PERCENT DECAY

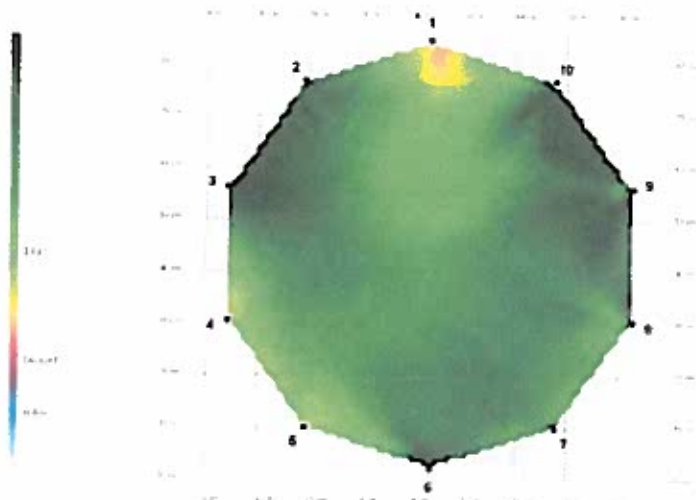
Regarding the sound-wave images, the results indicated near-complete absence of decay. This suggests that the wound directly above the upper reading is effectively walling off movement of decay, especially in a vertical direction, downward. The absence of decay at the lower reading, combined with the good appearance of the buttress roots, suggests that the tree has good strength at a critical area - where the stem and support roots connect.

**FIGURE 3: SONIC TOMOGRAPH AT 63 INCHES ABOVE GRADE SHOWING ONE PERCENT DECAY**

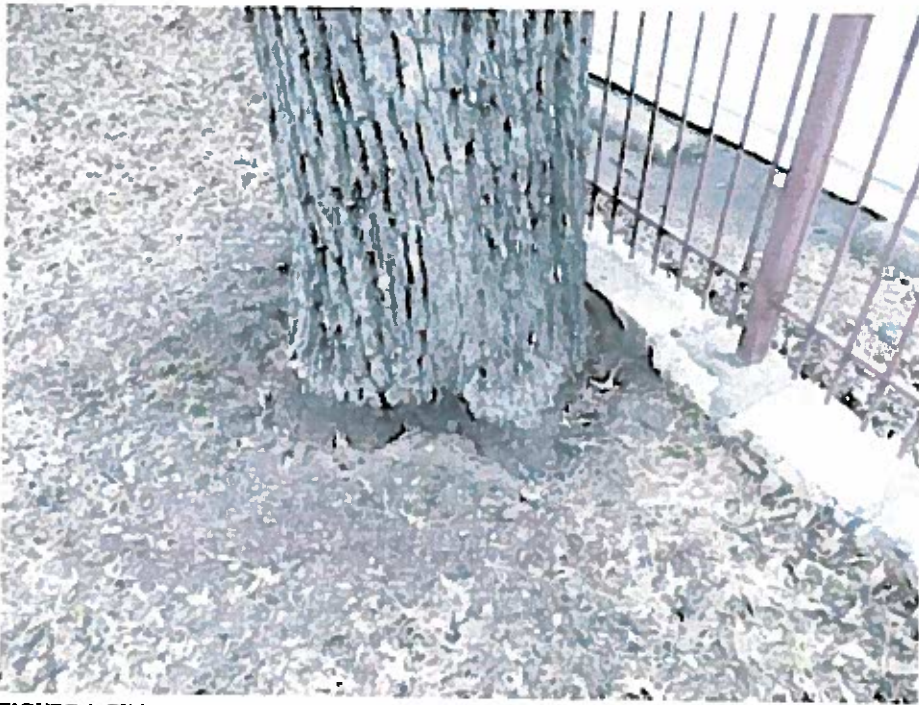
Using the compressed-air tool, we excavated the root collar to about eight inches to expose more area of the buttress roots. No defects were visible based on this examination (Figures 4 and 5).

**FIGURE 4: EXCAVATED ROOT COLLAR**

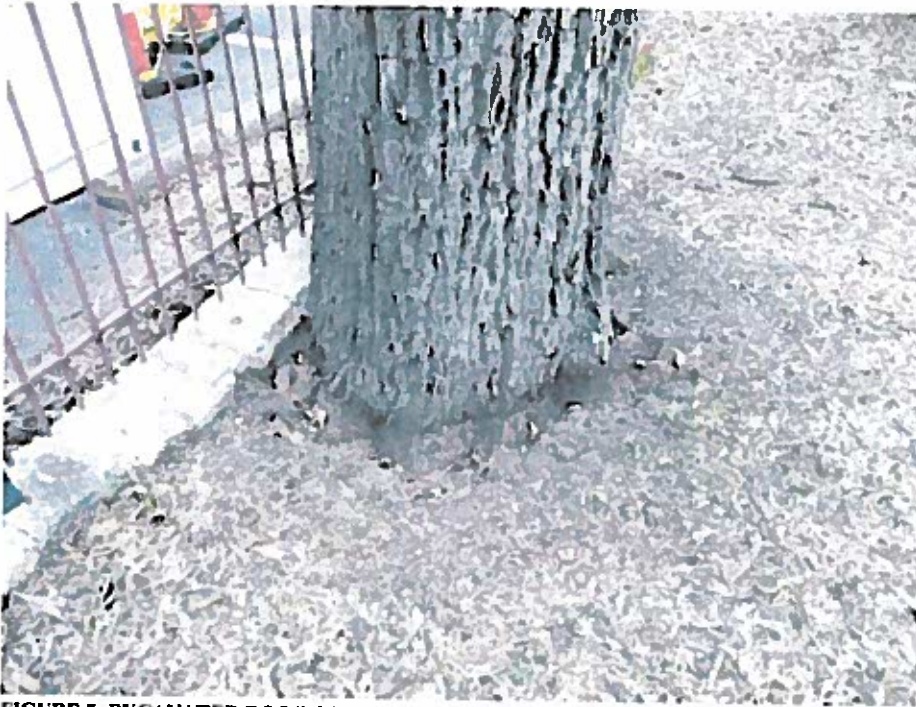
FIGURE 5: EXCAVATED ROOT COLLAR, OPPOSITE VIEW

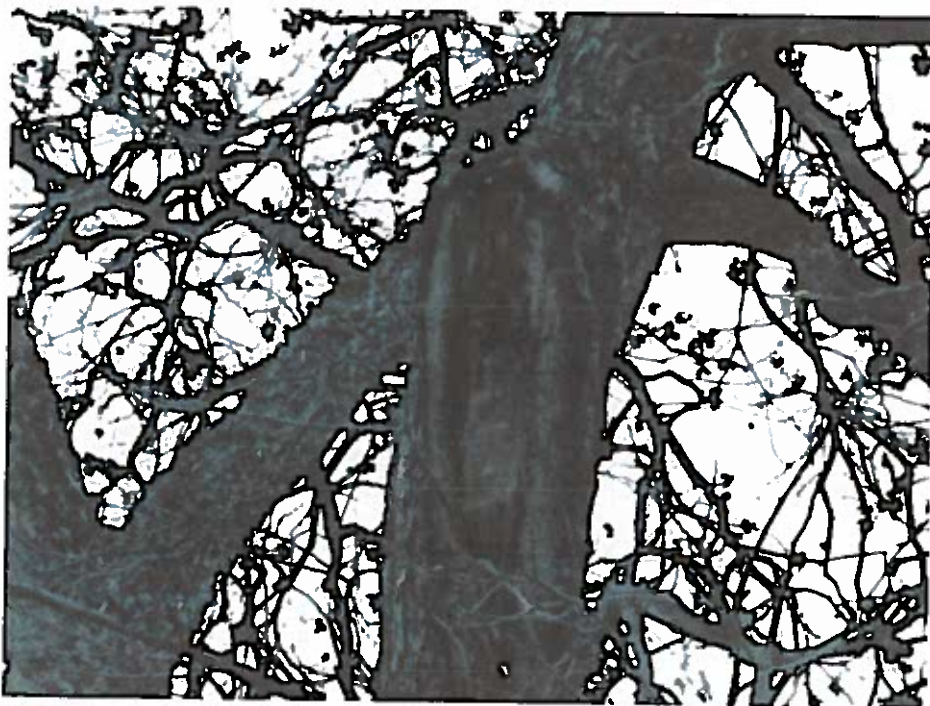
FIGURE 6: WOUND ON WESTERN MOST SCAFFOLD BRANCH

Our inspections show the subject tree to be healthy with good structure and enough vigor to resist the impacts of wounding. To err on the side of caution, I do recommend that the western most scaffold branch have weight-reduction pruning to reduce risk of failure, given the wound that we observed on this limb.

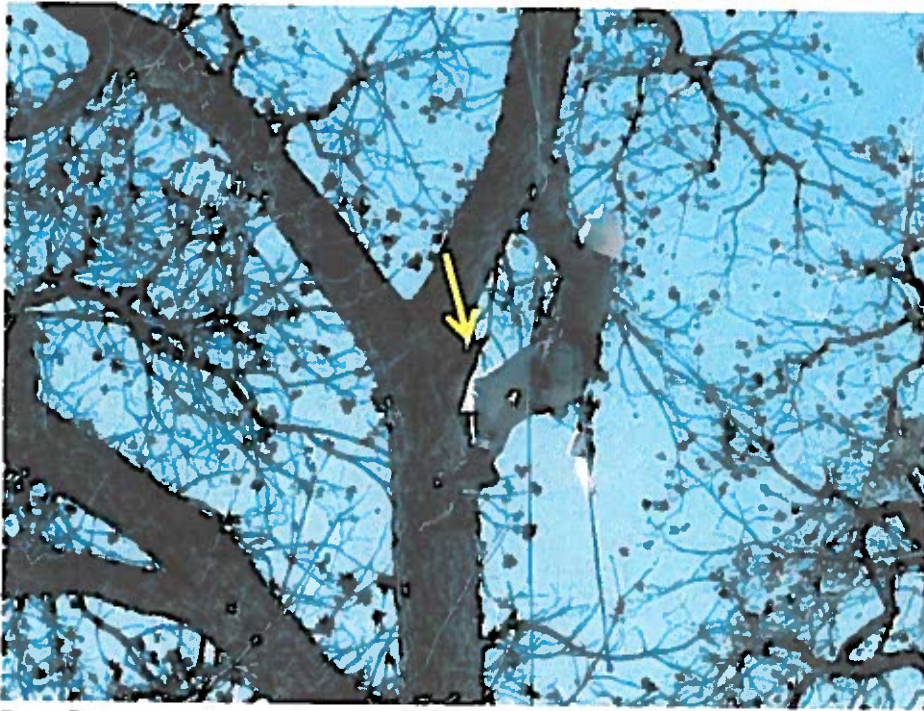
The second wound is located on the eastern most scaffold branch and was caused by a previous branch failure (Figure 7). No cavity or decay is visible on the wound.

**FIGURE 6: PREVIOUS FAILURE ON EASTERN MOST SCAFFOLD BRANCH**

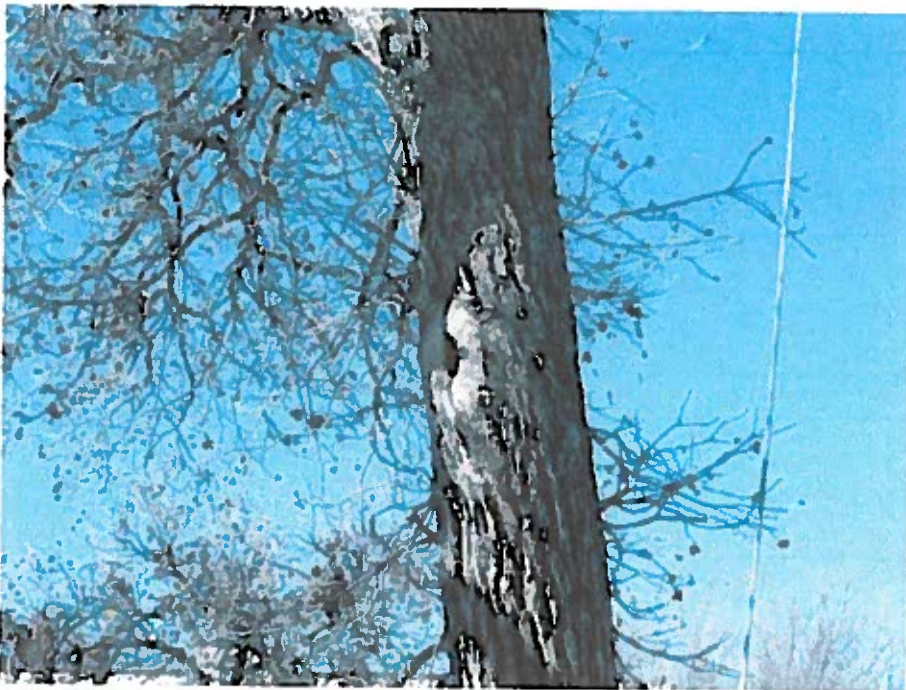
**FIGURE 7: SMALL CAVITY ON SOUTH SIDE OF STEM**
