Willowbrook Reach Riparian Restoration: A Case Study SR-13-04, February 15, 2013

Staryn J. Wagner

City of Austin
Watershed Protection Department
Environmental Resource Management Division

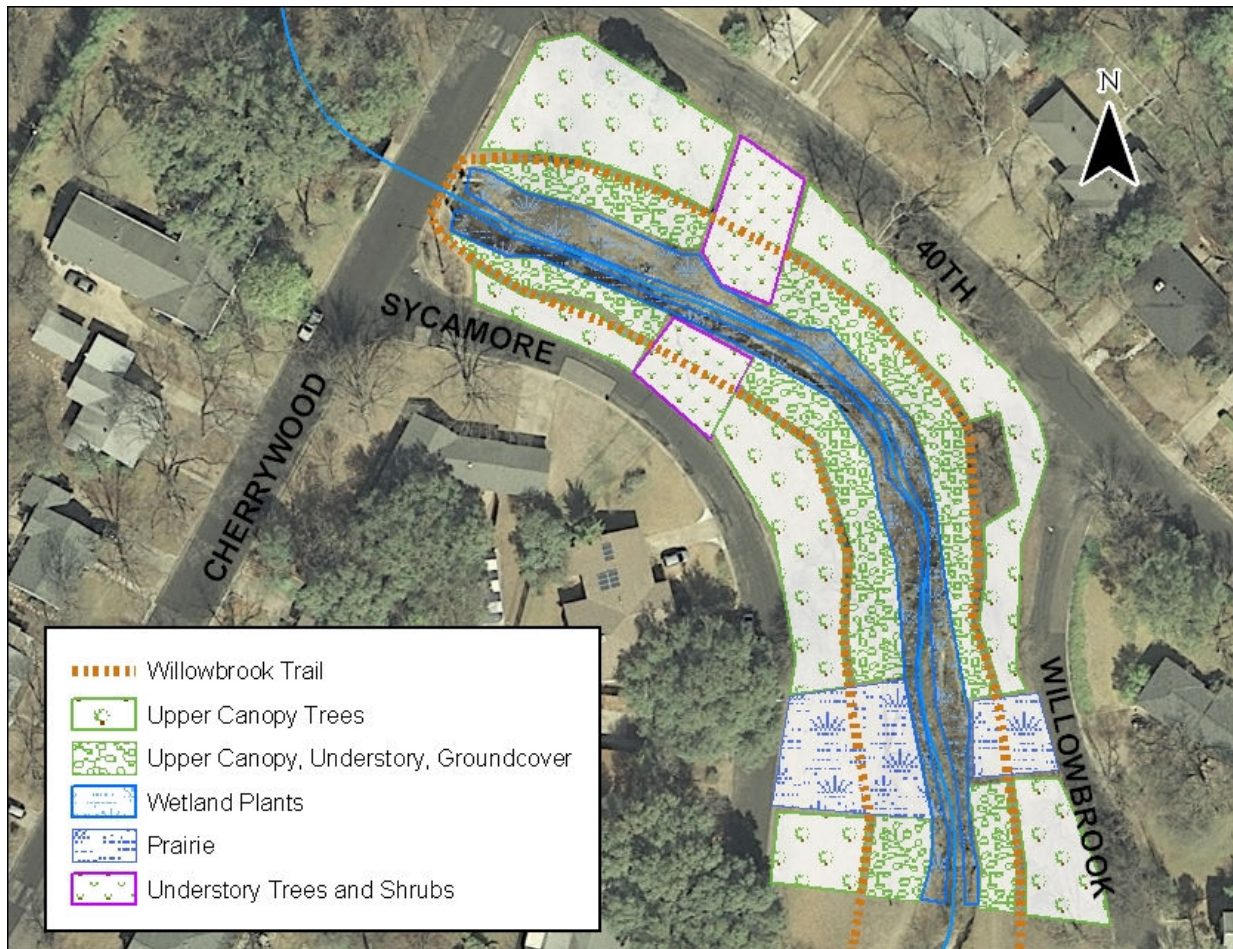
The neighborhood had a concern with the obstruction of view from the road while walking on the trail. The solution was to break up the landscape plan into different zones (Figure 2). The zone between the street and the trail would be planted with only an upper canopy tree layer, enabling a more open view below the canopy, between about 3 ft and 8 ft. The zone between the trail and the stream would be planted with three tiers of vegetation, upper canopy, understory, and groundcover. Other requests from stakeholders were to have wildflower prairies and view corridors crossing the stream. To accommodate both requests, prairie plantings were placed immediately opposite each other along the stream using that as a view corridor. There was a request from the neighborhood association to put in a pedestrian bridge across the stream. This would have been prohibitively expensive and outside of the scope of this restoration project. A location was identified along the stream that was already a natural crossing and improvements were made in lieu of construction of a pedestrian bridge.

Figure 2. Planting zones delineating the different plant communities used to create the landscape design. The trail indicated is the new trail located further from the top of the stream bank than the previous trail.

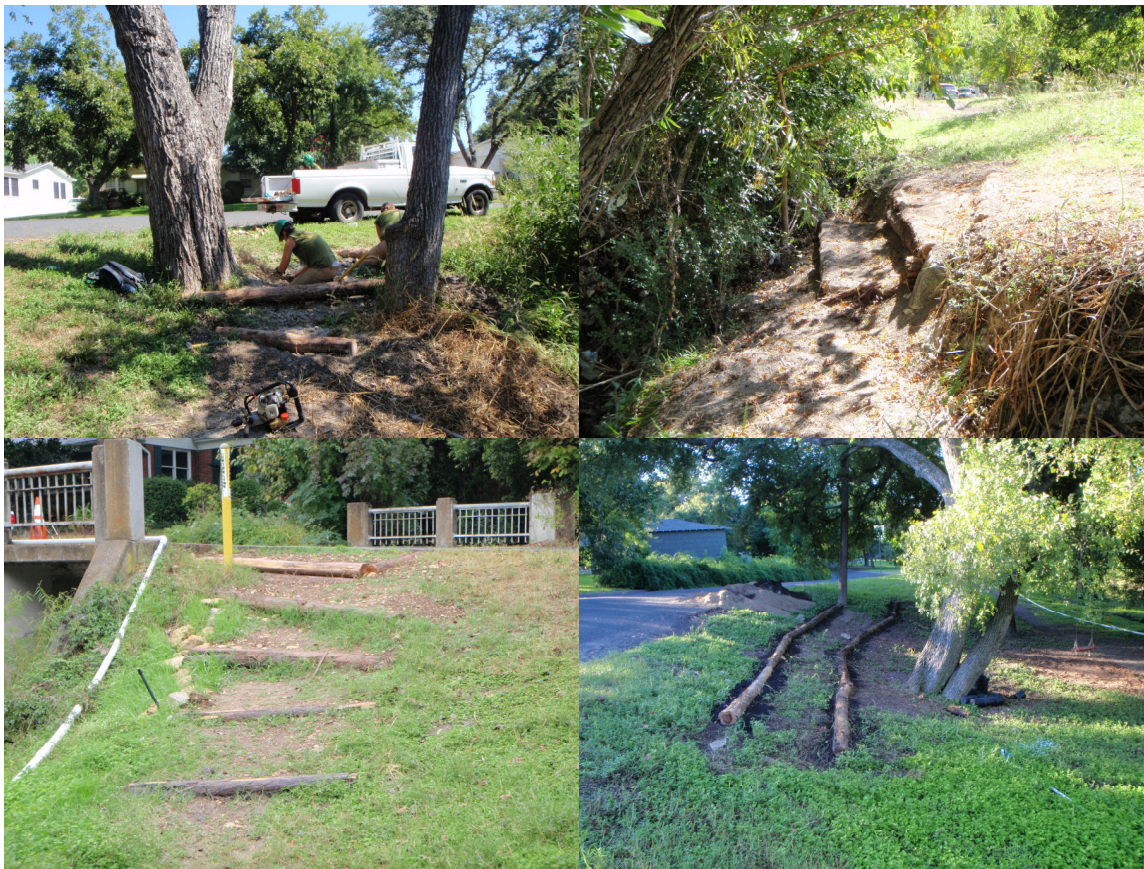
Figure 3. Examples of hardscaping installed by AYW include juniper log access steps and terraces to prevent street from street runoff.
