## **FLOW MEASUREMENTS AND GENERAL OBSERVATIONS IN RELATION TO THE PROPOSED DRIPPING SPRINGS WASTEWATER TREATMENT PLANT DIRECT DISCHARGE TO ONION CREEK**

David A. Johns, P.G.  
Hydrogeologist  
City of Austin, Watershed Protection Department

DR-14-02: March 2014

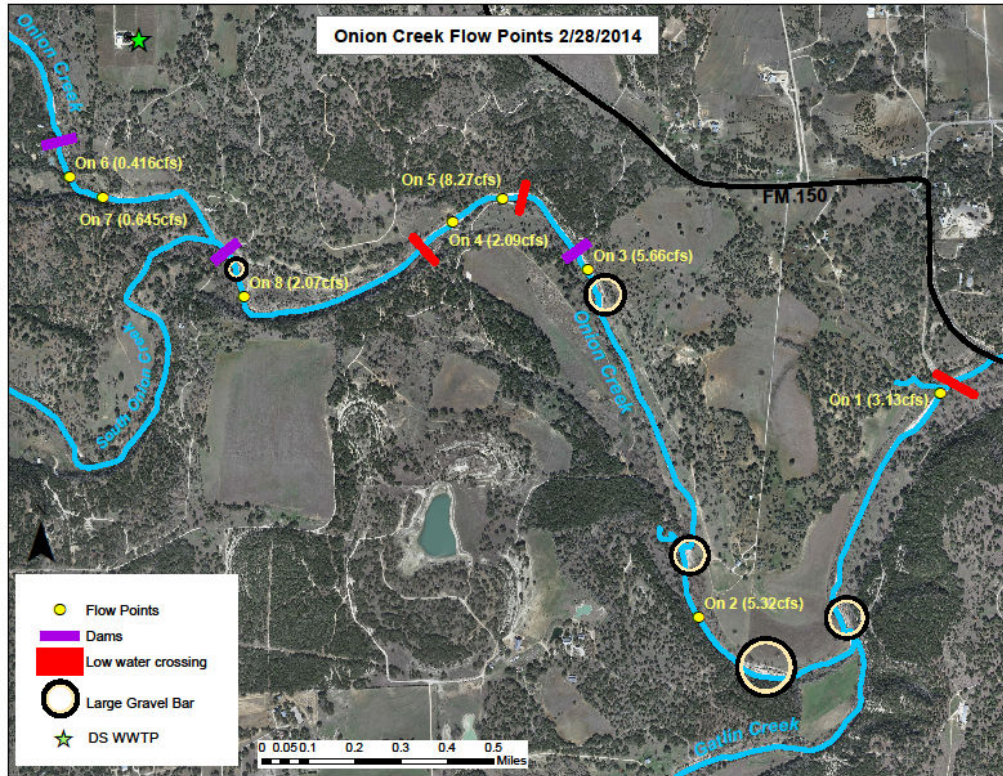
Flow measures show an overall gain of 2.7 cfs in creek flow from the upstream end of the study area to the downstream end (Figure 1). Wierman et al. (2010) also documented gaining creek flow in a longer reach of creek that included the current study area. The maximum flow measured was 8.3 cfs at site “On 5” with two measurements greater than 5 cfs further downstream. The most downstream site (On 1) had 3.1 cfs suggesting that there was a significant loss of water (approximately 2.2 cfs) over a one mile reach of creek between sites “On 2” and “On 1”, which is also the area where a fault is inferred from Wierman et al. (2010). Gatlin Creek also joins Onion Creek in this reach so flow losses may be higher than documented in this report if Gatlin was contributing water to Onion as well.

There is a discrepancy in flows from sites “On 4”, “On 5” and “On 3” which suggest an increase in creek flow over a relatively short length of channel (Figure 1). However, “On 5” had much greater flow than “On 3” located 1,100 feet downstream and much greater flow than “On 4” only 650 feet upstream. The gain in flow of 3.6 cfs between sites “On 4” and “On 3” appears valid but the flow at “On 5” appears anomalous at this time. Additional flow measurements should be made to verify these changes.

Flow measurements indicate an overall gain of 2.7 cfs of creek water from upstream to downstream within the study area. There is gain in flow of 1.5 cfs between sites "On 7" and "On 8" and 3.6 cfs between site "On 4" and "On 3". Creek flow of at least 2.2 cfs is lost between sites "On 1" and "On 2", which is also where a fault is inferred to cross the study area. Numerous faults and fractures visible in the channel may play a significant role in localizing groundwater flow into the creek channel or in recharging the underlying Trinity aquifer as well as influencing the orientation of the creek channel. The locally thick alluvial bank deposits may also contribute water to the creek, receive water backed up behind low water crossings and check dams, or locally route water around portions of the creek channel.

Figure 1. Aerial image of the study area showing results of manual creek flow measurements from February 28, 2014 as well as significant channel features such as road crossing, dams, and large gravel bars.

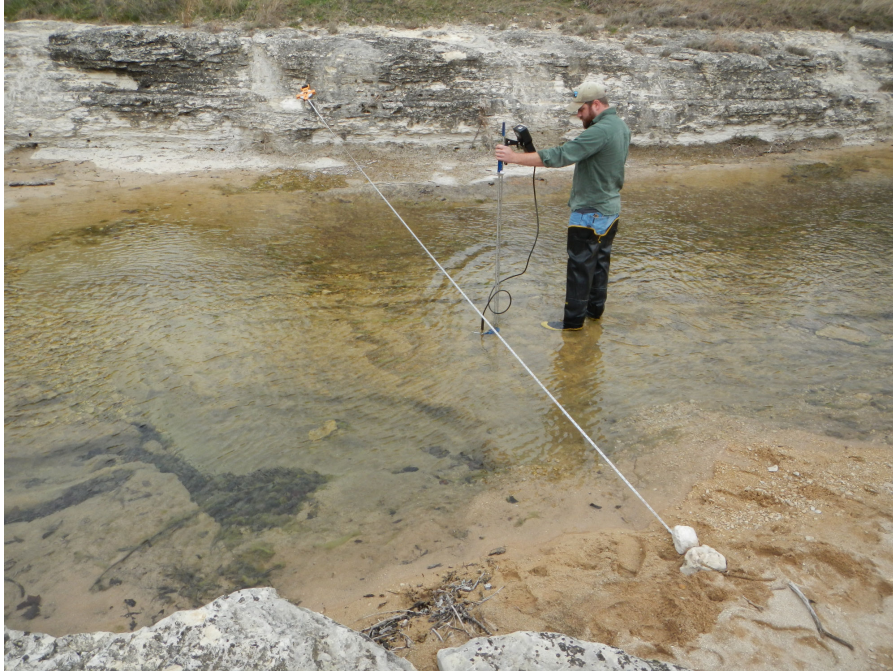
Limestone bedrock is exposed commonly along the channel bottom and most flow measurements were made in bedrock reaches (Photo 1). Composition of the creek banks may be important in understanding flow measurement results as water may enter these bank deposits during storm events or at locations where the creek channel is partly obstructed by natural or man-made features. The banks were comprised of bedrock on both banks at two of the eight sites, or on one bank at four sites or were comprised of alluvium on both banks at two sites. Creek banks in most areas accessed are comprised of alluvial sediments of varying thickness, generally from a couple of feet to greater than 10 ft. Some possible discharge points were observed in alluvial banks as indicated by vegetation (Photo 2) but no measureable discharges were seen. There are at least five large gravel bars that probably backup creek flow and allow water to move as underflow through channel alluvium toward downstream. Measurement sites were located avoid flow problems from the gravel bars. There are five check dams, low water crossings without culverts or road crossings with culverts (Figure 1, Photo 3). These may influence movement of water into and out of the channel that is especially noticeable in low creek flow conditions.

Photo 1. Site “On 1” showing limestone bedrock channel and banks.

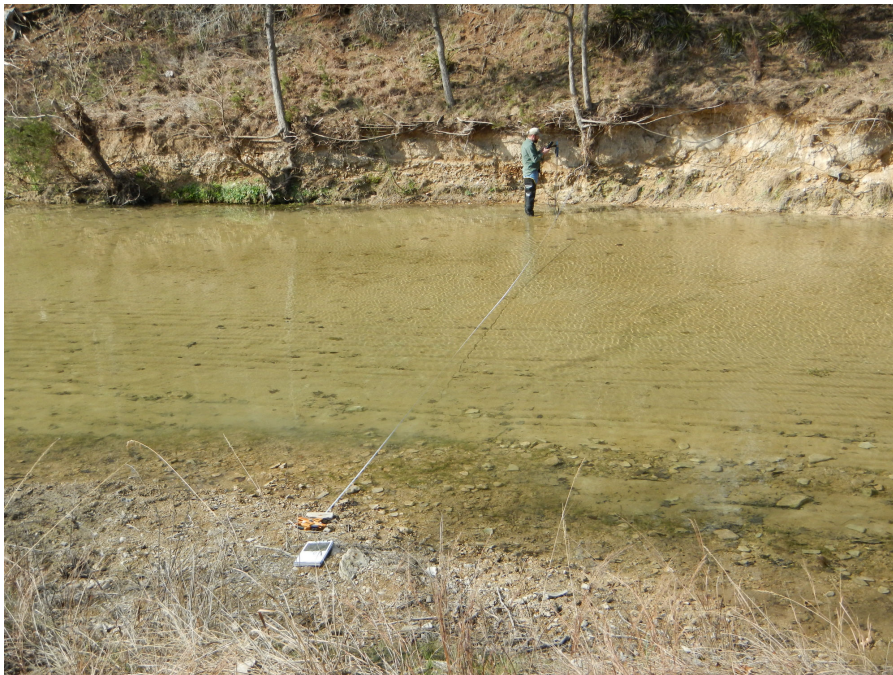
Photo 2. Site “On 2” showing limestone channel bottom and a steep alluvial bank. The alluvial bank appears to have local vegetation that may indicate groundwater seepage to the creek.

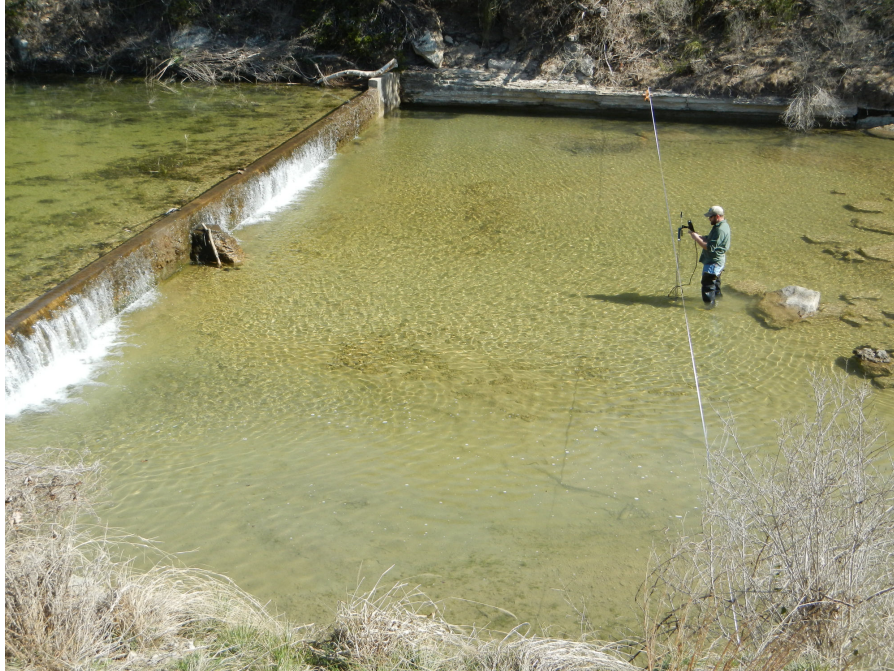
Photo 3. Site “On 3” showing limestone bedrock channel bottom and bank. The check dam is approximately 4 ft high.

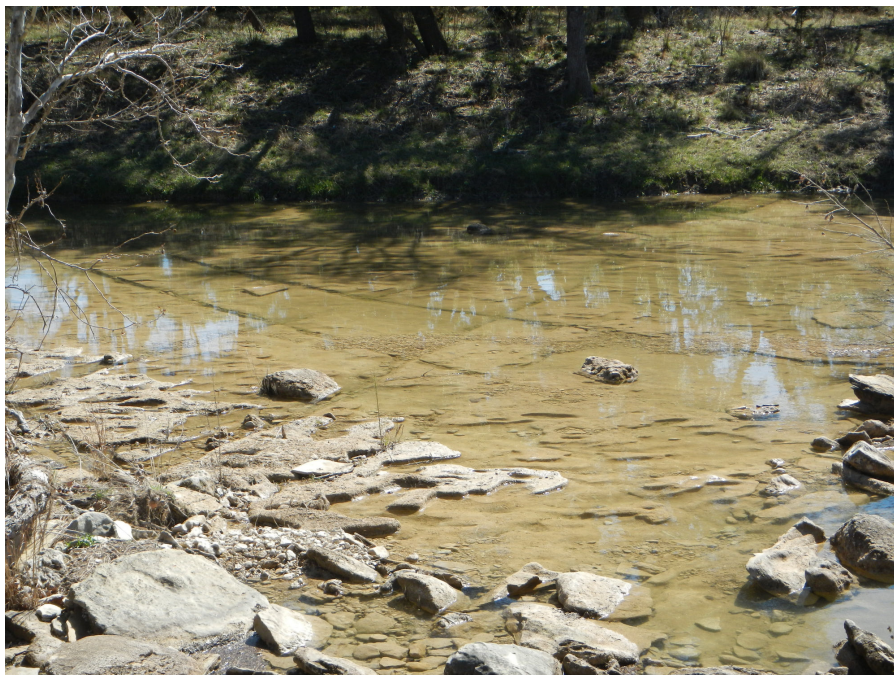
Photo 4. Limestone bedrock with prominent fractures trending N48E and N32W which are visible on aerial imagery in Photo 5.

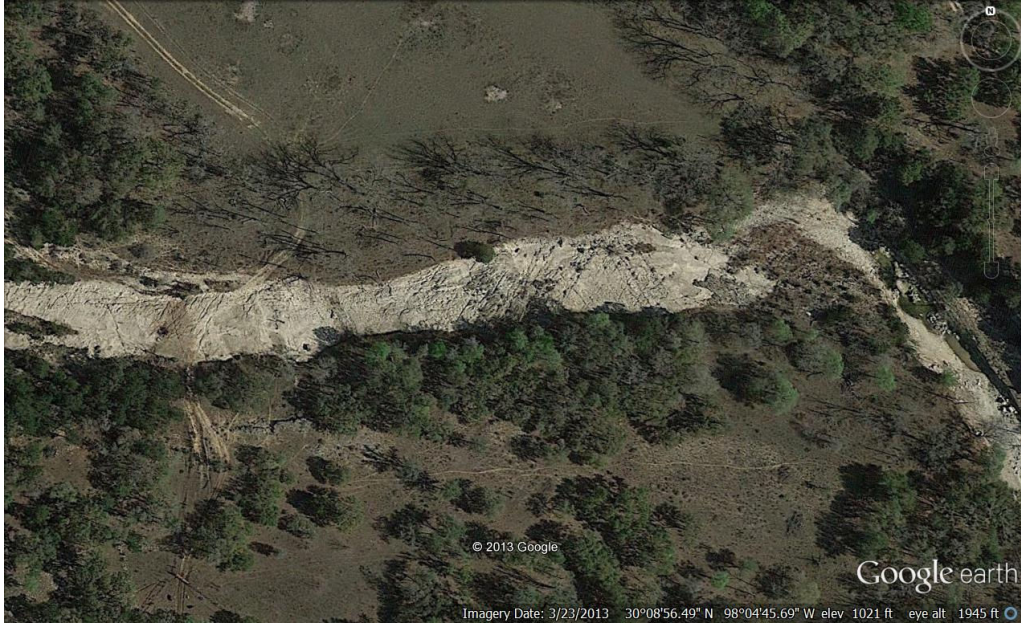
Photo 5. Aerial image showing Onion Creek with clearly visible fractures in the limestone bedrock channel bottom on Lucy Hibbert's Ranch near the upstream end of the study area. Photo 4 was taken from the north bank in this creek reach.

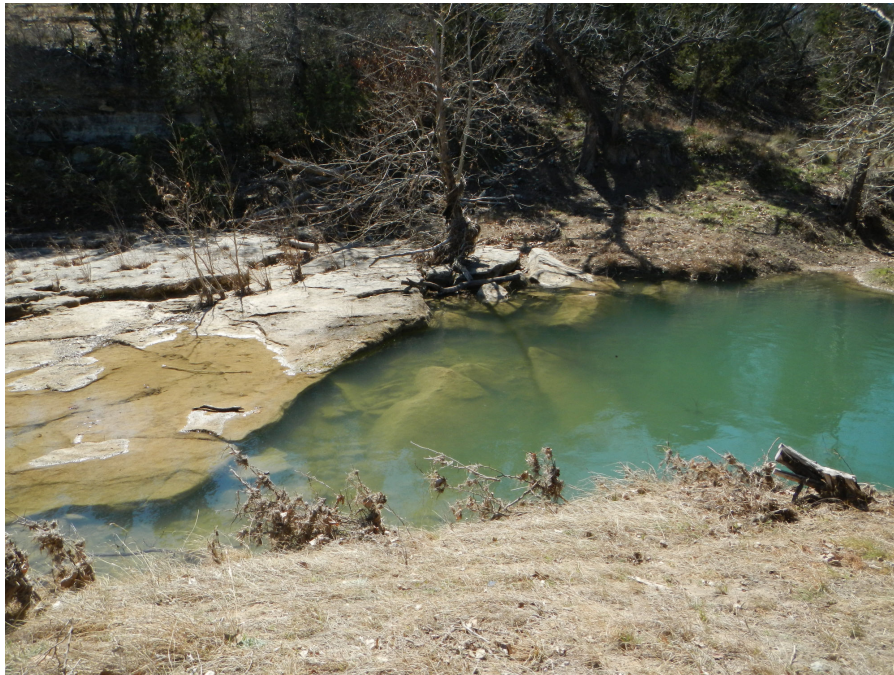
Photo 6. Possible fault trending N40E crossing the Onion Creek channel near the upstream end of the study area. The amount of displacement was not determined. Several small faults exposed immediately downstream show displacement of less than one foot. The creek flows from left to right.
