## TEXAS NATURAL RESOURCE CONSERVATION COMMISSION

Re: Investigation Report Complaint No. 119700417

ALLEGED SOURCE: FM Properties/Barton Creek Properties  
LOCATION: Within the tributary in the proposed Section E. Also identified as "Pod 9".  
CITY, COUNTY: Austin, Travis County - 227  
INVESTIGATION DATE: 4/21/97, 4/30/97, 5/1/97, 5/2/97, 5/9/97, 5/12/97, 5/14/97, 5/20/97,  
5/30/97, 6/06/97  
VIOLATION FOUND: Texas Water Code 26.121  
COMPLAINT NUMBER: 119700344  
INVESTIGATOR(S): Melissa M. Lopez

**INITIAL PROBLEM:** Silt generated by construction activities is being discharged from into Barton Creek downstream of Pod 9.

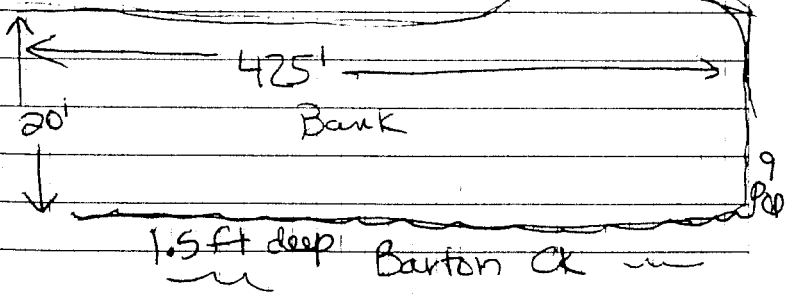
10/8/97 Pod 9

Bank cliff 20" high  
 at top of cliff - trees have been  
 cleared w/ hydro mulching area  
 w/ clearing directly up to  
 bank of ca. 425' additional  
 area mulched but a  
 buffer is left. Several trees  
 knocked over edge of cliff into  
 creek.
