Table of Contents for 504 East 8th Street Tree Permit
Heritage Tree Variance Package

**ADDRESS
OF PROPERTY:** 504 EAST 8TH STREET

TREE PERMIT #: ROW ID 11422103

SUBJECT: 504 East 8th Heritage Tree Ordinance Variance

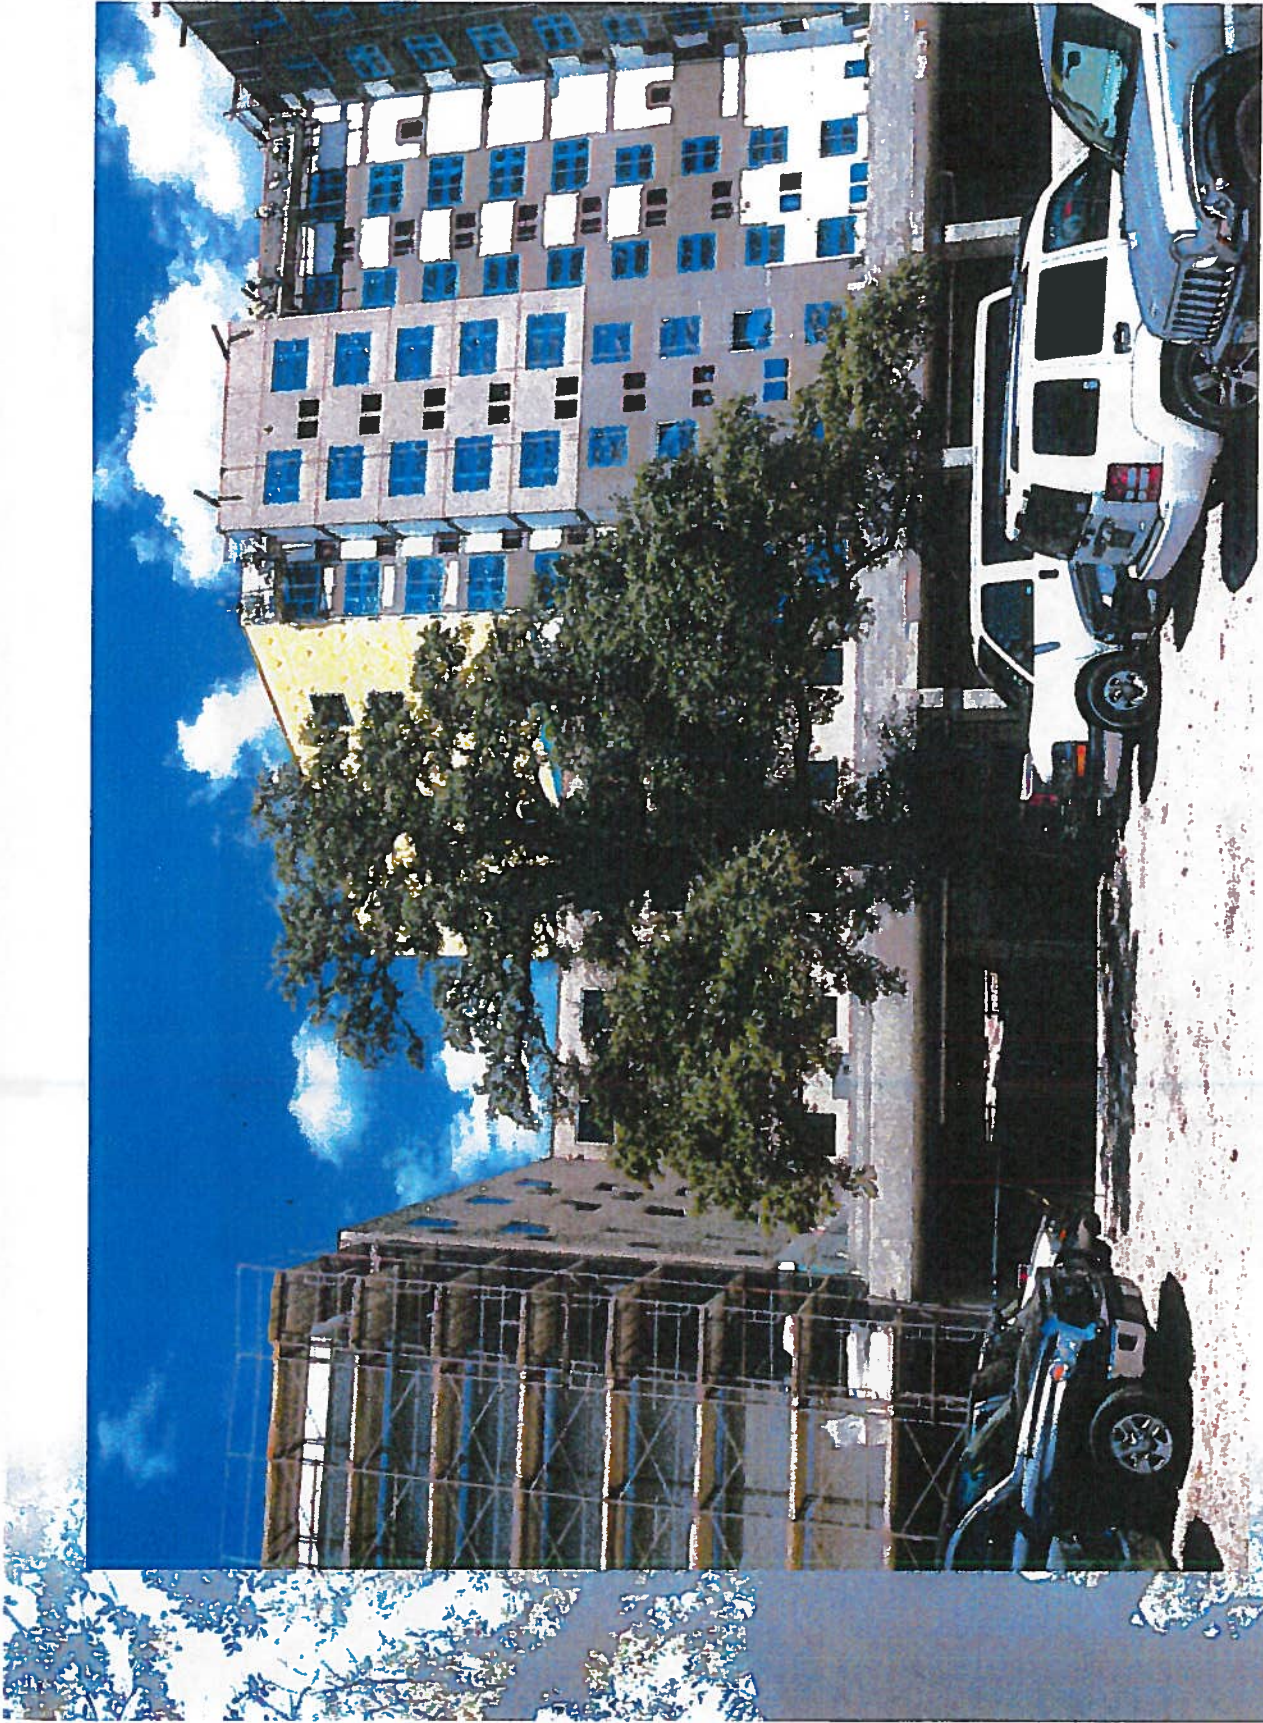
Exhibit 1

The canopy architecture displays minor asymmetry (Exhibit 1). Storm damage is evident in the canopy as the main leader has been damaged (Exhibit 2). Extensive epicormics growth is apparent (Exhibits 3 and 4). Epicormic growth is generally associated with the tree's response to stress likely related to the root system (see below).

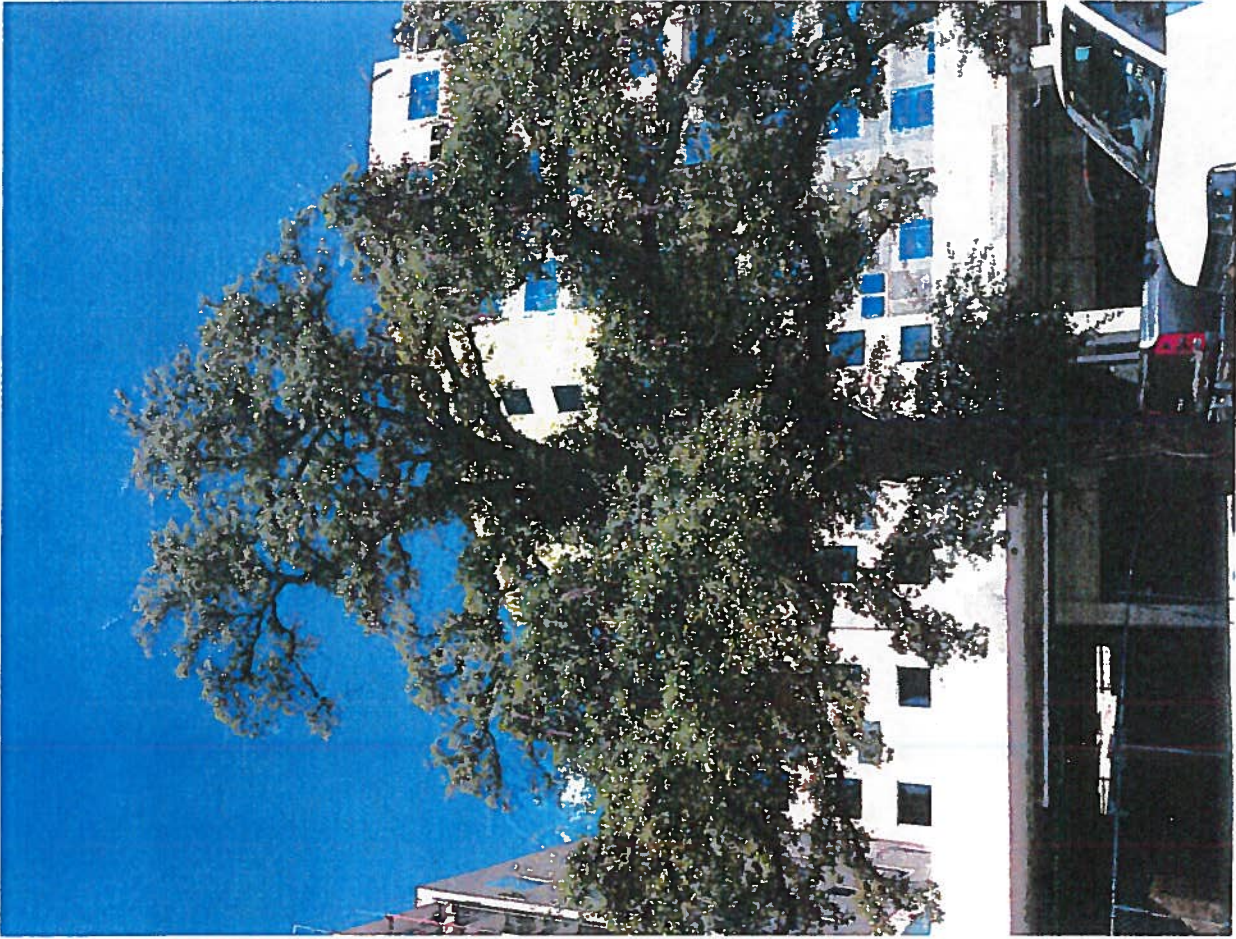
Exhibit 5

Storm damage is apparent in lower limbs (Exhibit 5). Otherwise, unremarkable.

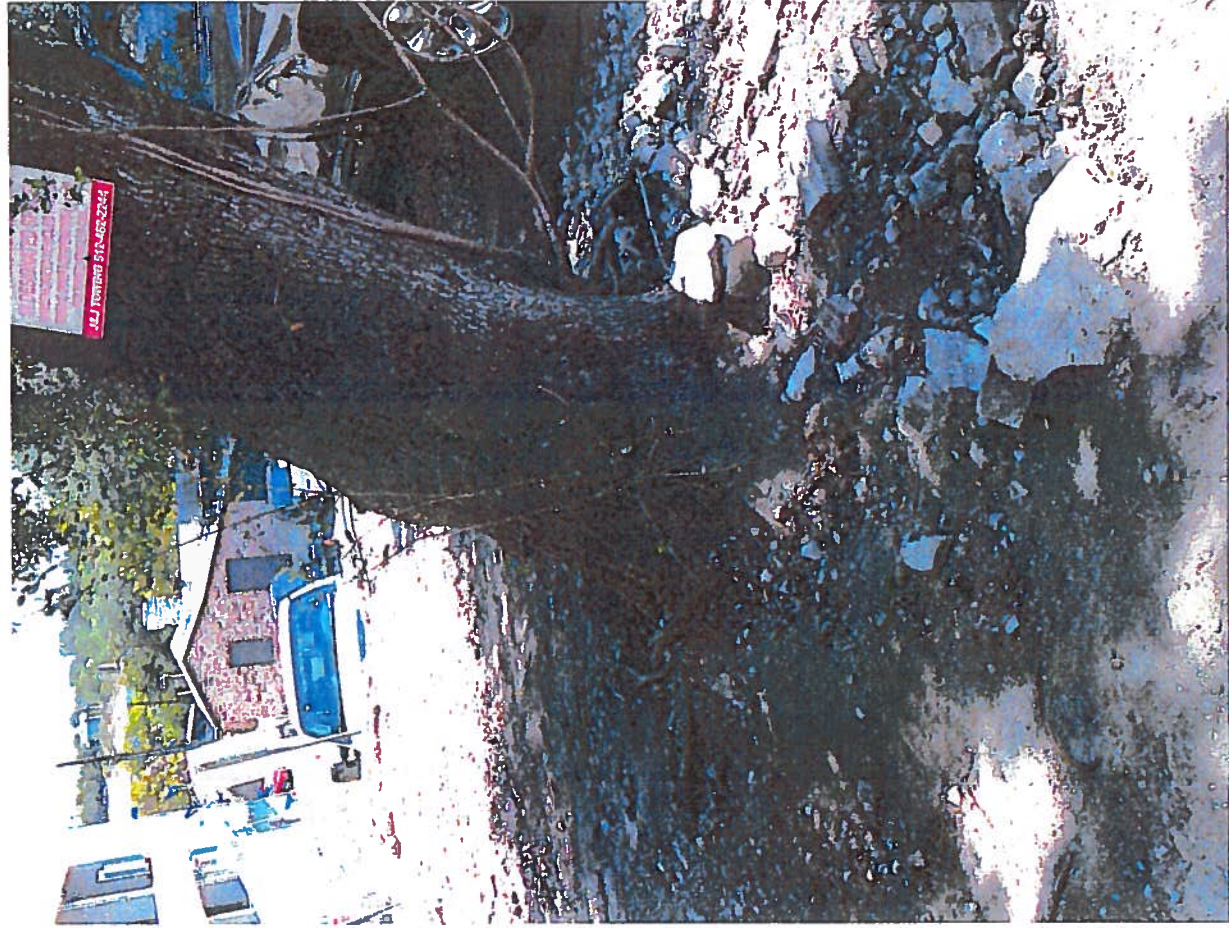
Exhibit 6

Root flare is buried under fill material (Exhibit 6). Critical root zone conditions are characterized by compacted parking areas (Exhibit 7) and cut on the northern half of the critical root zone (Exhibit 8). Girdling roots are present (Exhibit 9). Root decay is present. Extent of root decay is unknown but is a concern.

RESPONSE: The presence of excessive epicormics sprouts is a sign of extreme stress. The trunk collar/ root collar has been buried beneath 8-12 inches of fill soil consisting of soil, rocks, bricks, and asphalt has taken a toll on the tree.

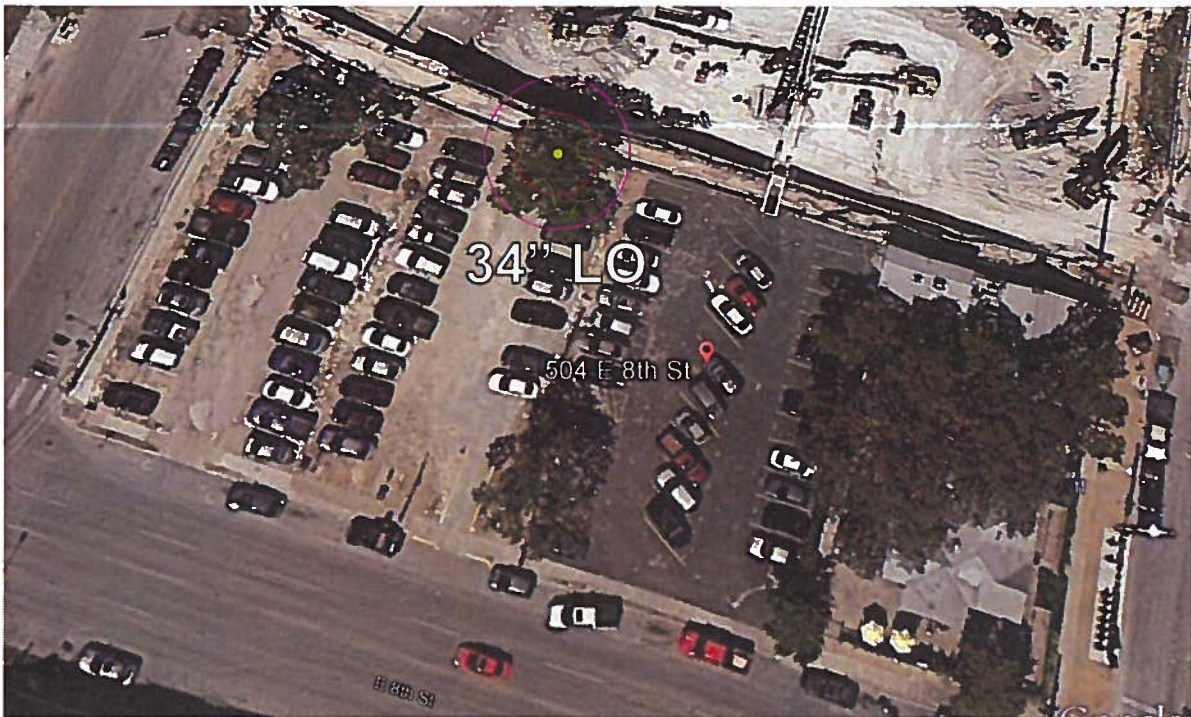
EXHIBIT A: Current Site Aerial with 34" Live Oak Tree Location

There is currently one Live Oak (LO) heritage trees on the site (Exhibit A) in poor health that is being requested for removal – a 34" LO in the center of the North side of the side abutting the alley (Exhibit A). Two other trees in ill health have been requested for removal by an administrative process.
