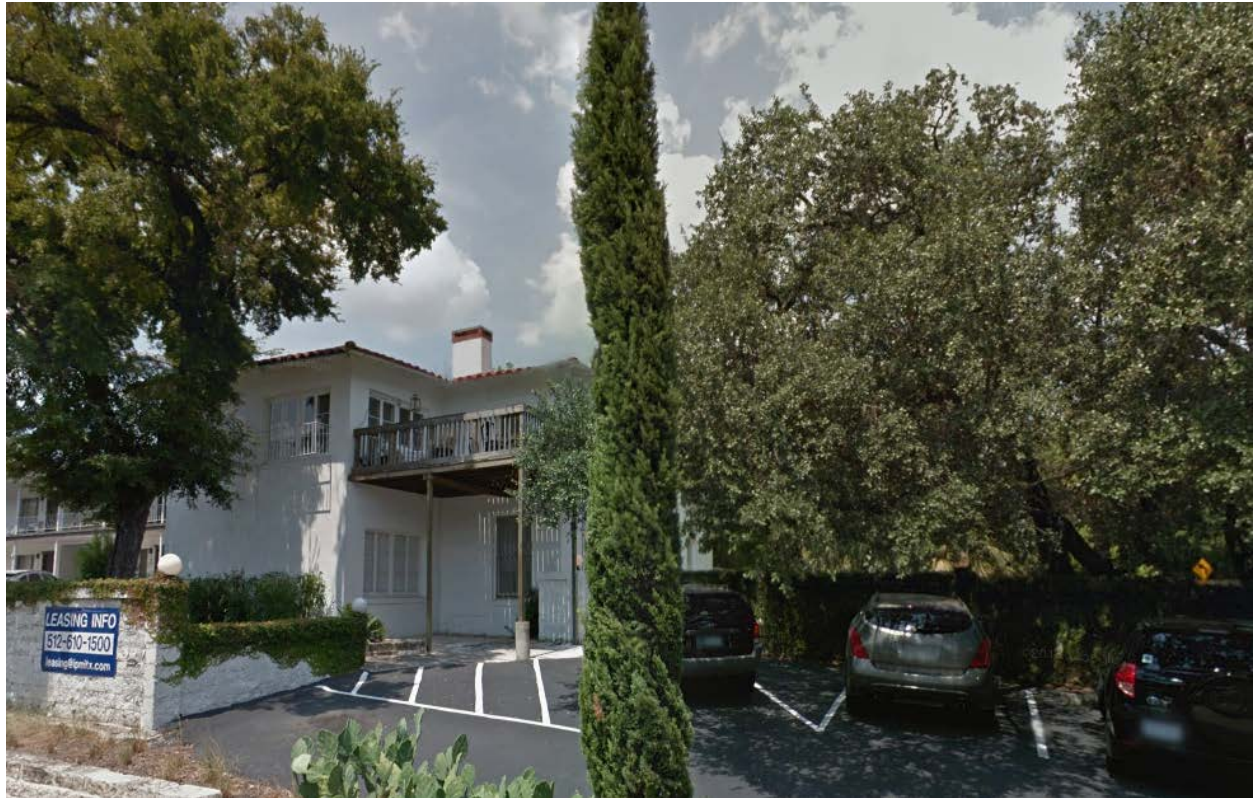
View of wooden balcony proposed for replacement
