HISTORIC LANDMARK COMMISSION
SEPTEMBER 26, 2016
PERMITS IN NATIONAL REGISTER HISTORIC DISTRICTS
NRD-2016-0044
1715 SUMMIT VIEW PLACE
OLD WEST AUSTIN

Re: Mold Inspection and Assessment

1715 Summit View Place
Austin, Texas 78703
AAB Project #: 216-11-106

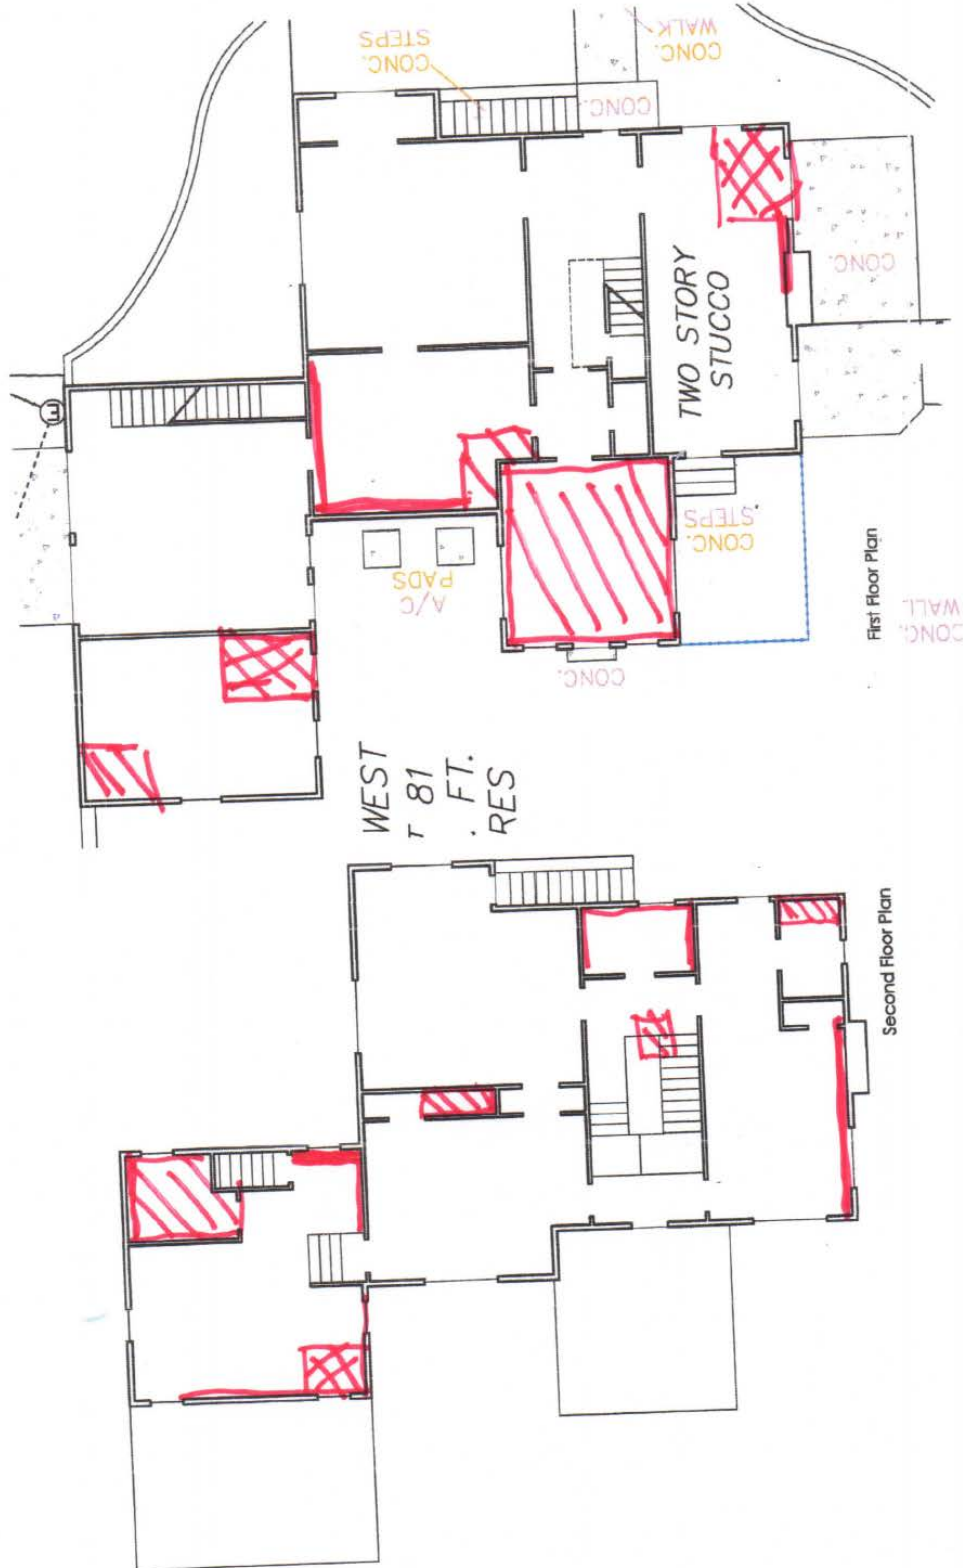
— MOLD DAMAGE

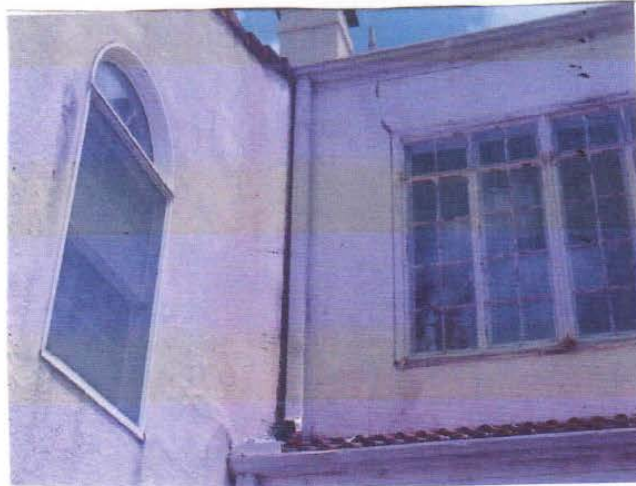
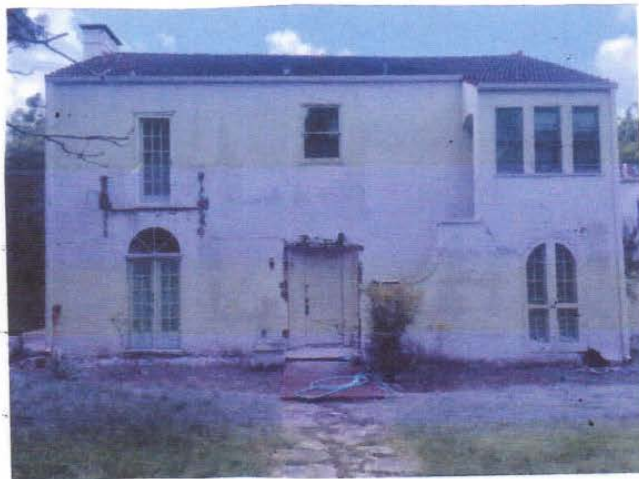
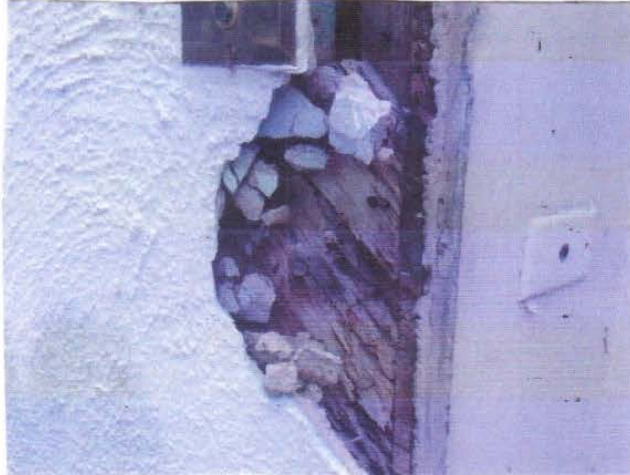
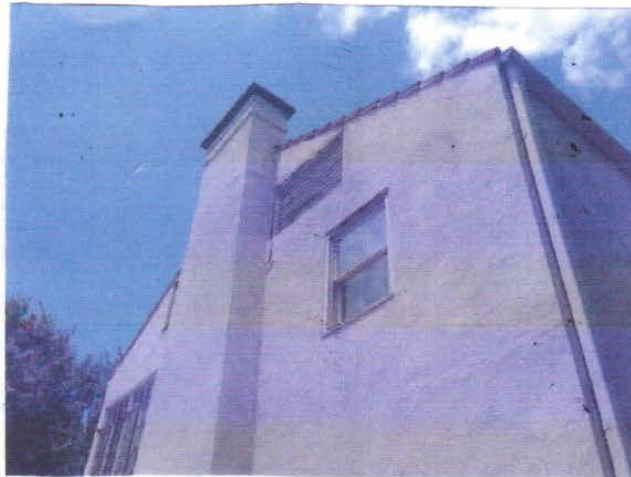
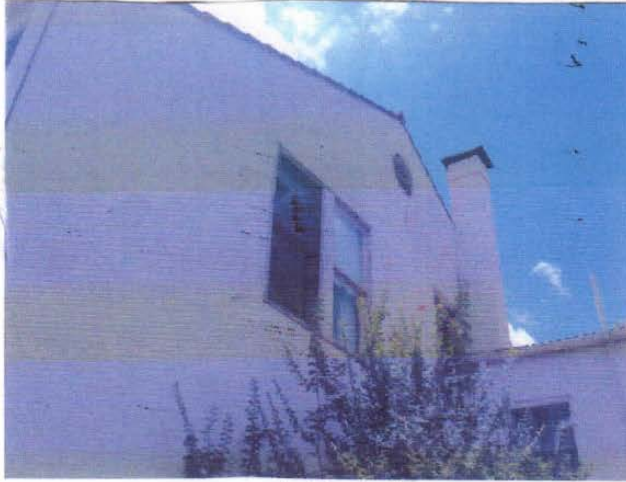
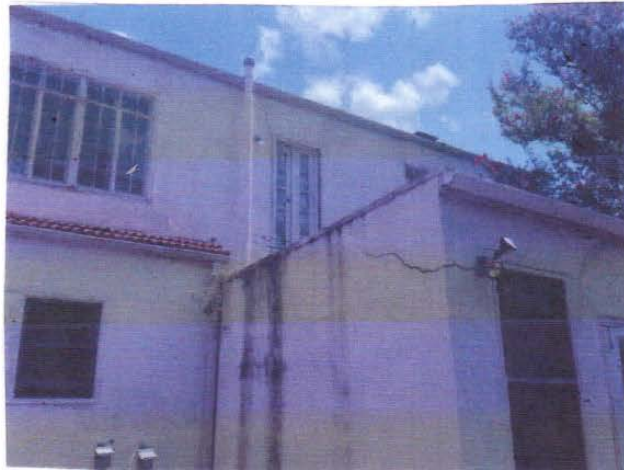
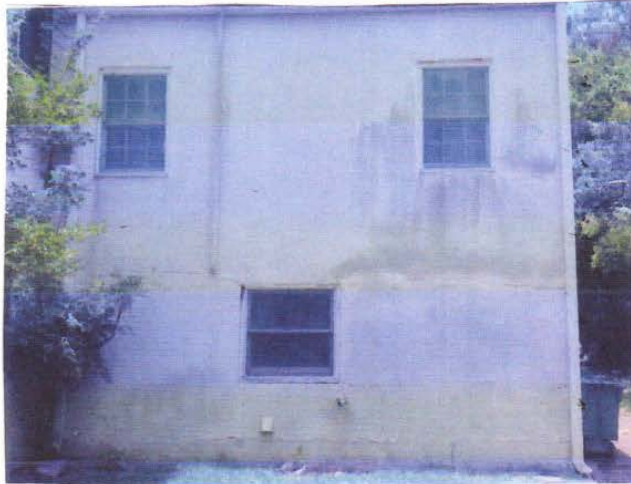
1. Stucco: Cracks/unsealed stucco was observed on all sides of structure. This issue is allowing significant amounts of moisture into the interior walls. In most cases, the sheathing located behind the stucco is rotten.
2. Windows: Improperly flashed and in many cases rotten exterior window trim was observed throughout the structure. This issue is allowing significant amounts of moisture into the interior walls.
3. Doorways: Improperly flashed and in many cases rotten exterior doorway trim was observed throughout the structure. This issue is allowing significant amounts of moisture into the interior walls.
4. Interior: Significant mold growth/water damaged was observed at approximately 40% of the interior wall/ceiling materials and within the HVAC ductwork. The most likely cause of the observed damage is roof/siding leaks located throughout the structure.

Damaged Exterior Stucco

- Remove all of the HVAC ductwork.
- Remove the stucco and inspect the newly exposed sheathing for rotten materials. Remove all rotten sheathing. Clean and treat all remaining sheathing.
- Remove all mold affected wall and ceiling sheet rock within the structure (approximately 40% to 50% of all surfaces – see floor plan for damaged areas).
- Remove all mold affected cabinetry – Kitchen and bathrooms.
- Remove all rotten studs and ceiling joists. Clean and treat all remaining structural materials.
- In order to obtain a CMR – “Certificate of Mold Damage Remediation” all remedial actions are required to be performed by a Texas licensed mold remediation contractor.
- A licensed mold assessment consult is also required to perform a final inspection prior to the rebuild process.

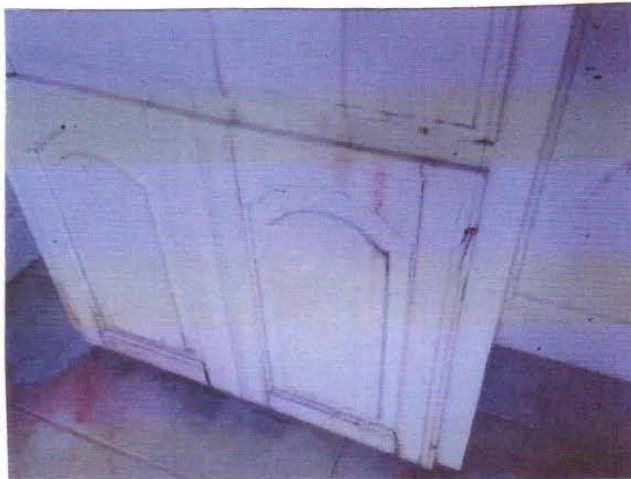
Damaged Cabinetry – Upstairs Bathroom

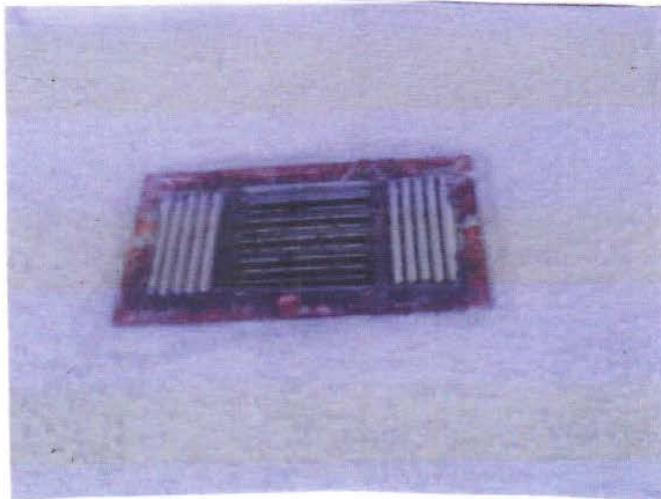
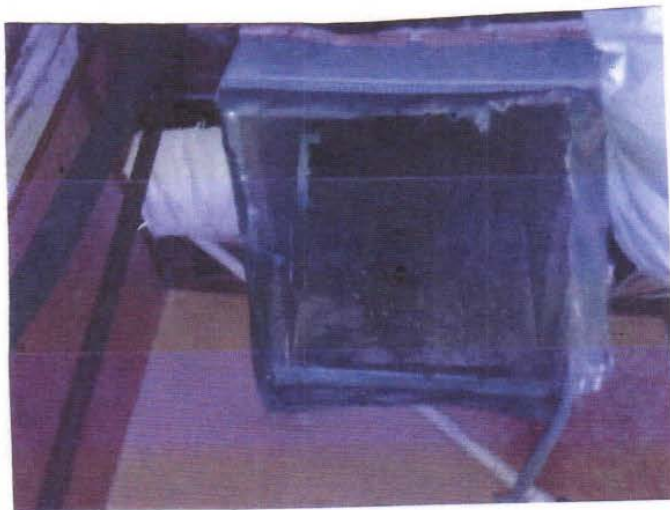
Mold Affected Ductwork

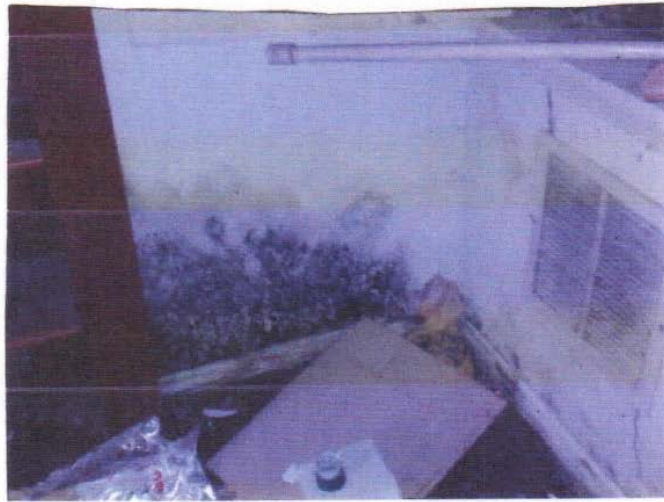
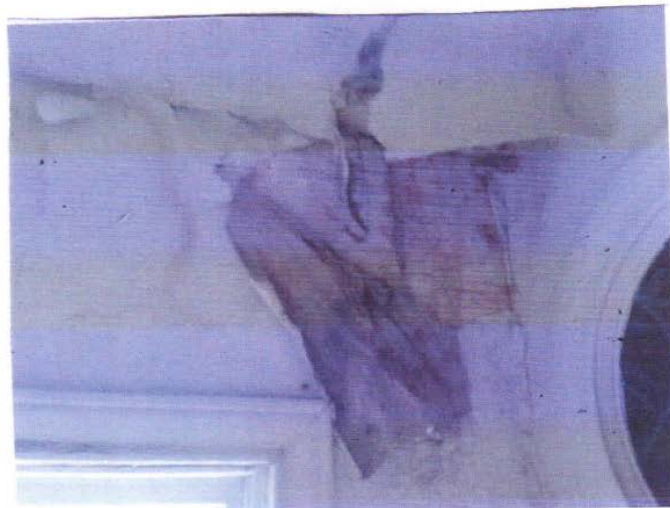
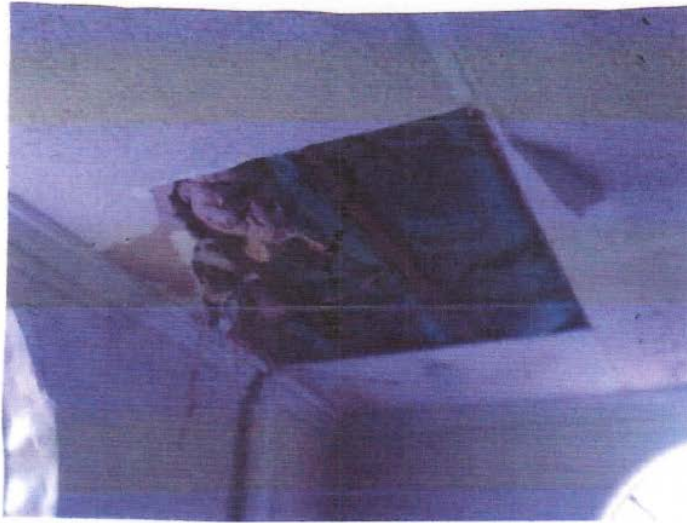
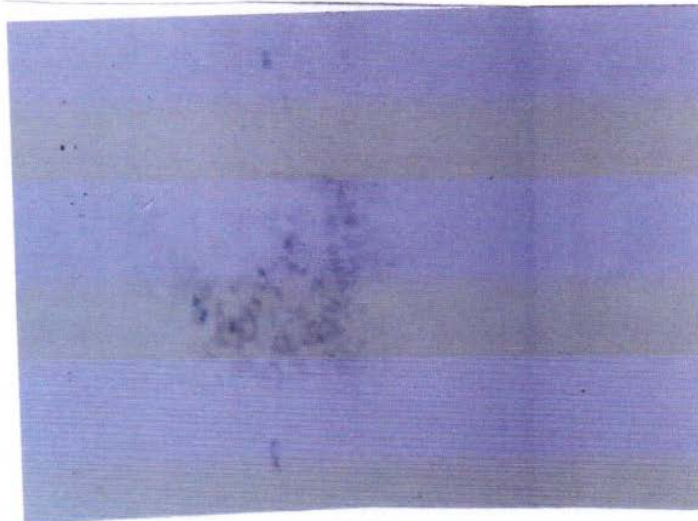
Typical Mold Damage
