**HISTORIC LANDMARK COMMISSION  
MARCH 25, 2019  
DEMOLITION AND RELOCATION PERMITS  
HDP-2019-0090  
1603 WILLOW STREET**

Demolish a ca. 1902 house.

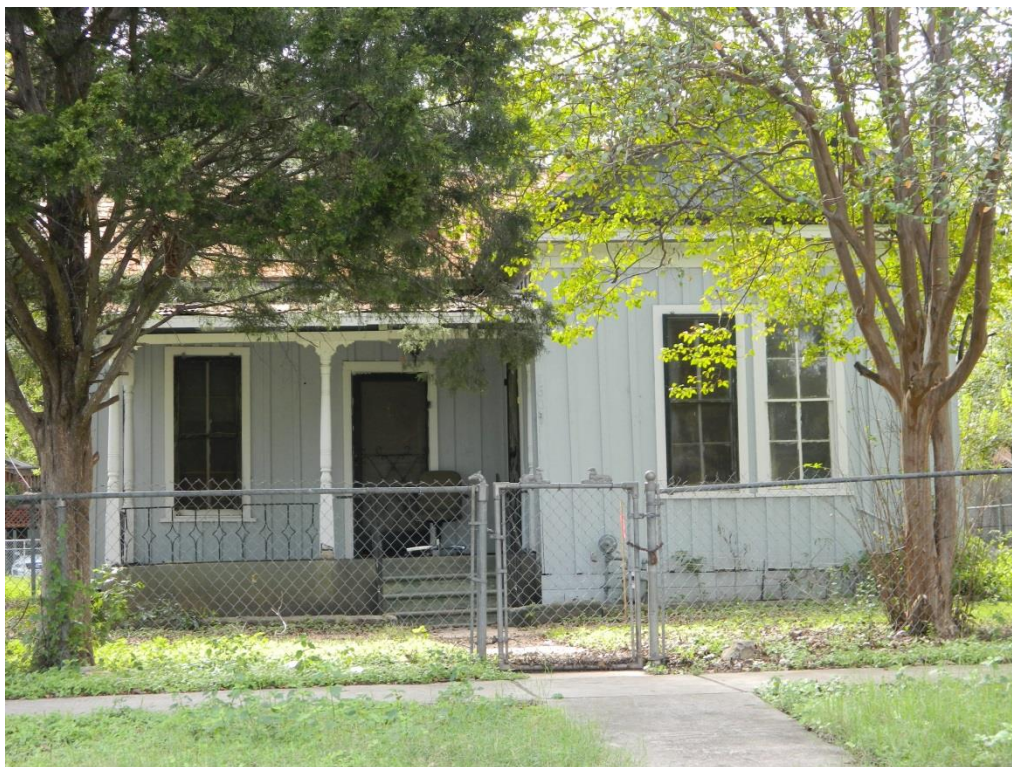
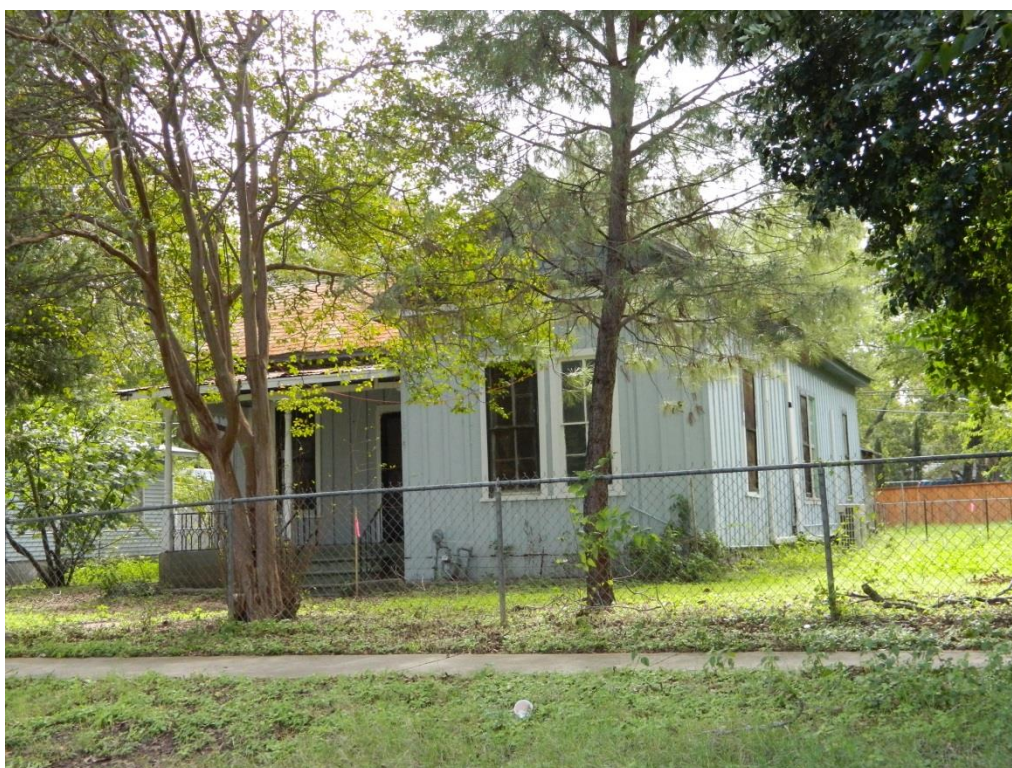
Photographs from 2015-16

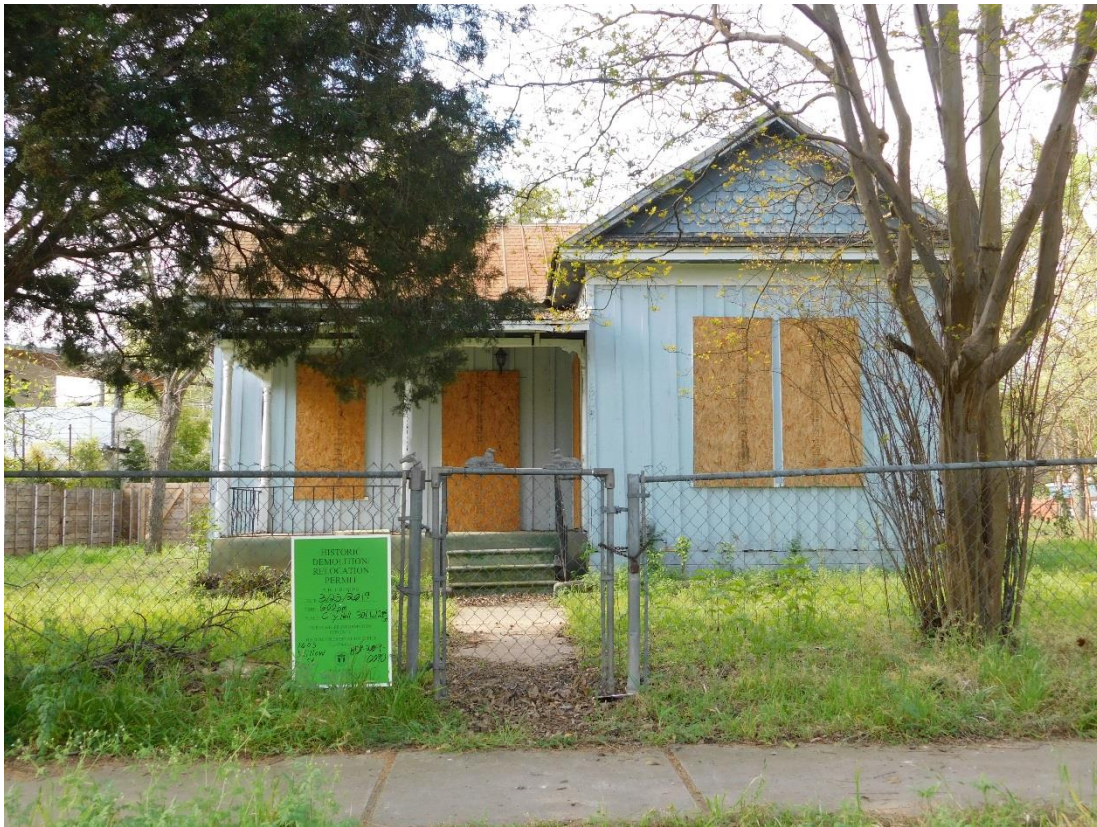
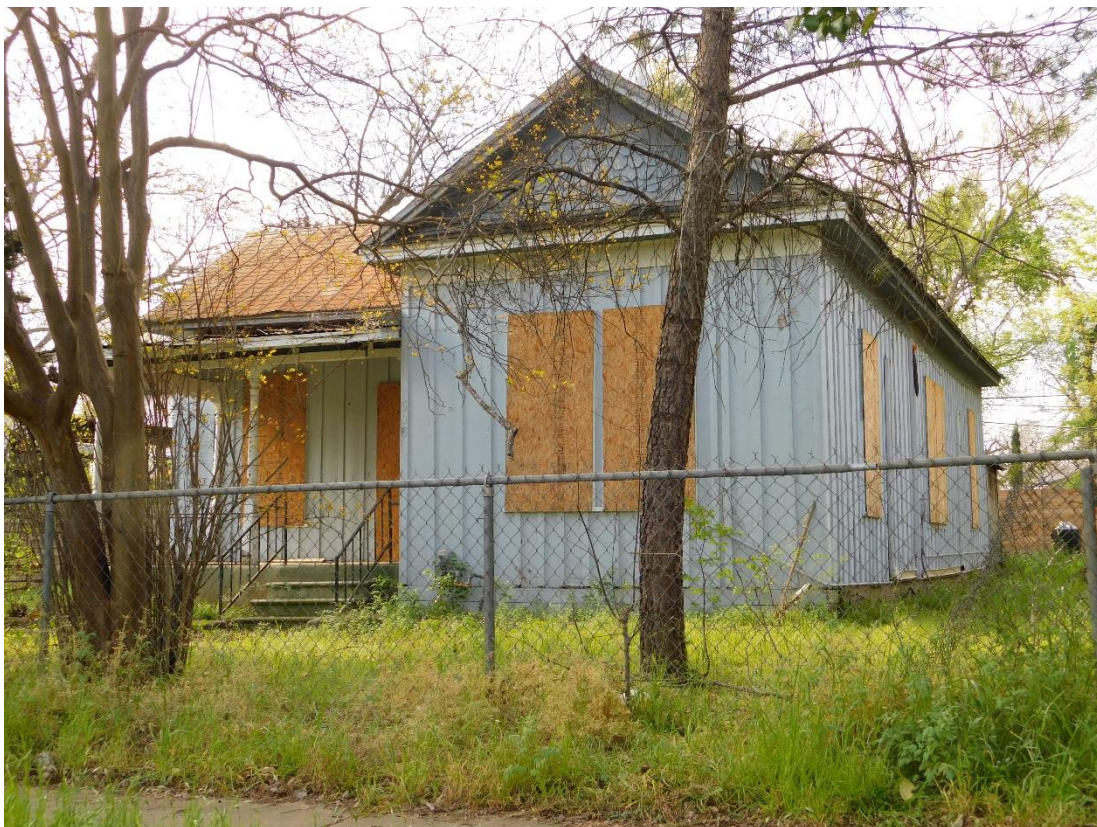
Photographs from March, 2019

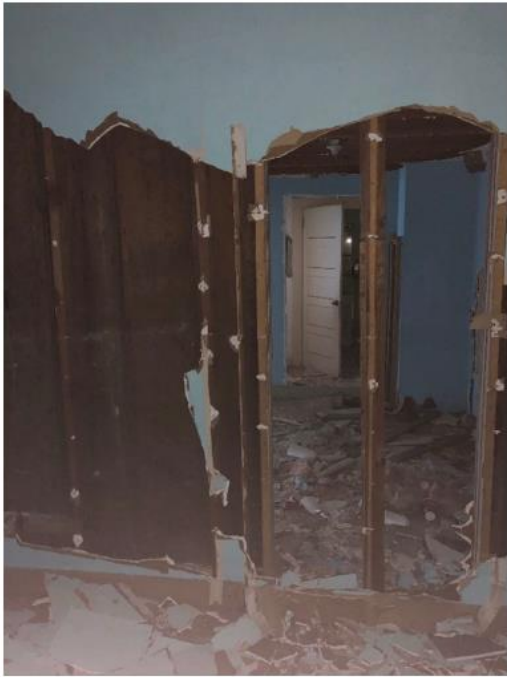
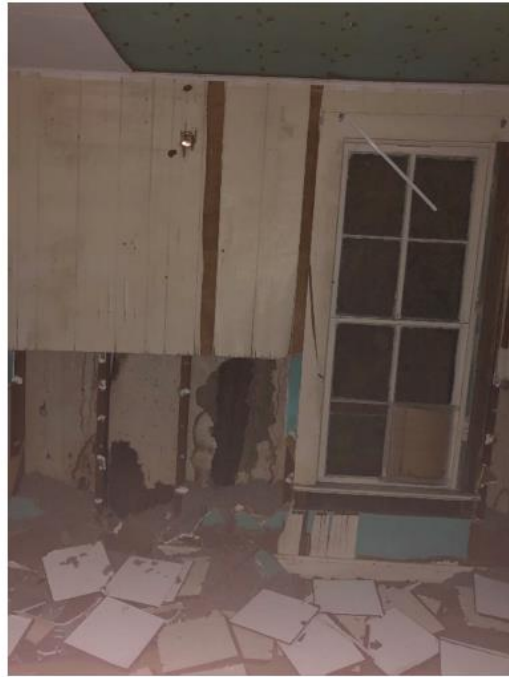
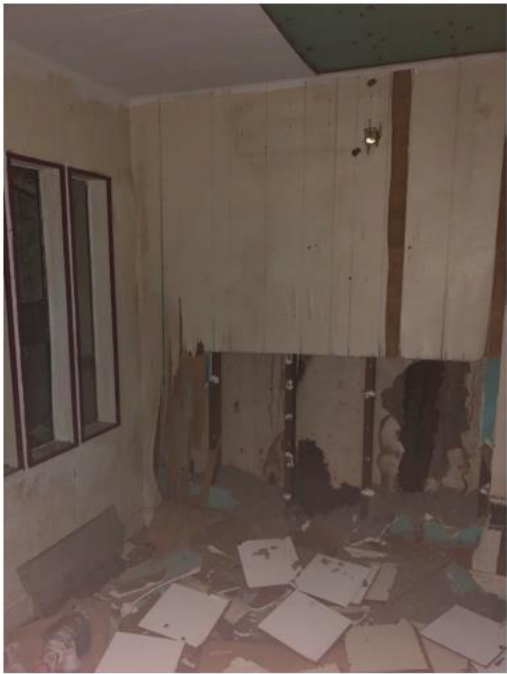
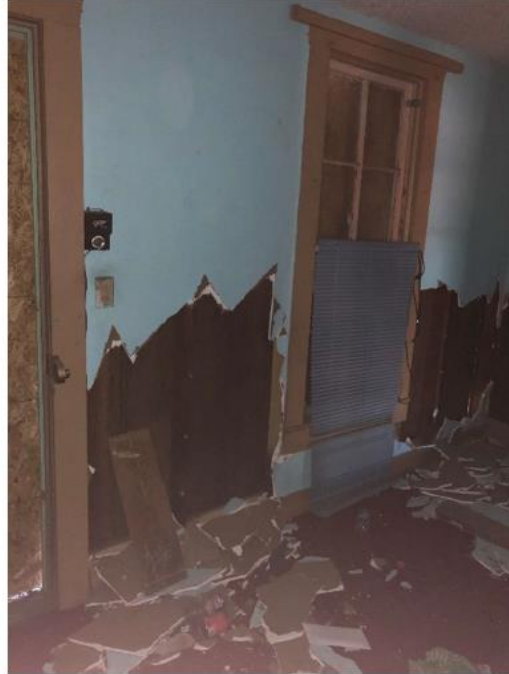
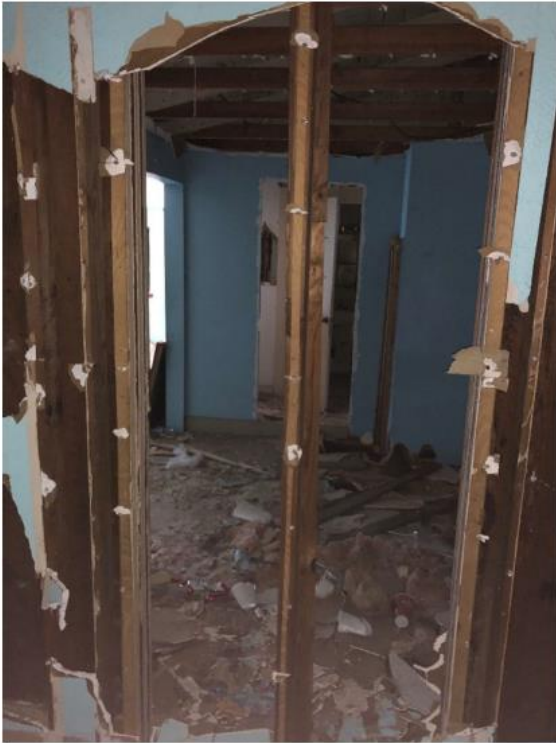
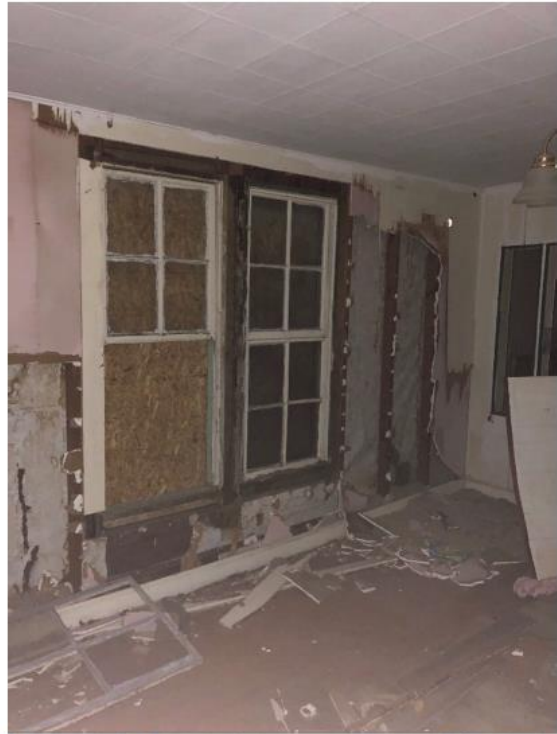
Based on the condition observed during the site visit, the subject property appears to be in very poor condition. The roofing system appears to be metal, in poor condition, the current roof is not salvageable and will need to be completely replaced. There appears to be multiple leaks that have caused damaged to the framing structure.

Most of the ceiling framing appears to be of 2x4 construction and not properly braced. The 2x4's are not up to the current IRC code. The ceiling joist and roof structure will need to be completely re-constructed to bring them up to current code as well as to be able to properly and safely carry the roof load.

The current state of the interior of the home is in poor condition. There is exposed electrical wiring where sheetrock or wall paneling has been removed. This entire electrical system will need to be replaced due to the wiring being out of compliance. All ceilings and walls will need to be repaired. The flooring throughout the house is in poor condition and will all need to be replaced. There are multiple rotten areas in the floor framing and extensive repair and replacement work will need to take place to bring the structure up to a livable condition.

The foundation appears to be wood piers with no concrete foundation or base. All wood piers will need to be replaced with concrete piers, engineered to support the structure of the house. The foundation work needed would be extensive.

Overall, the property would require significant repairs to bring the home up to code. It is the opinion of Oakman Building Company that the home should be demolished. The cost to remodel the home would far exceed the cost of demolishing the home and re-building.
