**Subject:** Please, deny HTO variance 37 inch tree 2111 Rio Grande, c-8

Best,  
Zoila Vega-Marchena, Ph.D.  
Austin Heritage Tree Foundation

# Decay Detection in Red Oak Trees Using a Combination of Visual Inspection, Acoustic Testing, and Resistance Microdrilling

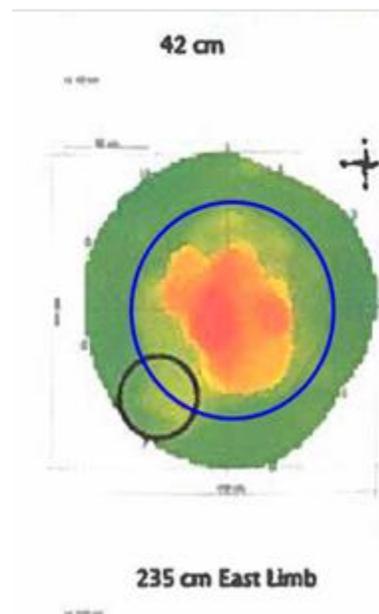
- The interpretation of the tomography scan at the base is incorrect. Traditionally, certified arborists have considered a tree structurally sound until decay exceeds 70% of the cross sectional area (has a minimum 30% wall). The standard when reading a tomography scan is that the red area represents potential decay, the green potential solid wood and the yellow potential incipient decay. **Incipient decay is defined as “wood in the early stages of infection or invasion by a wood decay fungus, so that the wood is not yet evidently softened”**.

- The Davey Tree report states in the discussion section that “there is an area near the center **suggesting** less sound wood that reaches the shell wall at 30%”, but in the report’s conclusions this is elevated to “the base of this tree **does have** less sound wood present at the shell wall at 30%”. But the area being referred to shows as faint yellow, not red. Faint yellow indicates potential incipient decay, not potential decay. The rest of the cross section is solid, as are the other 4 scans. This tree is solid.

- Stating that this tree has decay that has reached the 30% shell wall has 3 issues:
  - 1) The 30% rule should be calculated based on the cross sectional area, not the linear diameter. It’s erroneous to show a black circle on the section in question to indicate a 30% linear dimension, instead of calculating a cross sectional area.

- 2) Newer standards challenge the 30% rule and state that a tree could be structurally sound up to 10% depending on wind loads.
  - 3) The tomography scan of the base only shows a faint yellow small area reaching the 30% wall. Since this may be potential incipient decay, this scan is too uncertain and not sufficient to declare the tree hazardous.

The green areas represent sound wood, where the sound traveled quickly between the sensors.

The yellow suggests less sound wood, where the sound traveled slower.

The orange and red suggest cracks or pockets of decay where the sound moved very slowly between the sensors.

The purple areas suggest a decay pocket where the sound traveled the slowest.

The white circle indicates an area where the scan is purple, suggesting the presence of a decay pocket.

- 4) Davey Tree has not confirmed the potential decay with simple resistograms tests, and has not done the root evaluation needed to determine the health of this tree.

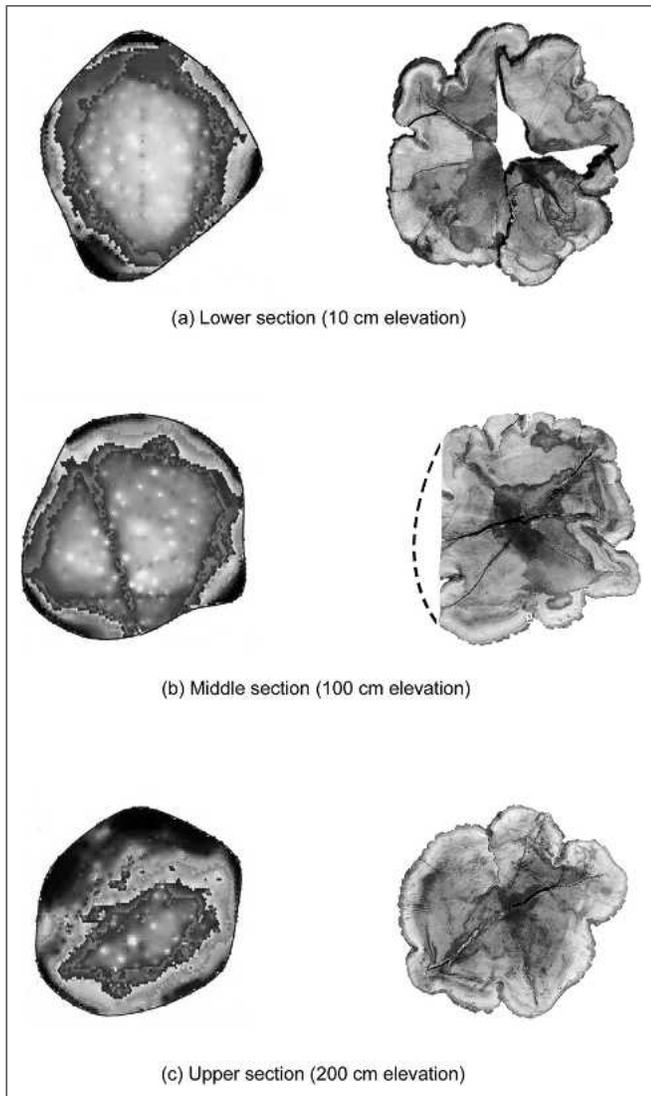
**Figure 1. Comparison of acoustic tomographs and photographs of corresponding cross-sections for red oak tree No. 307.**

After being cut down, tree No. 307 was found to have heartwood decay at all three elevations. Laboratory examination confirmed the presence of white rot decaying fungus. The decay was less severe in the upper cross-section (200 cm [80 in] elevation), but it increased in size as the elevation dropped.

In addition to decay, major internal cracks were present in the cross-sections of tree No. 307. The combination of extensive decay and large lateral cracks caused the base disk to fall into several pieces during transportation. The photographs of the disks show that lower and middle cross-sections had multiple lateral cracks and the upper cross-section had one large lateral crack.

Figure 1 shows the comparisons of acoustic tomographs and photographs of the cross-sections at three elevations for red oak No. 307. The dark-colored zones (brown if it is in color print) in the tomograms represent solid wood, and the light-colored zones represent potentially decayed wood (if displayed in color, the tomograms use green, violet, and blue to represent increasing degradation by decay). It is clear that the tomographs show a strong correspondence to the images of the disks. Extensive decay and radiating lateral cracks in the lower and middle cross-sections were reflected by large light-color zones in the tomographs. The tomograph of the upper cross-section accurately located the position and orientation of the big lateral crack and heartwood decay.

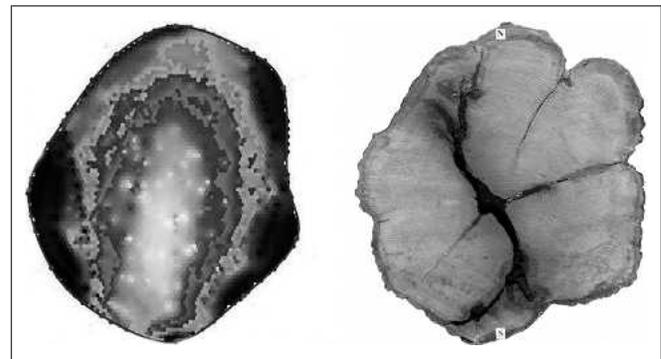
**Figure 2. Comparison of acoustic tomograph and photograph of the cross-section for red oak tree No. 123.**

For red oak No. 123, the visual inspection revealed trunk seams and cracks with cankering on the south side with associated *Ustulina deusta* fungus. The single-path stress wave tests revealed a stress wave transmission time ranging from 1908 to 2320  $\mu\text{s}/\text{m}$  (581 to 707  $\mu\text{s}/\text{ft}$ ). The tomography revealed a large area of defect. The Resistograph drilling revealed a large snake-shaped crack. Figure 2 shows the comparison of the acoustic tomograph and photograph of the cross-section for red oak No. 123.
