**Re: York Rite Expansion & Rehabilitation  
Existing Façade Support  
311 W 7<sup>th</sup> Street, Austin TX**

## **York Rite Expansion & Rehabilitation**

### **Preliminary Narrative for Support of Existing Facade**

June 17, 2019

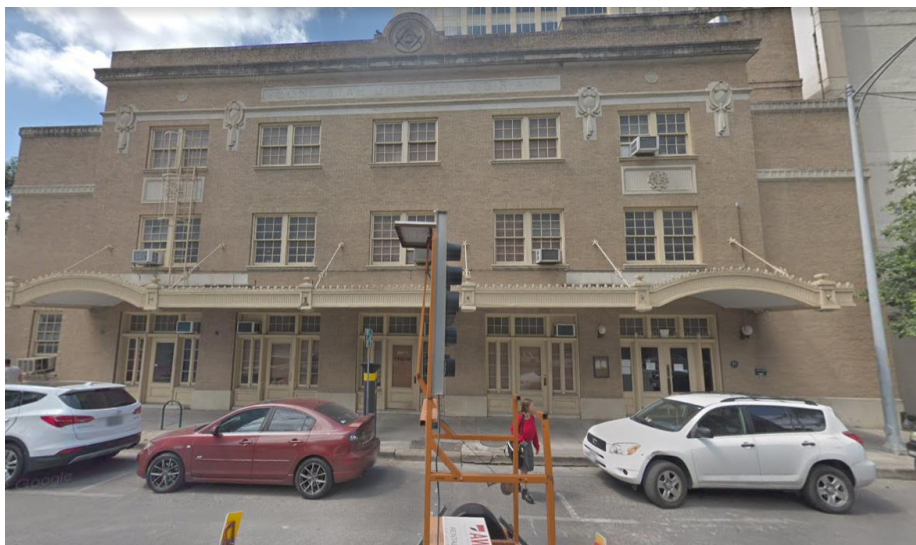
## Floor Plan

With the location of the structural frame along the perimeter, as well as providing lateral and potential vertical support of the existing façade we, are proposing that the structural frame along the perimeter be kept intact as much as possible. We feel keeping this frame will provide several advantages in both minimizing potential damage to the façade during demolition and construction as well as provide a structural substrate that can be utilized for both temporary and

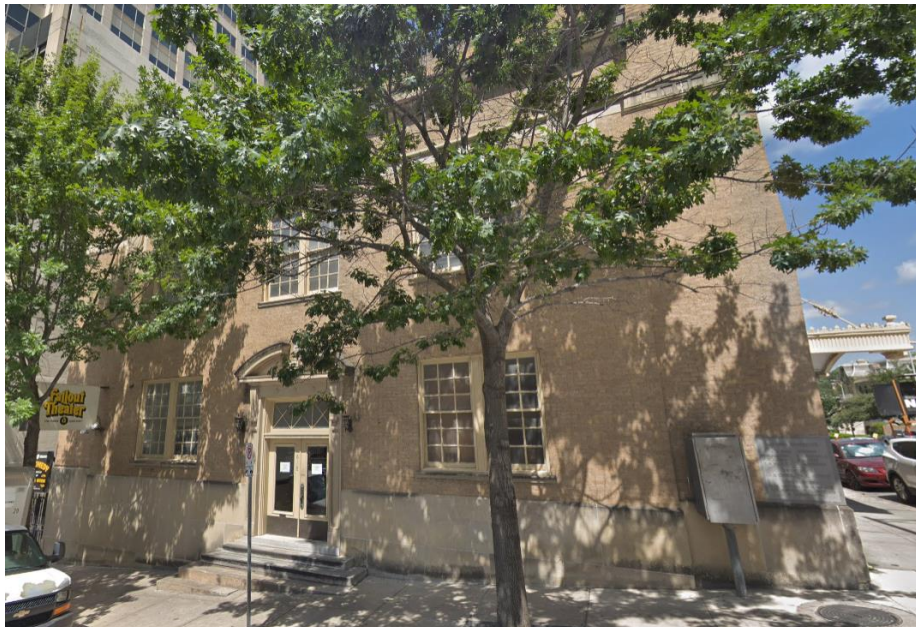
**View From 7<sup>th</sup> Street**

We understand the existing façade consists of brick masonry which is assumed to be non-load bearing. Based on the visual observation it is assumed the masonry is vertically supported by the basement wall as no horizontal relief joints could be observed however this has not been confirmed. Size and thickness of the existing masonry is not known at this time. Based on experience with similar structures of that age we anticipate the exterior façade to be a cavity wall construction with a secondary non-load bearing layer on the inside face. Based upon the Property Condition Report dated March 15, 2018 by Partner Engineering and Science, Inc. we understand that the exterior walls are in general good to fair condition with some minor areas of deteriorated mortar.
