# Restoring Shoreline

## at Emma Long Metropolitan Park

Andrew Clamann  
WPD, ERM

7/17/2019 Environmental Commission

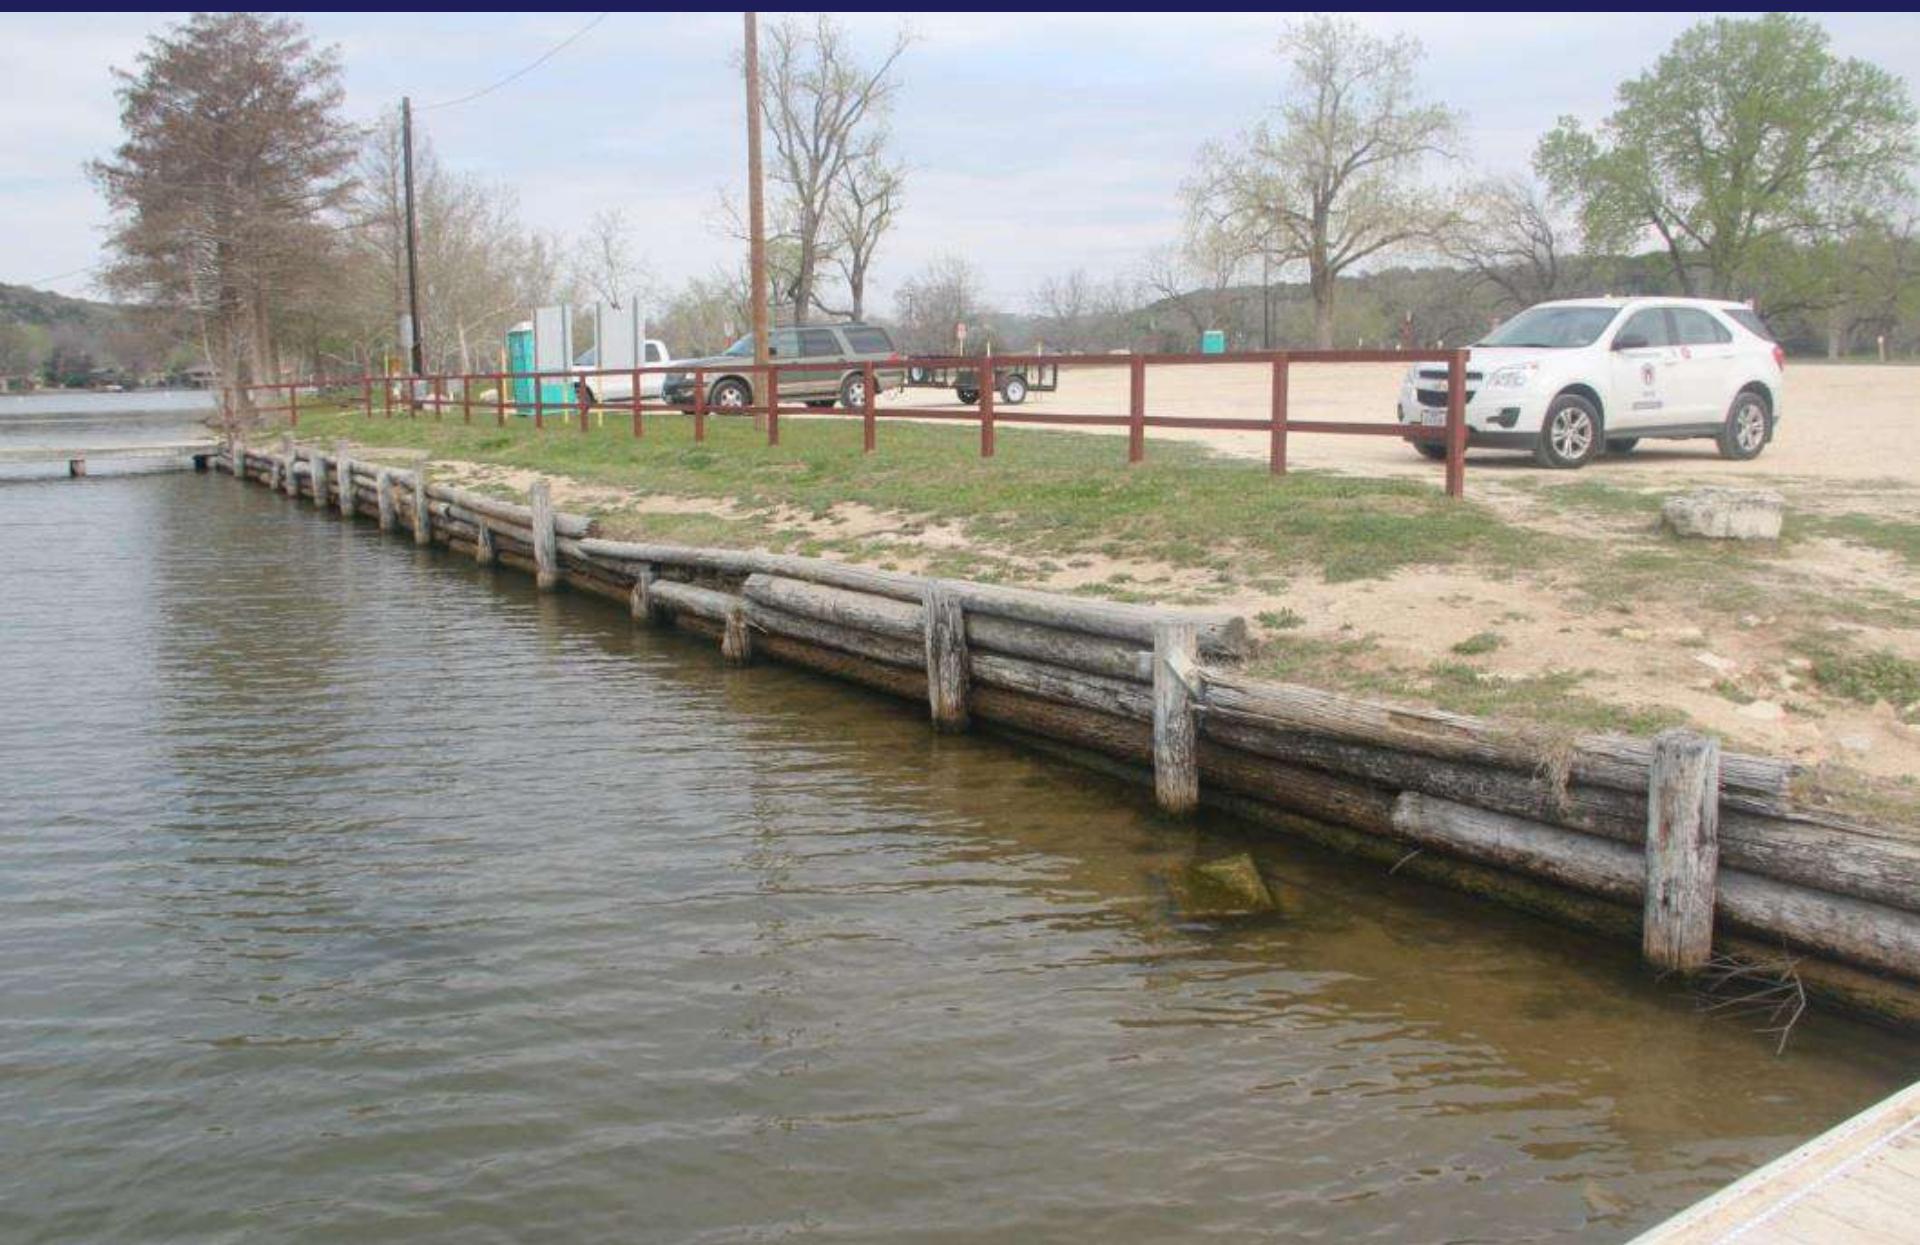
Project area:  
140 ft shoreline between piers  
at the boat ramps

Problem: The old wood bulkhead wall was failing, and vertical walls are no longer compliant

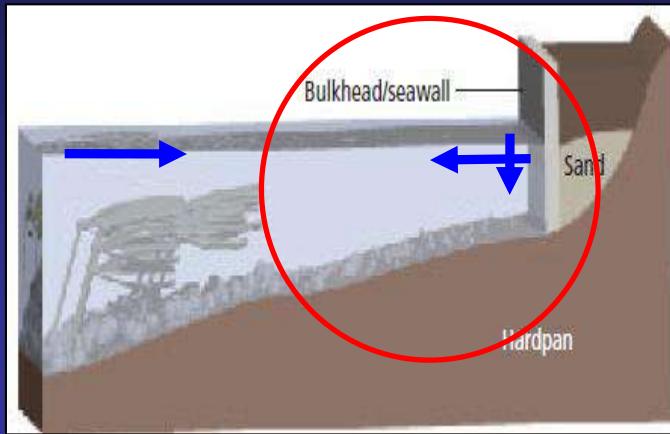
**Vertical walls  
erode  
the lake bed**

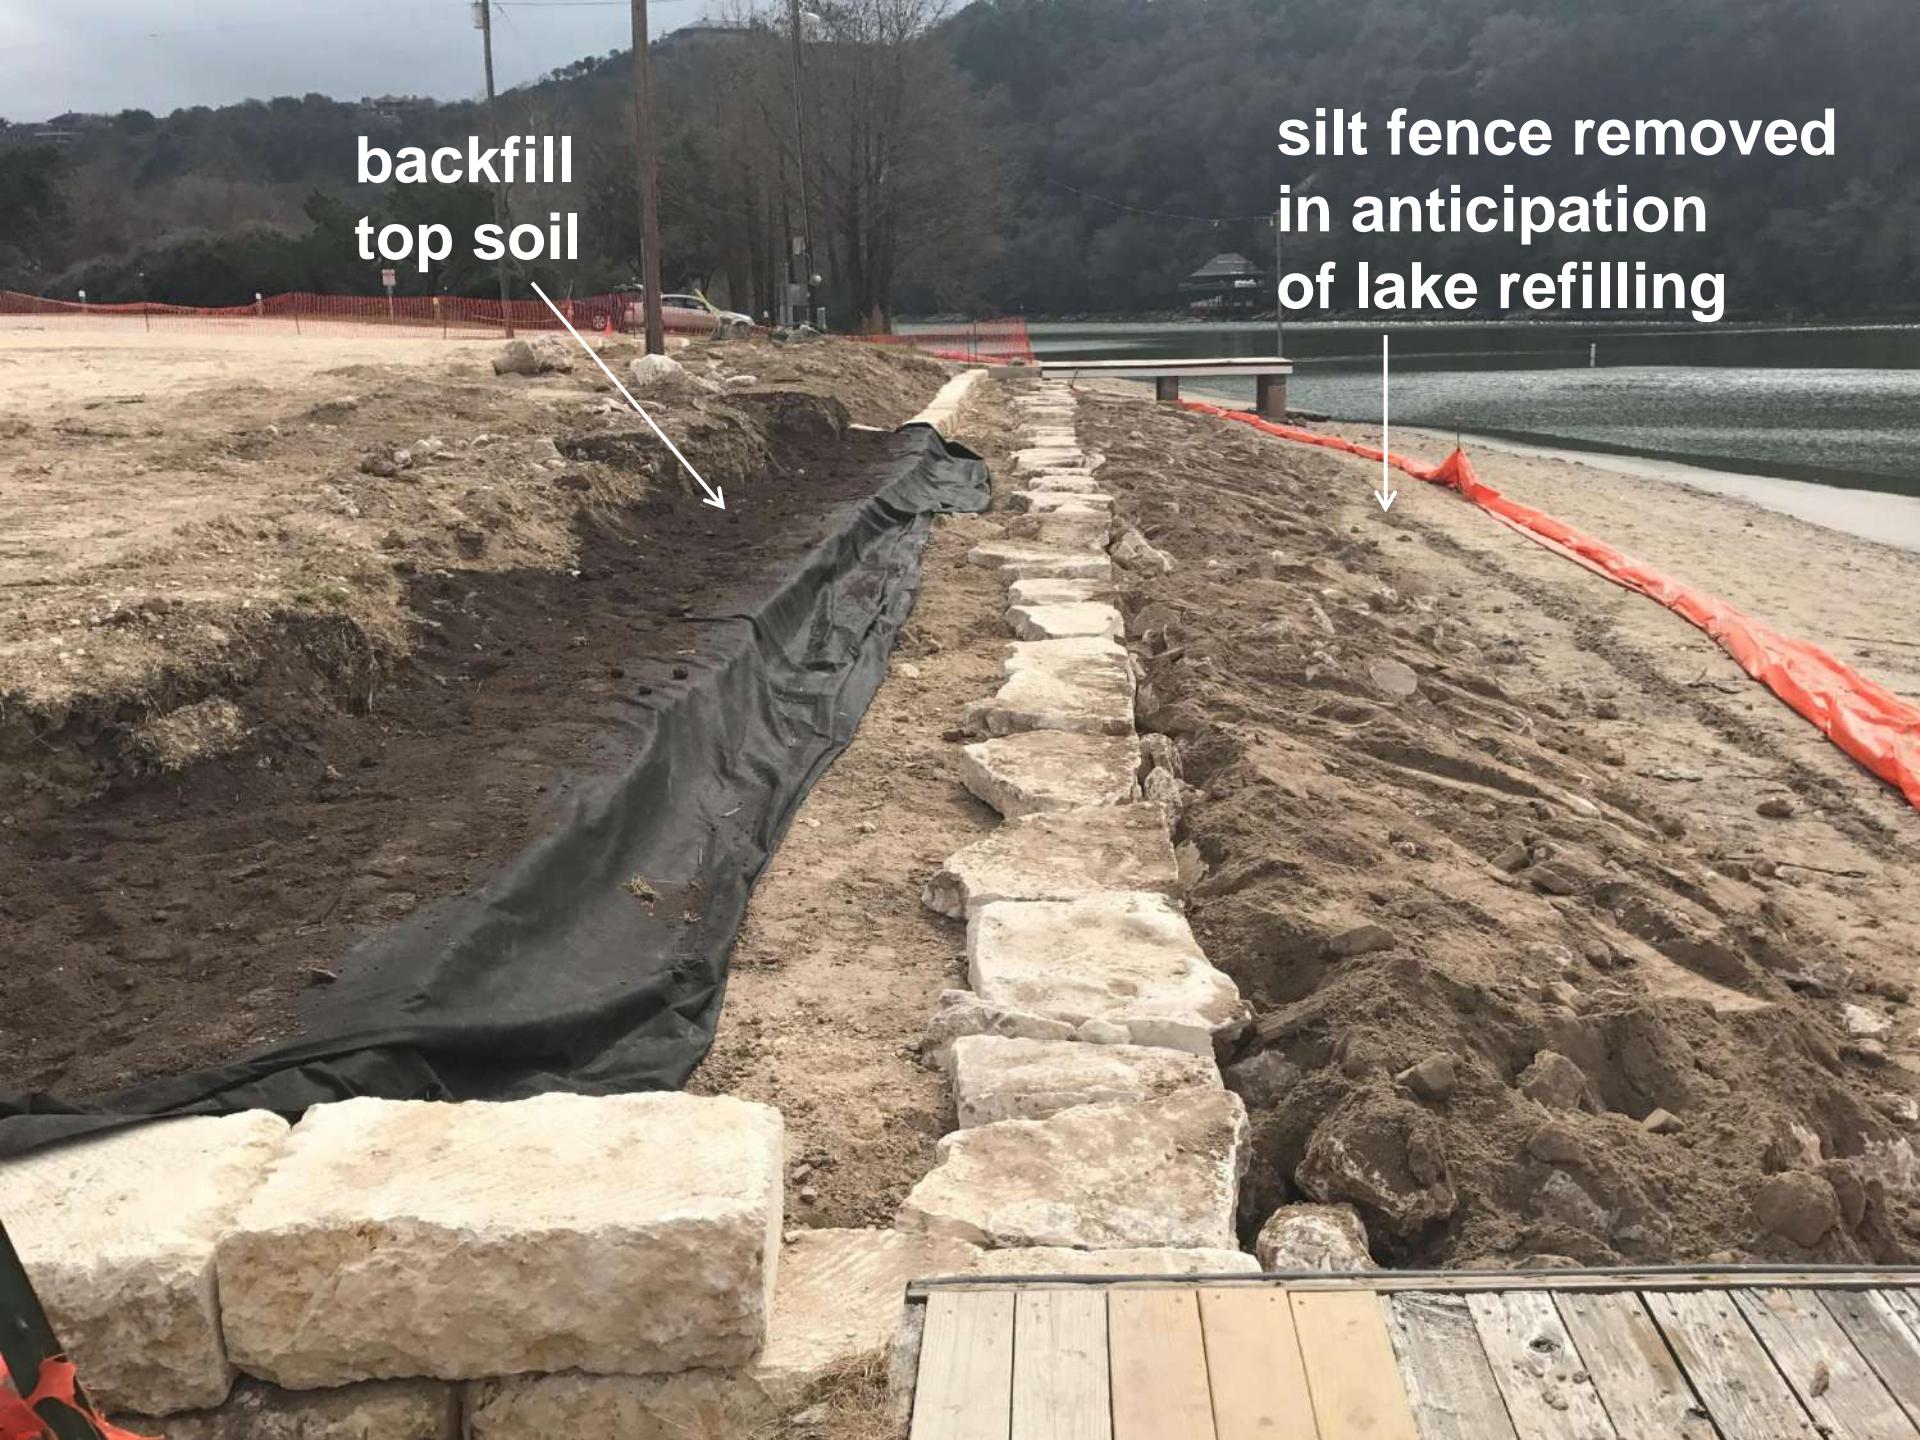
turbidity  
contained  
after a storm

Install third  
boulder wall
