1215 W 9th St : *West Line NRHD* - Proposed Partial Demolition / New Addition

1215 W 9th St : Exterior Overview - Existing Conditions

1215 W 9th St : Material Alterations Over Time

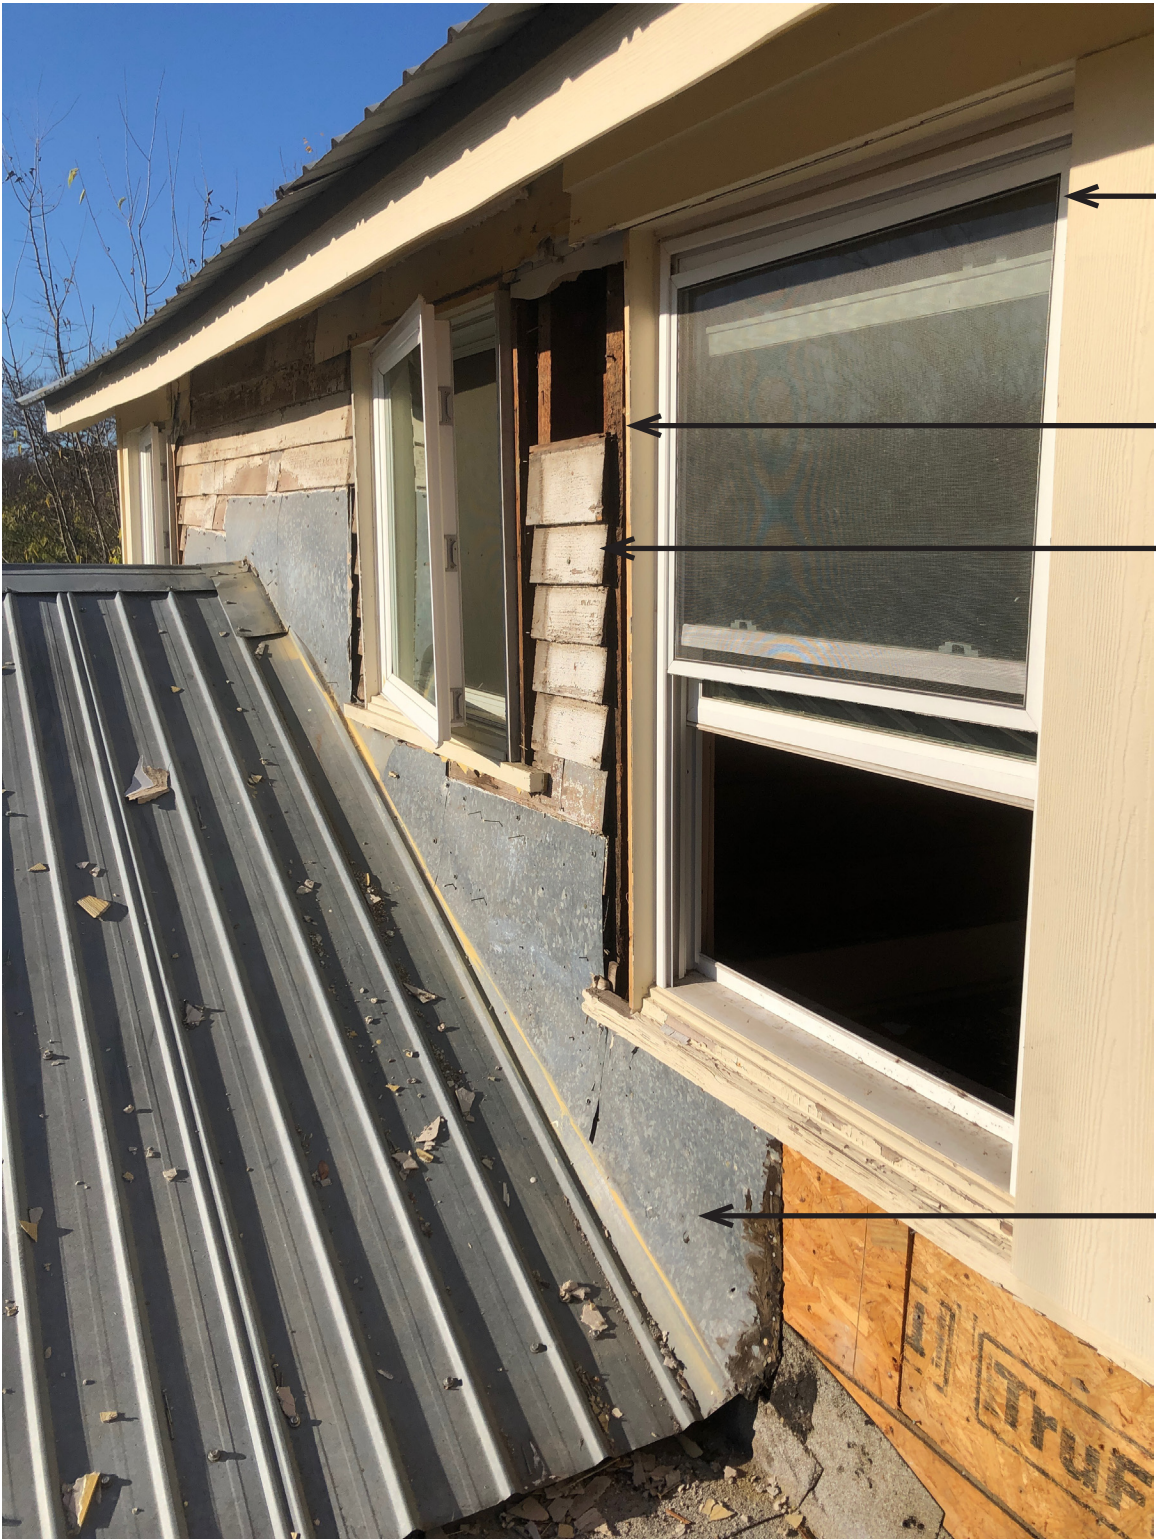
Vinyl replacement window

Wood framing (varies)

Original siding

Metal flashing in lieu of

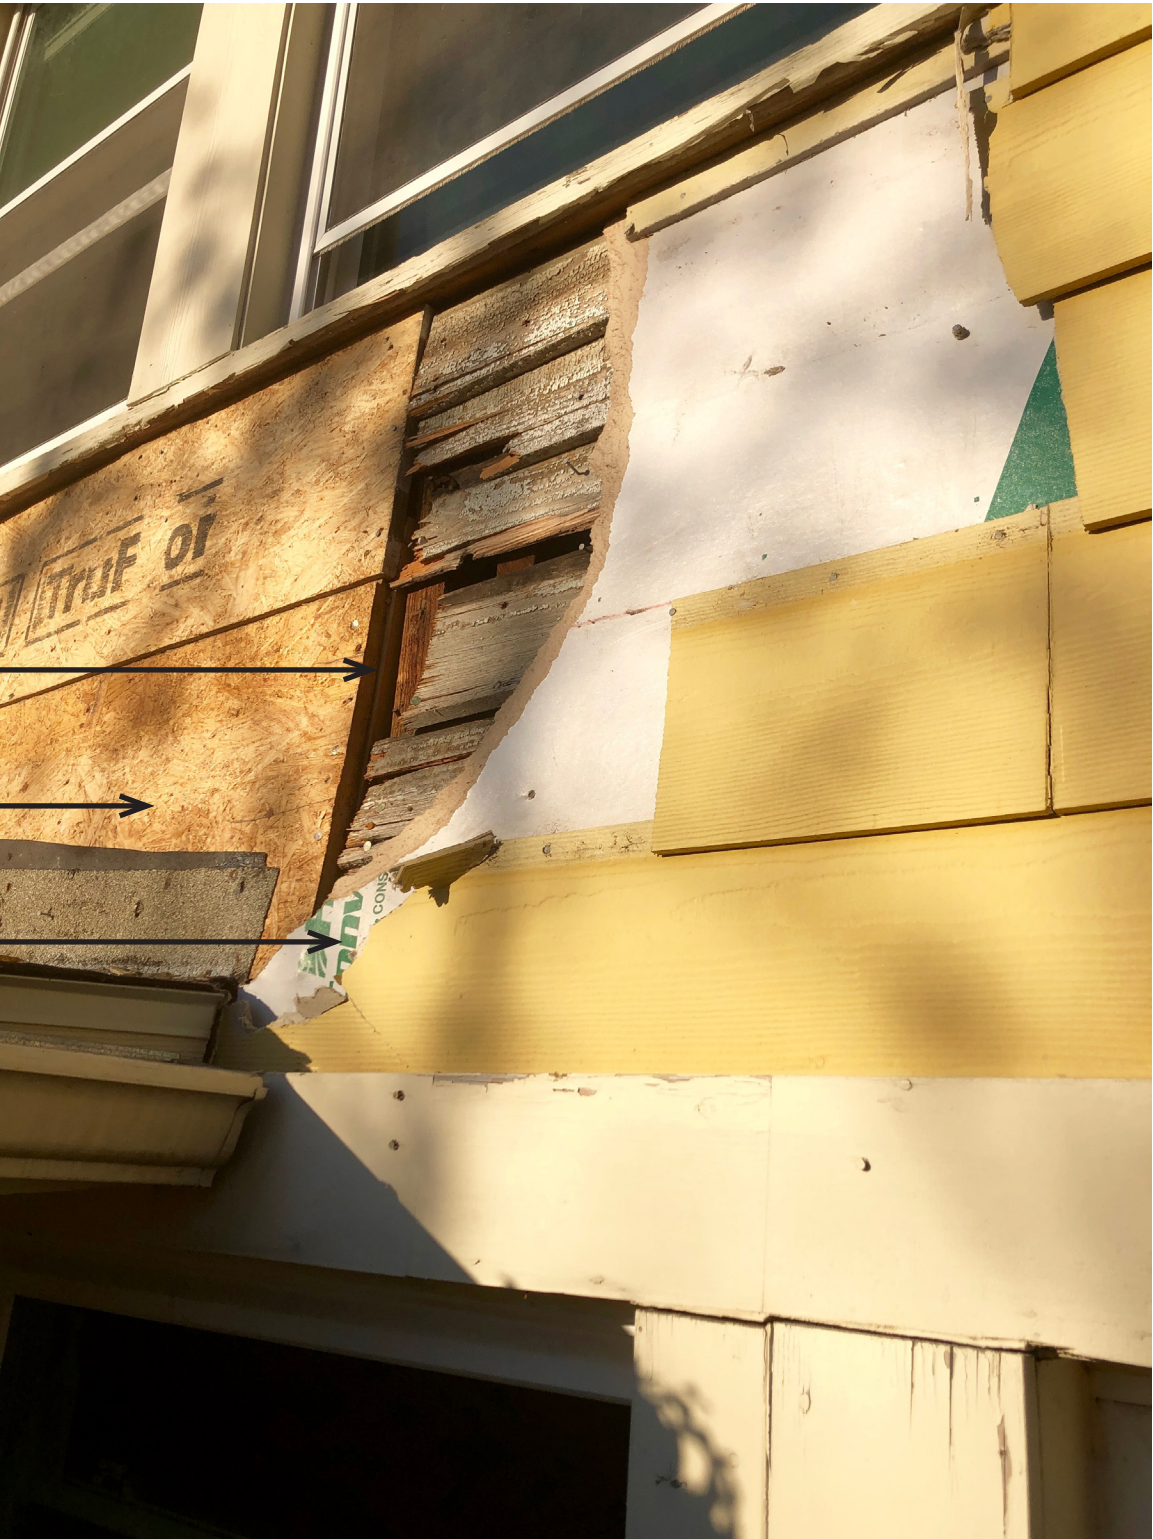
Original siding

OSB replacement material

New fiber cement siding

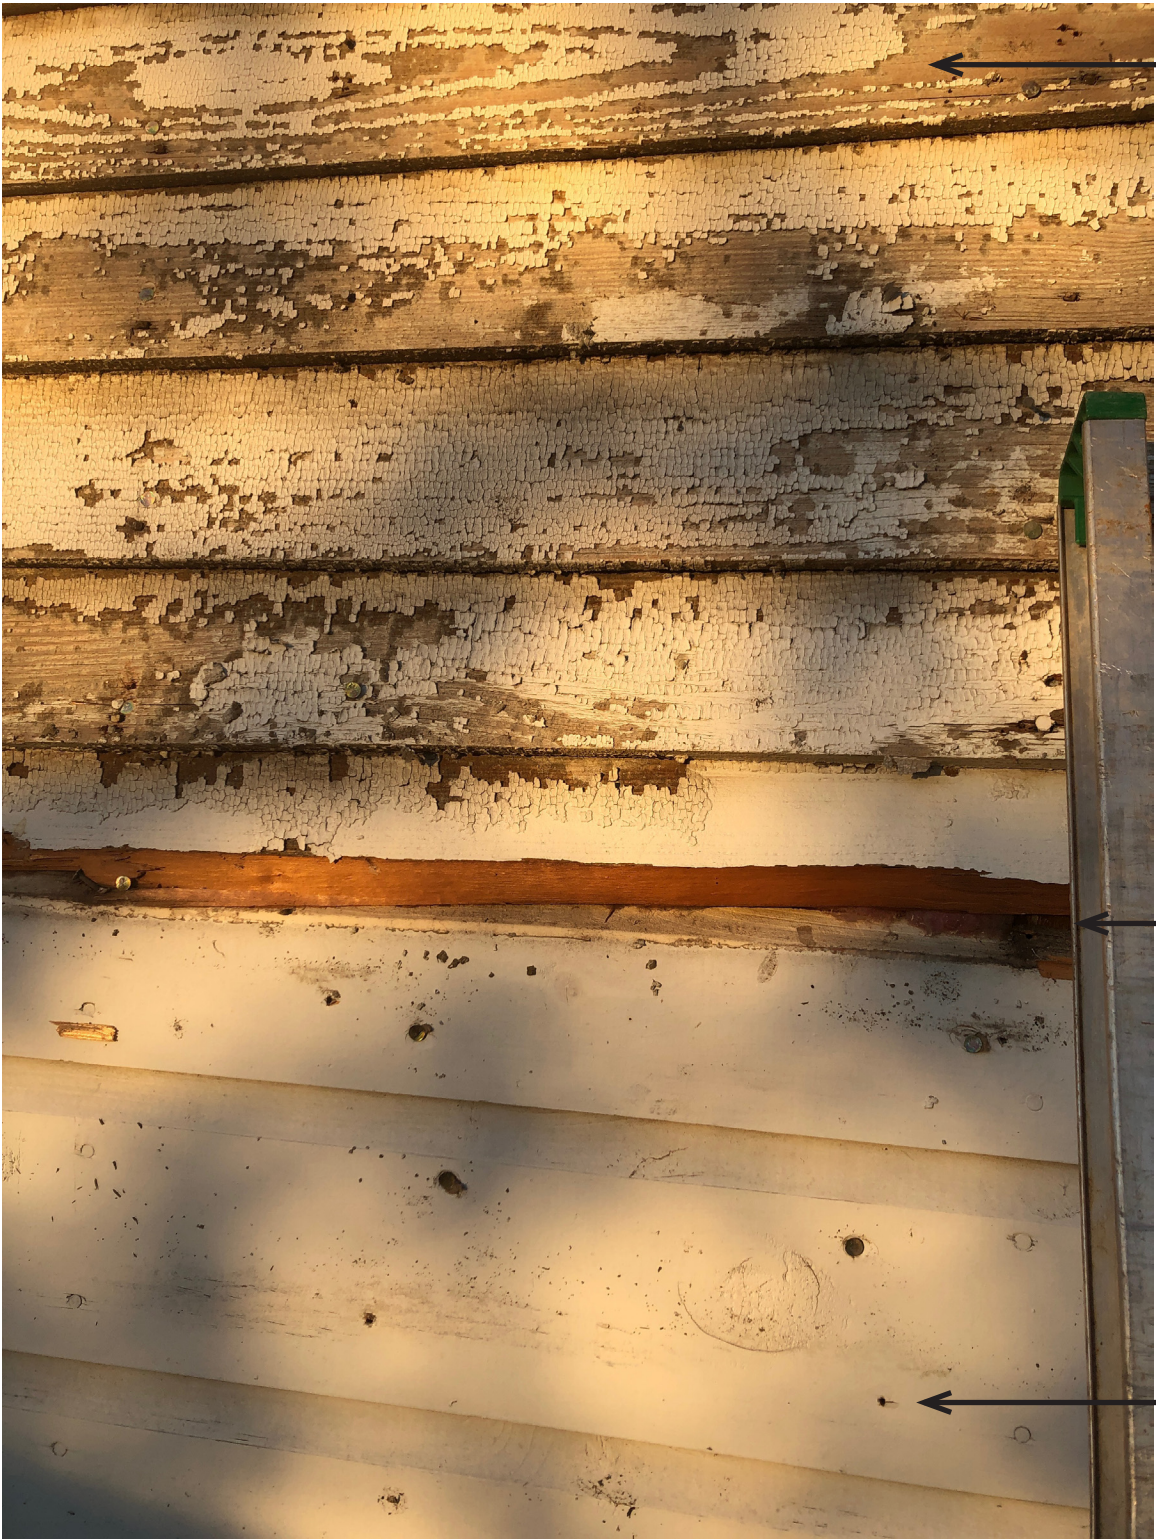
Original siding

Siding transition

Non-original siding

New framing at corners

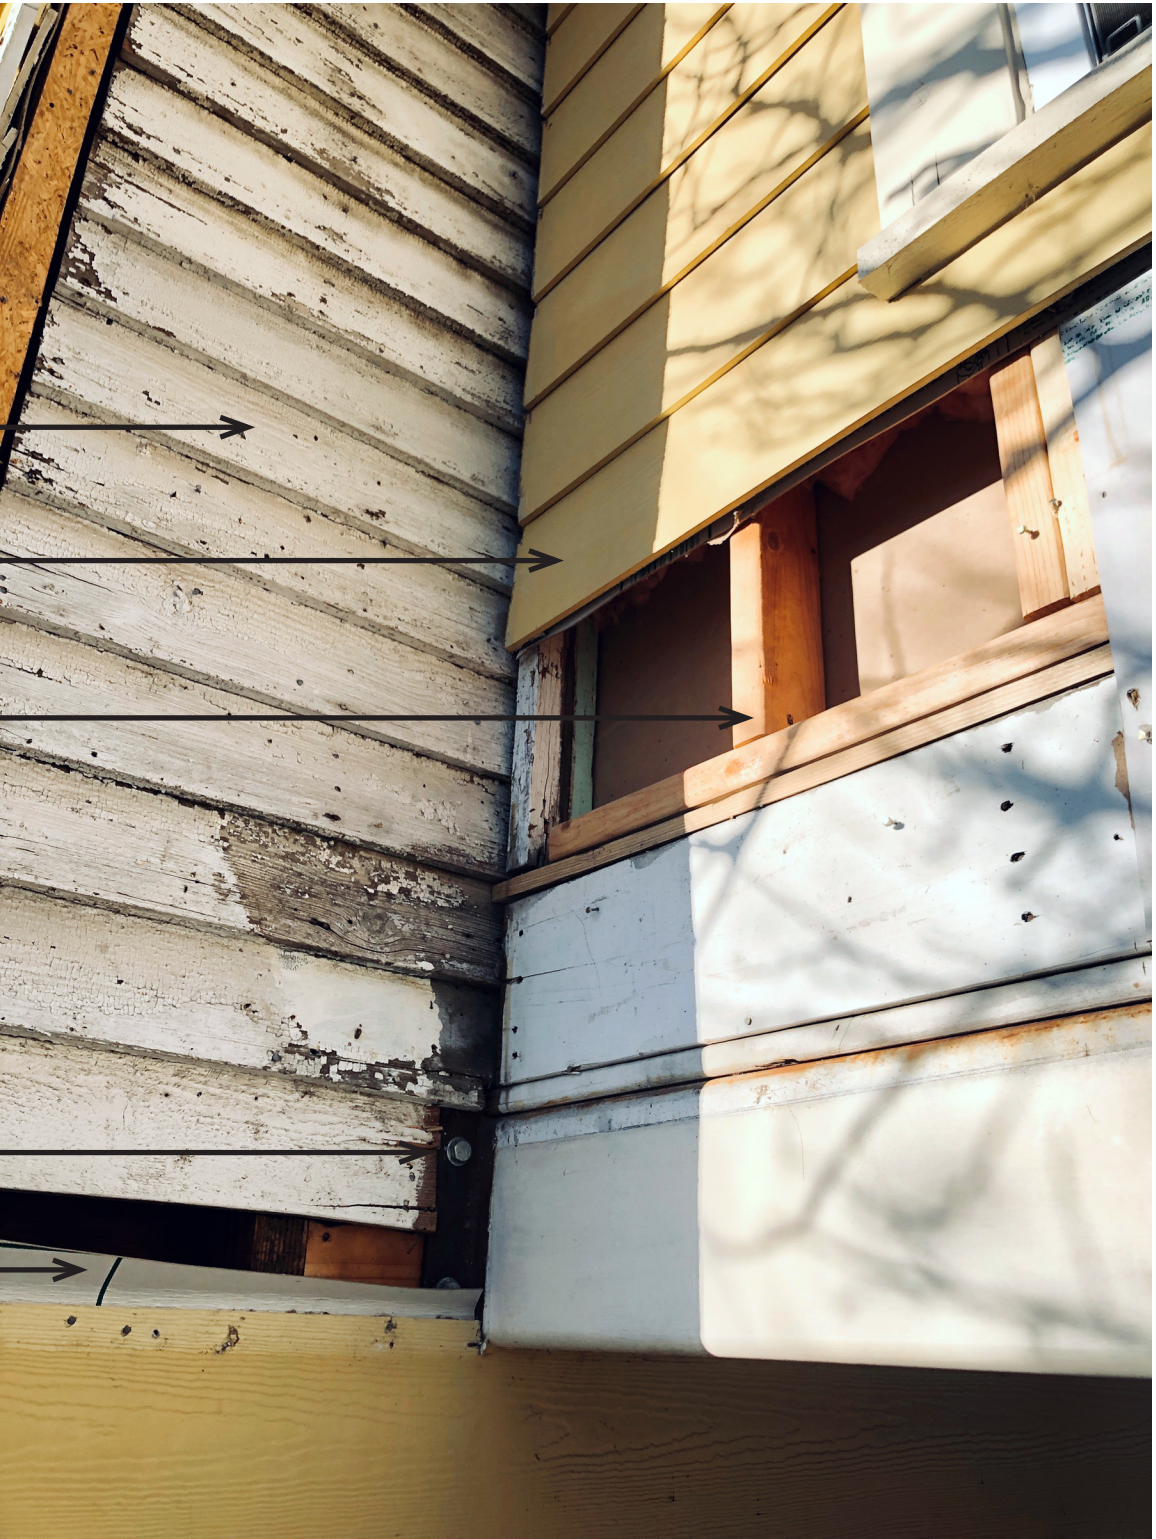
Original siding

New fiber cement board

New steel framing

Siding transition
