# D-2/2 LATE BACKUP

Subject: Tree Assessment

Address: 1711 Waterston Ave  
Austin, TX 78703

Assessor: James Burtchell  
ISA Certified Arborist, TX-3593A  
ISA Texas Oak Wilt Qualified, TXOWQ-134  
ISA Qualified Tree Risk Assessor

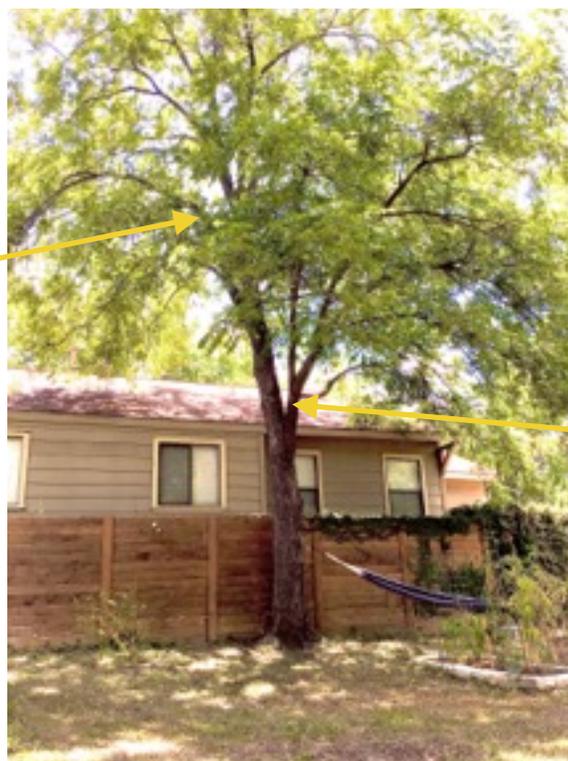
Branch  
Removal

If the 2nd story addition concept is chosen, a large percentage of the canopy will require pruning to accommodate the new structure. As a rule-of-thumb, it is recommended to not remove more than 25% of live foliage from a tree, in a single pruning session. Excessive pruning can stress a tree and cause a tree to decline. Once a tree becomes stressed, it is susceptible to further secondary stressors such as pest and disease. Compounding stressors have the ability to severely impact a tree and threaten the overall health, integrity and mortality of a tree. With regards to the required pruning for a 2nd-story build concept, I recommend maintaining a low home elevation that will not require the tree to be severely pruned.

Any build concept to reduce the amount of impervious cover of the critical root zone is also recommended, as impervious materials and grade changes have the ability to suffocate underlying roots. Practices such as cantilevers and pier-and-beam foundations have less intrusive impacts within the critical root zone and reduce the overall percentage of impervious cover. Excavating with a Airspade tool within the critical root zone will also help to preserve roots and allow building practices that will cause less impacts to the roots and tree. Design the footprint of the new foundation to stay as far out of the critical root zone as able.

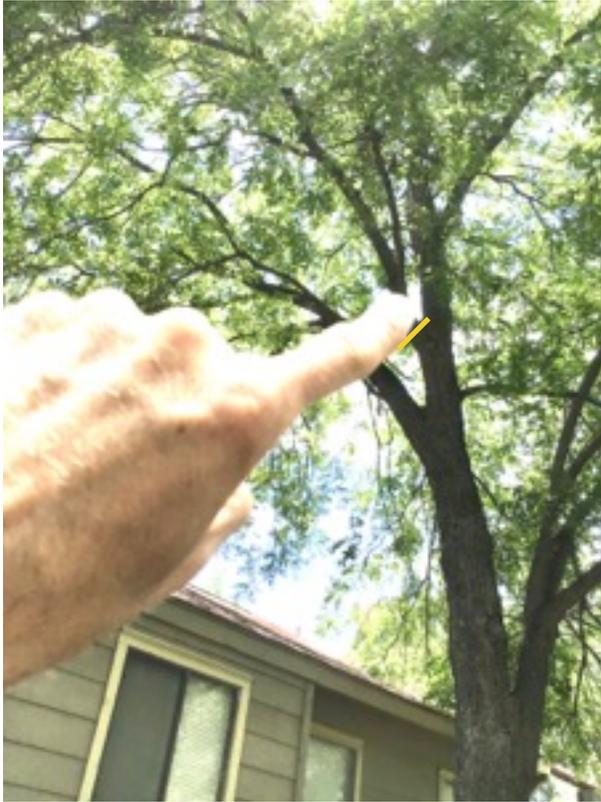
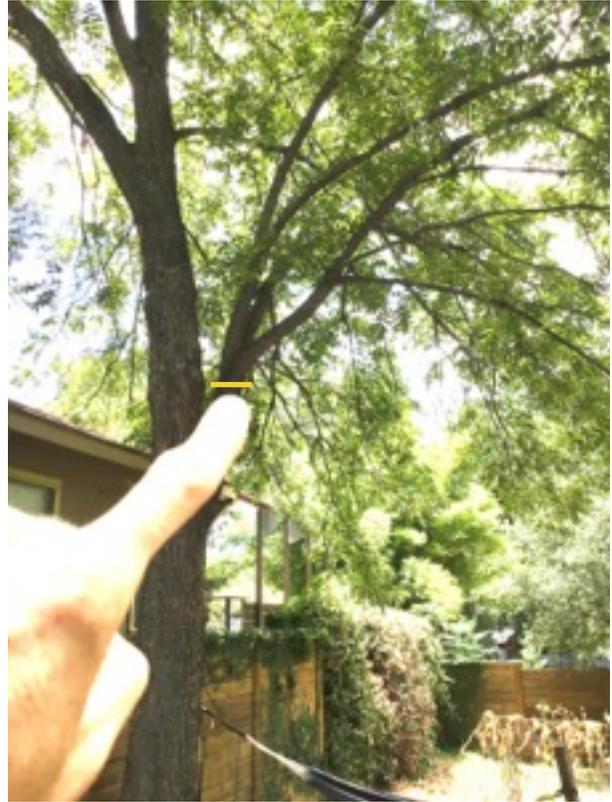
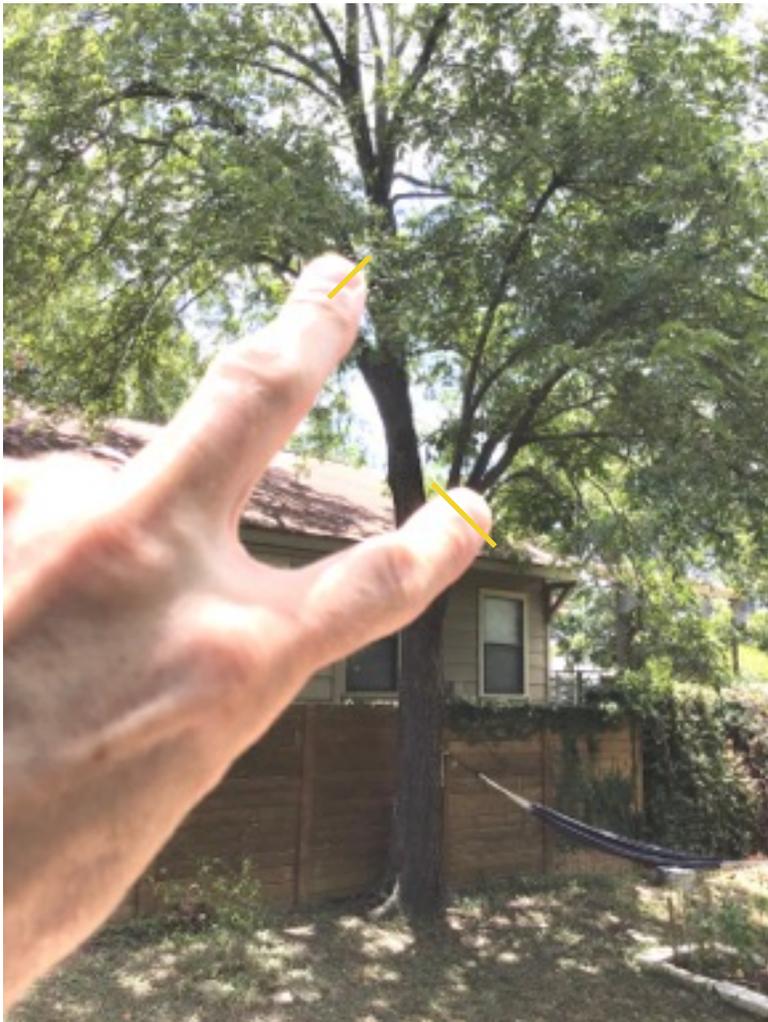
Pecan tree with  
required pruning cuts  
for clearance

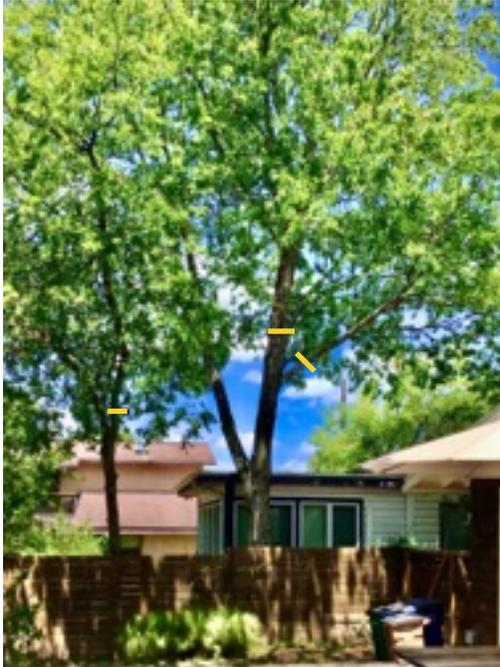
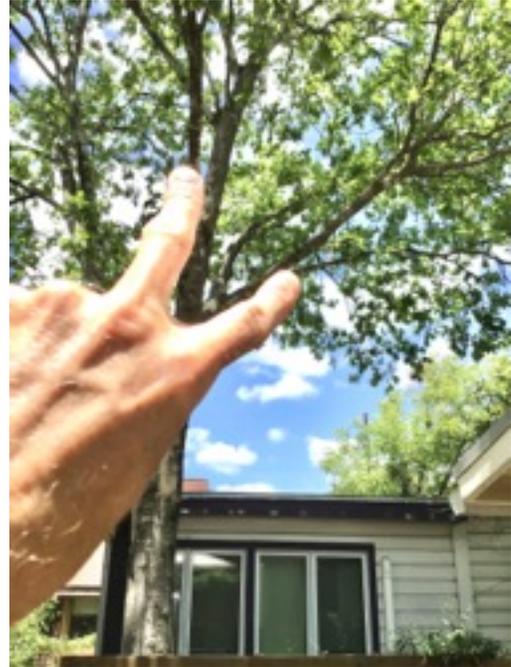
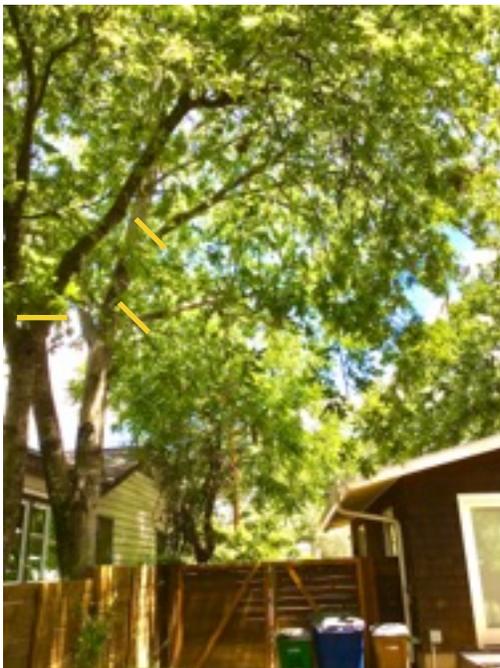
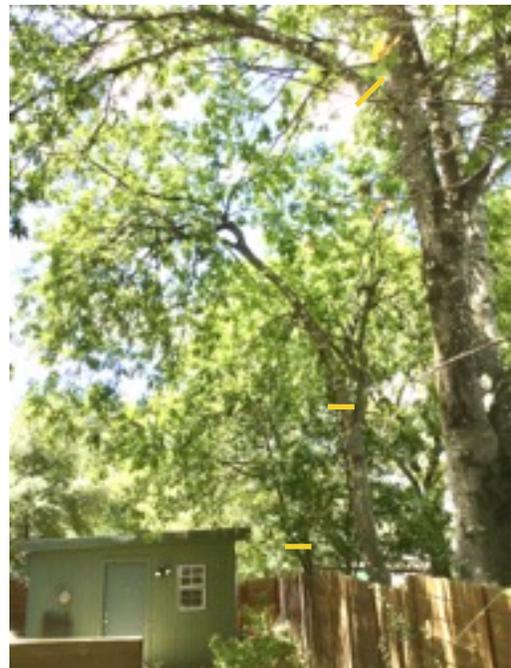
There are neighbor's Hackberry trees that hang over the back right corner of the existing home and over the right side of the detached structure in the back yard. If the 2-story addition concept is chosen, the trees will require substantial pruning to accommodate the new structure. As notated with the Pecan tree, excessive pruning can cause stress on a tree, impacting the overall health and vigor. Pruning to accommodate the structure can also imbalance the canopies, which could affect the tree's structural integrity. I recommend the single-story build concept to maintain the health, structure and aesthetic integrity of the neighbor's Hackberry trees and other shrubs along the fence-line.
