6414 N Lamar, Austin TX

THREADGILL'S
NORTH

6414 N. LAMAR BLVD.
AUSTIN, TX 78752

THREADGILL'S NORTH
OVERALL
FLOOR PLAN

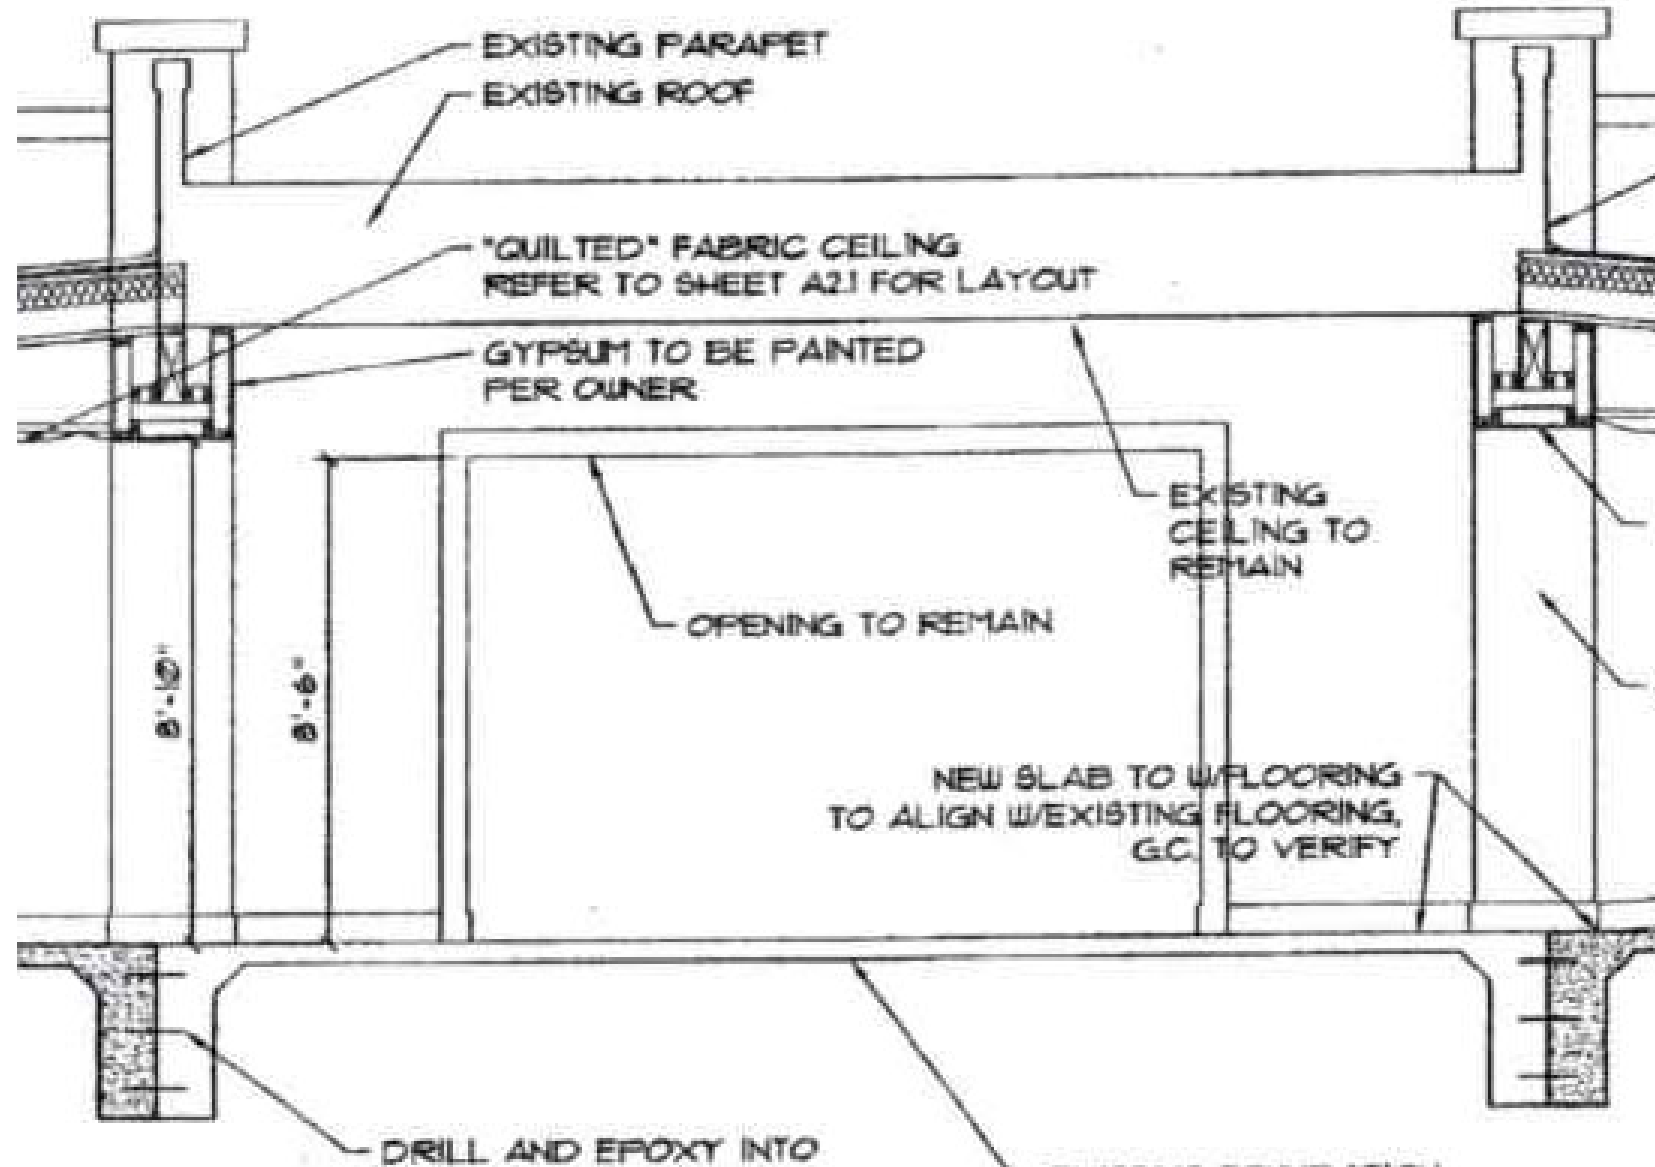
I BUILDING SECTION
 SCALE: 1/4" = 1'-0"

Section through the original open front element
Amended to receive additions in 2006 and 2007

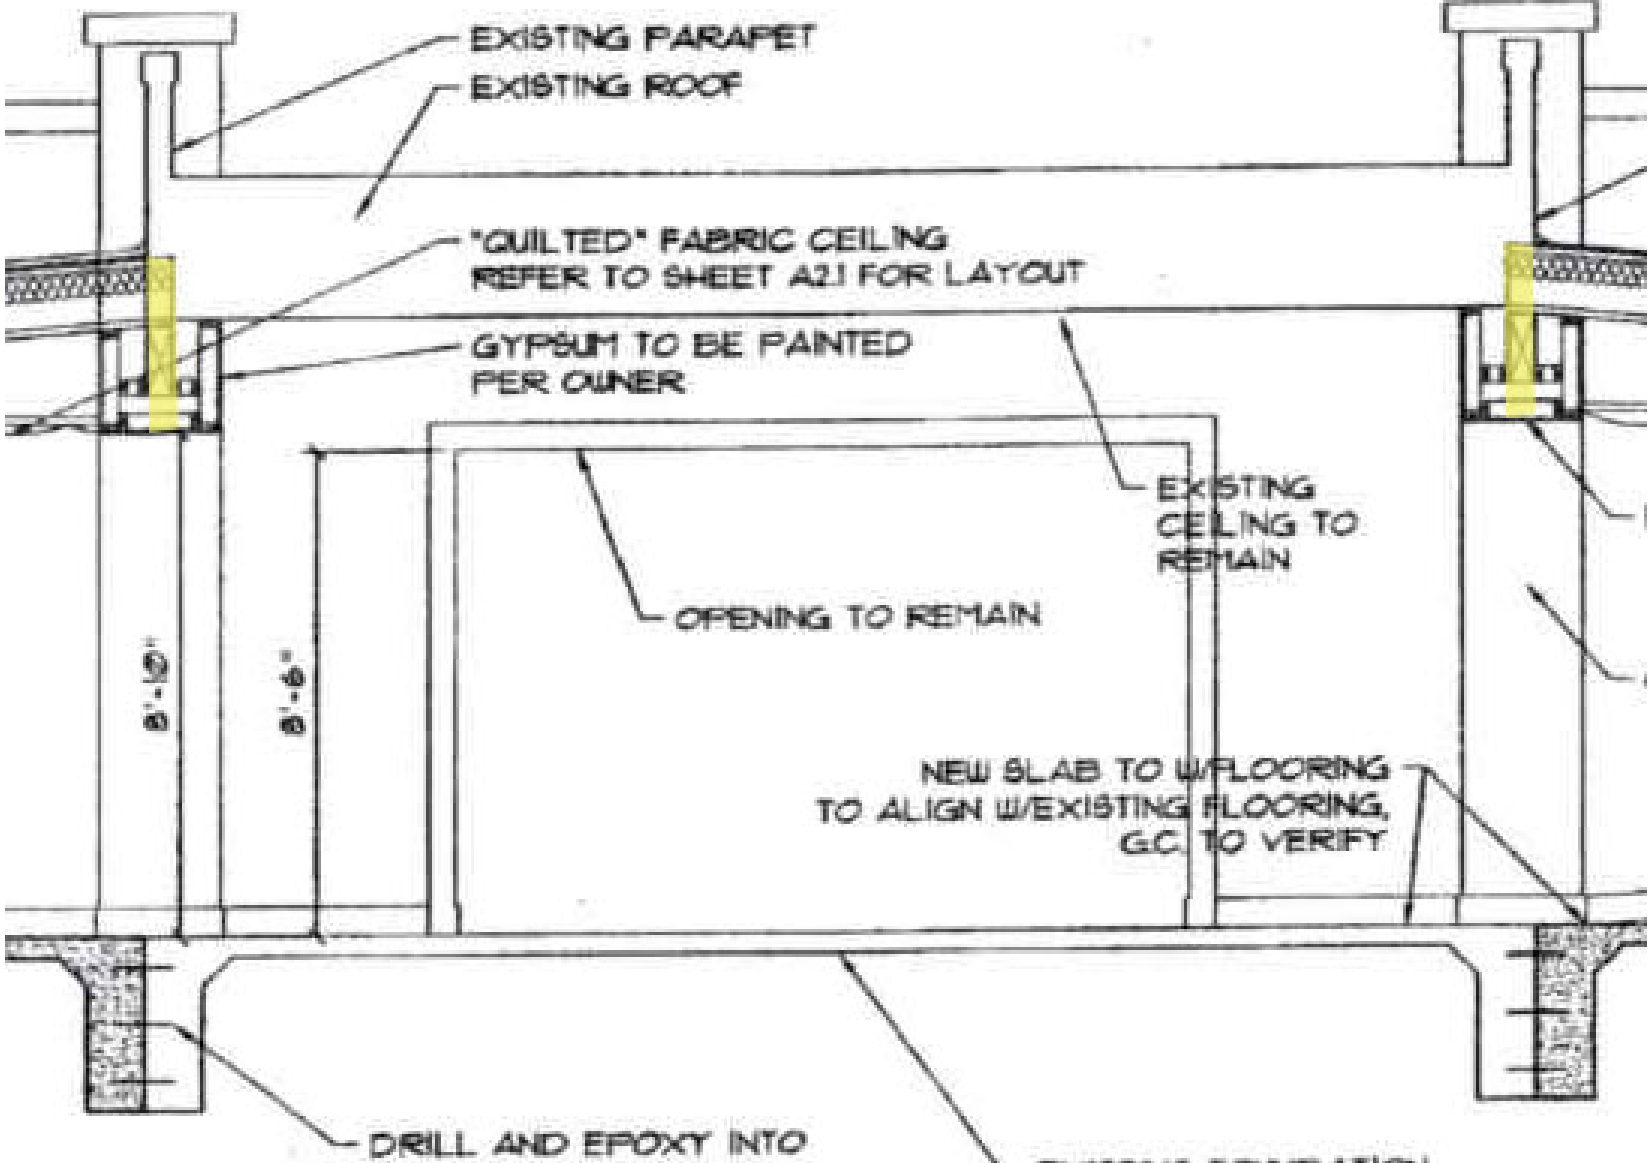
2006 and 2007 Renovations involved removing the yellow portions of the exterior walls

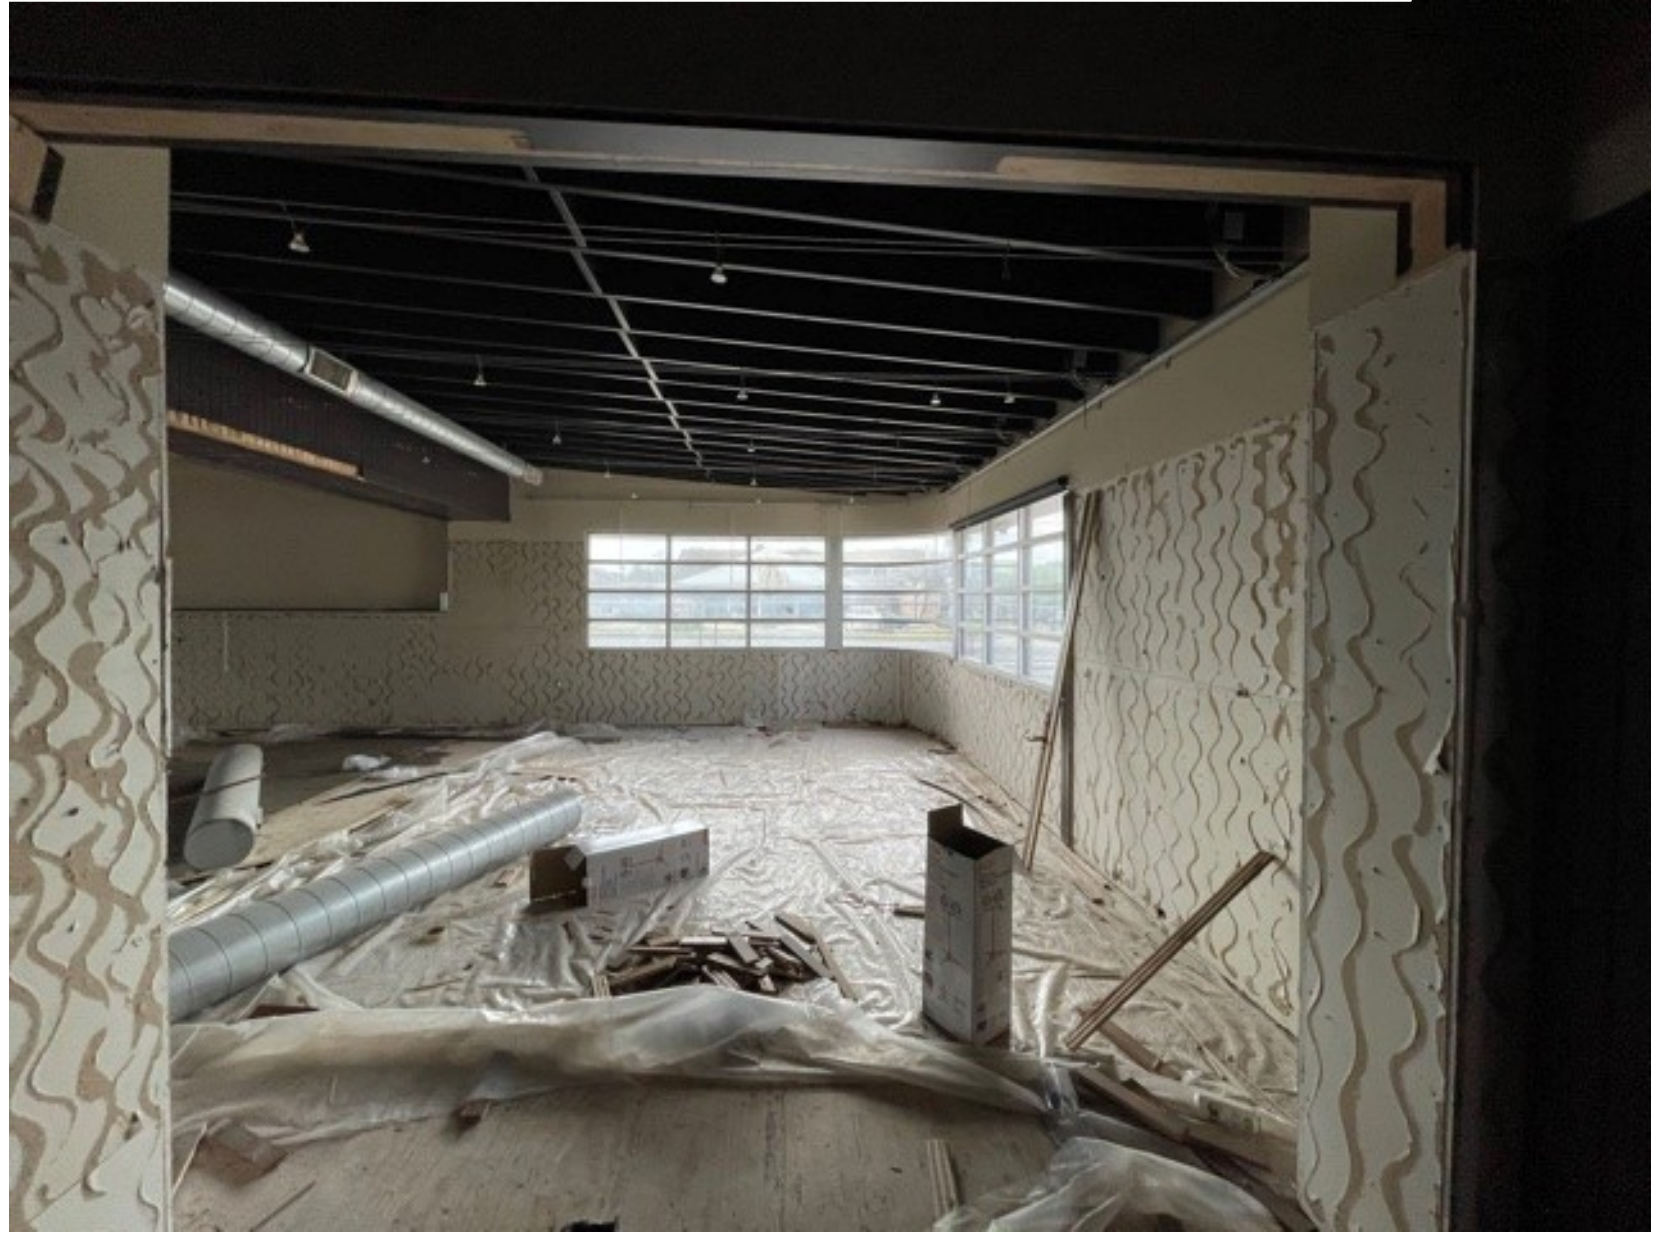
Interior photos of existing condition showing ceilings, floors, stage, booths, walls, and all significant items related to the former use having been removed by the former owner

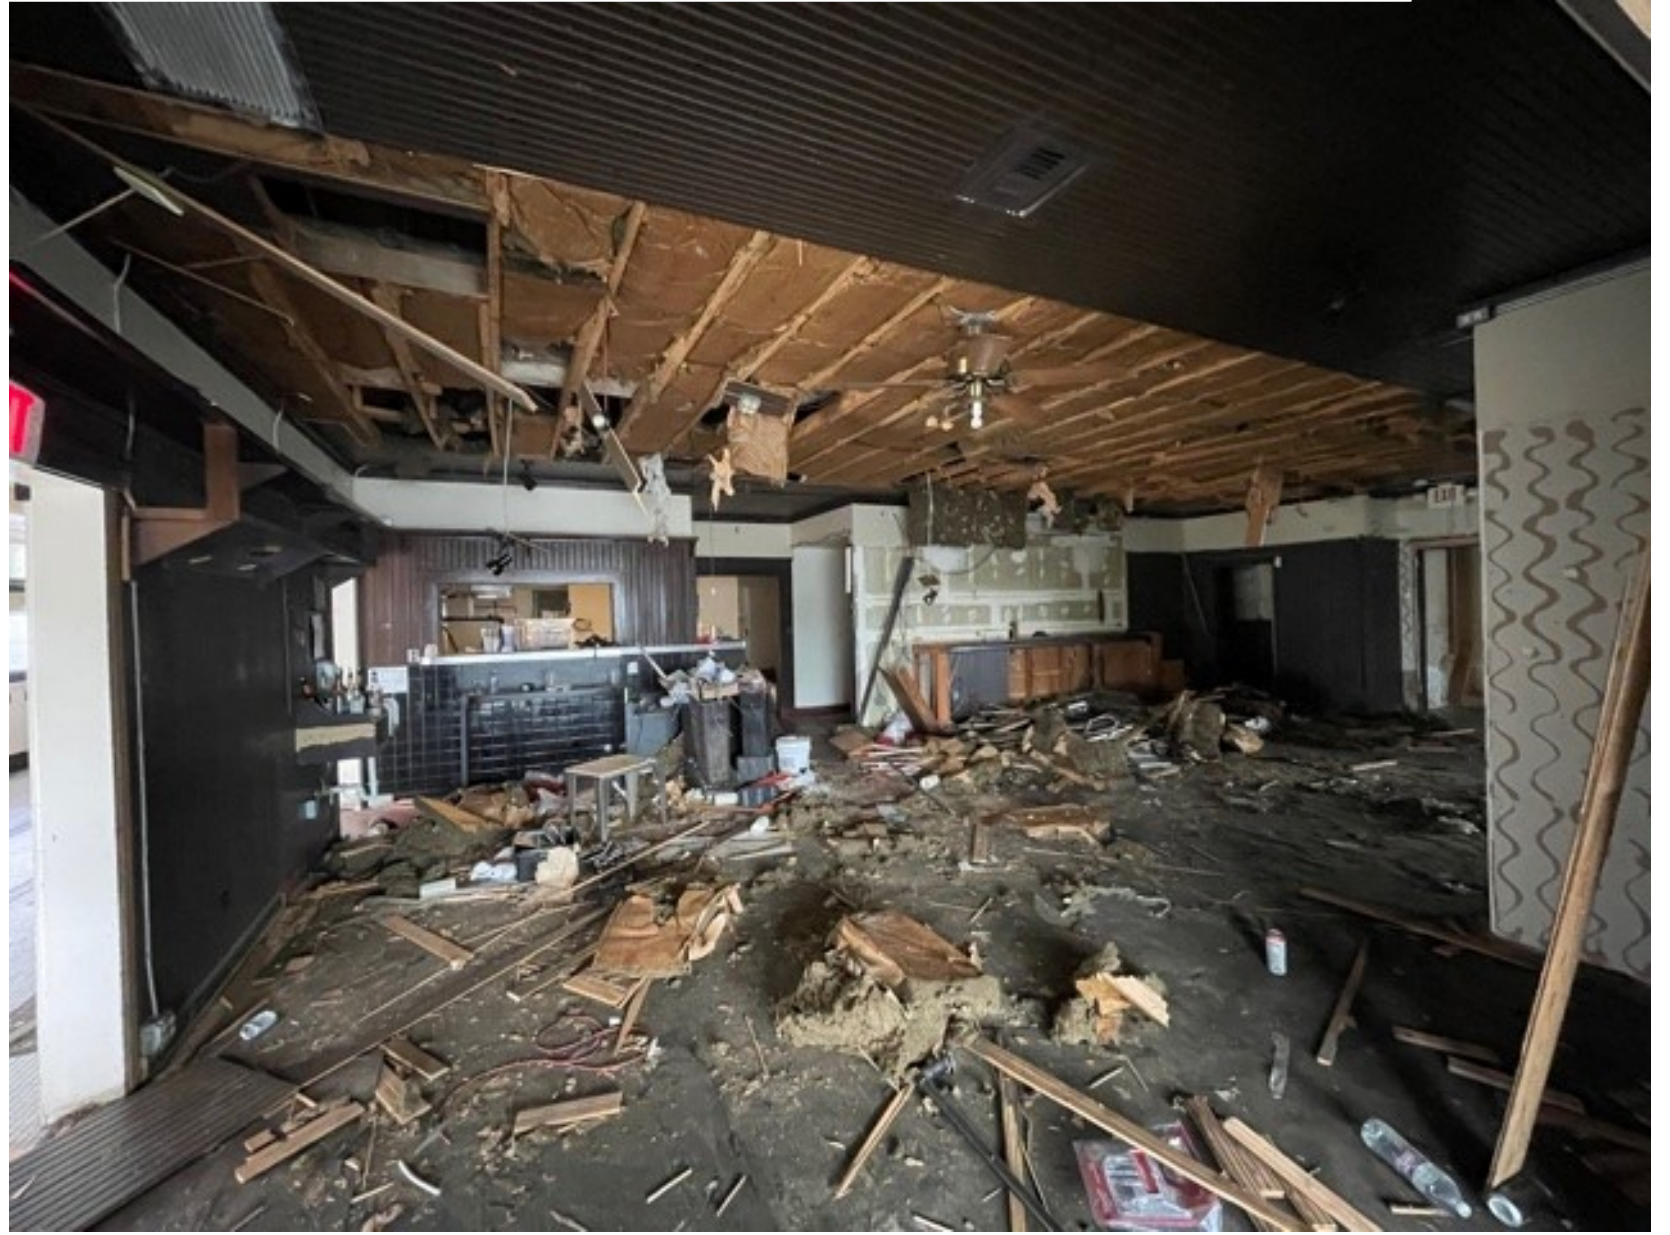
Interior photos of existing condition showing ceilings, floors, stage, booths, walls, and all significant items related to the former use having been removed by the former owner

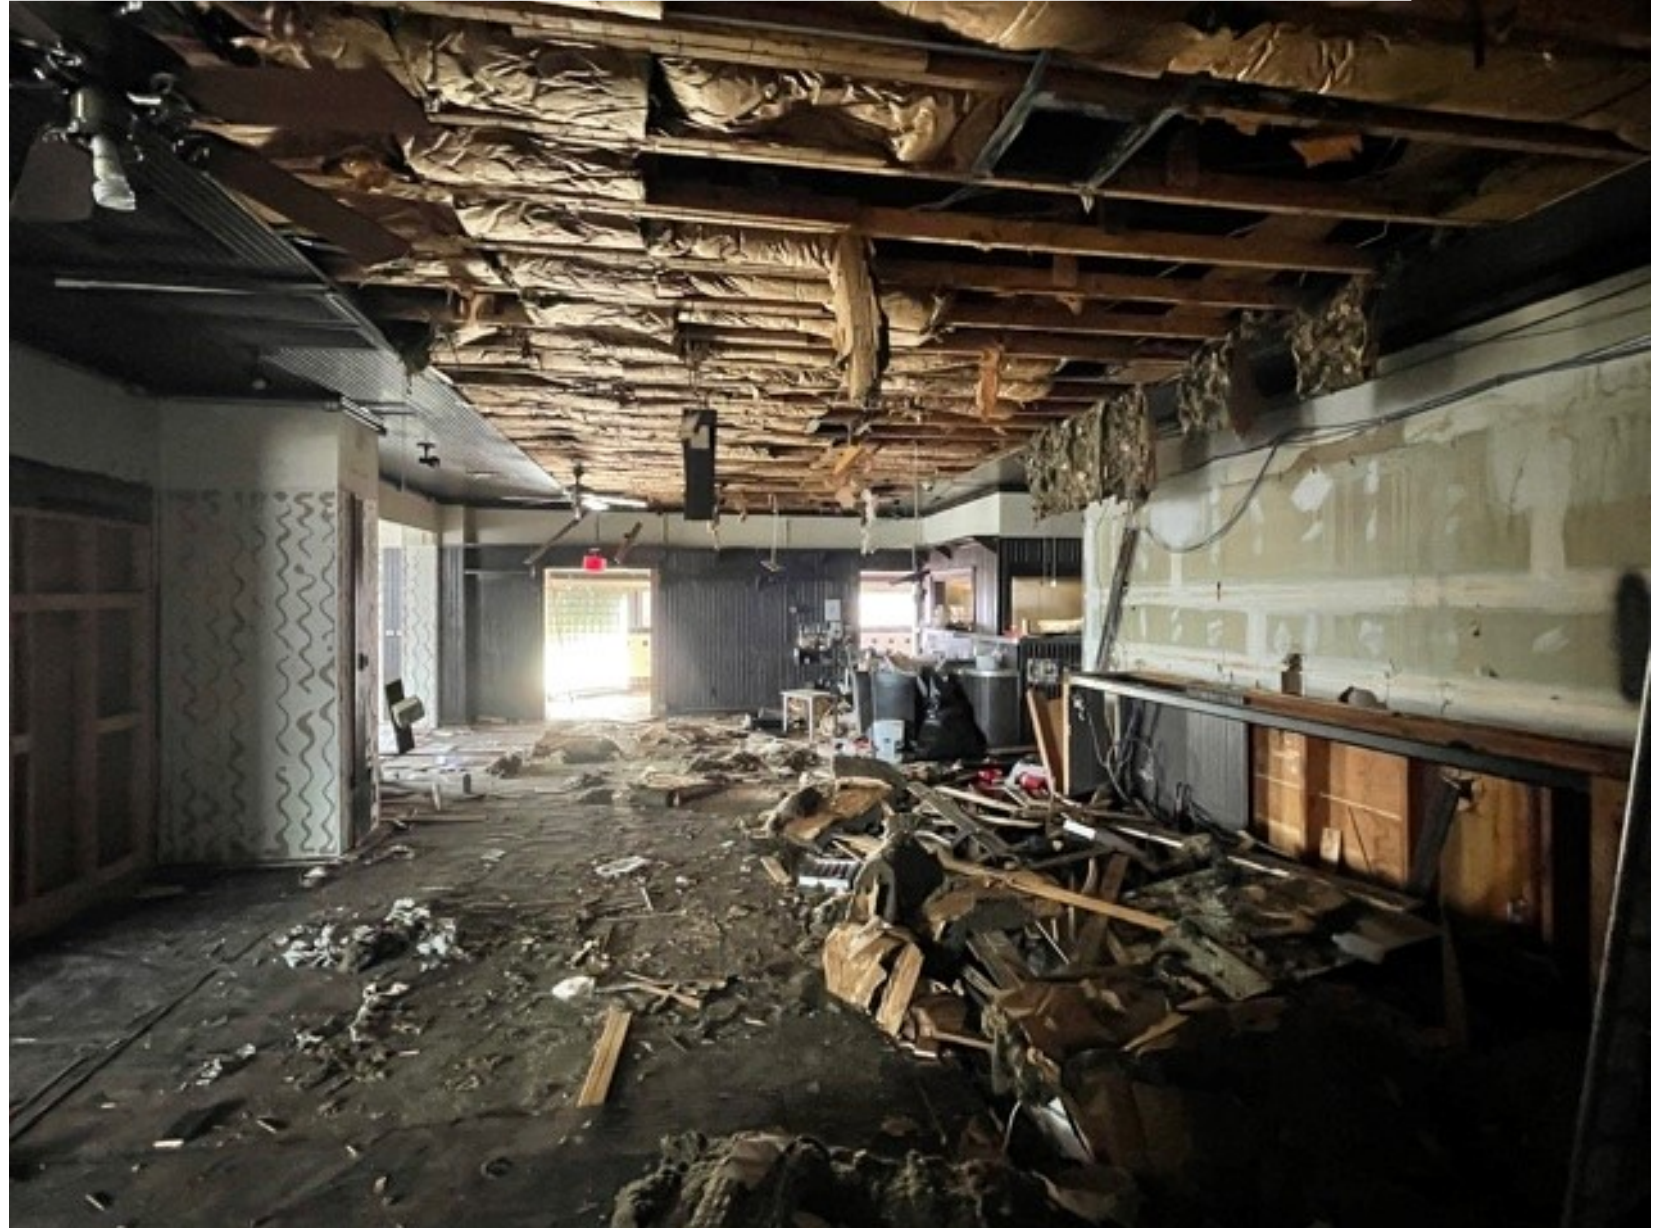
Interior photos of existing condition showing ceilings, floors, stage, booths, walls, and all significant items related to the former use having been removed by the former owner

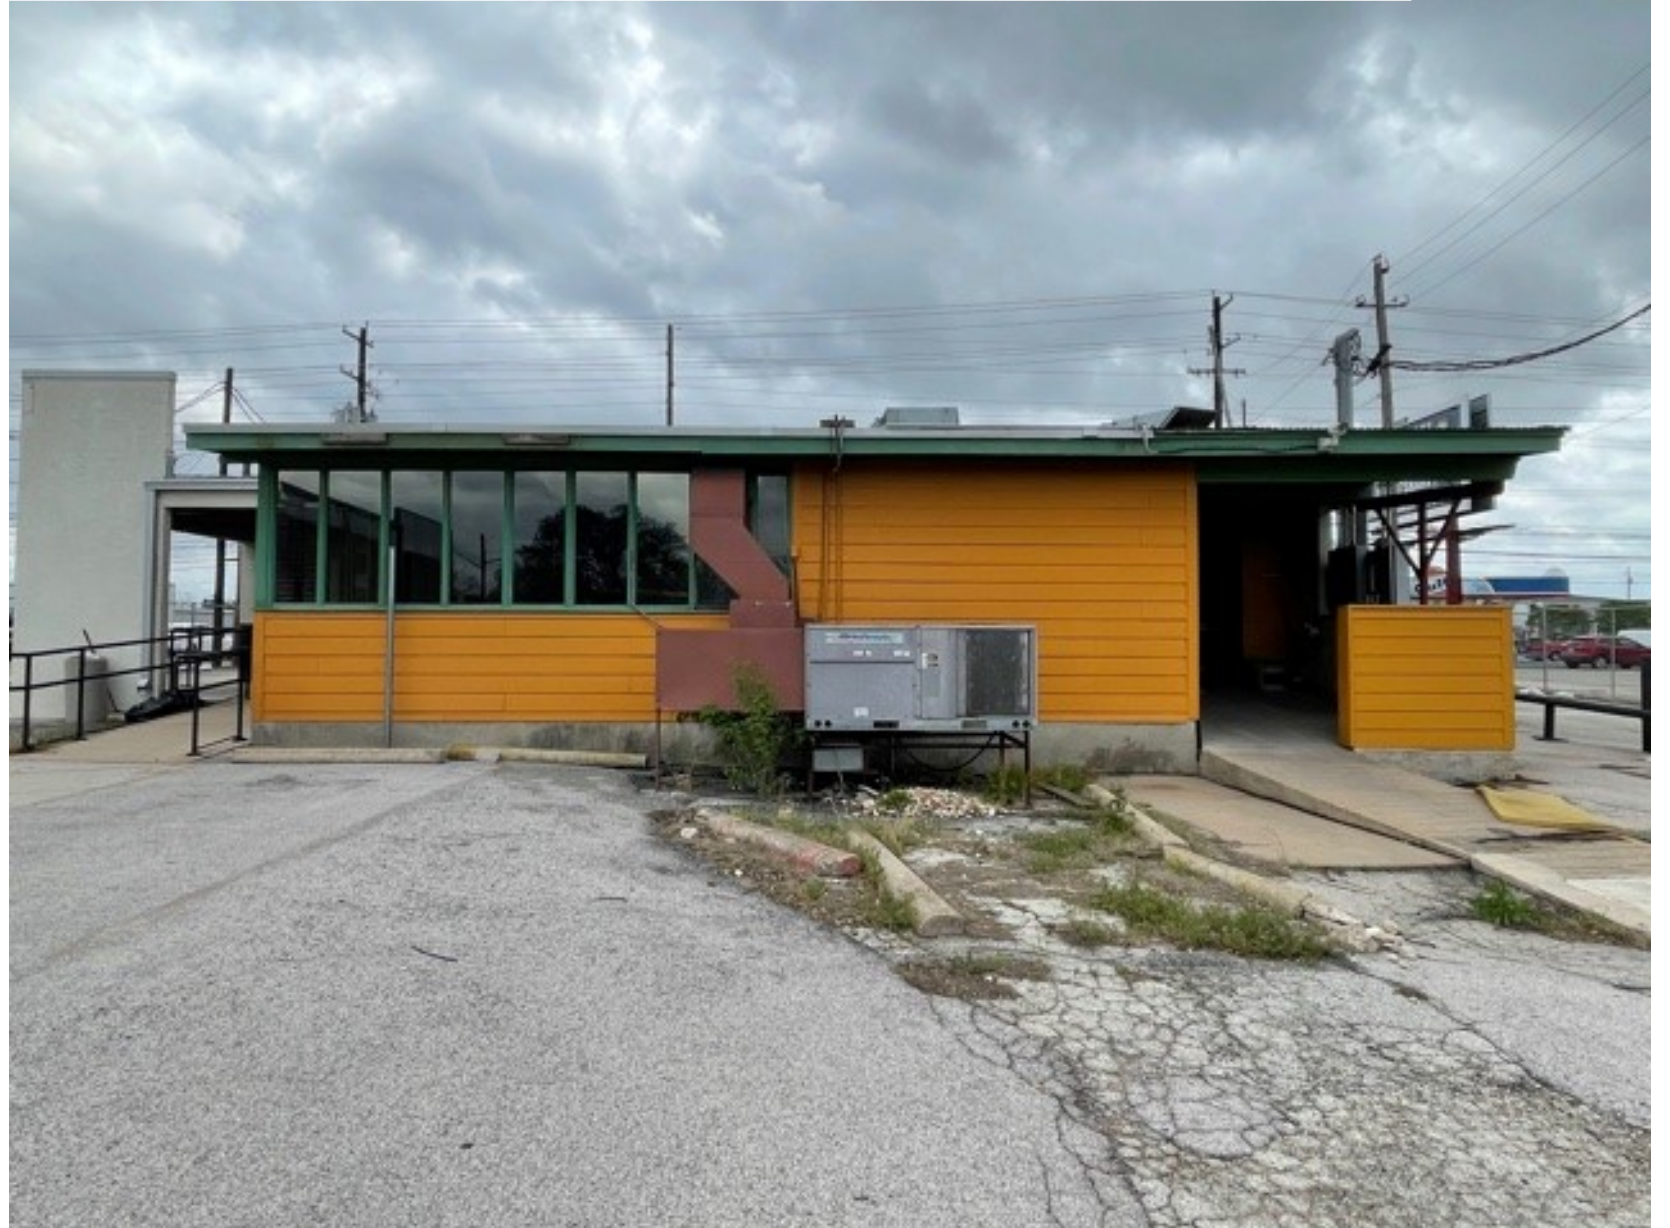
Exterior photo of rear of building in its current state. The additions shown mostly replaced the existing building in previous renovations

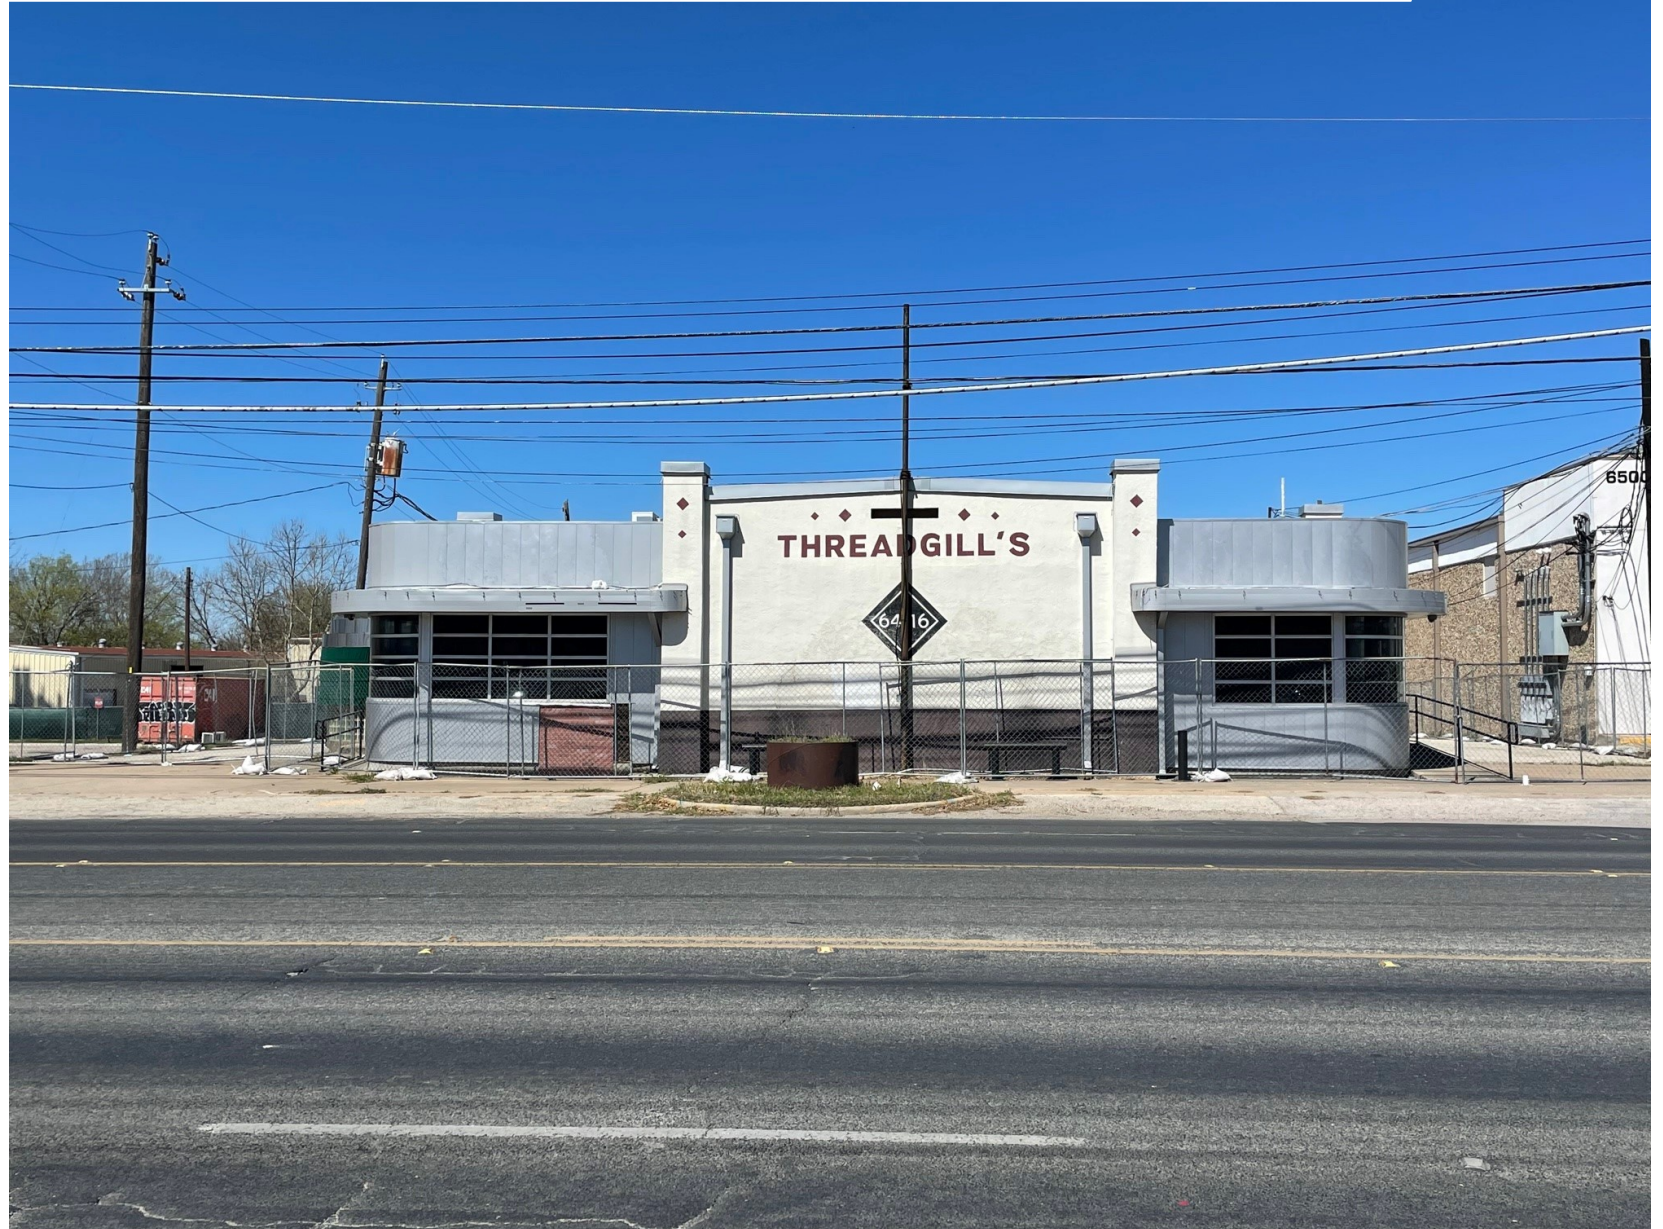
Exterior photo of front of building in its current state. The additions shown to each side of the original open element were added in 2007 having done significant damage to the original structure beyond. The front wall of the open porch was filled in at some unknown date.

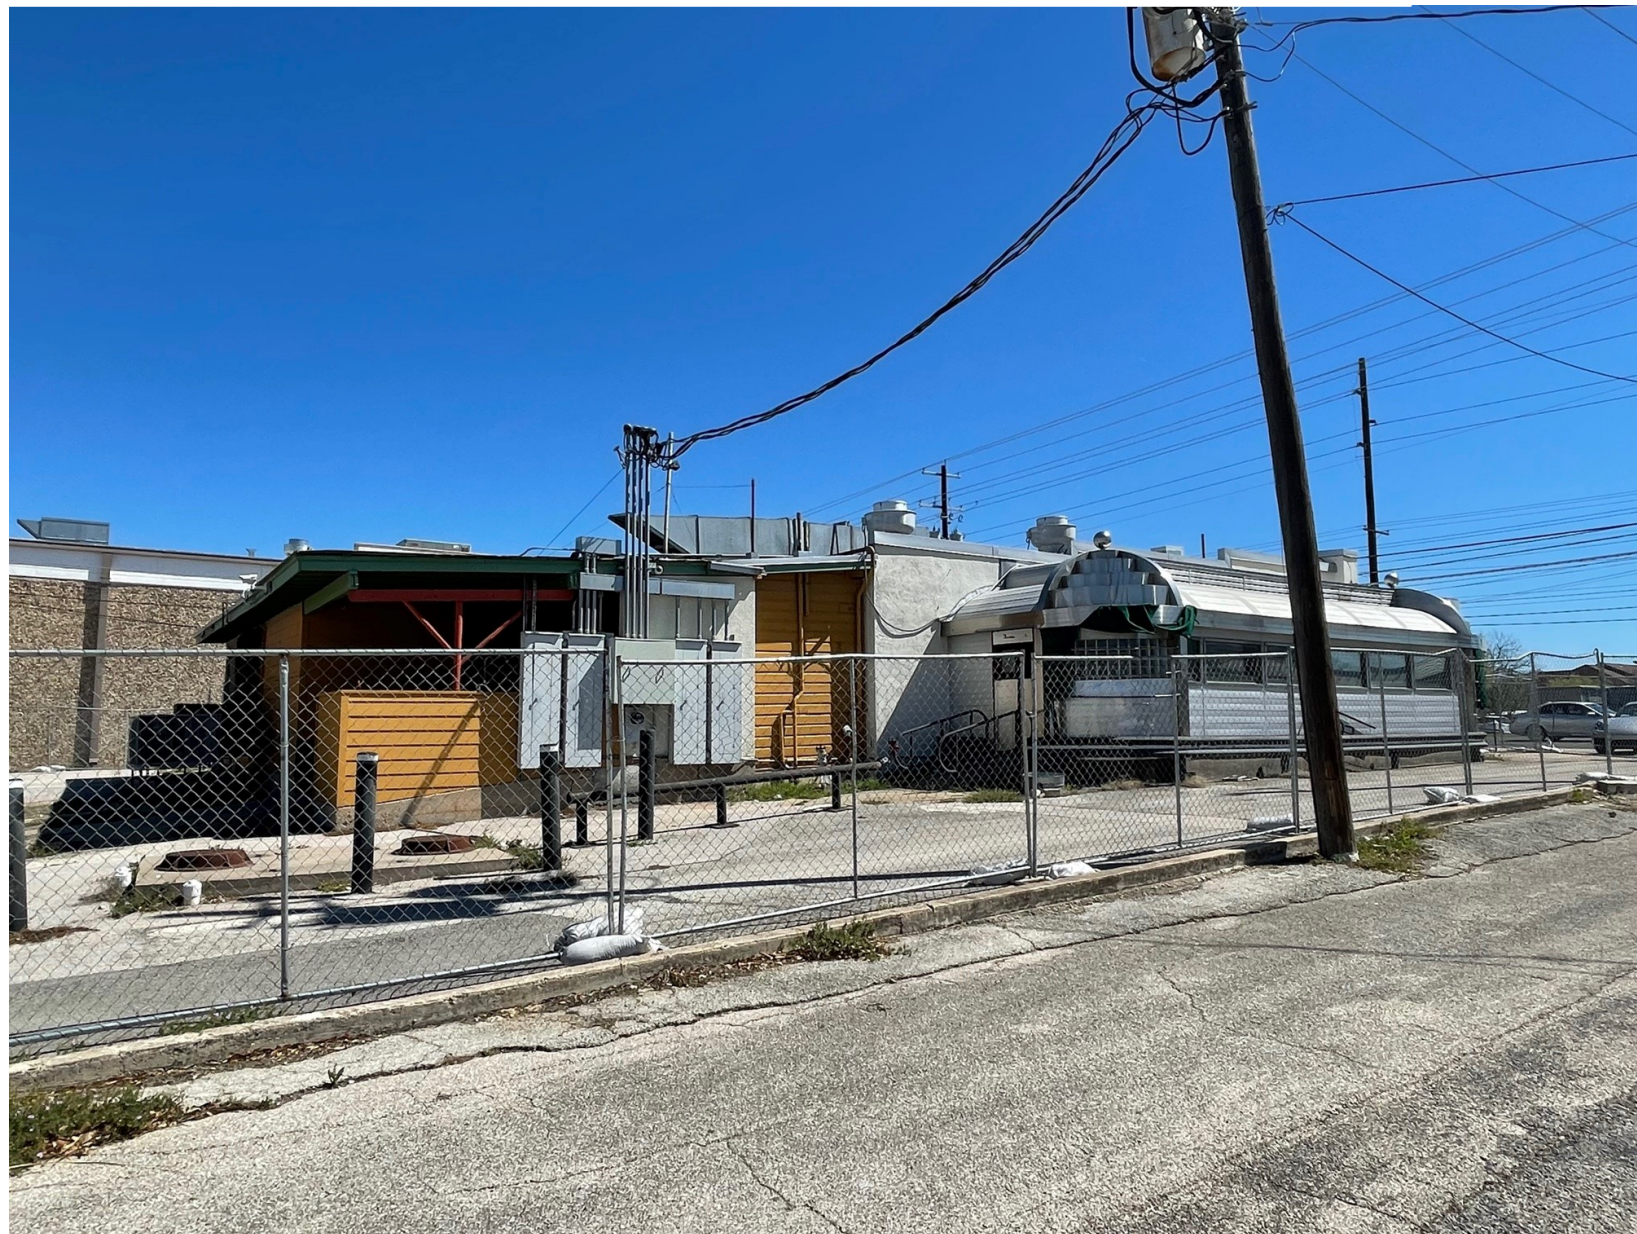
Exterior photo of south side of building in its current state. Various relatively recent additions have obscured or in large parts removed the original structure.
