Appeal Regarding the Urban Forester's decision on the removal of a Cottonwood tree

20" Tree Located in the Right of Way on Crown
Ct, Austin TX

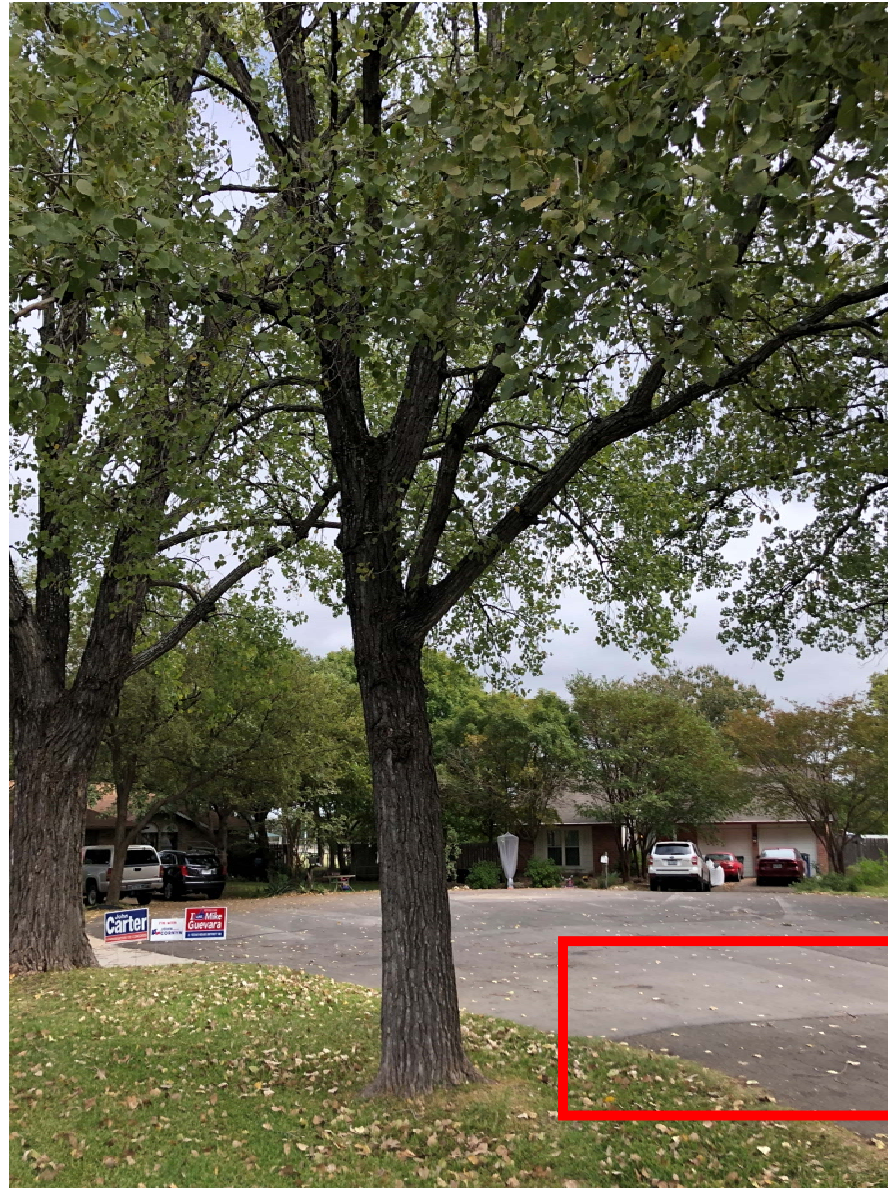
**Street cuts at
base of tree**

20" Cottonwood Tree and Water Main

- Base of tree is within inches of the street pavement.
- Street cuts from water main repairs are at the tree.
- Street cuts directly adjacent to this tree indicate that this tree is at least responsible for some of the damage to the water mains.

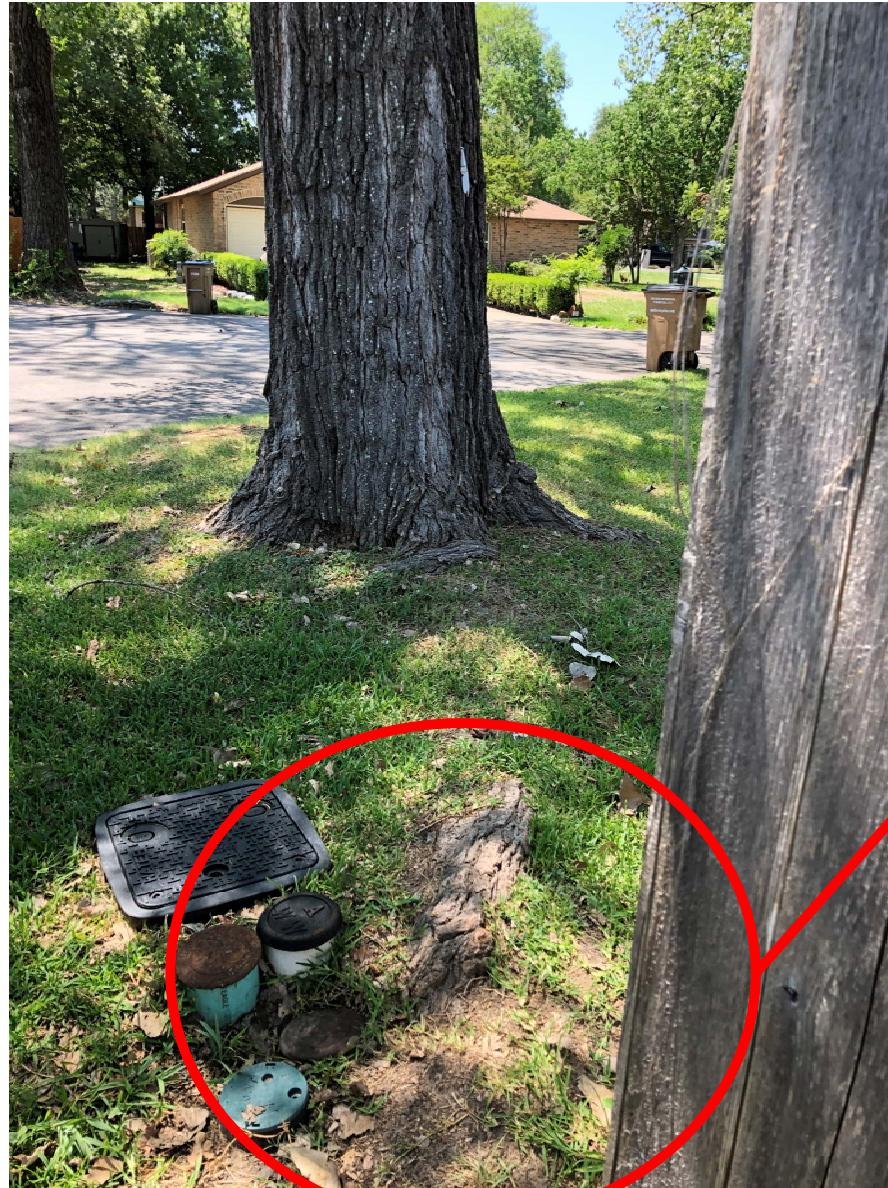
34" Tree – roots visibly bending water valves on the surface. Urban Forester refused to acknowledge this fact.

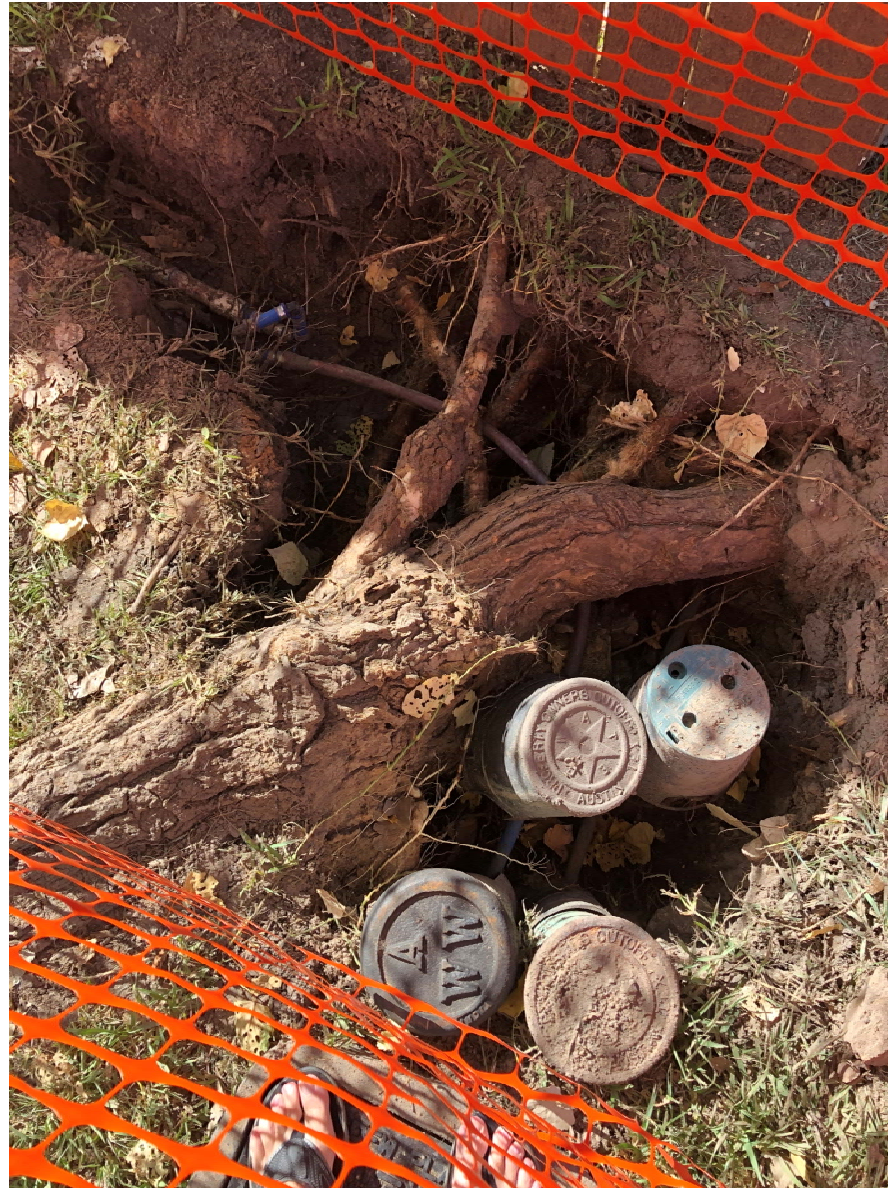
Root was excavated
by Austin Water –
Roots are clearly
destroying pipes.

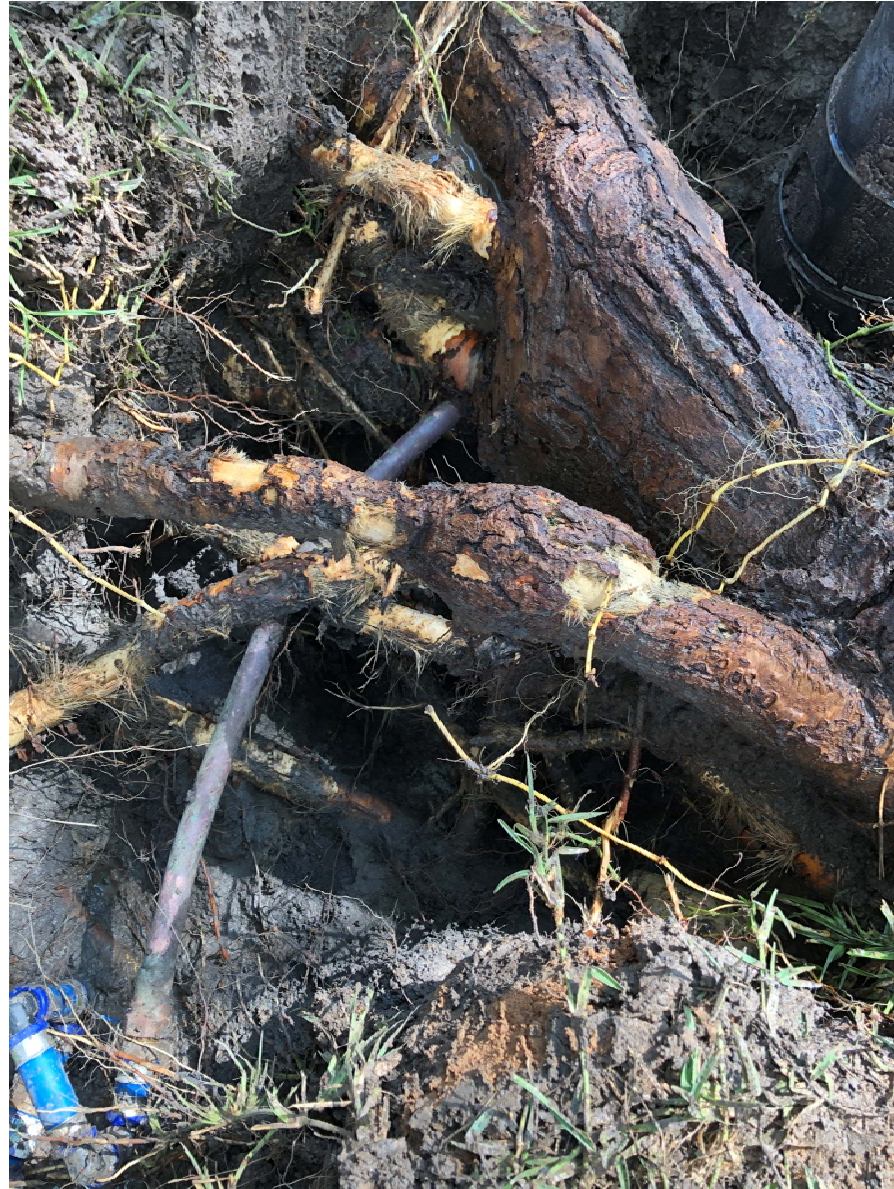
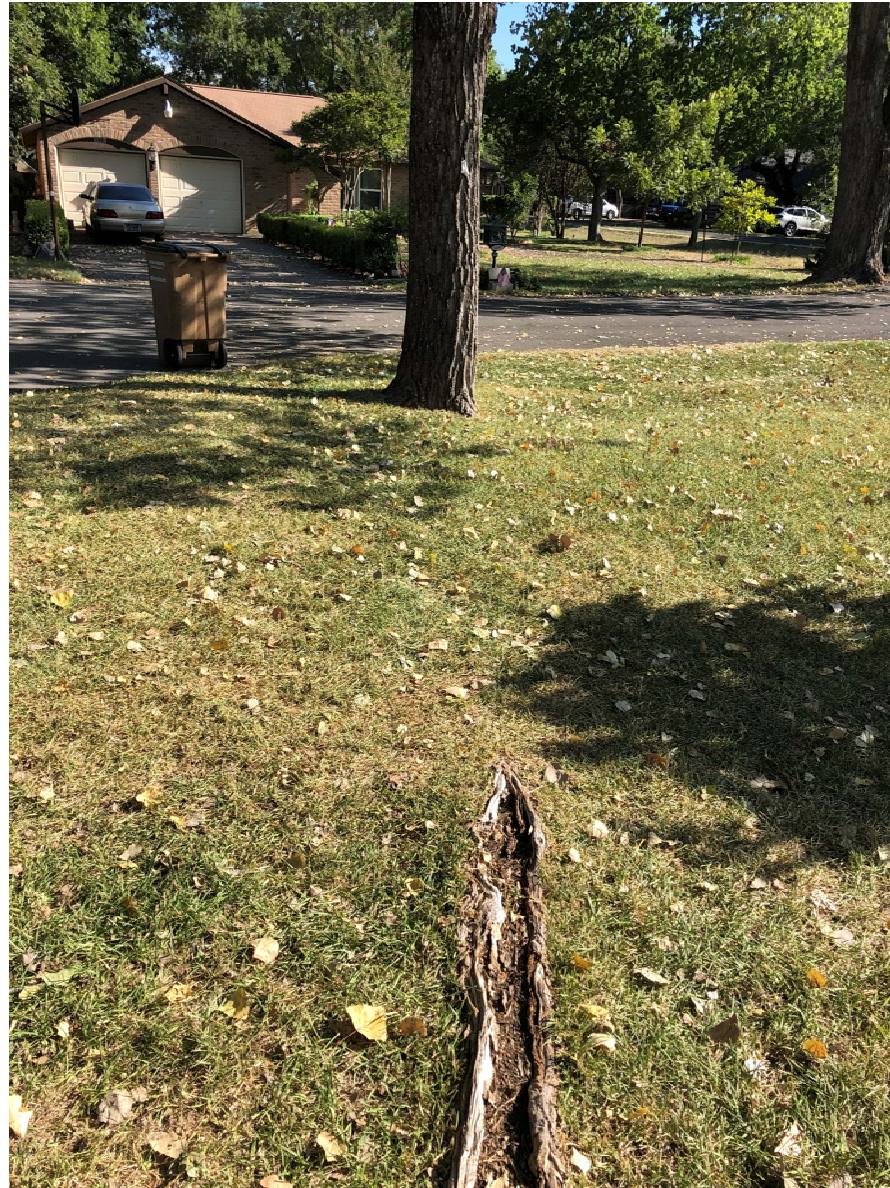
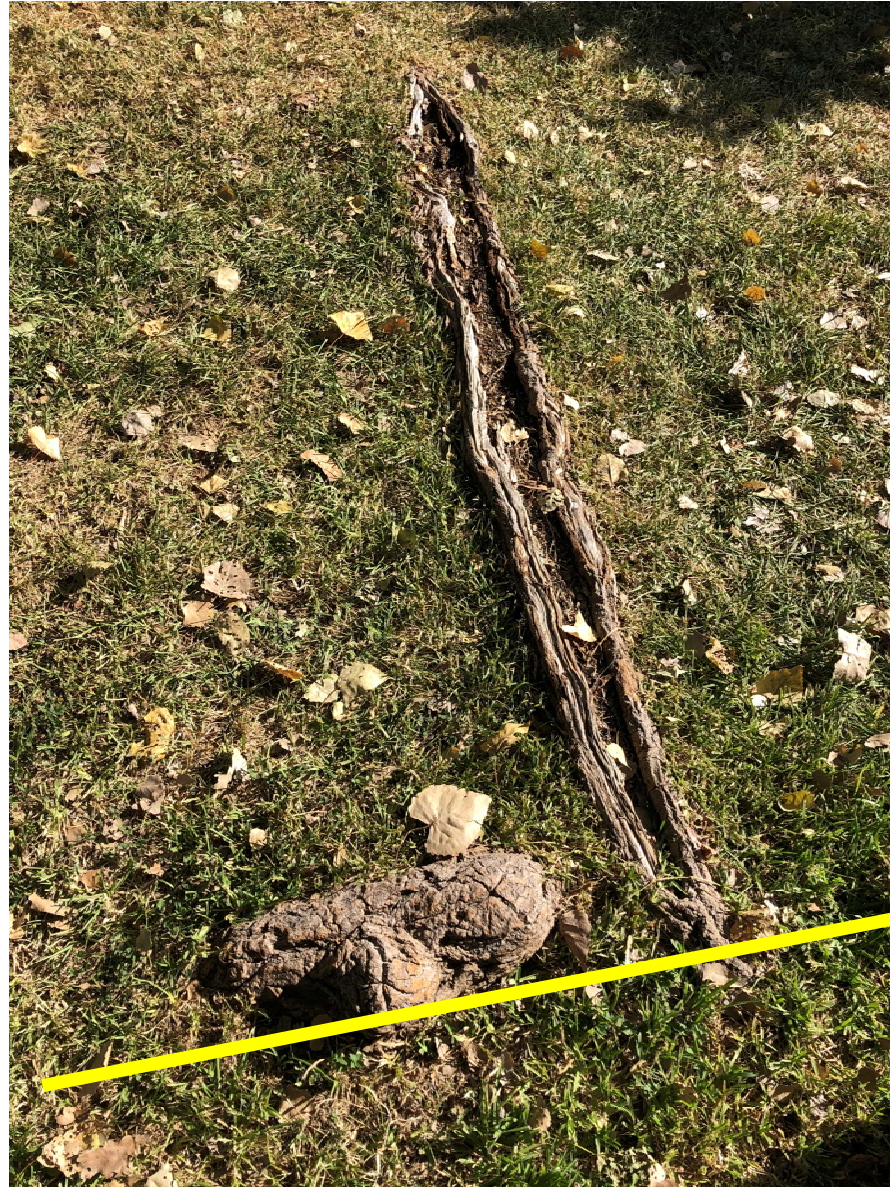
**Large root from 20''
Cottonwood tree over
my water main. Has
previously caused
damage to my pipes.
Yellow line indicates
approximate location of
water line.**

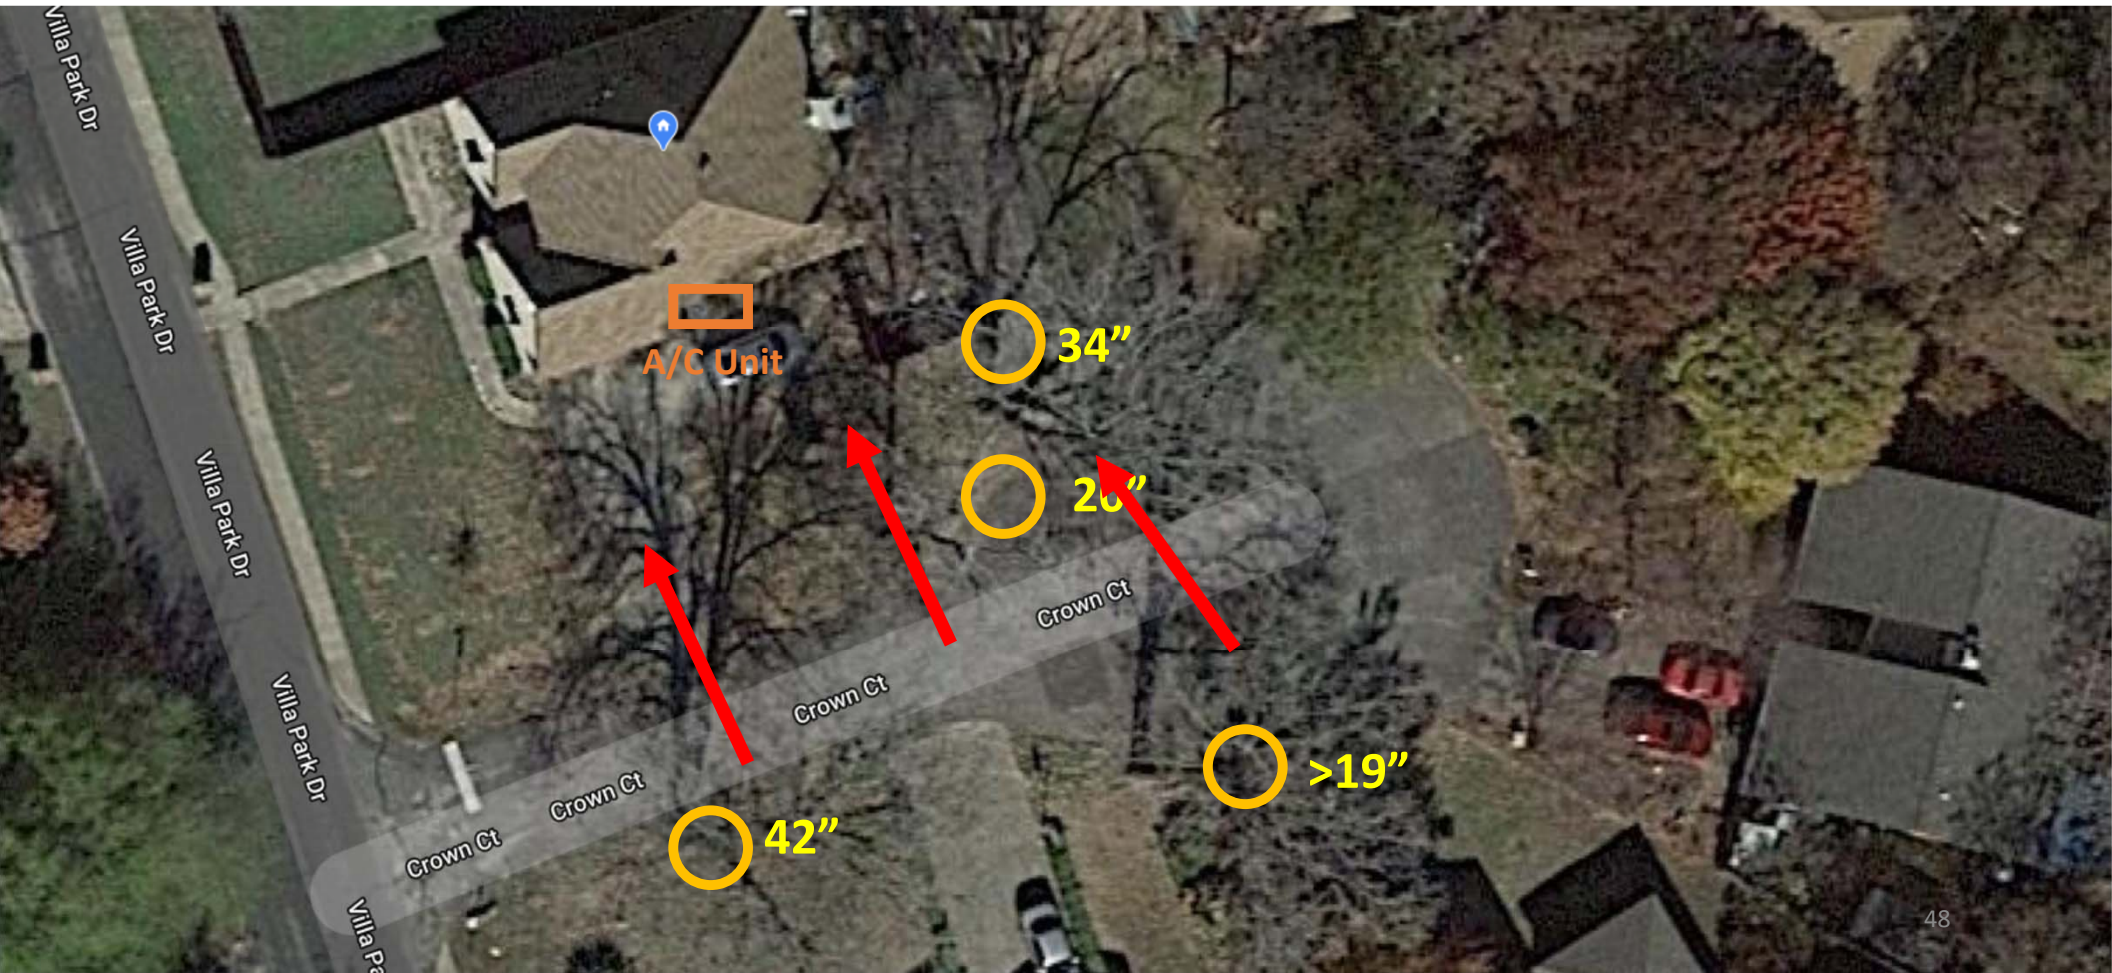
WIND DIRECTION

- The predominant average hourly wind direction at Austin-Bergstrom International Airport varies throughout the year.
- The wind is most often from the *south* for *10 months*, from *February 3* to *December 8*, with a peak percentage of *77%* on *July 13*.
- The Wind in Austin is predominantly from the south when the Fuzz is present. These trees are all south of my property.
- The wind deposits a lot of this fuzz onto my property and clogs my A/C unit daily.
