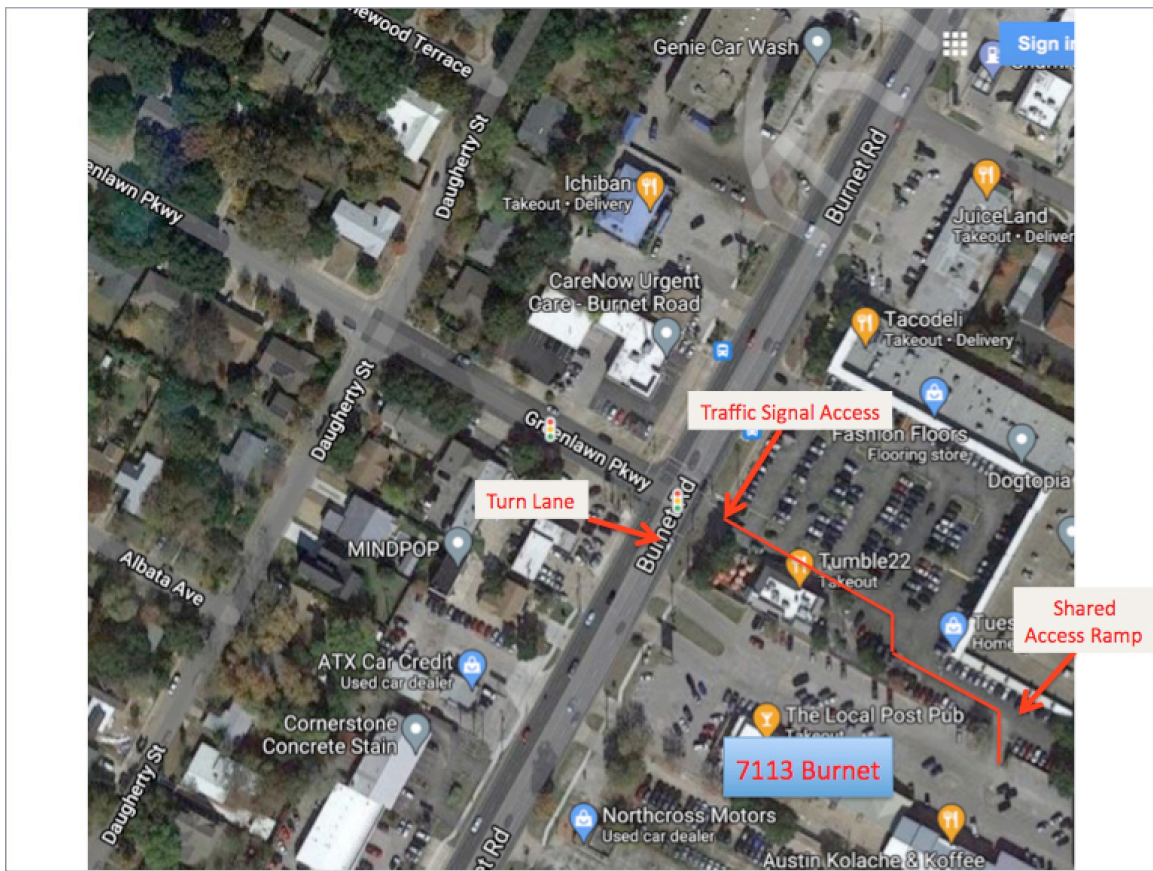
Here is what the traffic layout looks like. You can see that the turn lane obstructs southbound access. This same issue was considered in the Burnet Road Corridor Study

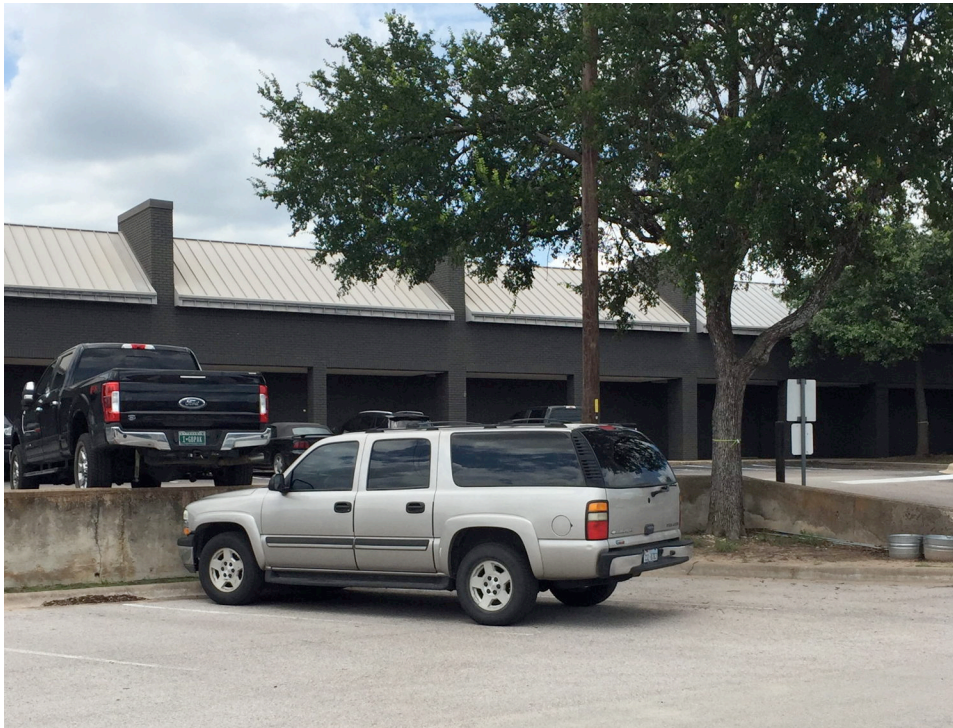
First notice the difference in elevation of the two parking lots.

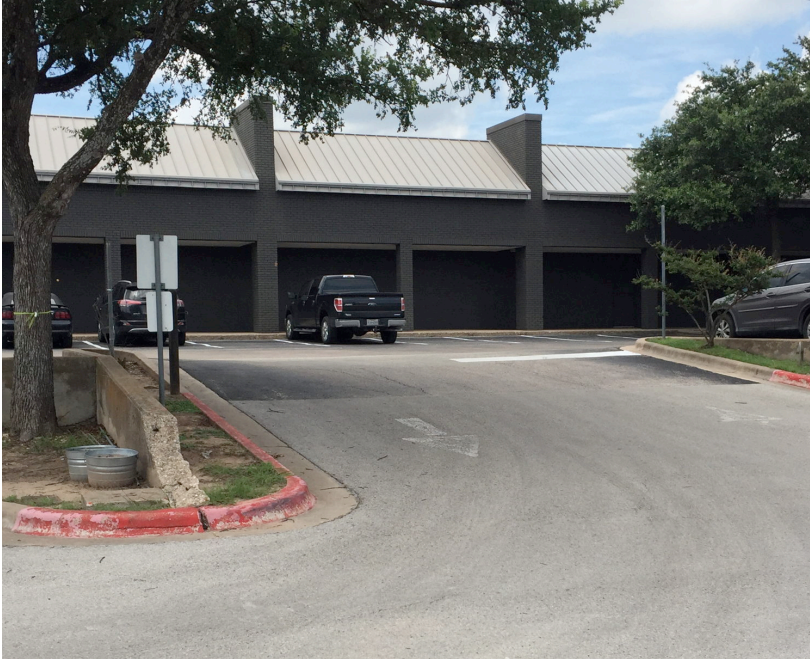
And, that the ramp slopes at about 12% to 16% grade to match the elevations. And, the ramp is constrained on the top side by buildings and customer parking. This forces ramp use to start and end with a turn. For trucks, this is an 'S' turn: cab turns in, cab goes to exit while truck tail is still hasn't entered, cab must start turn to avoid parking and building, truck tail enters ramp and immediately begins turn to exit.

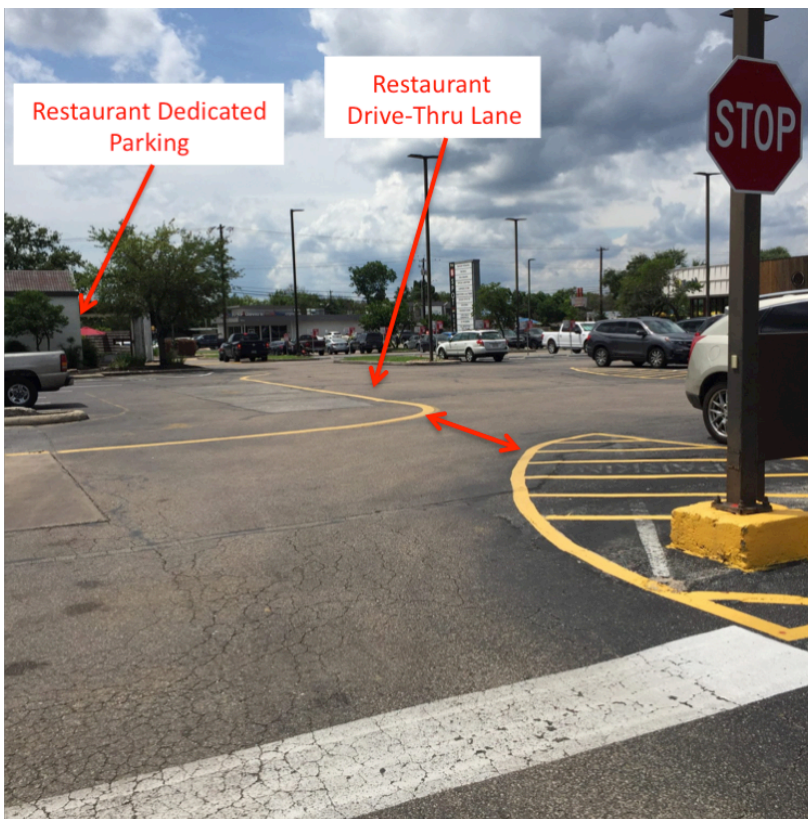
As seen here, the route through the parking lot is narrow.

The route is only wide enough for a single car at a time. And, the restaurant traffic turn radius prevents widening the route.

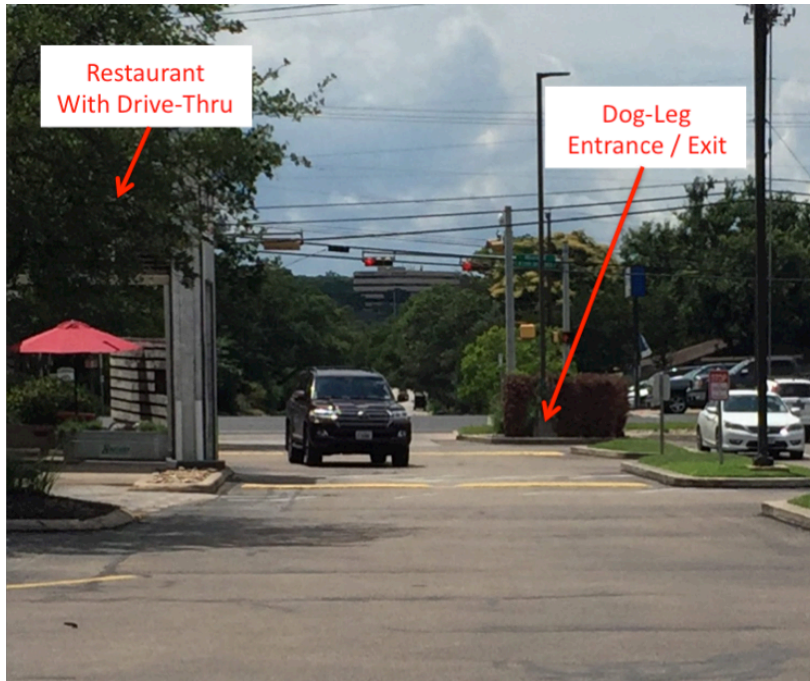
The main route through the parking lot is not straight, there is a dog-leg.

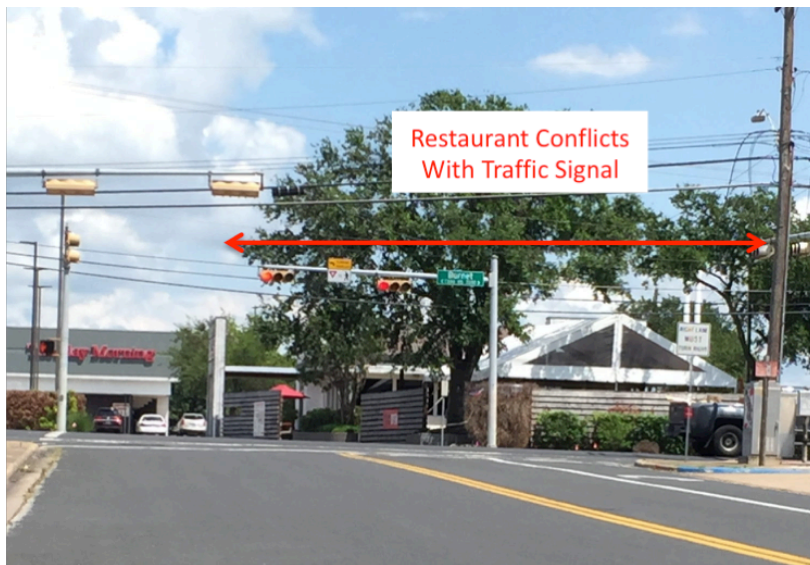
Access into the parking lot from Burnet and Greenlawn is conflicted at the Signal.
