## **3004 Lafayette Avenue**

Summary: The owners/occupants of 3004 Lafayette Ave are requesting demolition of the two bedroom, one bath home so they may build a new home more suitable for their family of four. They want to build a single family home that is compatible in both scale and style to other homes in the Cherrywood Neighborhood they love, taking their design cues from neighboring homes including classic shapes, a welcoming front porch, one and a half story design to reduce massing, roof corbels, and detailed window and house trim. We will also provide architectural drawings of the new home.

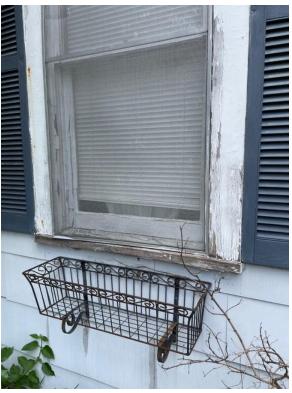
**Rotted Windows**

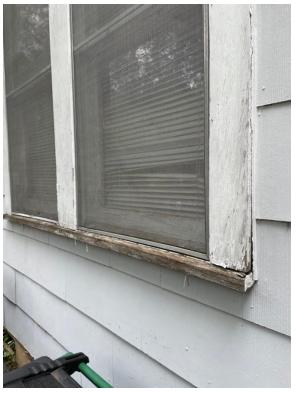
**Rotted Windows**

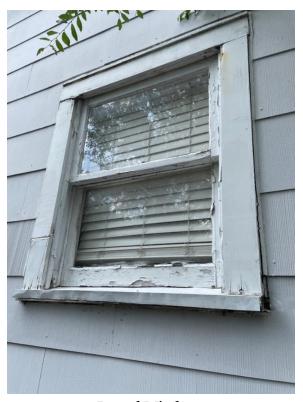
**Rotted Windows**

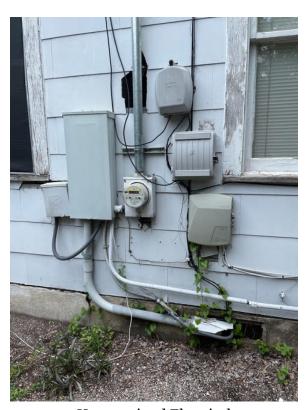
**Un-permitted Electrical**

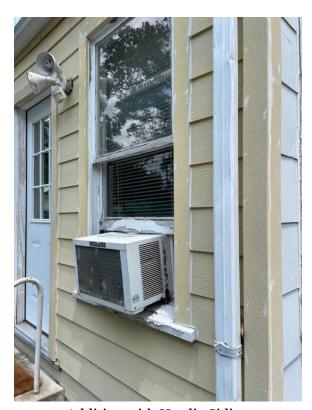
The existing home, while maintaining *some* original architectural elements, is largely unoriginal, having been poorly enlarged and remodeled at some point without permits in the 1980s or 1990s (see photos). There is new, unpainted Hardie Plank siding on the home at the area of the addition, a clear delineation where the old oak flooring stopped and the new pine flooring begins, a seam in the ceiling at the same location of the addition, and evidence of a difference in the foundation piers where the home was enlarged. While some of the wood windows are original, they are basic in design and have decayed and rotted to such a degree that they would all require replacement. The electrical system was upgraded at some point without permits, and is not to code. The front and rear doors have been replaced with newer, run-of-the-mill metal and plastic doors. Structurally the house is a mess, with rot from water intrusion and holes in the floor where the crawlspace beneath may be seen. The exterior shutters are plastic, sized improperly, and are simply drilled into the siding, not operable. The owners believe the lack of detailing on the home and poor maintenance by previous owners makes it a poor example of the period in which it was built, and the home would be grossly cost-ineffective to repair.

Addition with Hardie Siding

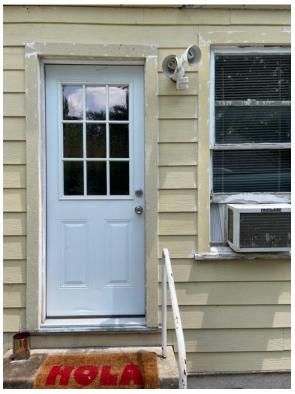
Hardie Siding and Metal Door

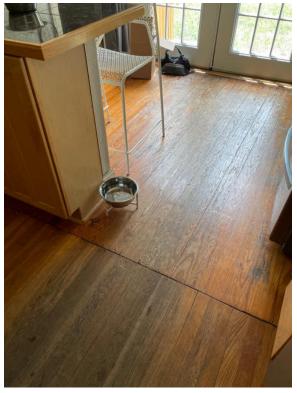
Flooring at Addition 1980s/1990s

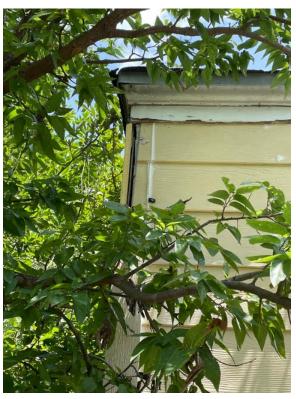
More Hardie, Other Side of House

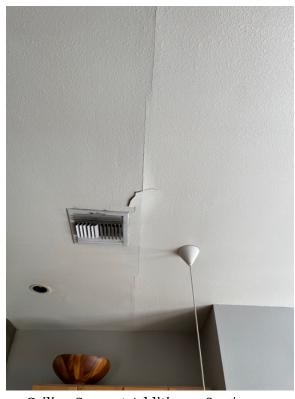
Ceiling Seam at Addition 1980s/1990s
