### 1104 Charlotte St

Kindra Welch and family

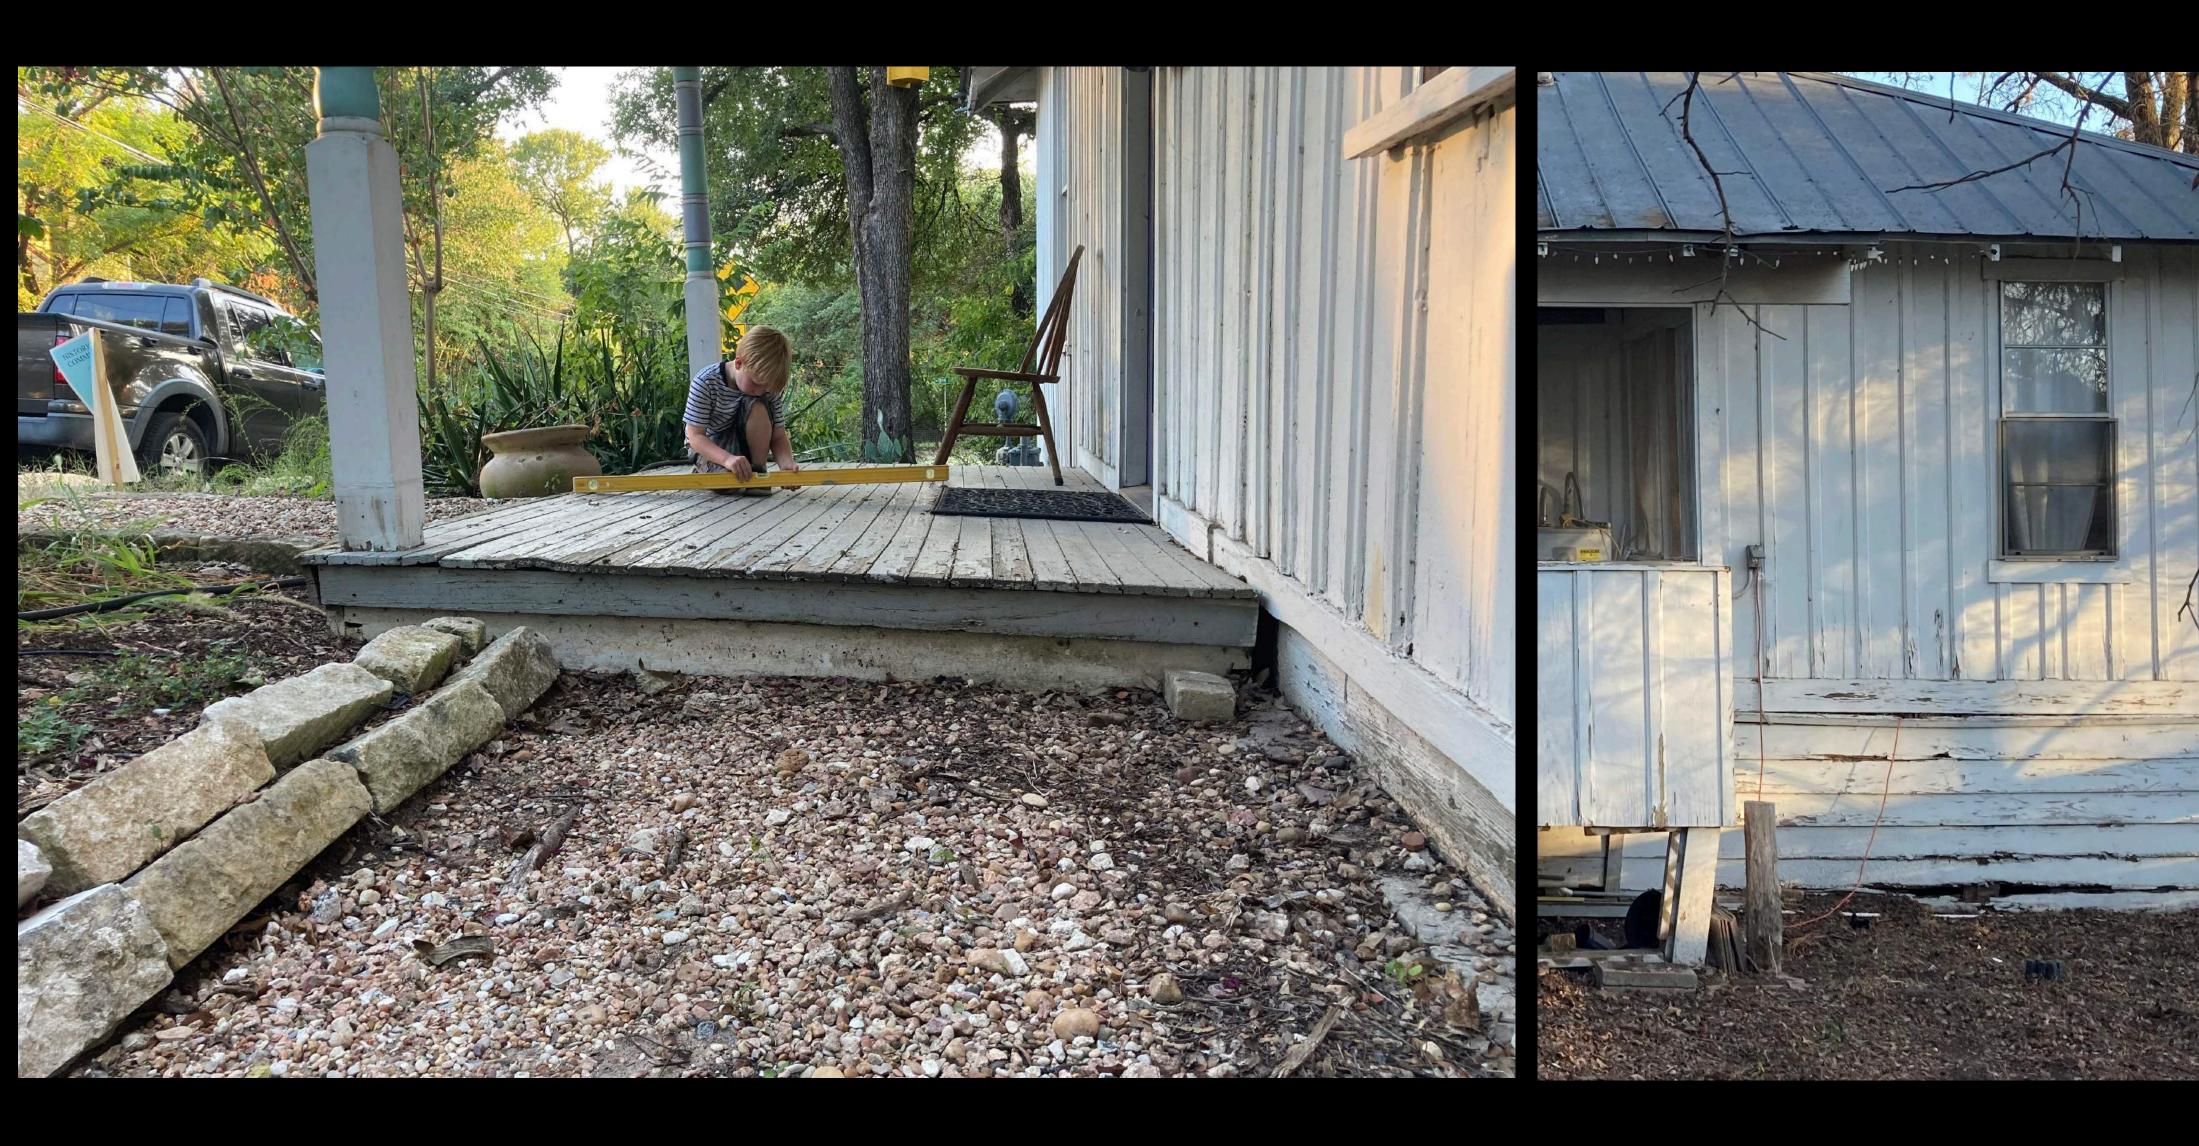
minor structural issues with original Juniper piers

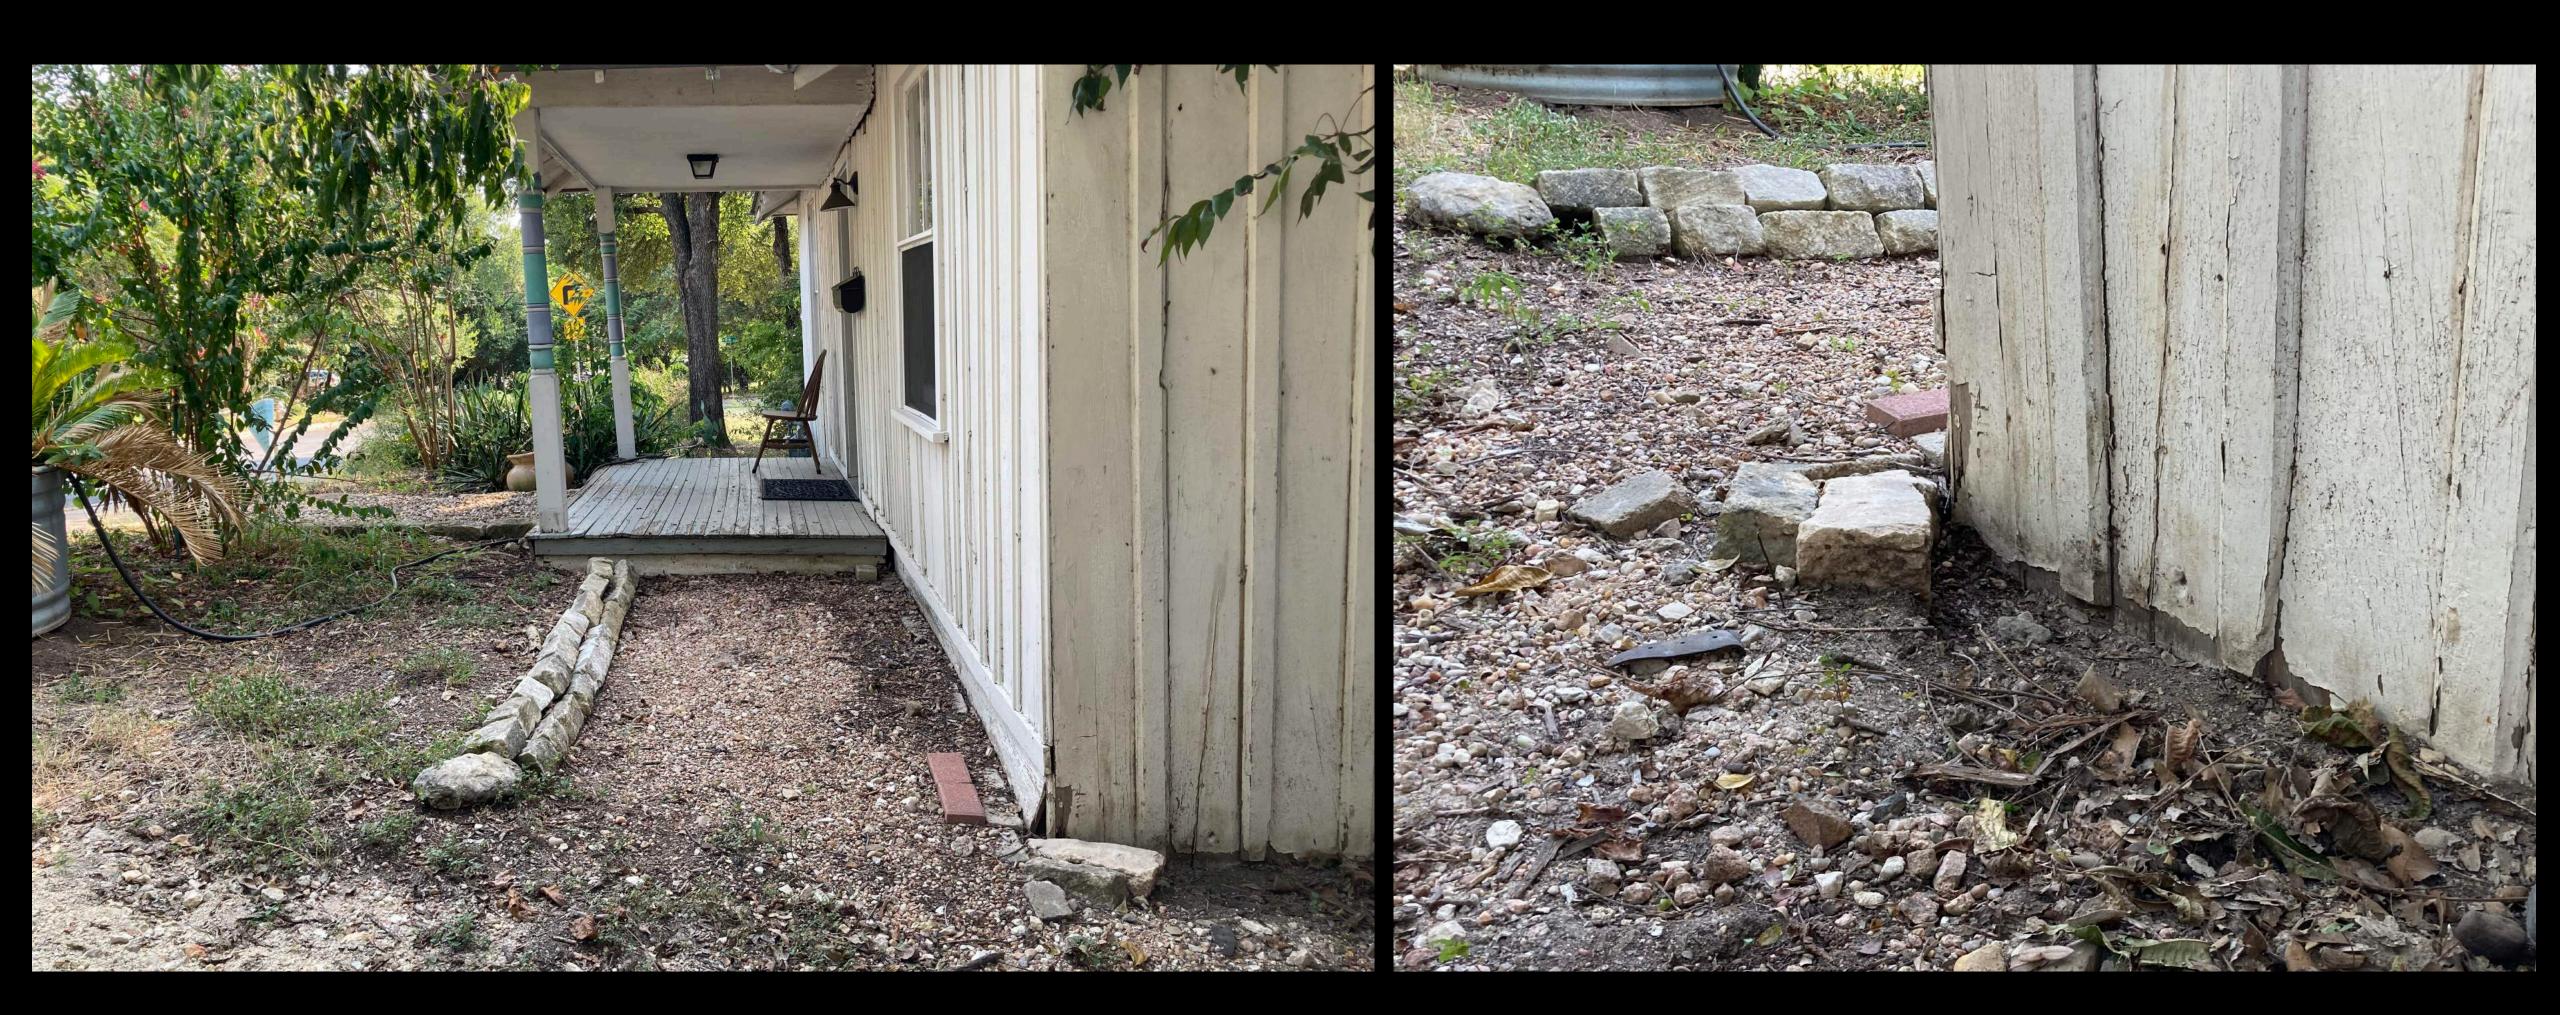
1. Eastern front corner sits directly on the ground enabling deterioration of wood structure and a near constant termite invasion

Significantly Raise the House

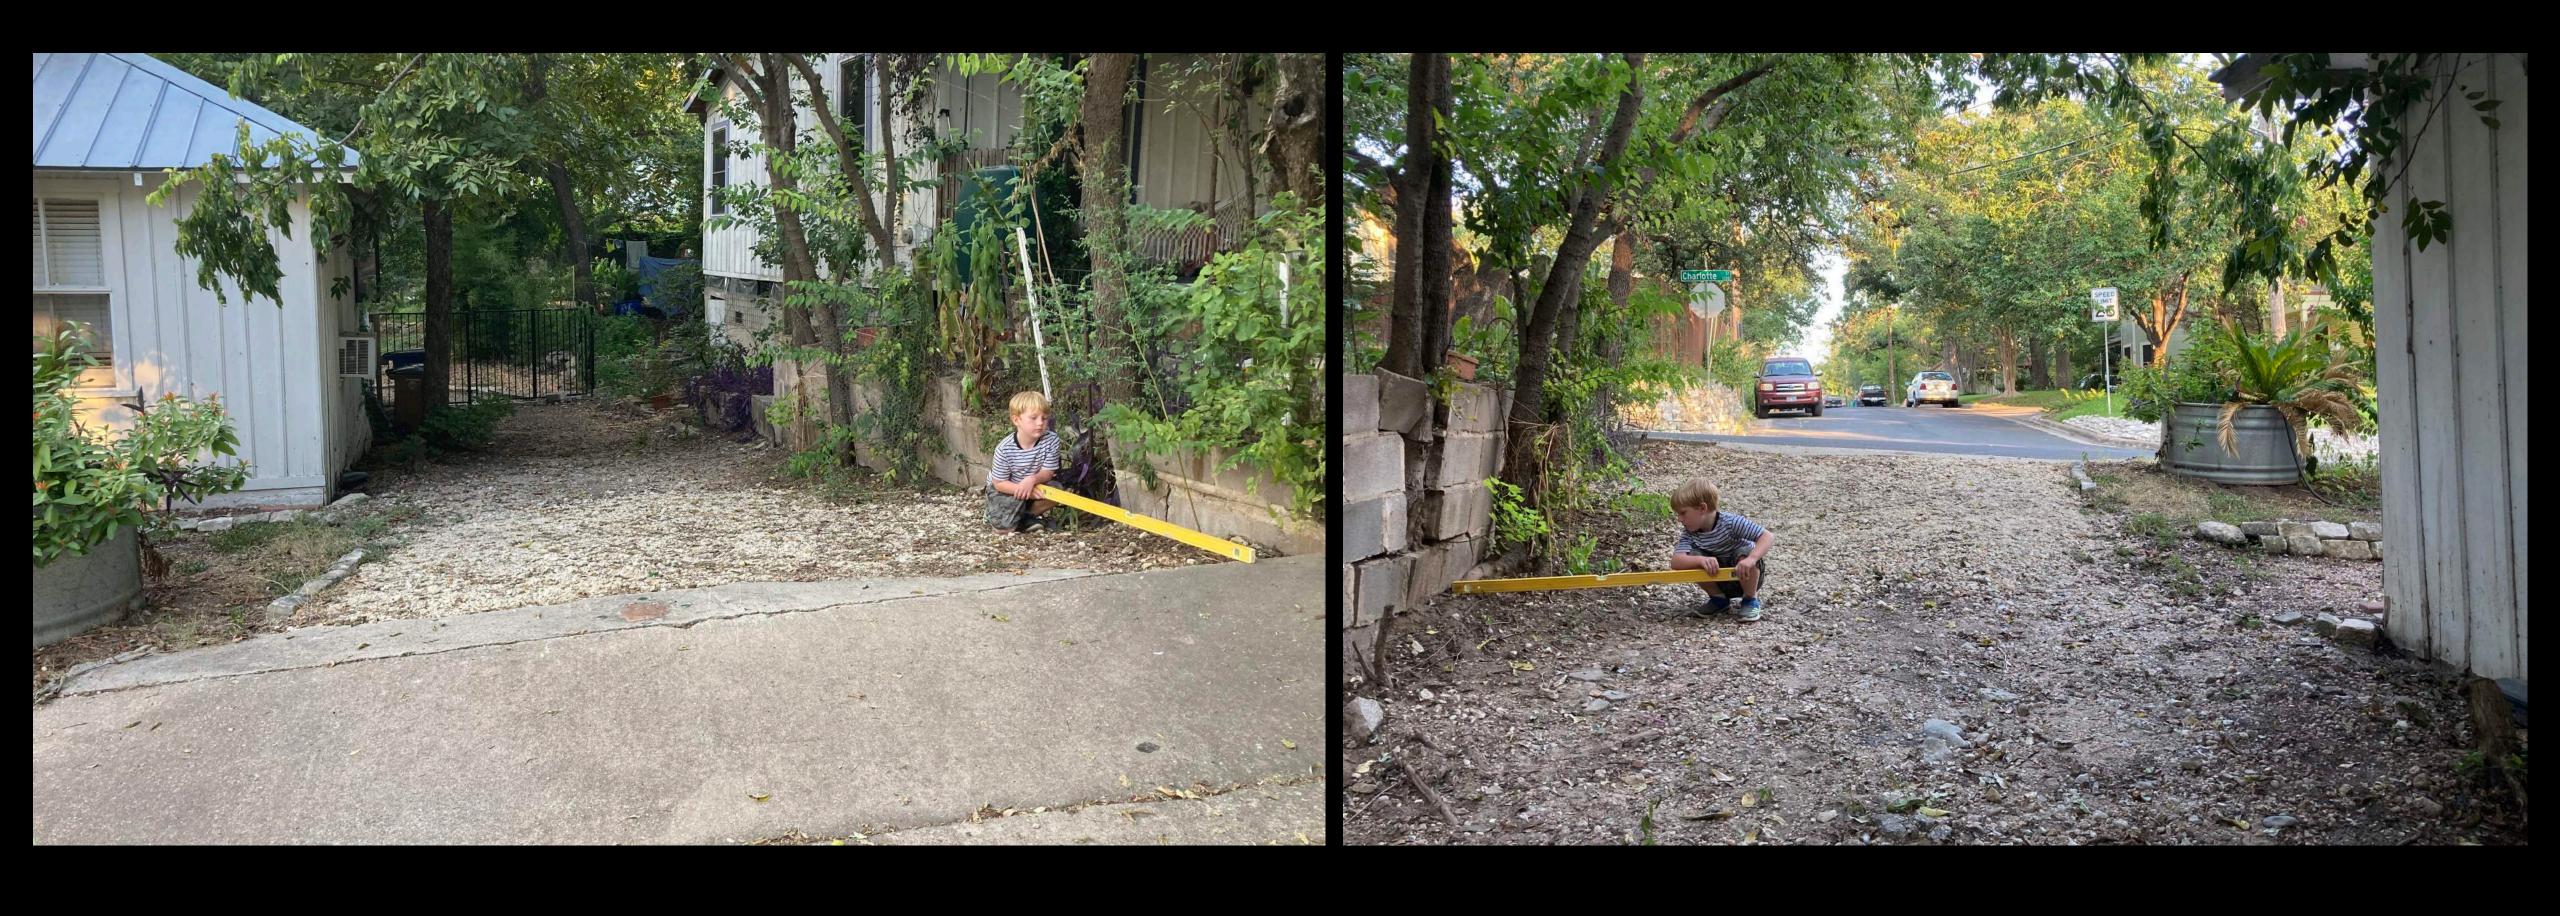
#### 2. Driveway slopes towards the house

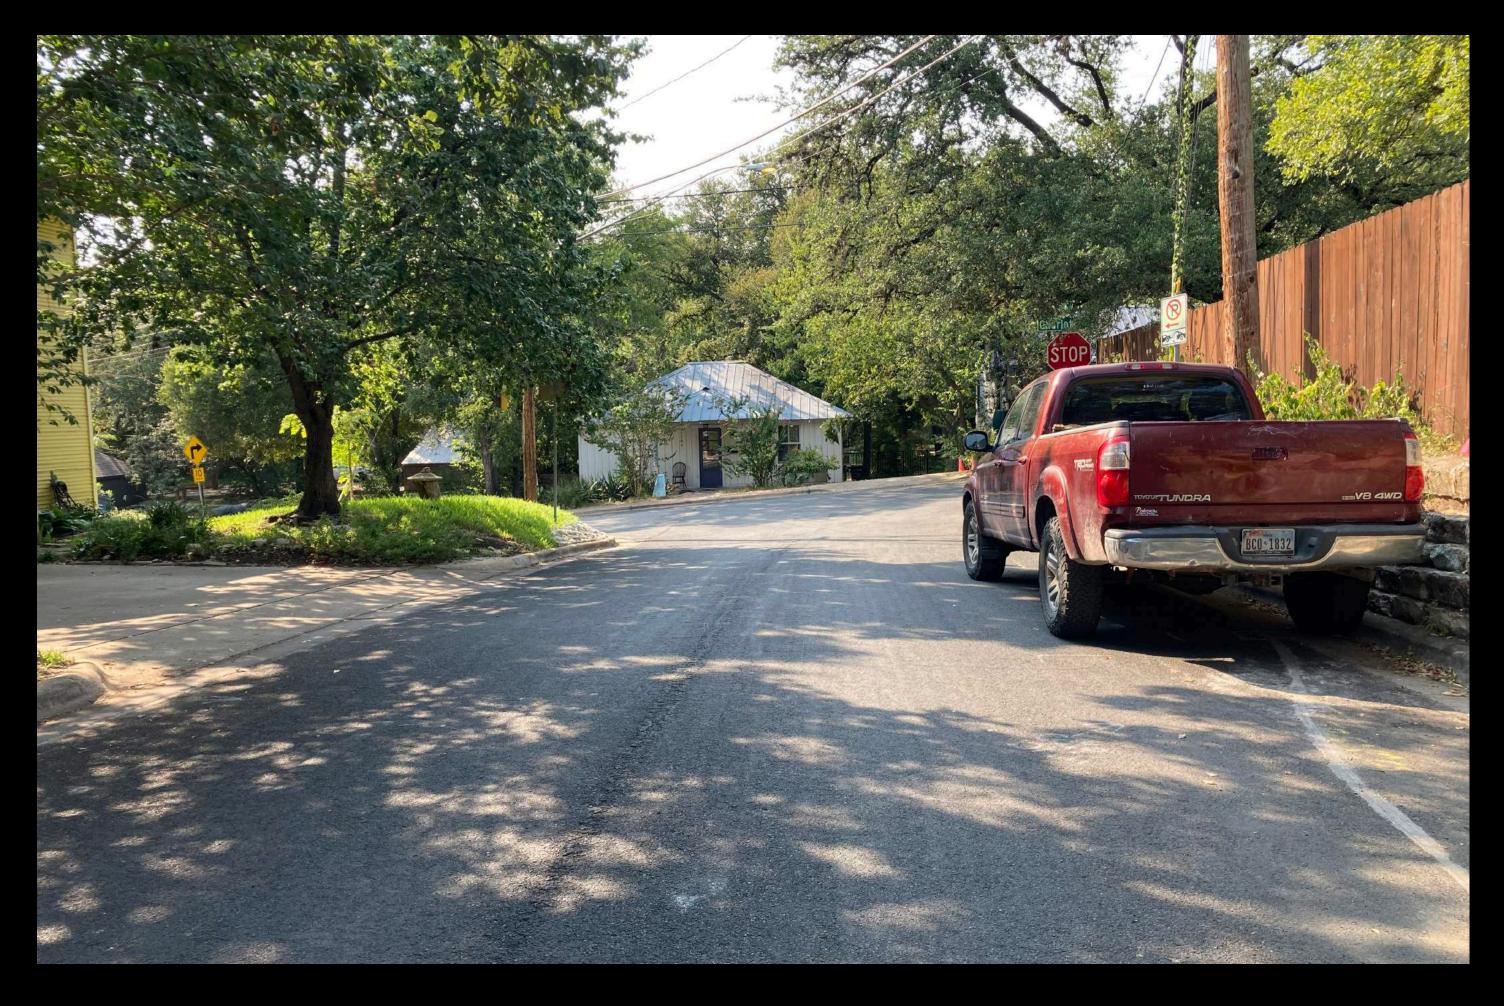
3. The house is the focal point of 12th street traffic, including restaurant and retail traffic from commercial area 1 block away. New Years Eve '03-'04 a driver crashed his truck through the front wall and into the living room.
