**HISTORIC LANDMARK COMMISSION**  
**APPLICATION FOR A CERTIFICATE OF APPROPRIATENESS**  
**FEBRUARY 28, 2022**  
**CASE NUMBER C14H-1977-0015**  
**REVEREND JACOB FONTAINE GOLD DOLLAR BUILDING**  
**2402 SAN GABRIEL STREET**

**PROPOSAL**

Remove ca. 1942 enclosure and return the second-floor balcony to its ca. 1923 appearance.

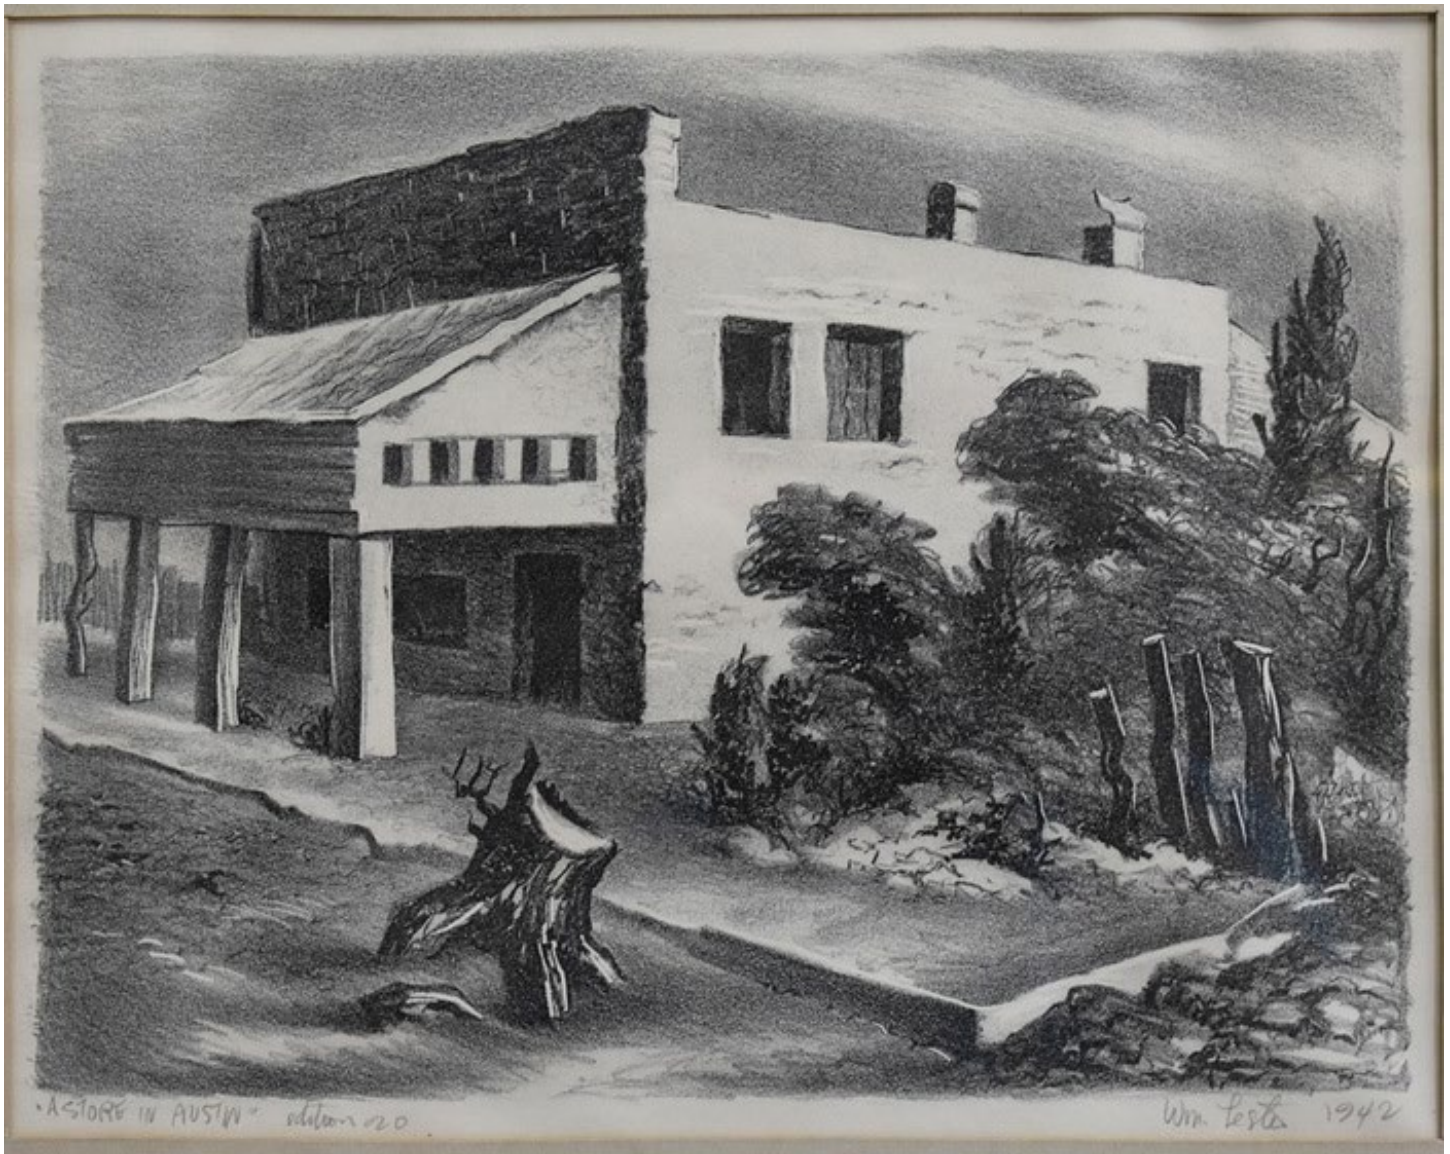
Figure 1. William Lester, "A Store in Austin," lithograph edition of 20, 1942.

The second-floor porch is thought to have been added in 1923, though no source is cited in either the 1977 landmark designation materials or the staff report supporting renaming the building in 2018. By 1942, the upper level had been enclosed, as shown in a lithograph that is the earliest identified depiction of the building (Figure 1). While it includes some

inaccuracies, such as the omission of the north addition shown on earlier Sanborn maps and four rather than three porch columns, it is sufficient to help date the balcony enclosure. It is unknown when stucco was applied to the first floor of the façade and columns. This appears in the earliest identified photograph of the building, dated 1964 (Figure 2).

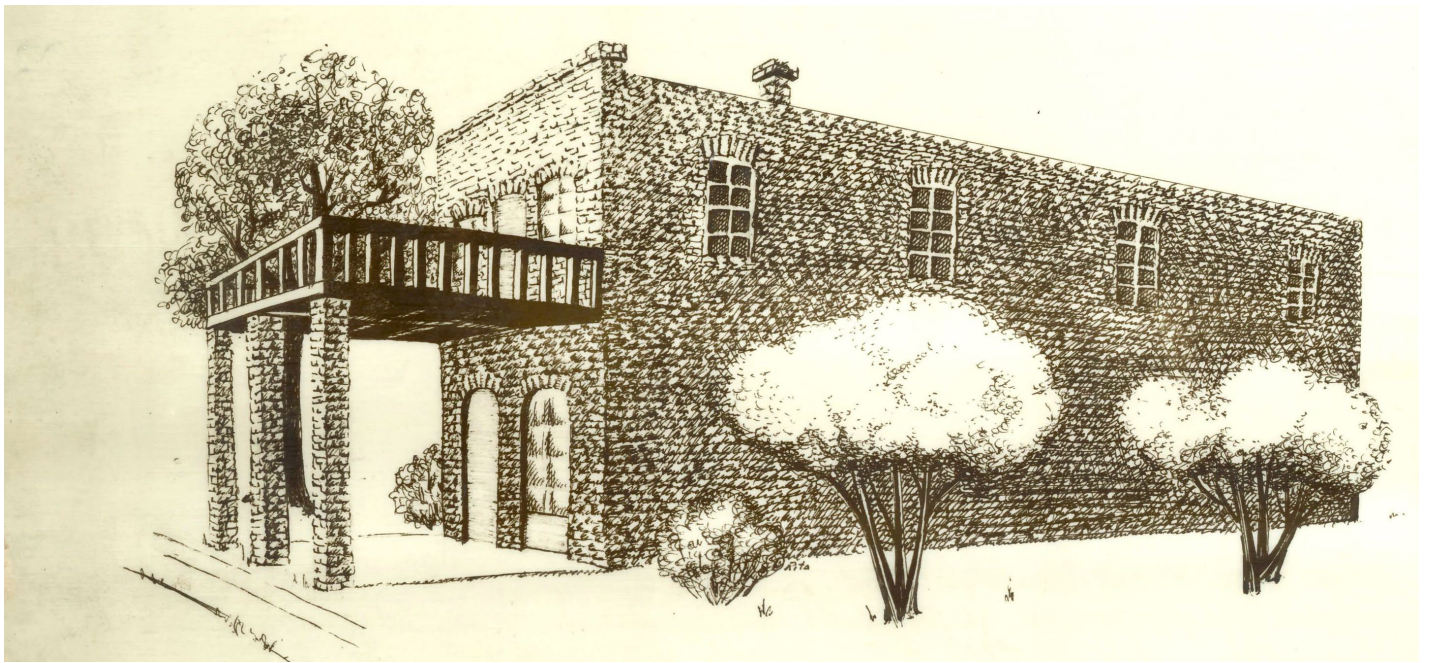
*Figure 4. Artist's rendering, undated, in historic zoning file, C14H-1977-0015, 1977.*

The building was originally constructed around 1869 as a one-story stone building, expanded to its two-story form around 1875.<sup>2</sup> An undated artist’s rendering in the historic zoning file suggests what the building may have looked like at that time (Figure 4). The building first appears on Sanborn Fire Insurance maps in 1922 as a two-story stone building with a one-story porch and one-story frame additions to the north and west. By 1935, the building is shown with a two-story porch, two-story veneered addition to the west, and one-story frame addition with a veneered front to the north.

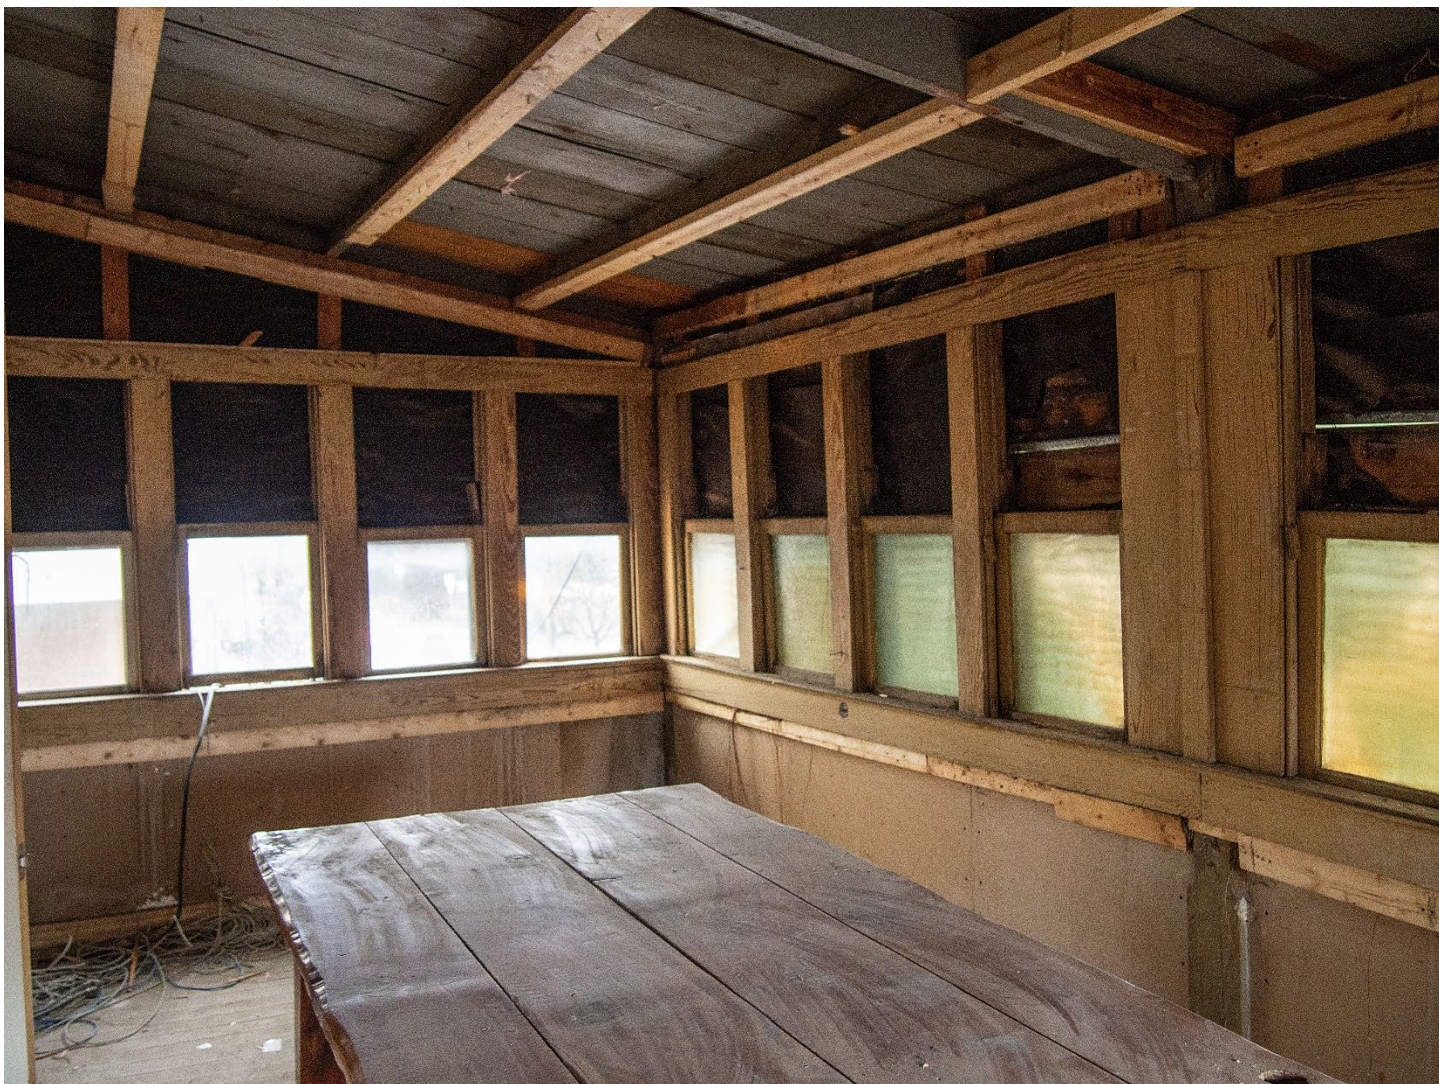
*Figure 10. Photograph by Historic Preservation Office staff, Jan. 31, 2022.*

Staff visited the site on January 17 and 31, 2022. Between the site visits, the applicant removed a later bead board finish from the interior of the balcony enclosure to help identify eras of construction. There are three distinct periods. Blue-gray paint appears on window frames at the masonry wall and the porch columns, beam, rafters, purlins, and decking, delineating the elements of the open balcony. The windows of the enclosure slide into wall pockets created by the horizontal siding, and there are no drain holes at the base of the vertical siding. Together, these details suggest the balcony was fully enclosed at once, not partially enclosed by siding first with the windows added later. Finally, newer lumber served as nailers for the bead board finish.
