**SITE PLAN REVIEW SHEET
ENVIRONMENTAL VARIANCE REQUEST ONLY**

CASE: SP-2021-0350C

PROJECT NAME: Shoal Cycle

Tree Risk Assessment Report

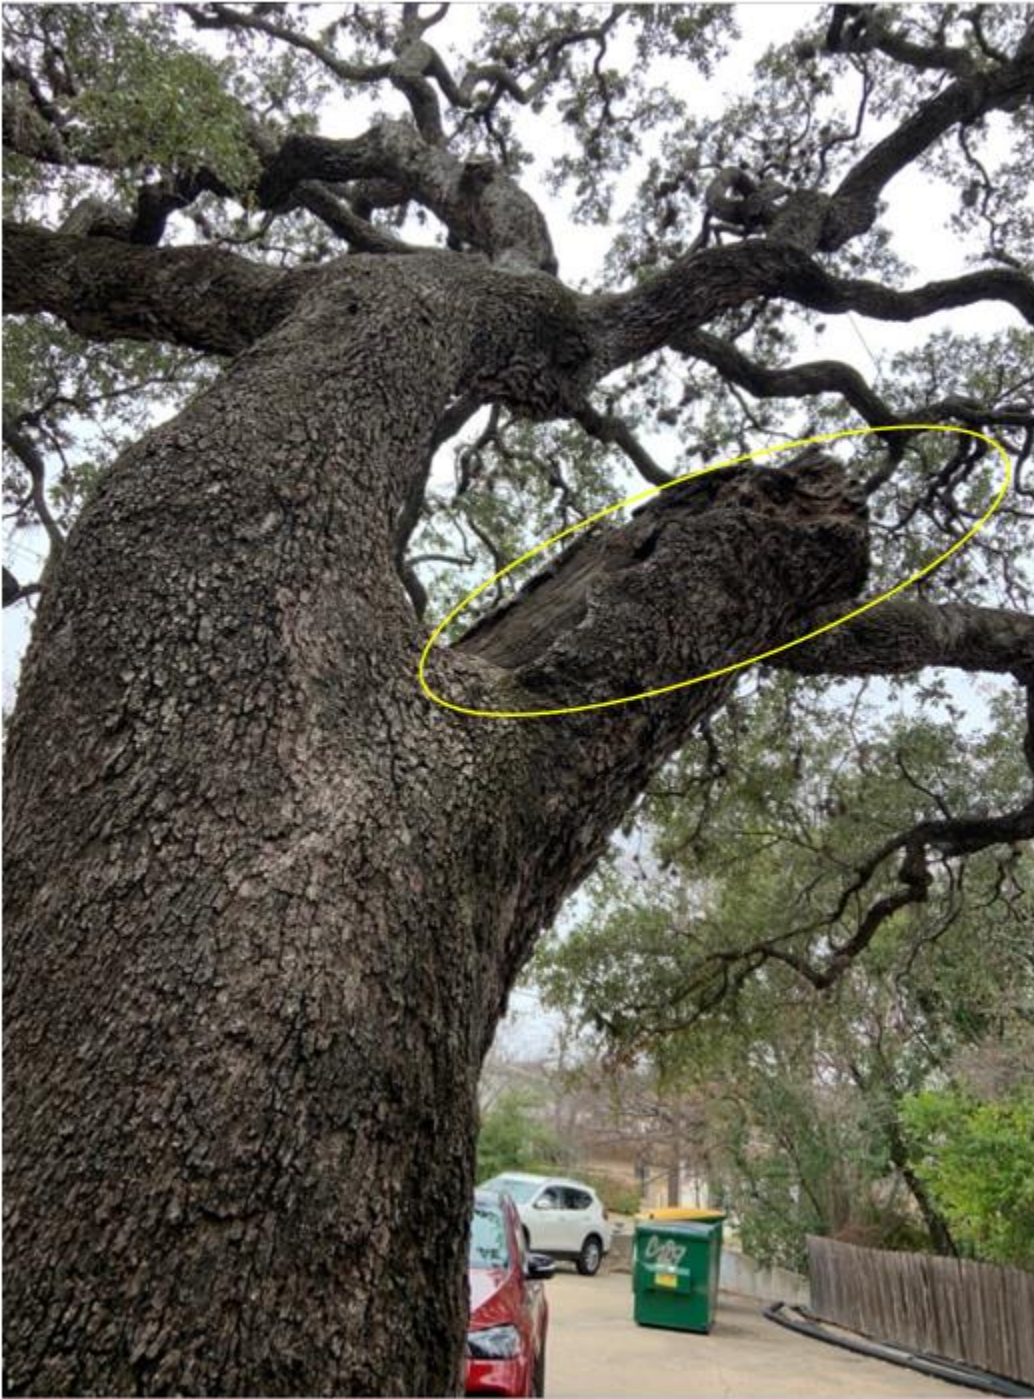
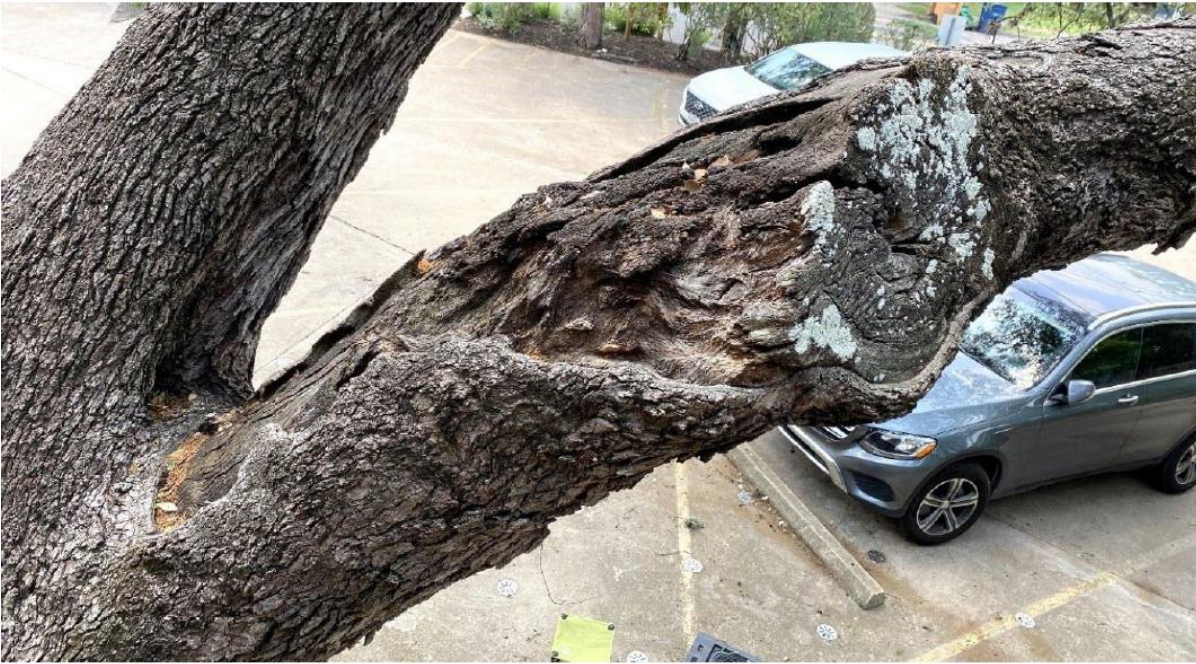
Exhibit 2: Large scaffold leader decay – west stem

Trunk leans over the parking lot. Sonic tomography was conducted of the trunk indicating moderate decay at three different vertical planes with the tree – estimates 22-24% loss in structural integrity of the tree. Large decay pockets on upper side of two scaffolding limbs observed.

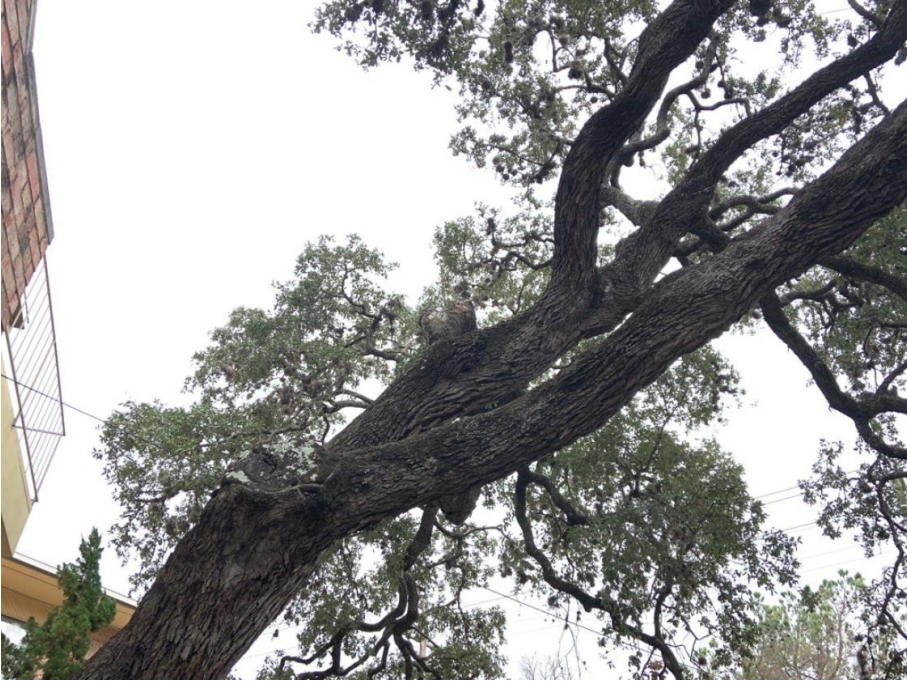
Exhibit 3: Thin Canopy; ball moss, chlorosis

Asymmetric crown; thin canopy; chlorotic (likely due to nutrient deficiency); copious amount of epiphytic ball moss usually prevalent on declining trees; leans southwest due to existing location of existing building; overhead utility lines run through the canopy.

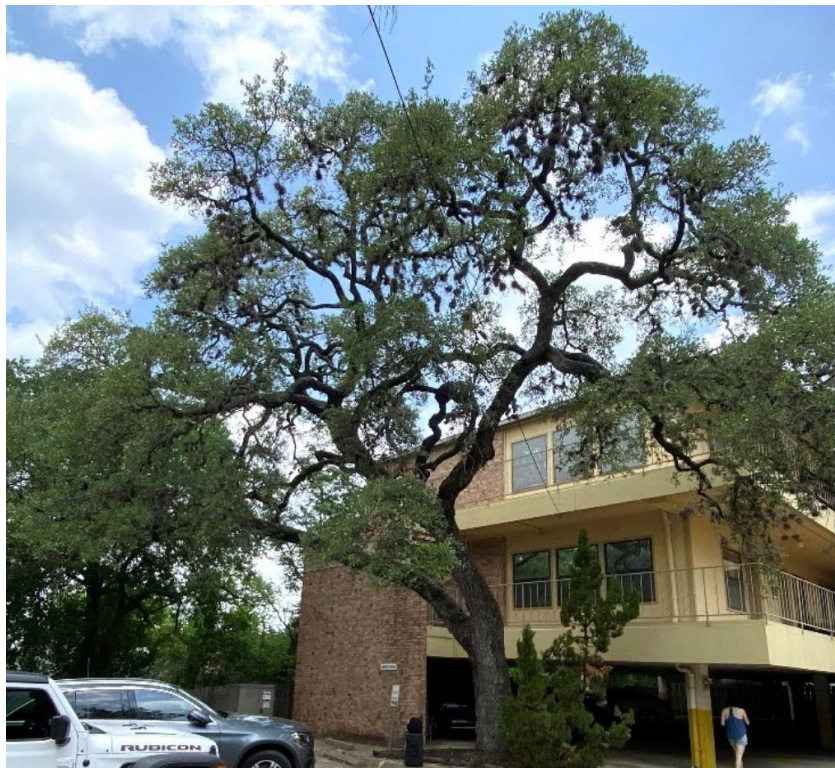
Exhibit D: 32-inch Live Oak

During the time when the transplant option was being considered, a level three advanced tree assessment was prepared for the 32-inch Live Oak by Michael Embesi of Bartlett Tree Experts on May 16, 2022. The tree was determined to be in fair condition. The report reflects that 95% of the critical root zone of the tree is covered by impervious surfaces (95% concrete coverage of the critical root zone is a significant barrier for tree viability and health), the tree is asymmetrical and leans over the parking lot, and that overhead utility service lines run through the tree canopy. Exhibit D below depicts an image of the tree and Exhibit E depicts existing conditions impacting the critical root zone. The asymmetrical canopy leans southwest as a result of the adjacent building and is characterized as "somewhat thin," see Exhibit F below. 40% of the tree canopy is missing. Of the remaining canopy (60%); 20% of the foliage is missing. This equates to a tree that is only 48% of the leaf cover of a typical healthy tree.

The foliage appears both green (healthy) and chlorotic (yellow). 15% of the canopy is made up of "dead twigs and branches with a maximum diameter of 2-inches."

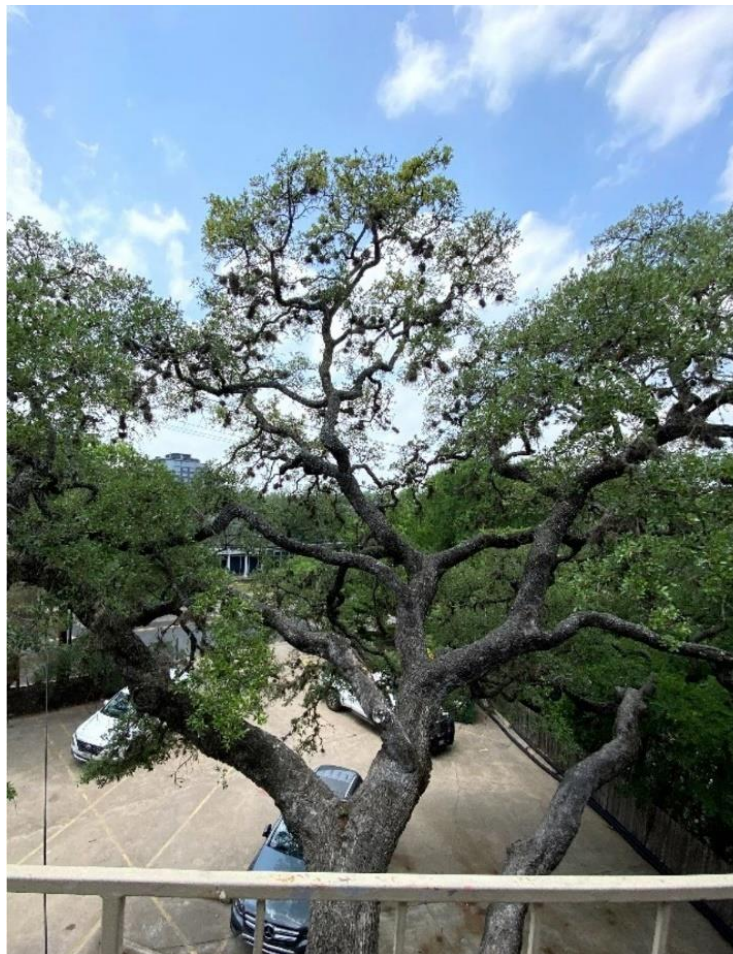
Exhibit F: Thin Tree Canopy

40% of the tree canopy is missing. Of the remaining canopy (60%); 20% of the foliage is missing. This equates to a tree that is only 48% of the leaf cover of a typical health tree. The foliage appears both green (healthy) and chlorotic (yellow). 15% of the canopy is made up of "dead twigs and branches with a maximum diameter of 2-inches." An east stem limb is decayed and if removed, the current canopy would be diminished by approximately 15-20%, thereby reducing the overall canopy size to 28% of a tree in good health of similar size and species.

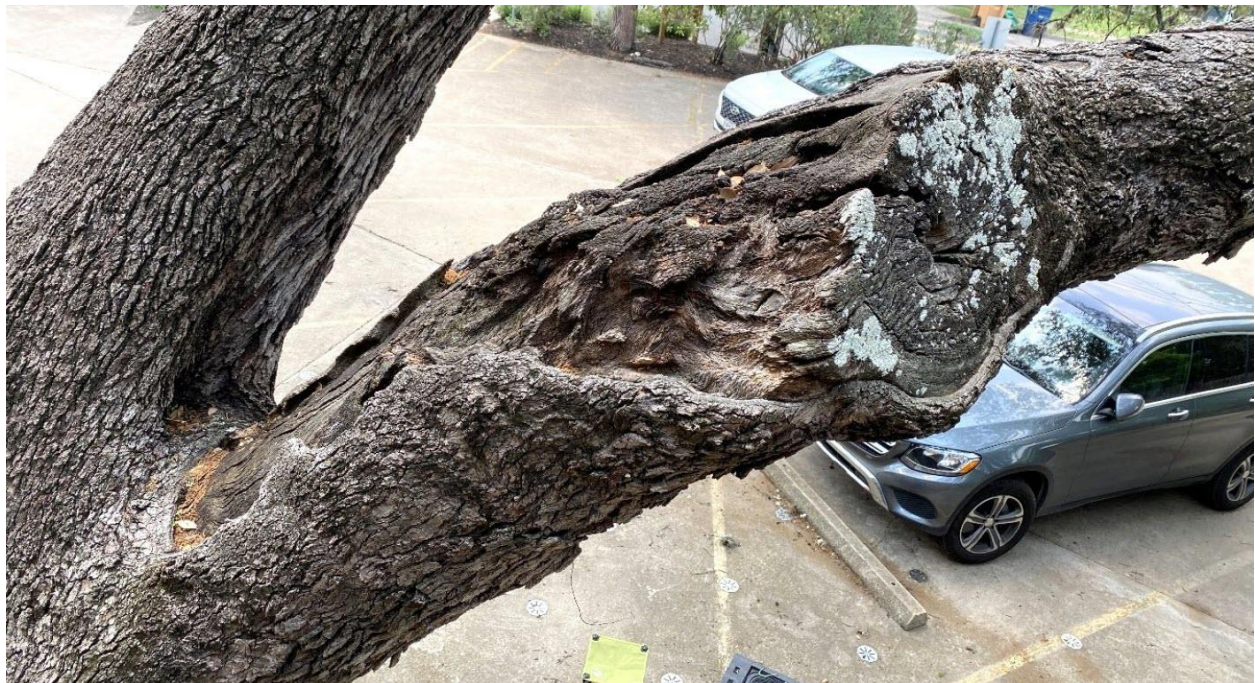
EXHIBIT G: West Stem Pruning Wound and Decay Exhibit

Additional significant decay is on the west stem limb shown in Exhibit G below. This limb is characterized by a large pruning wound of approximately 10 inches in diameter, and sapwood and heartwood decay, measuring 30 inches by 12 inches. This wound and decay area are noted to make up 1/3 of the circumference of the west stem with little response wood.

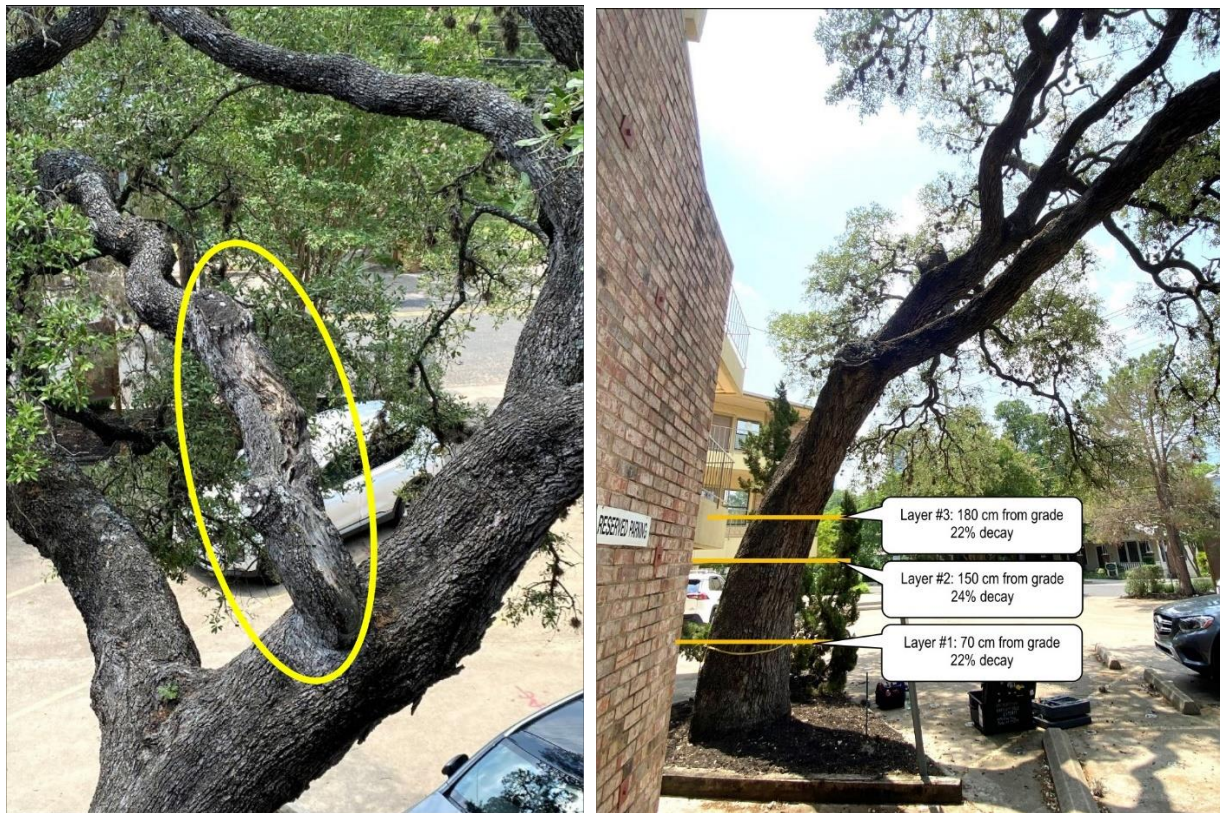
Exhibits H: East Stem Limb Decay / Exhibit I: Sonic Tomography Results

An 8-inch branch on the east stem of the tree is characterized by sapwood and heartwood decay located 25 feet above grade, see Exhibit H below. The size of this decay area comprised of 1/3 of the total circumference of the limb. Should this decayed limb, as referenced in Exhibit H, be removed, the current canopy would be further diminished by an additional approximately 15-20%, thereby reducing the overall canopy size to 28% of a tree in good health of similar size and species.

Sonic tomography was performed on the 32-inch Live Oak which indicated moderate decay at three different vertical planes within the tree: 22% decay at 70 centimeters from grade, 24% decay at 150 centimeters from grade and 22% decay at 180 centimeters from grade see Exhibit I below. Such measures of decay indicate 22-24% loss in structural integrity of the tree.

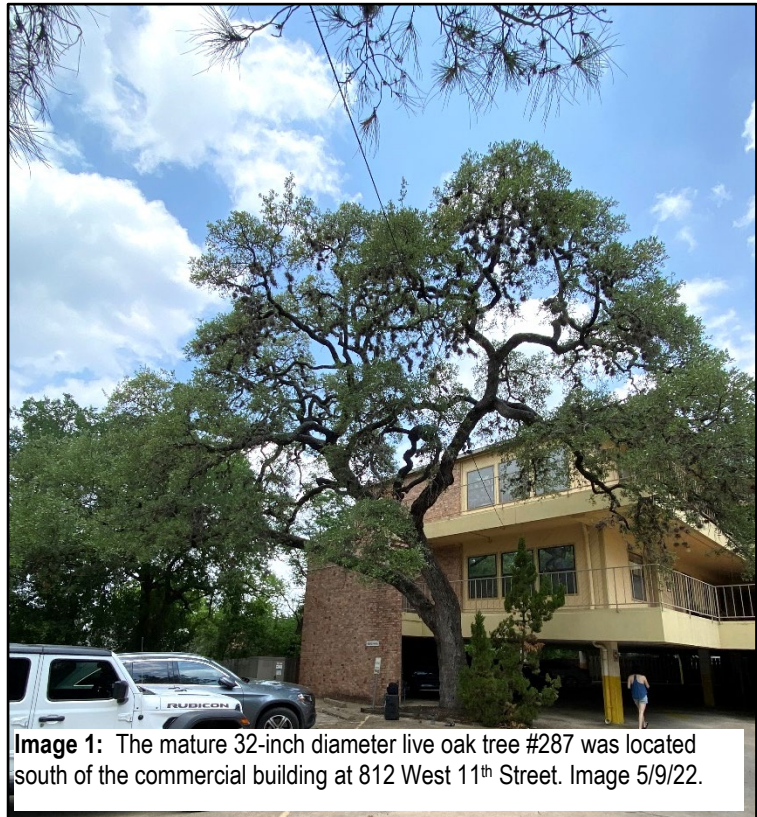
Image 1: The mature 32-inch diameter live oak tree #287 was located south of the commercial building at 812 West 11th Street. Image 5/9/22.

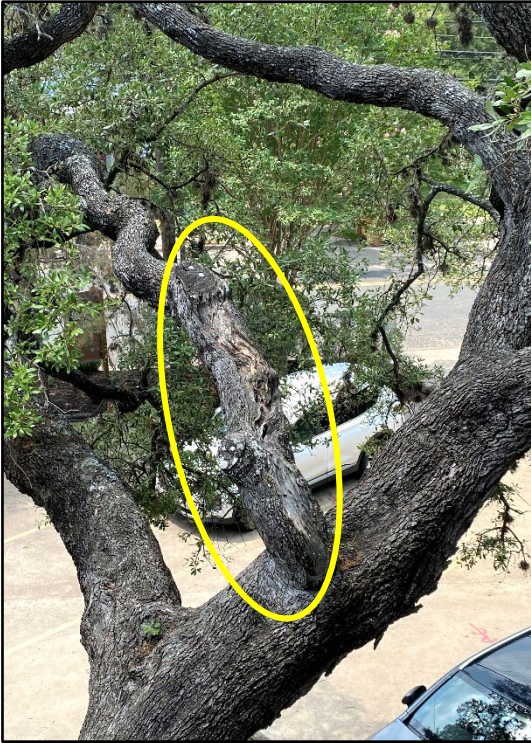
The east stem supported most of the tree's branches and foliage. At 25-feet from grade an 8-inch limb had decay that comprised 1/3 of the limb's circumference.

Image 2: Eight-inch branch arising from east stem had sapwood and heartwood decay (circled).

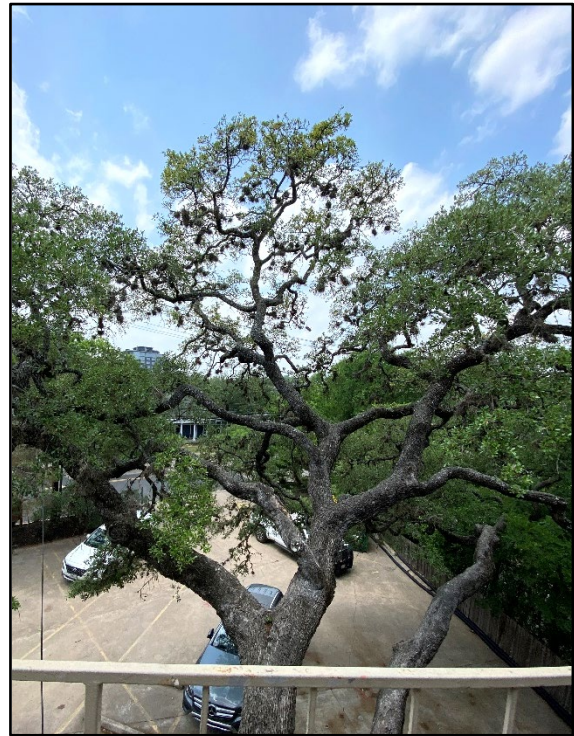
The mature live oak was in fair condition. The canopy was asymmetrical and leaned southwest. The live crown ratio was approximately 60%. The tree canopy was somewhat thin. Approximately 80% of the expected leaf surface area was present. Most of the foliage that was present was green and healthy in appearance. Twenty percent of the leaf surface area (near the center at the top of the tree) was chlorotic (yellow). Ball moss was present in the tree canopy.

Image 3: Center portion of the canopy was thin and chlorotic. East stem is in the center of the image and the west stem is on the right.

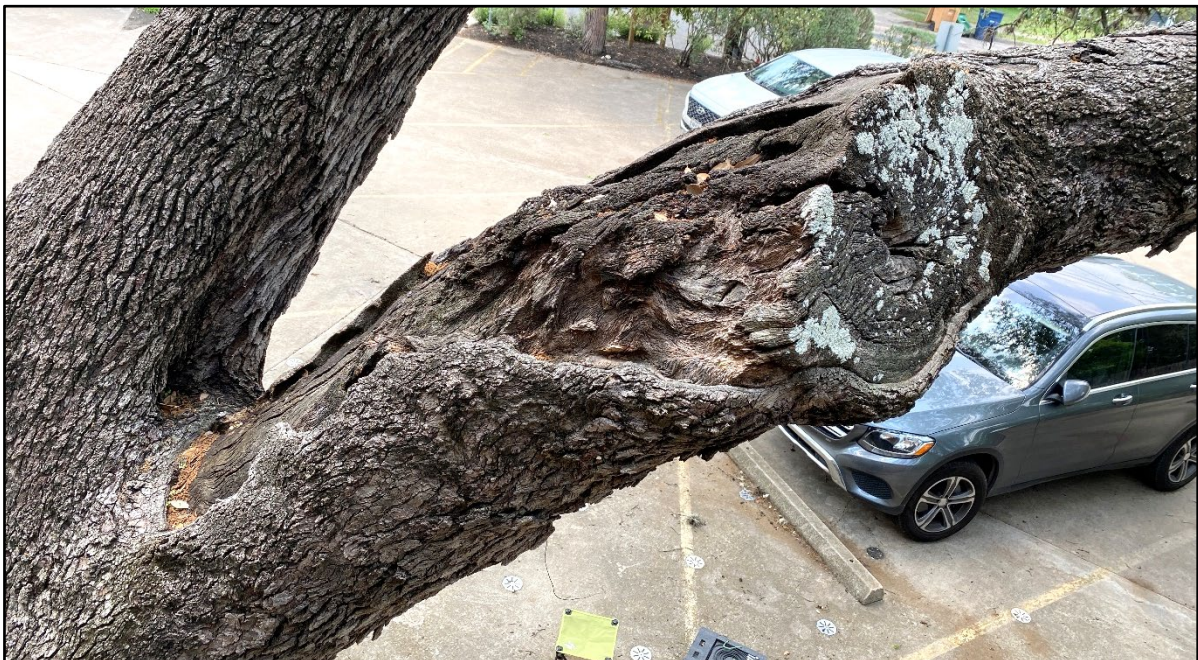
tree. The west stem was overextended. It had a large pruning wound approximately 10-inches in diameter. An area of missing sapwood was associated with this pruning wound that was approximately 30-inches in length and 12-inches in width. It comprised 1/3 of the circumference of the west branch. Very little response wound was present around the wound.

Image 4: Codominant union is on the left. The west stem arises from this union and has a large pruning wound approximately 10-inches in diameter. Sapwood and heartwood decay are present for an area approximately 30-inches in length and 12-inches in width. It comprises 1/3 of the circumference of the west branch with little response wood.

- Option One: Prune to remove 2-inch dead branches in the canopy. Removing dead branches will eliminate their residual risk.
- Option Two: Reduce weight of west branches and install cables to reduce the risk of branch failure. Pruning and cabling will reduce the residual risk of trunk, crown, and branch failure to low.
- Option Three: Remove the entire tree to remove the risk of root, root collar, trunk, crown, and branch failure. Grind the resulting stump and back fill the hole. There will be no residual risk for the trunk, crown, or branches, but there may be a tripping hazard with the remaining roots, stump, or grindings that you will need to address. The tree's risk may increase in the future as a result of not performing mitigation.

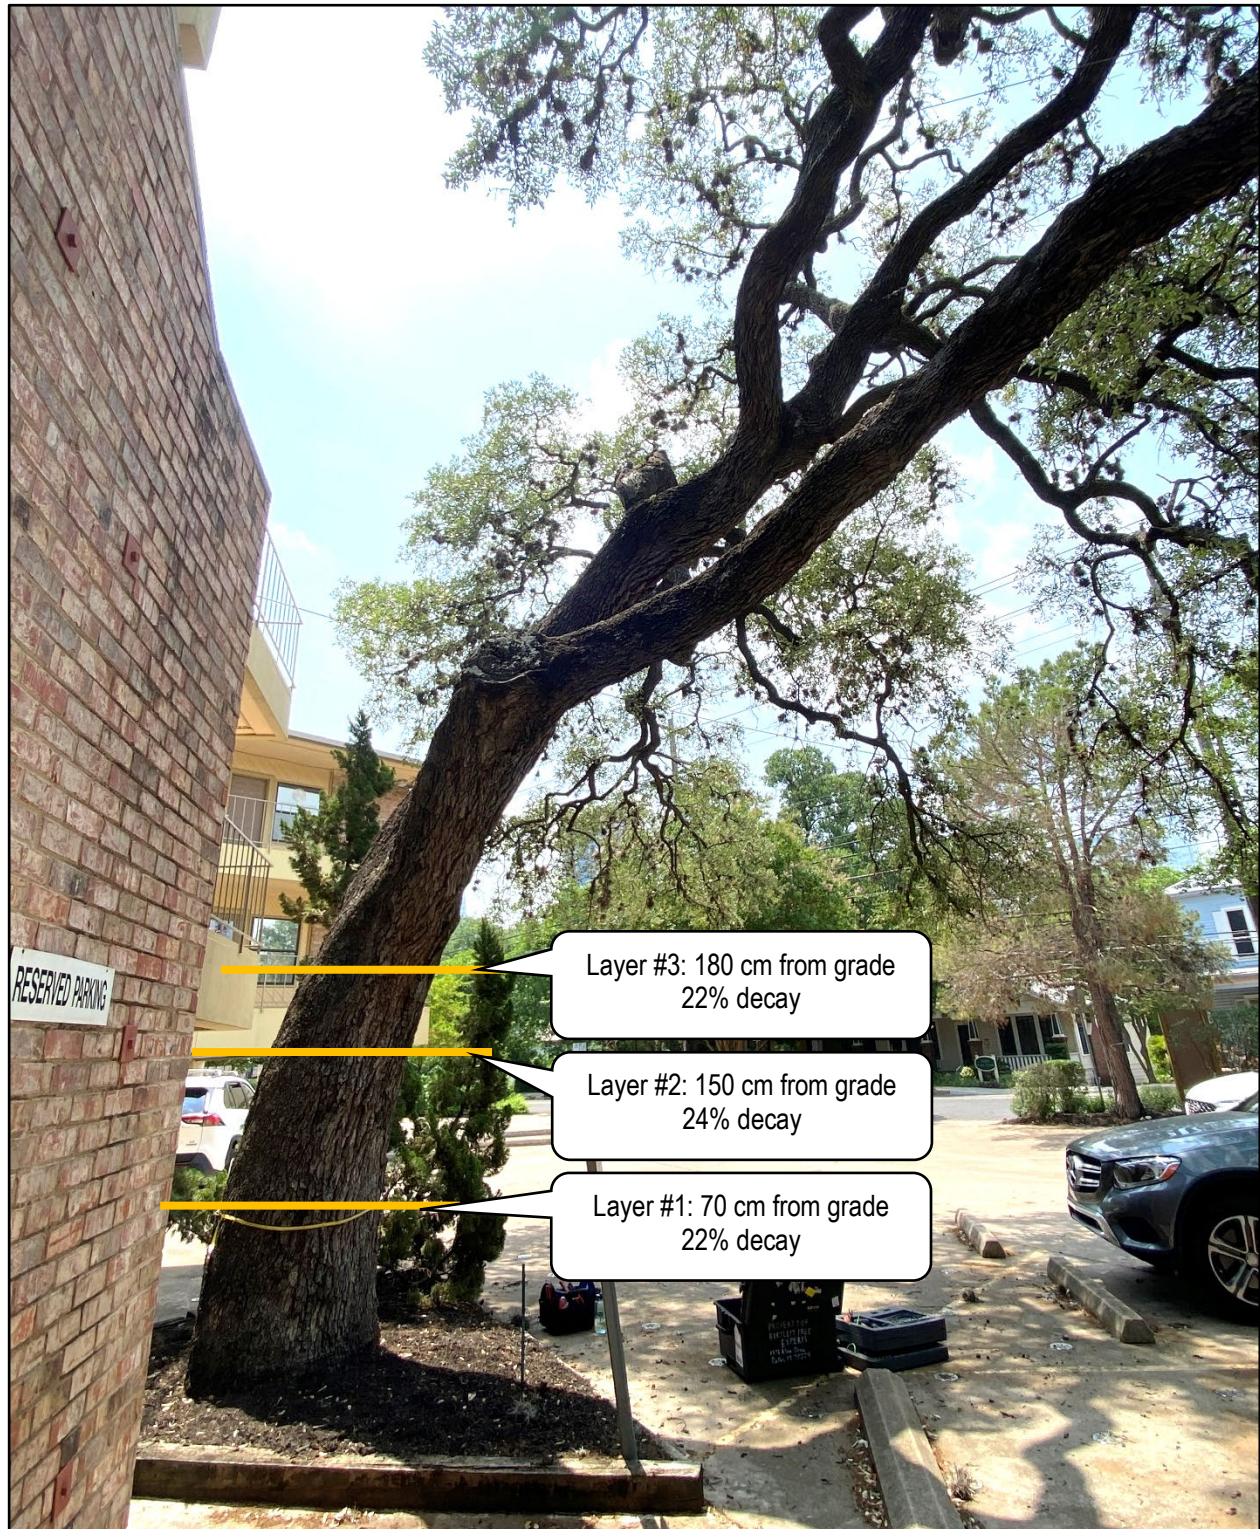
Image 5: Tree leans southwest over the parking area. Tree canopy is asymmetrical. Sonic tomography locations indicated by the yellow lines. A column of decay was located in the center of the stem. Pruning wound with decay on west stem is visible.

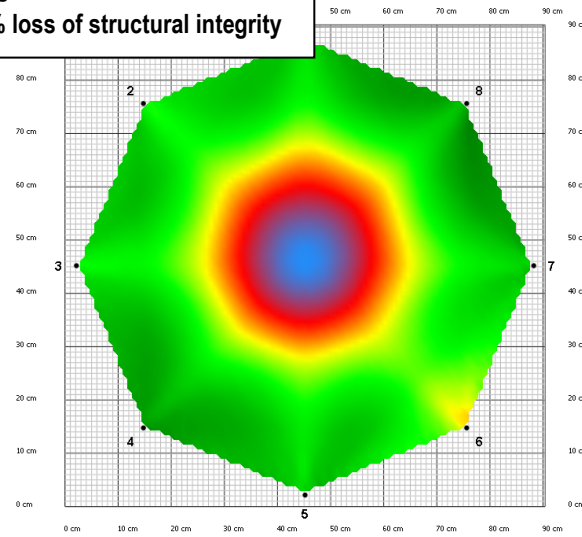
Height: 70 cm
22% loss of structural integrity

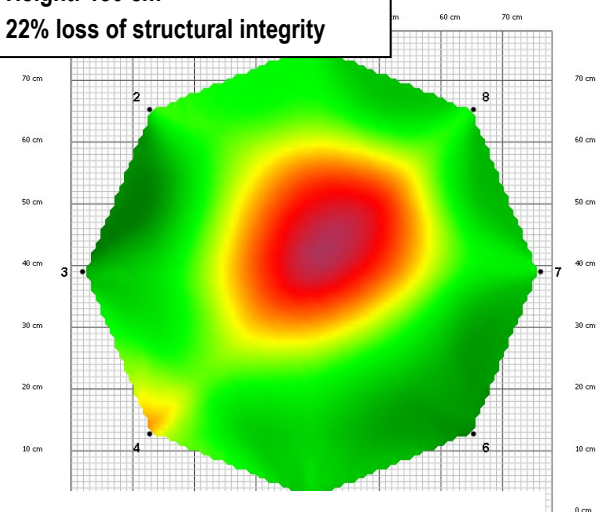
Height: 180 cm
22% loss of structural integrity

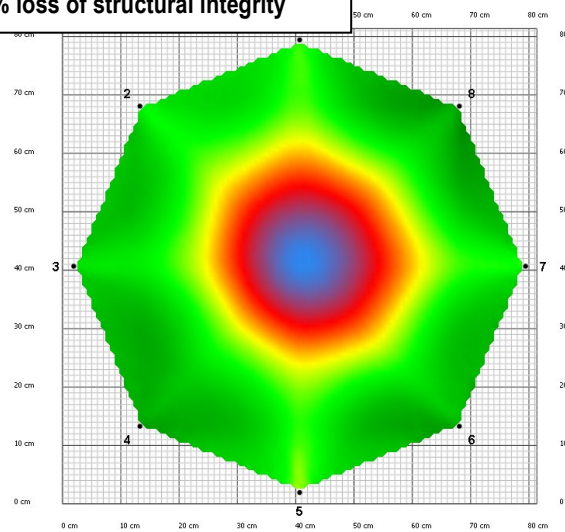
Height: 150 cm
24% loss of structural integrity

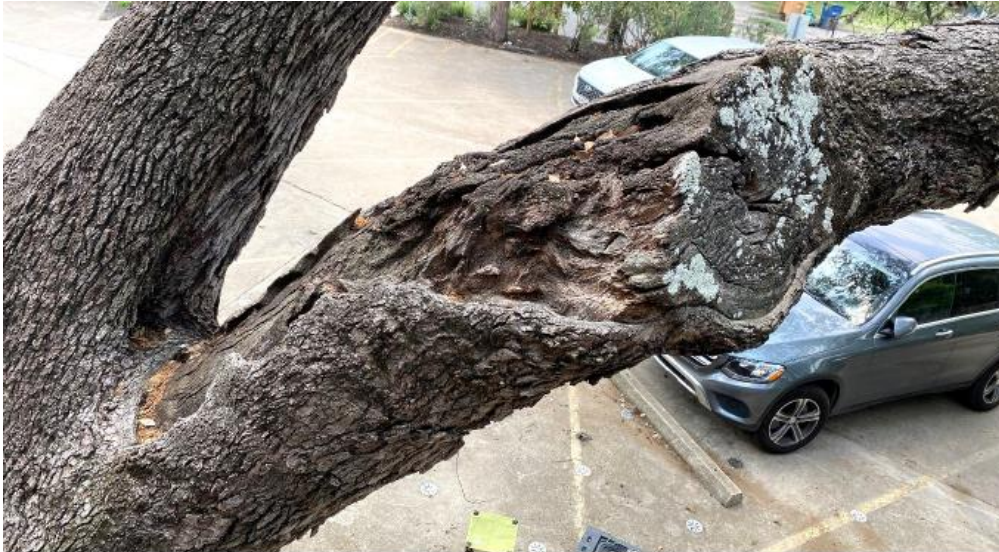
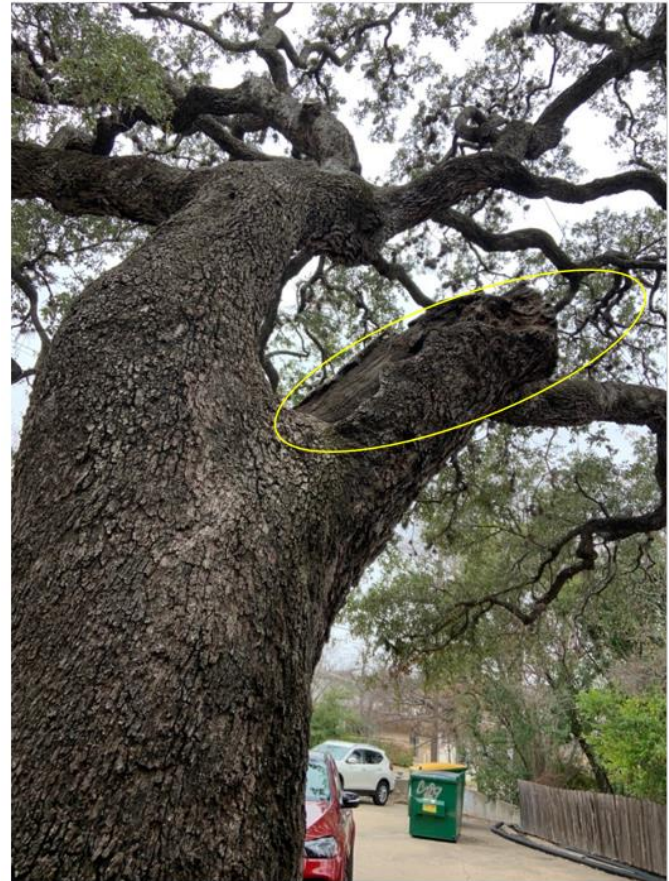
Tree structure

Large scaffold leader decay – west stem

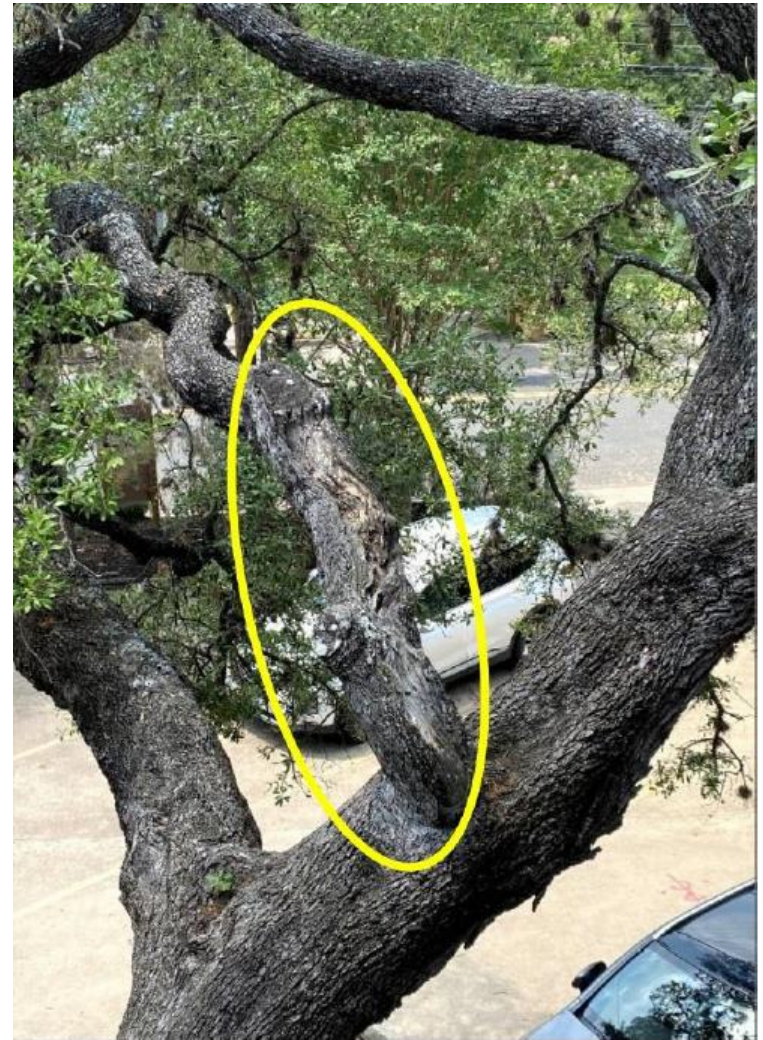
Tree structure (cont.)

Large scaffold leader decay – east stem

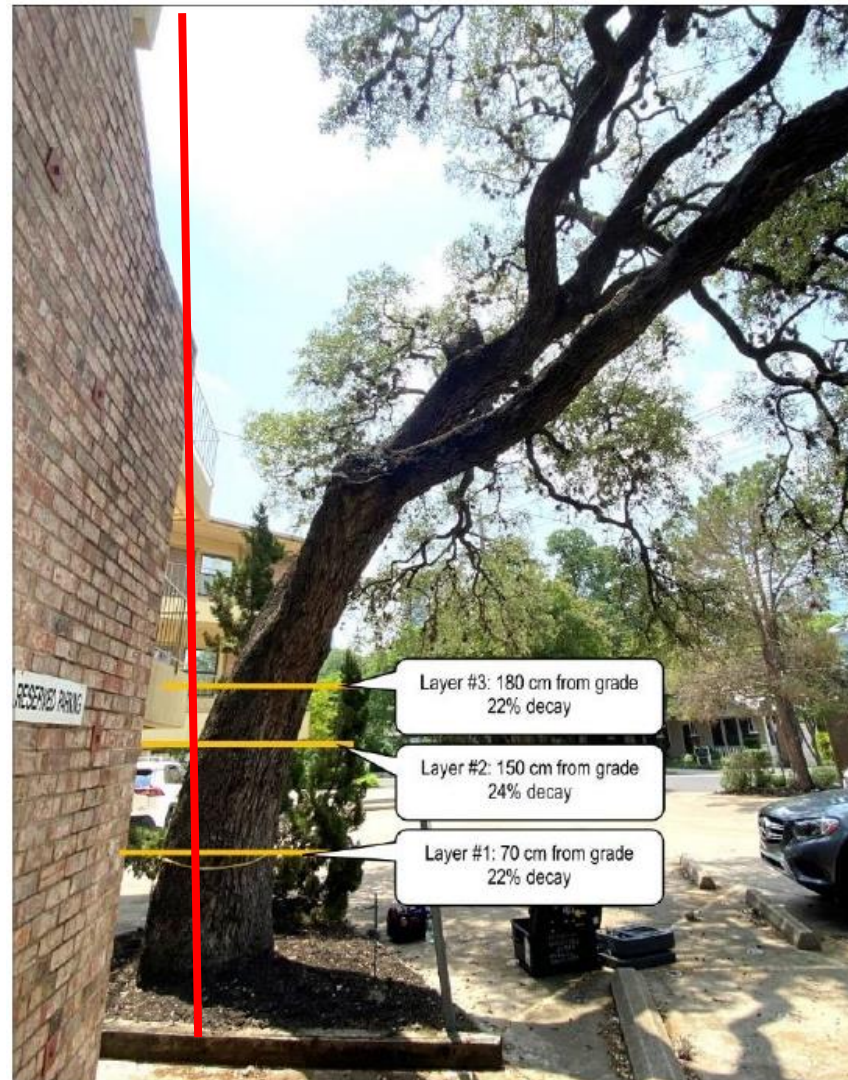
Tree structure (cont.)

- Unbalanced crown
- High load on top of asymmetrical structure

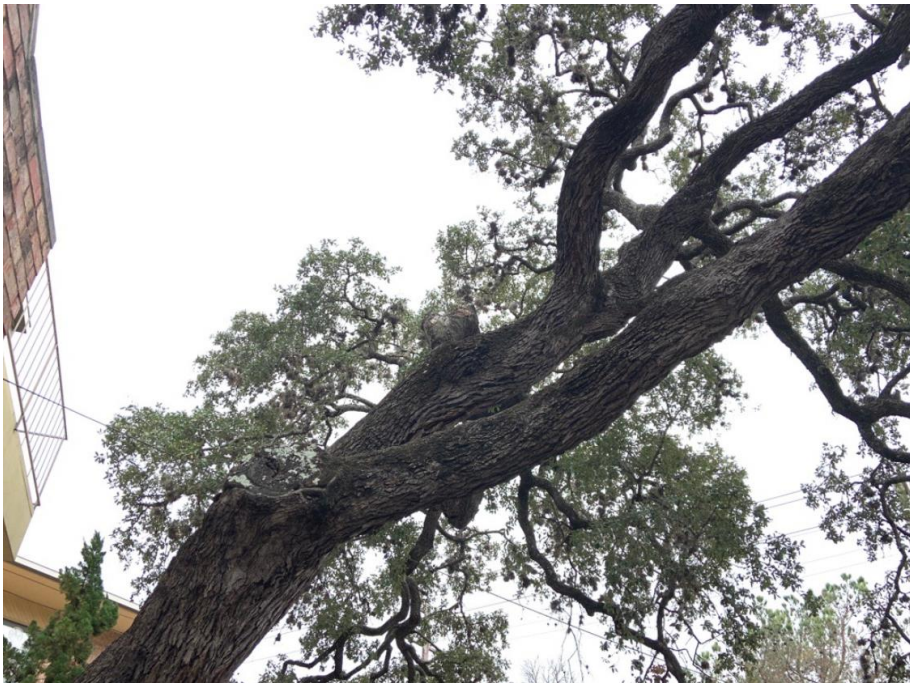
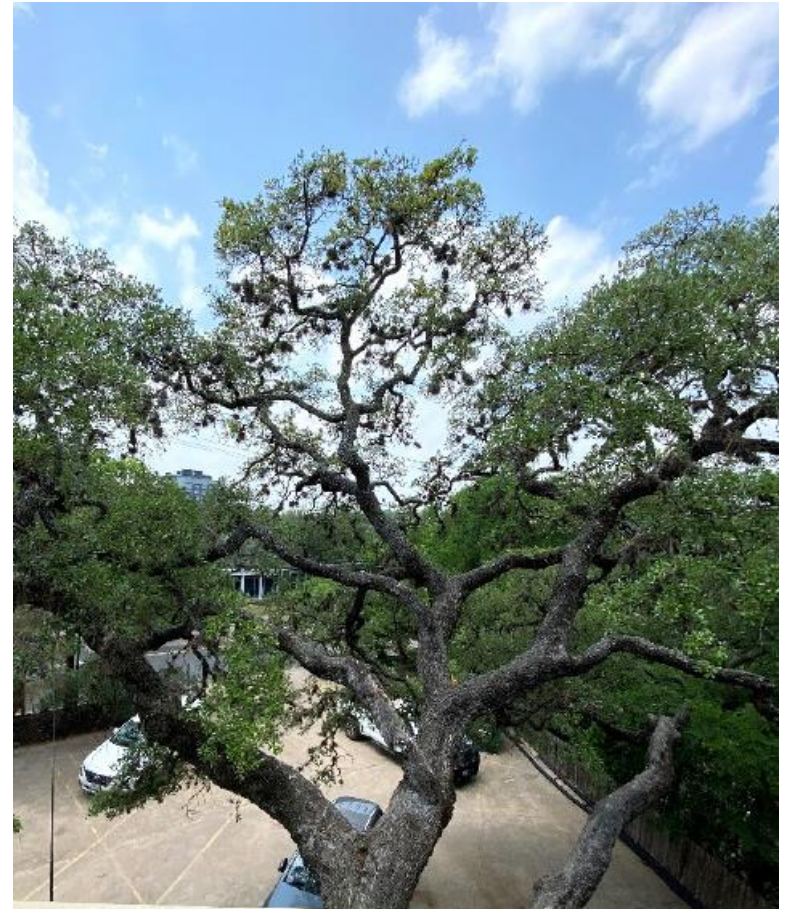
Tree Canopy/Crown

- Thin canopy
- Epiphytic ball moss
- Chlorosis

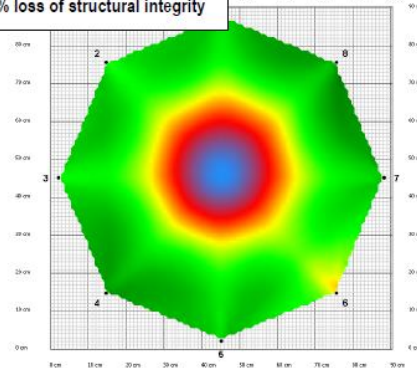
Height: 70 cm
22% loss of structural integrity

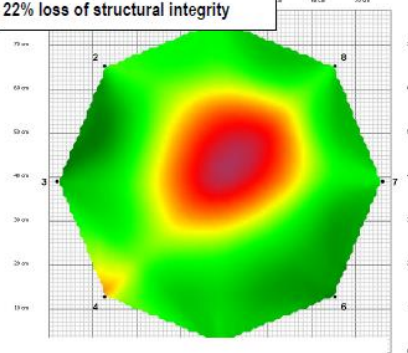
Height: 180 cm
22% loss of structural integrity

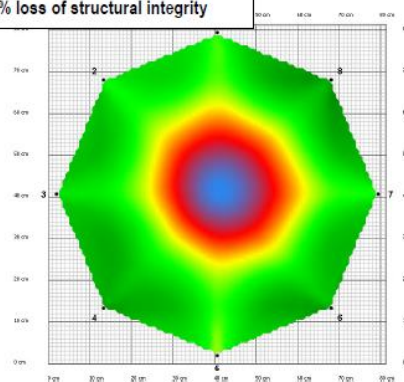
Height: 150 cm
24% loss of structural integrity
