# WOODLAWN RESTORATION PROJECT

# Preservation Approach

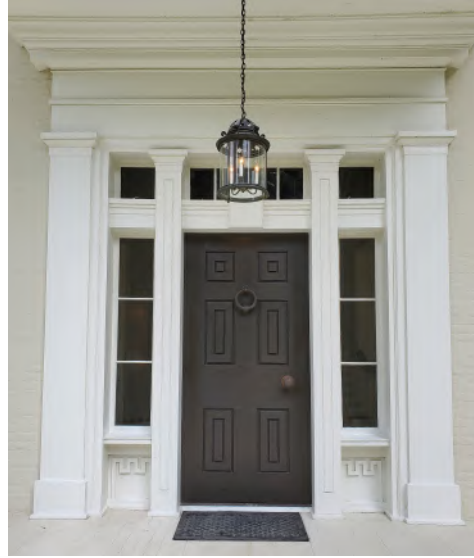
- Restore & refinish original 1854 front door and surround.

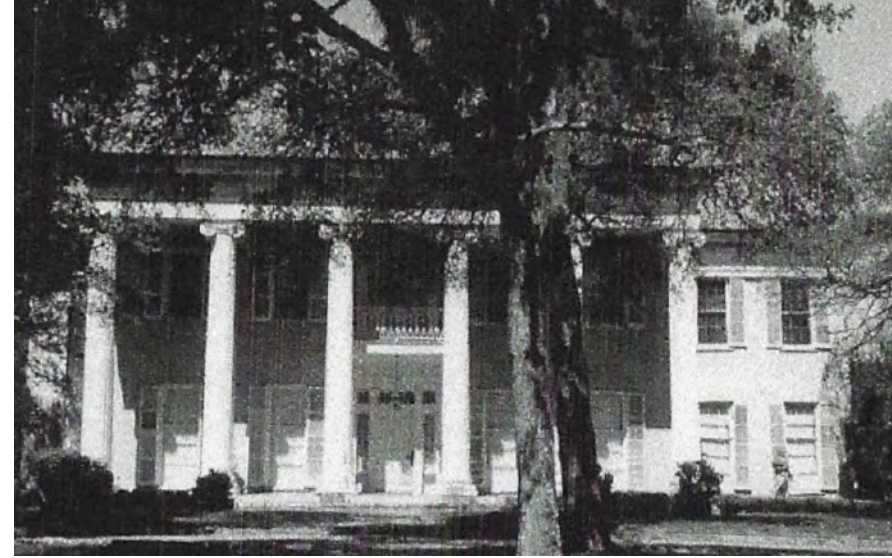
- Re-instate missing shutters, as per historic photo.
- Match shutter design and construct with long leaf pine, accoya, or equal.

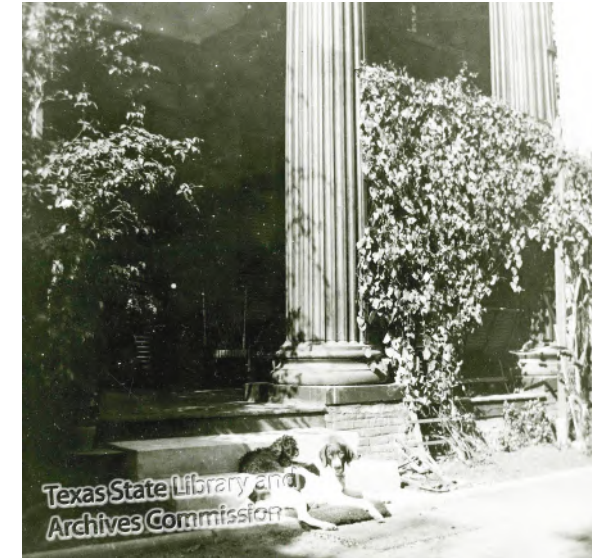
- Restore wood porch detailing and expose brick piers below columns, per historic photo.

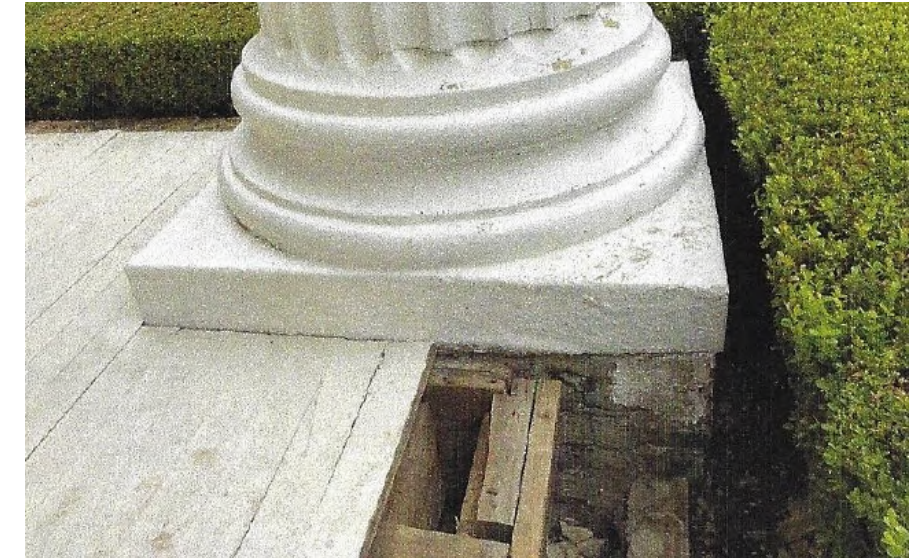
- East porch — remove rotten framing & decking.
- Remove fiberglass coating at column base plinth and repair limestone base.
- Repair rotten wood at columns.

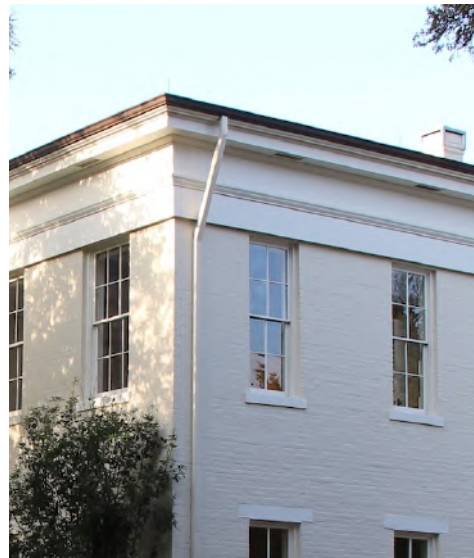
- Replace rotten wood and plywood at entablature.
- Remove existing gutters and downspout. Restore original scuppers and provide new built-in gutters.

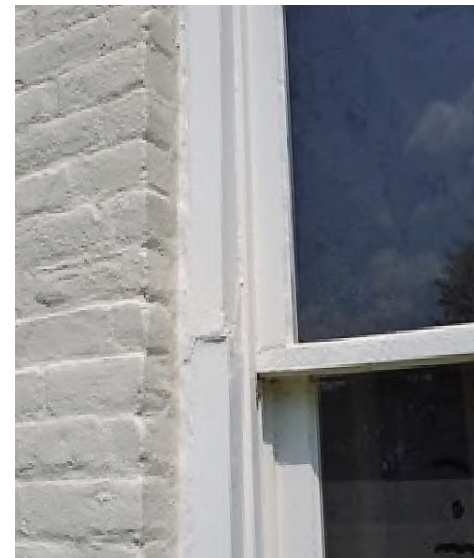
- Many original windows remain and will be repaired.
- Window replacement, when required, will be custom-fabricated long leaf pine, single glazed windows, profiles to match detailing of original windows.

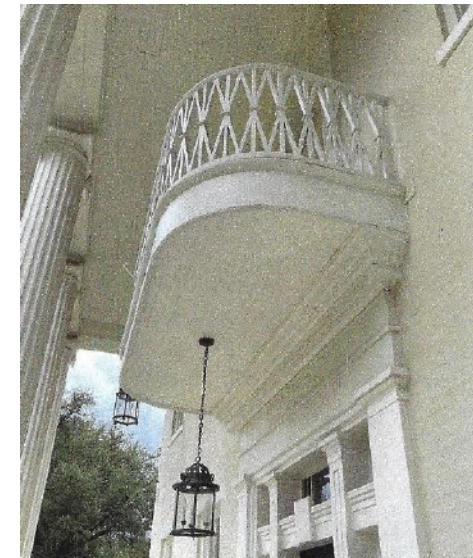
- Remove non-original trim above original door head trim.
- Replace rotten wood at balcony.
- Restore existing pendant lanterns at front porch.

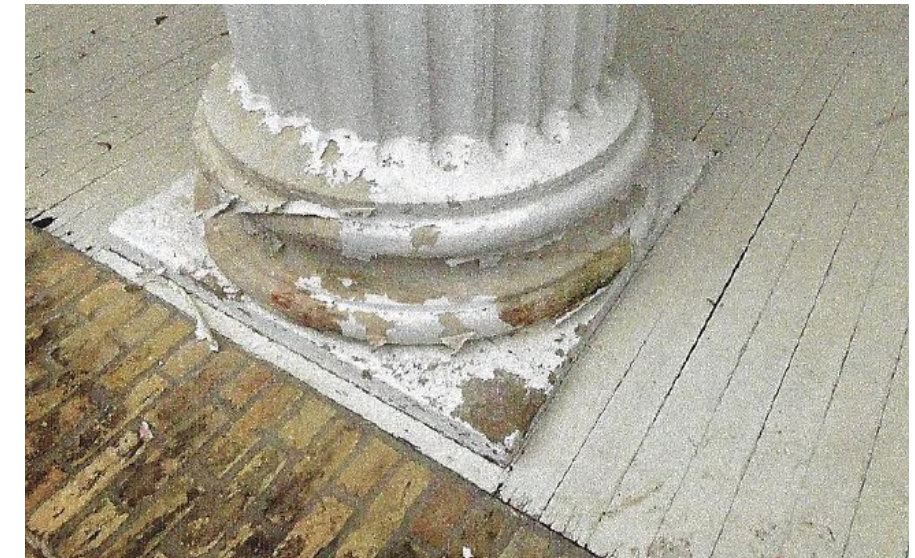
- South porch — remove brick steps surrounding porch now trapping water.
- Remove paint from column base and repair limestone base.
- New wood decking, long leaf pine, accoya, or equal.

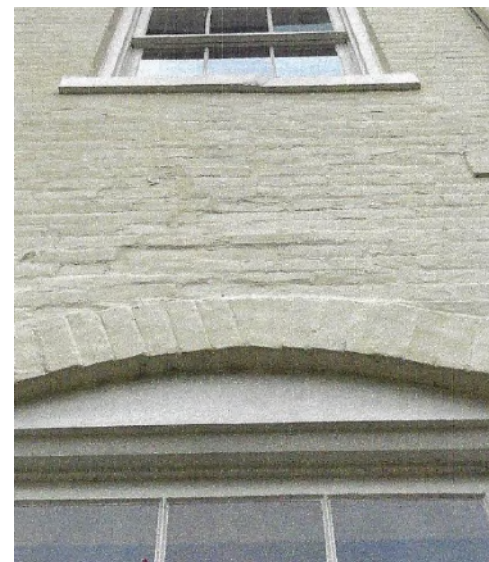
- Repair damaged, settling brick.
- Stabilize and repoint as needed.

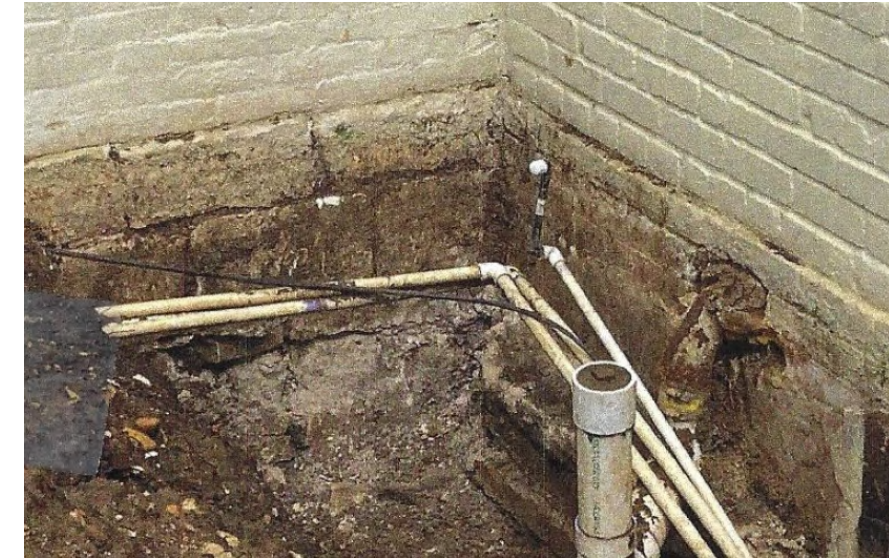
- Existing load bearing brick walls sit on continuous footing of limestone blocks, 18\"-24\" below grade.
- Stabilize and waterproof existing foundation.

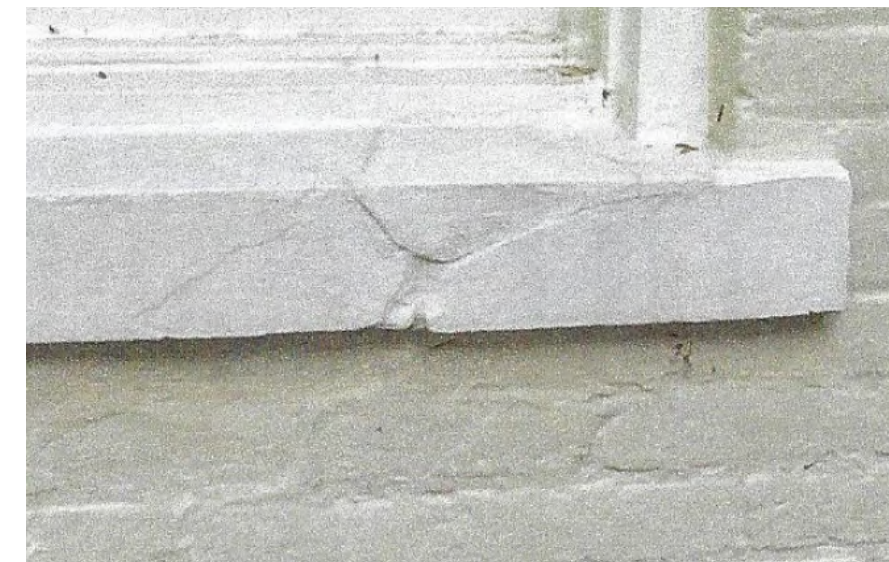
- Repair broken limestone sills. Patch when possible.
- Window sill replacement, where necessary, to be replaced with limestone or brick with matching design, texture and finish..

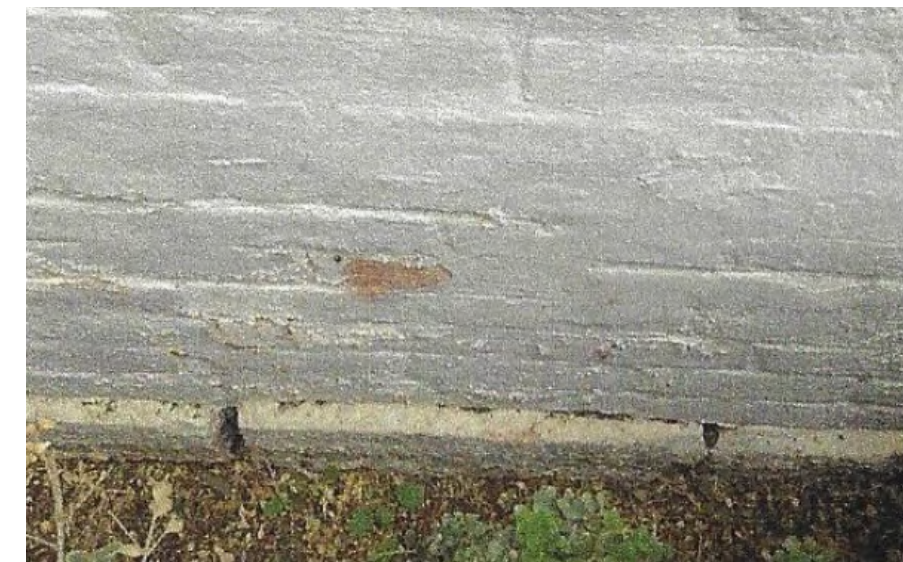
- Paint peeling at damp areas (note visible limestone footing).
- Repair and repaint damaged brick exterior.
