Lambert's Smoker Shed

410 W. 2nd Street, Patio  
Austin, Texas 78701

## Lamberts Downtown Barbecue

### Summary of repair

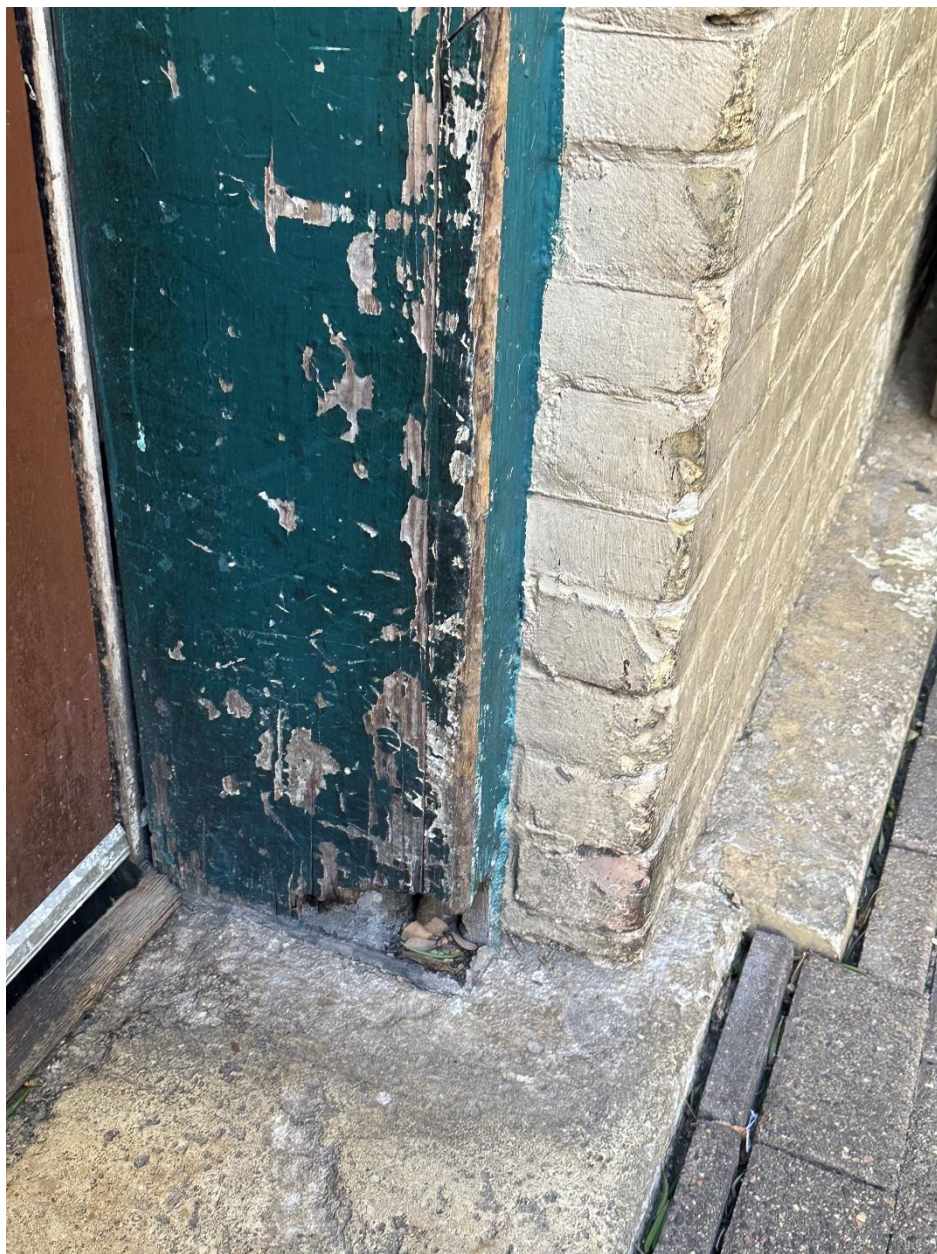
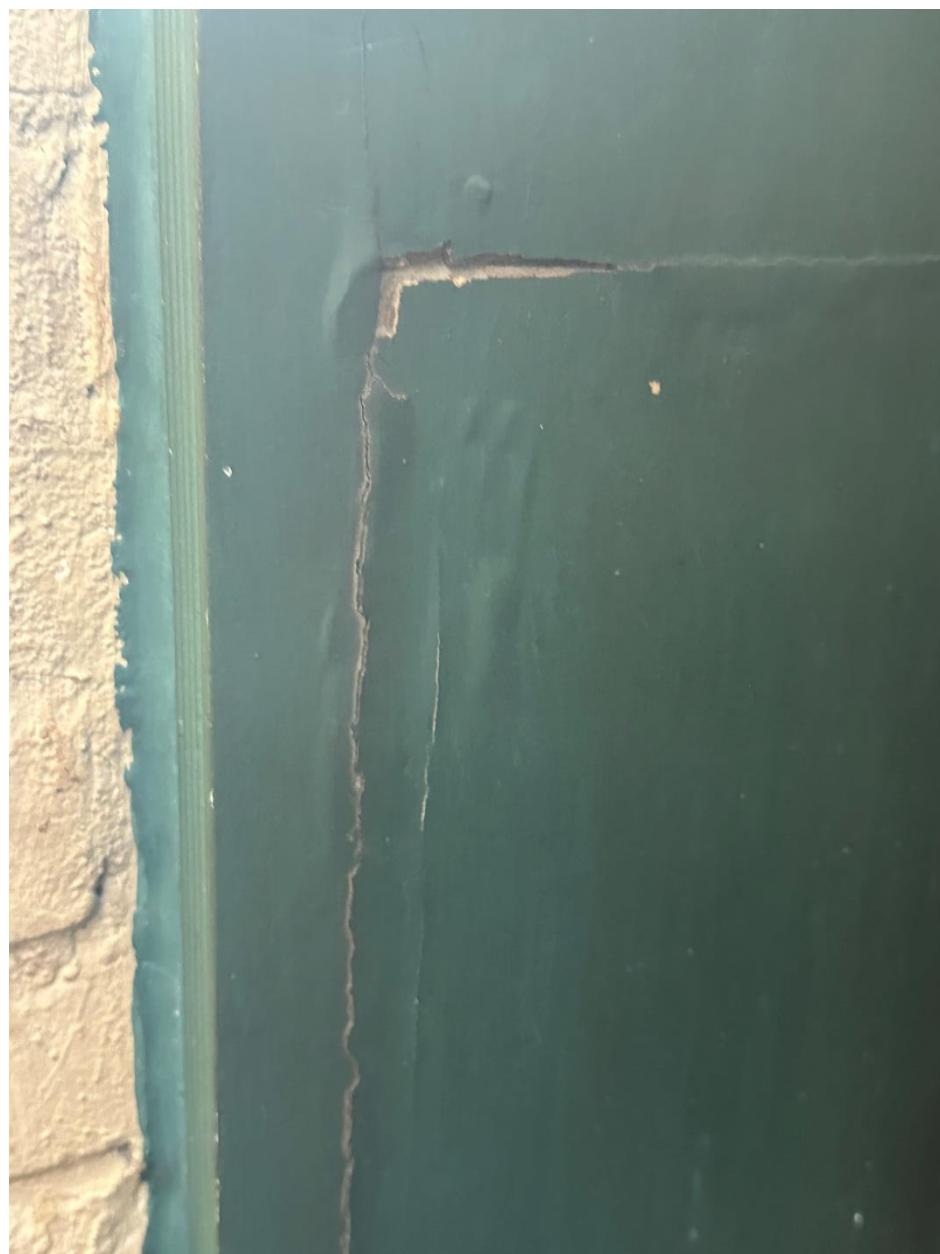
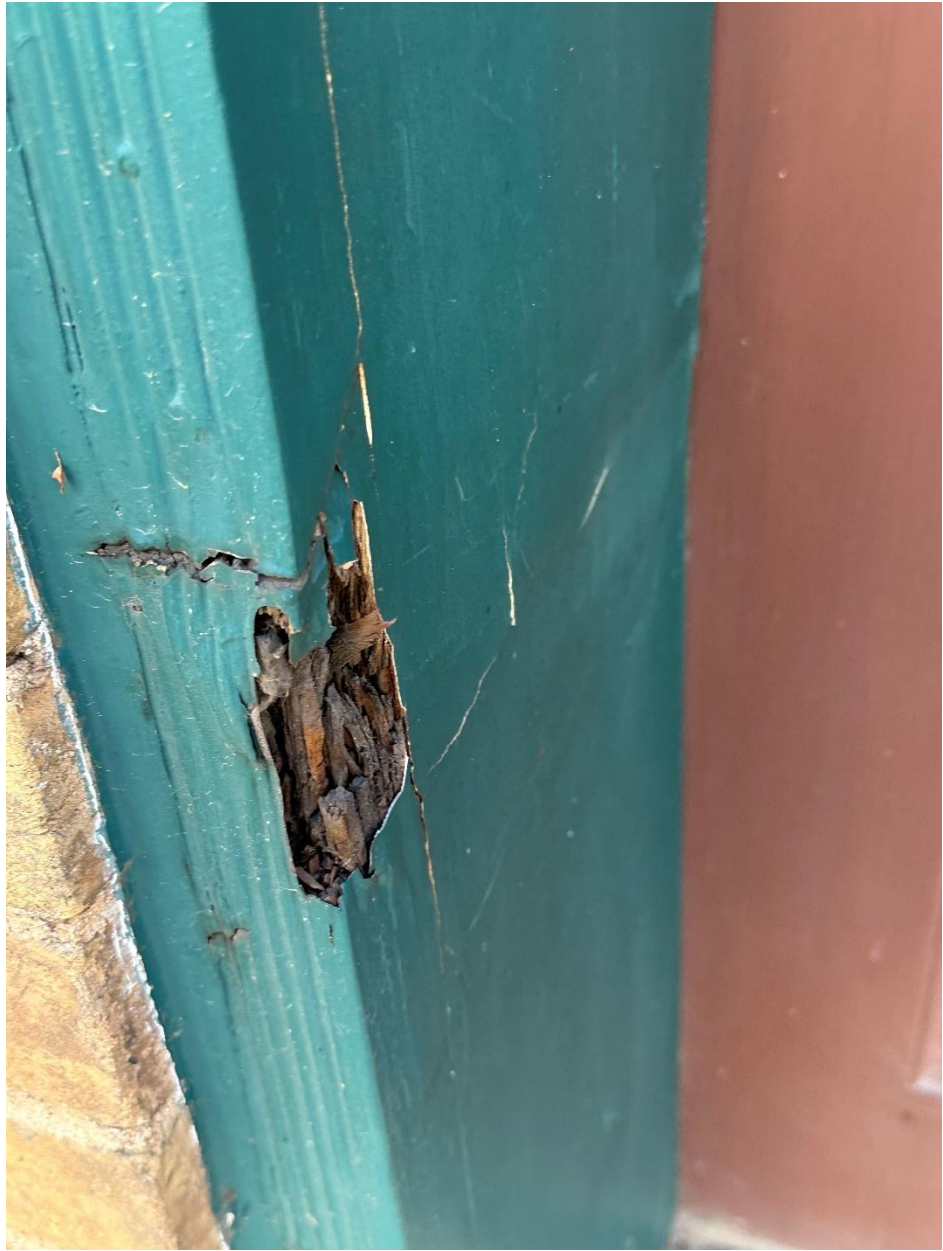
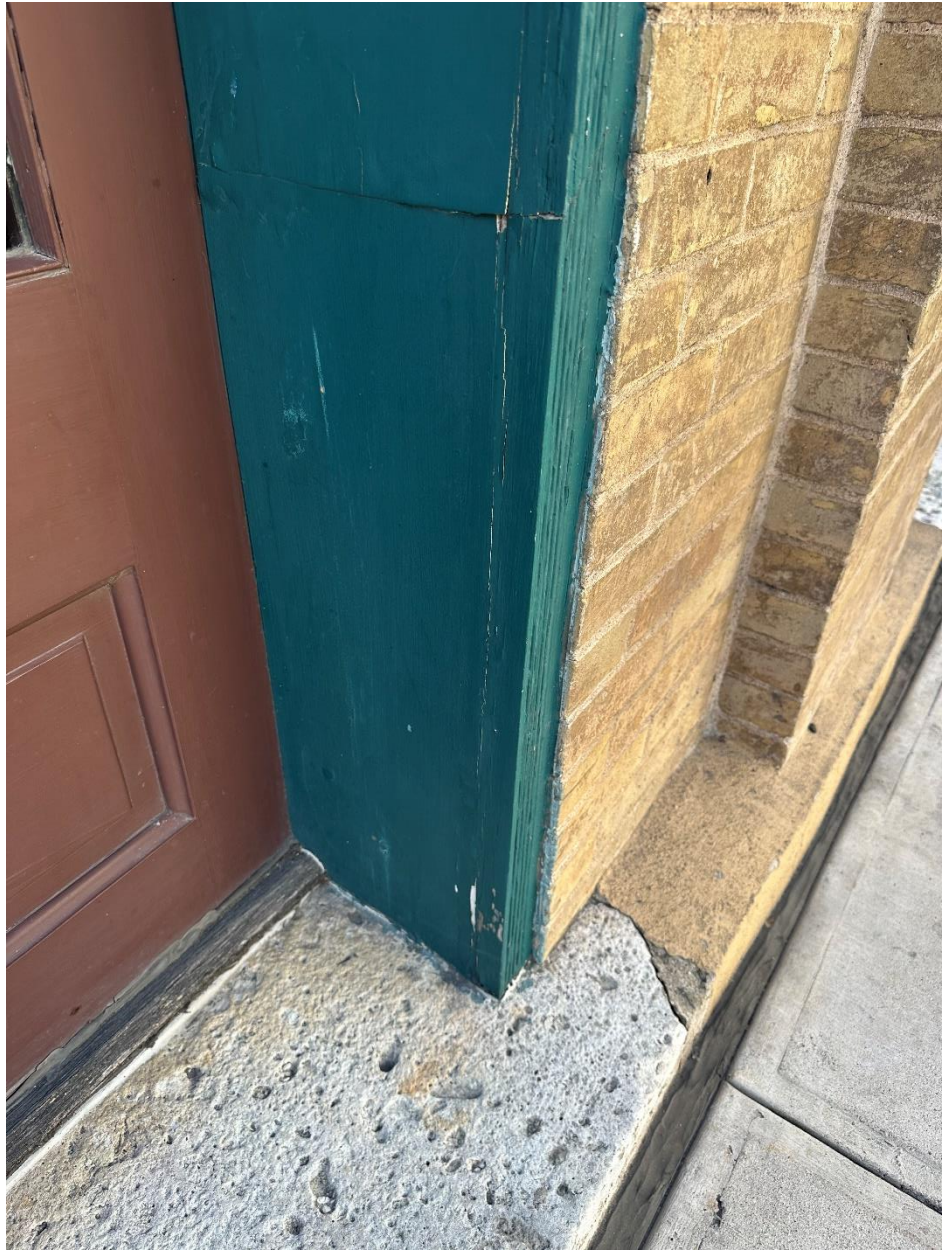
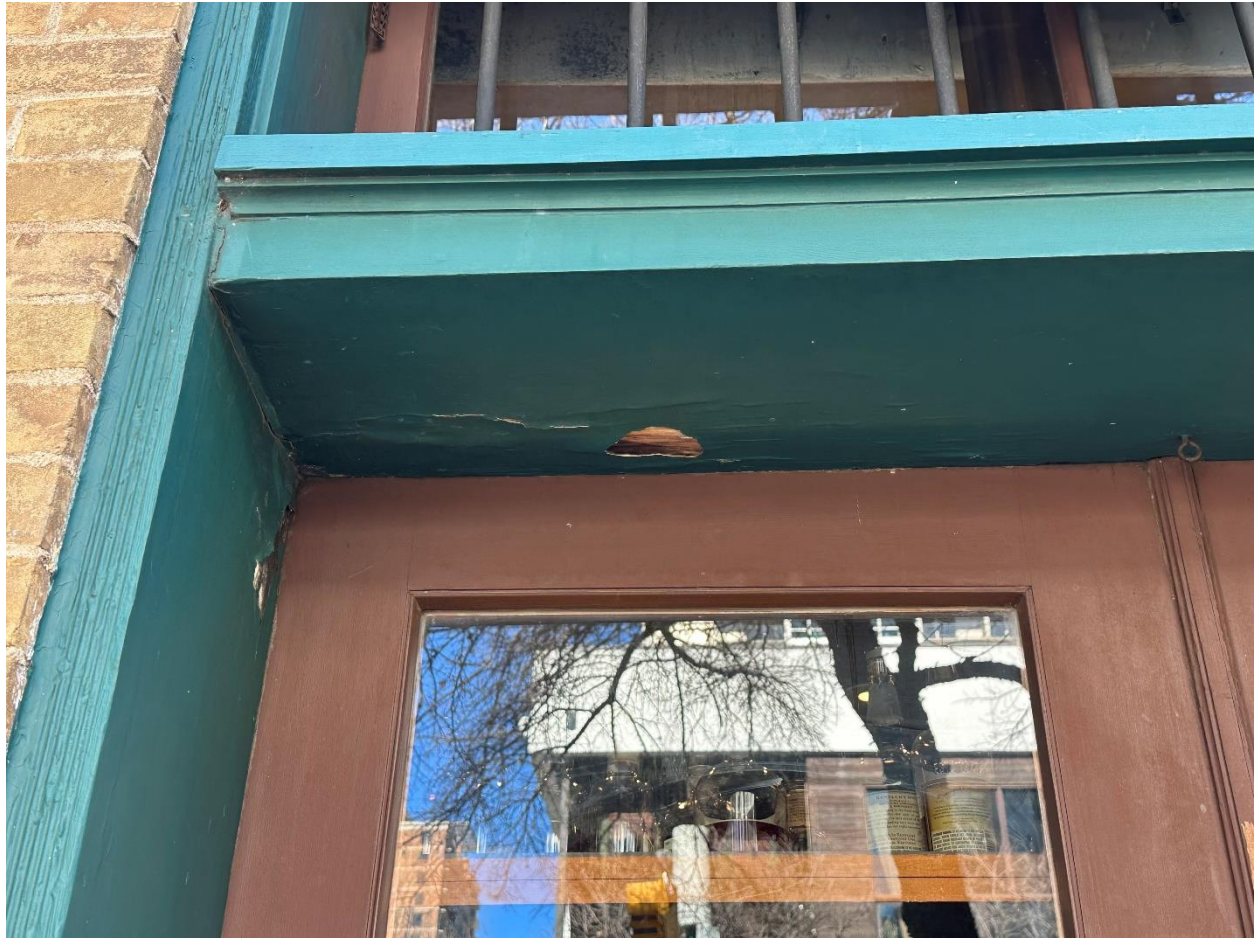
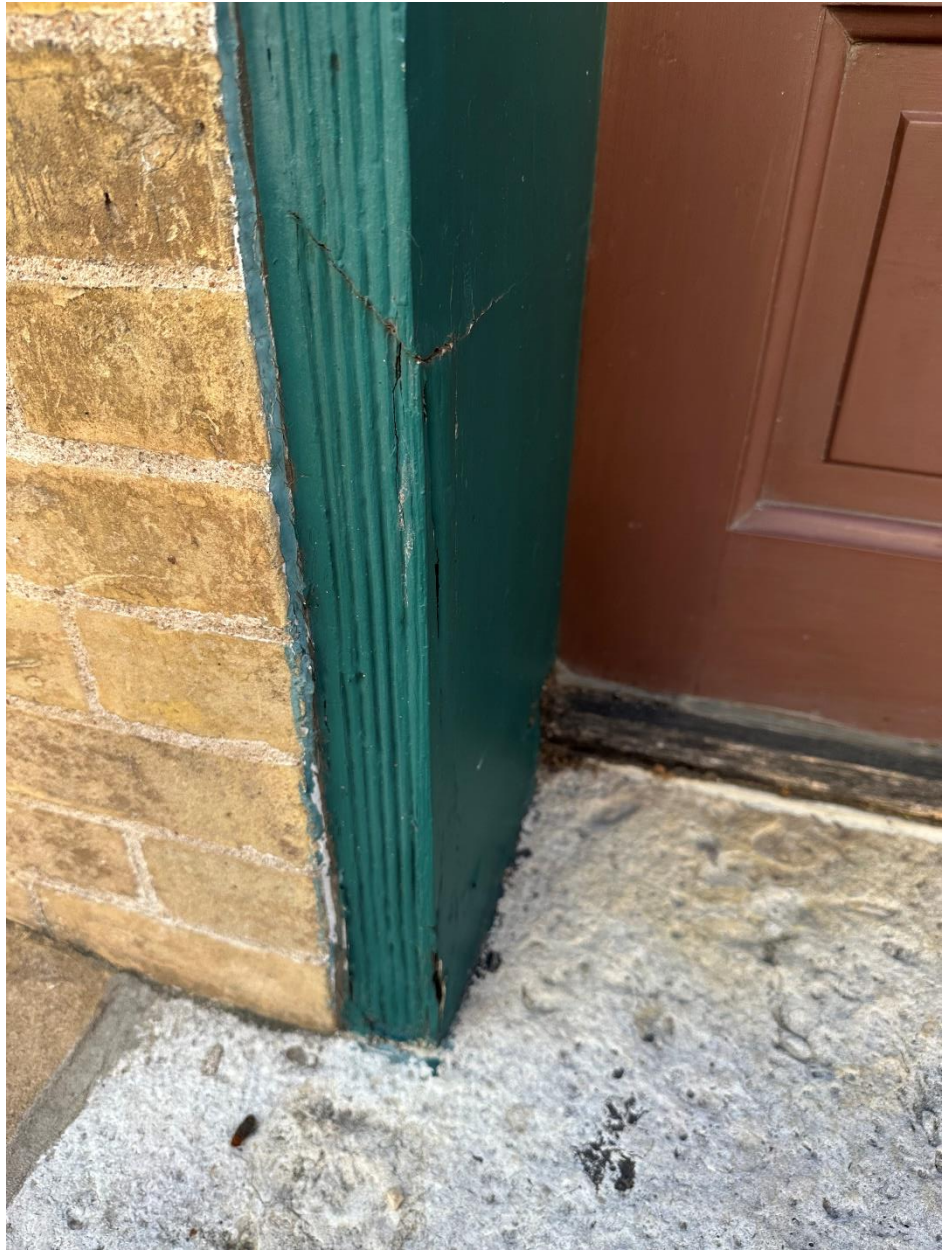
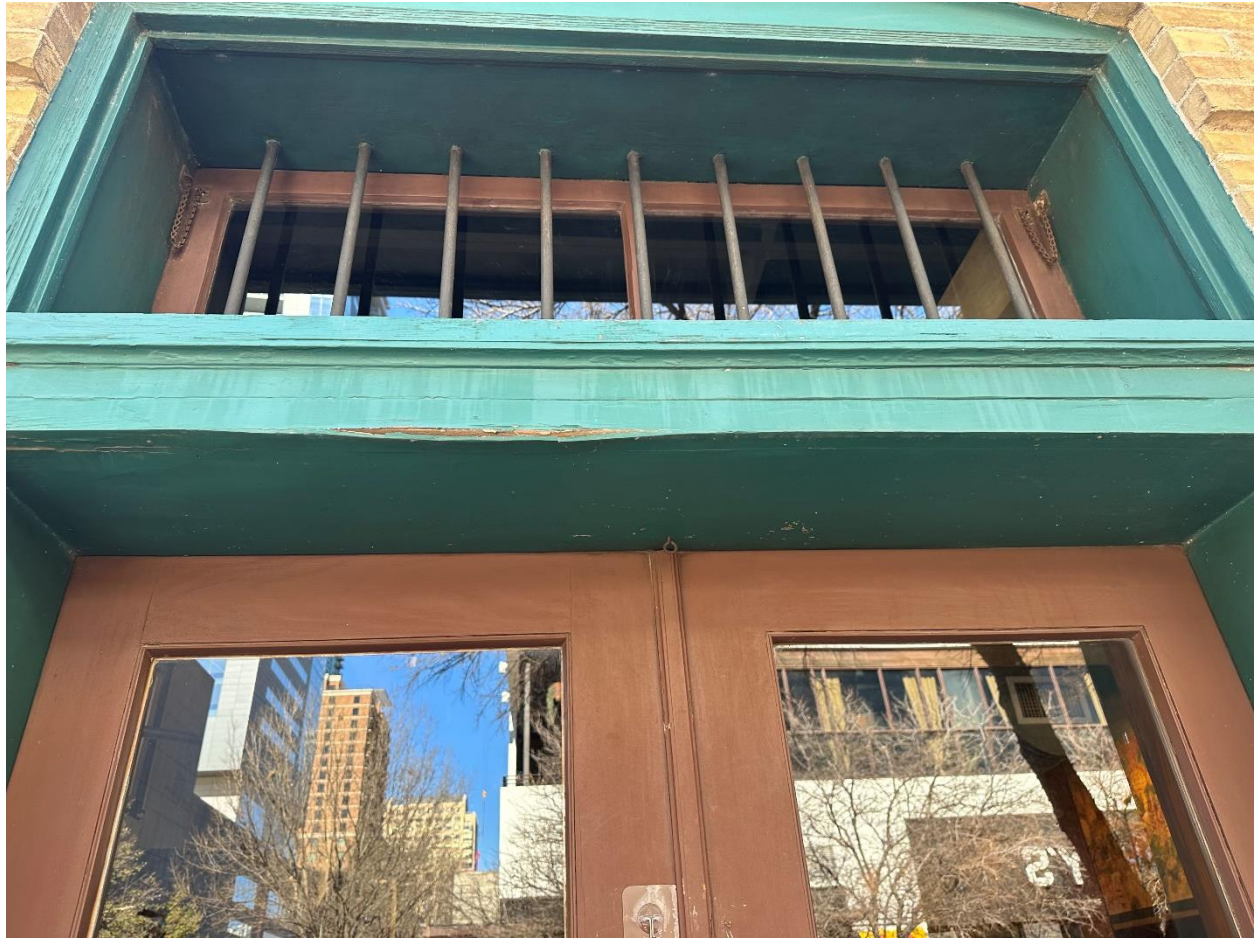
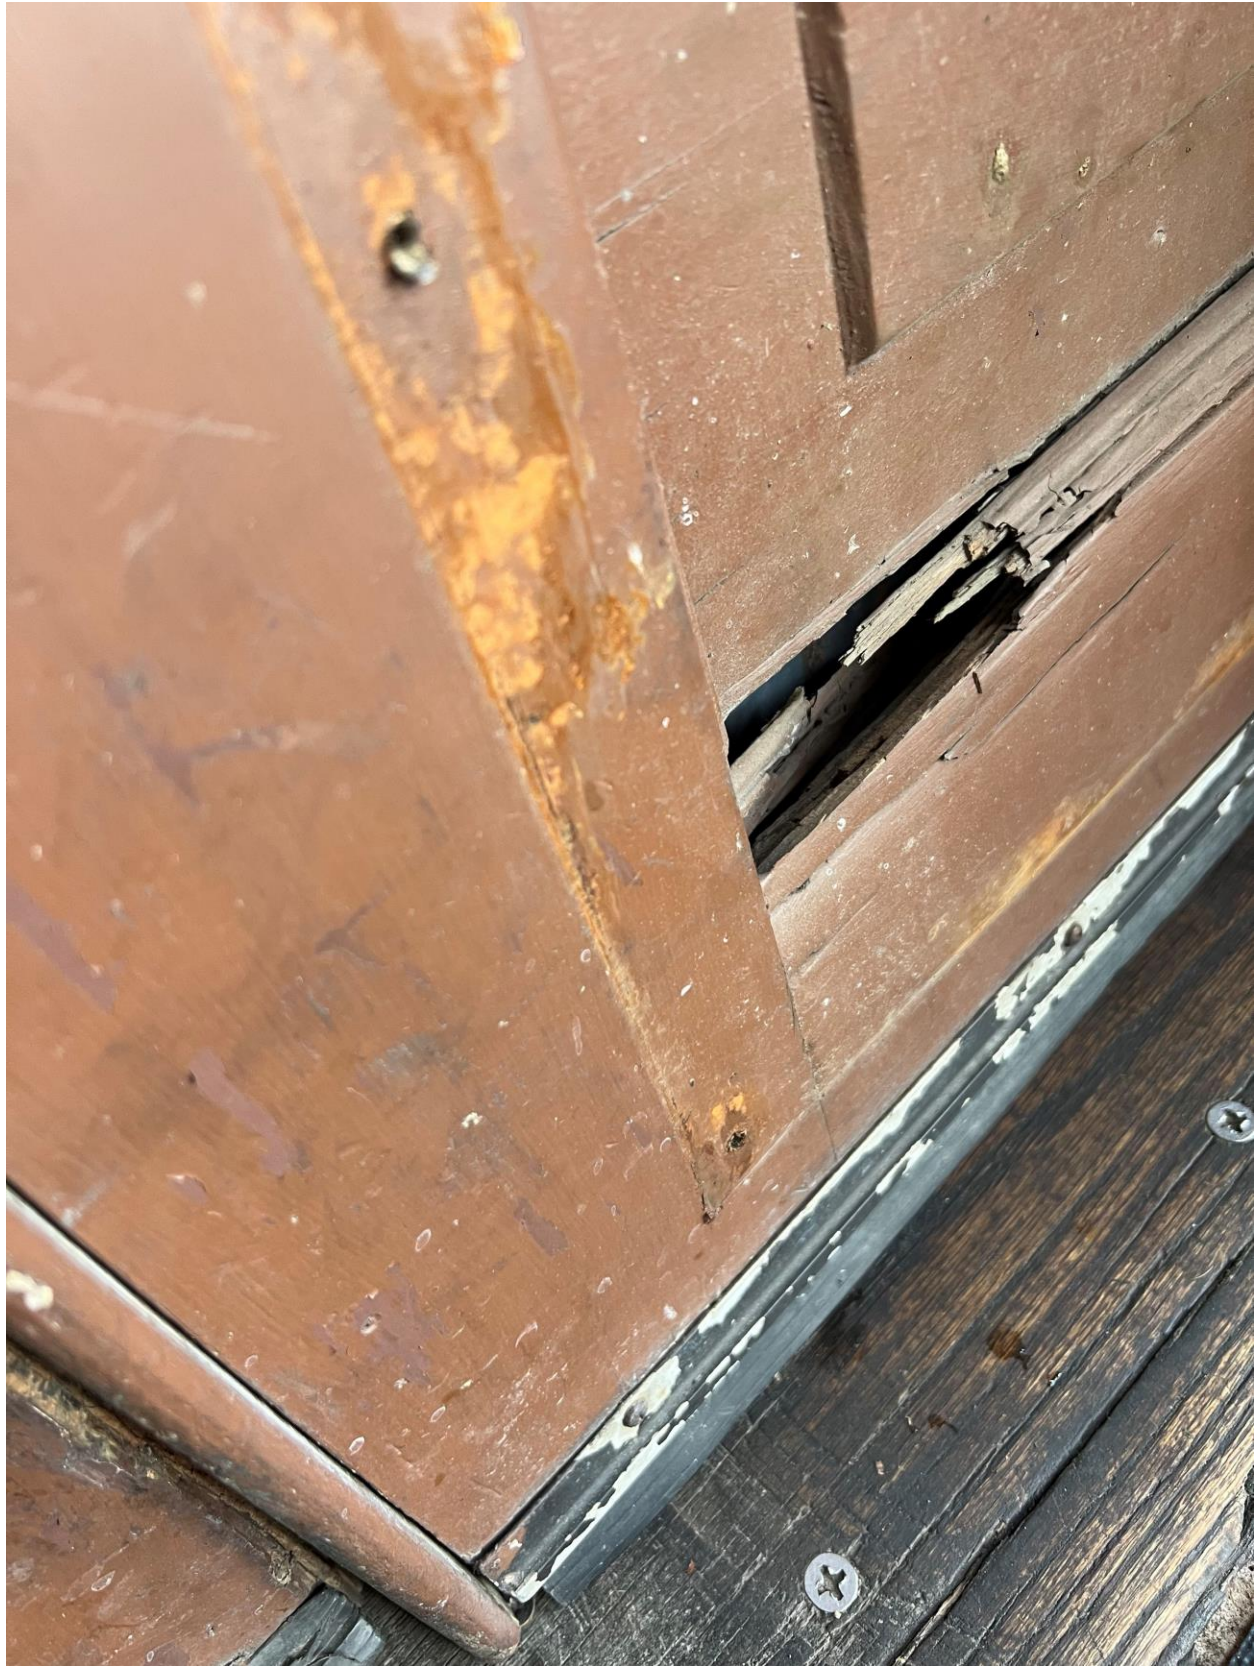
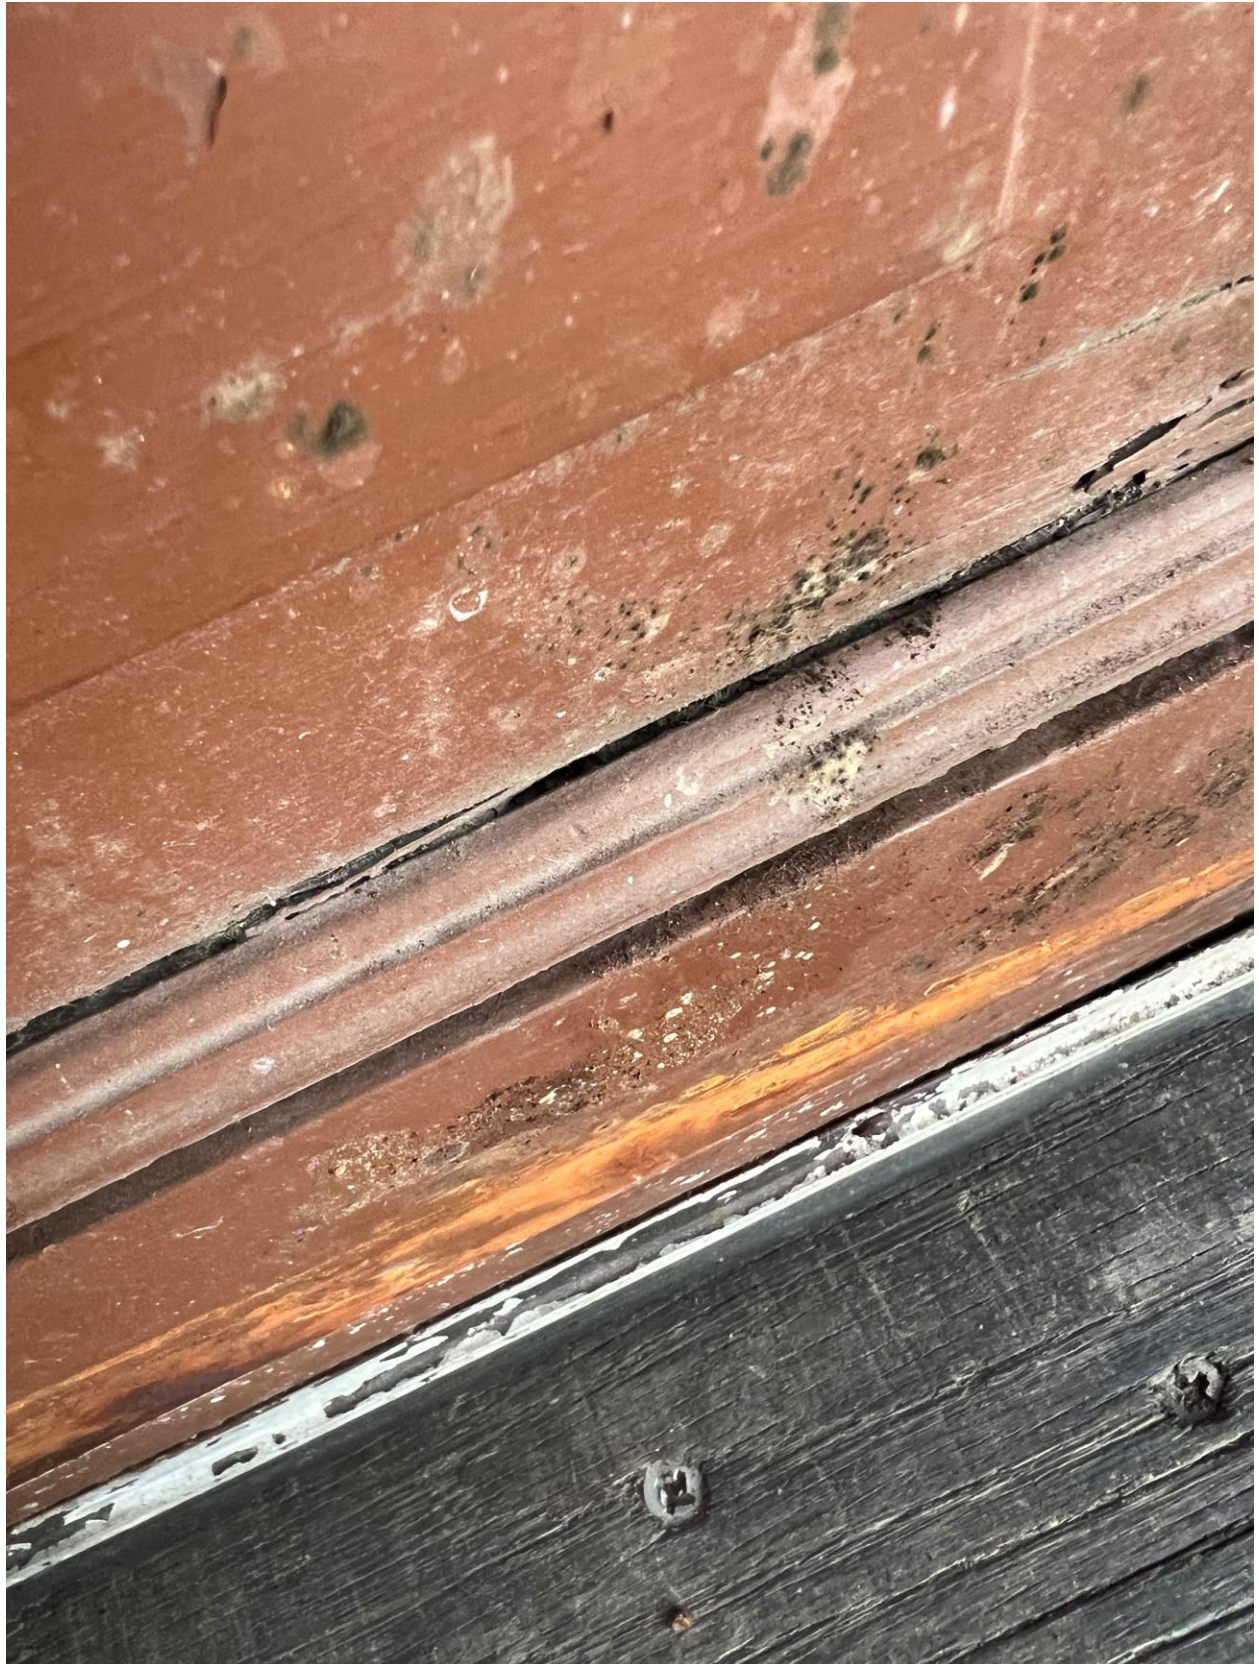
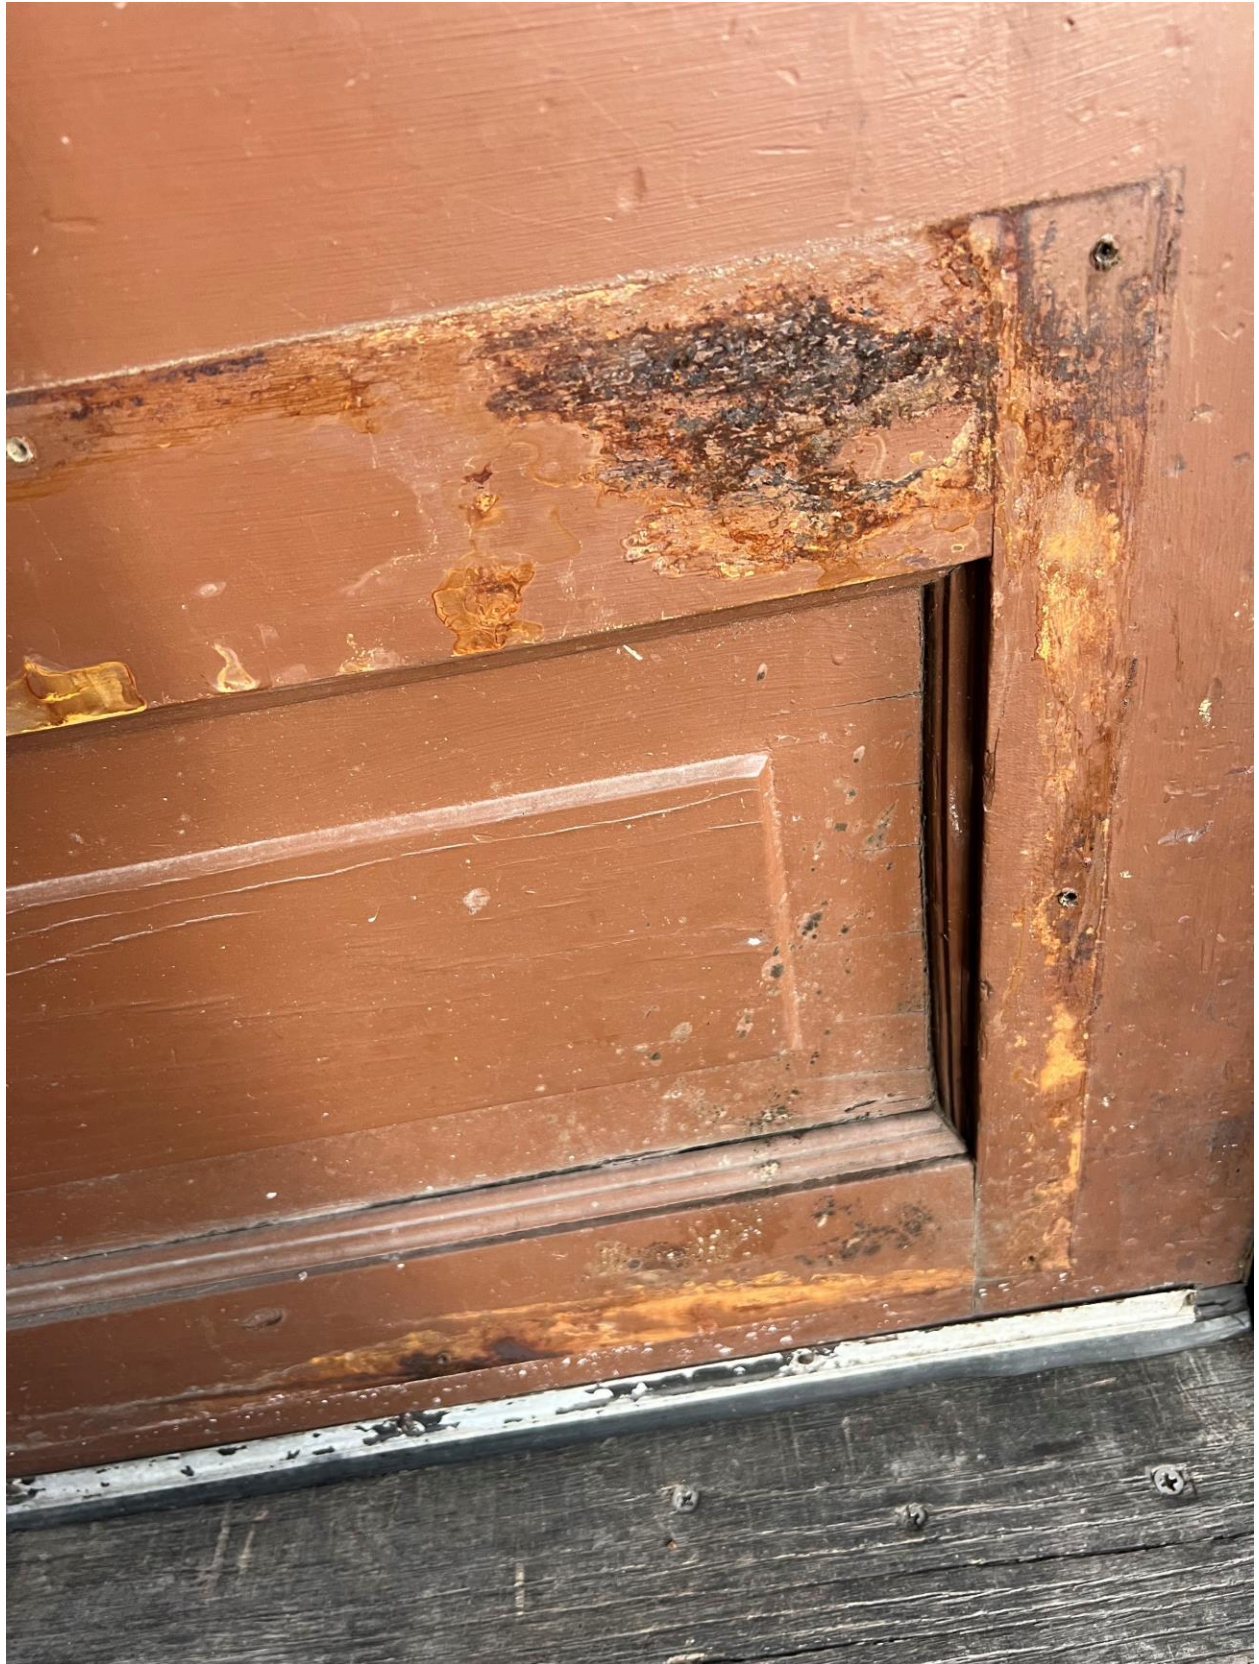
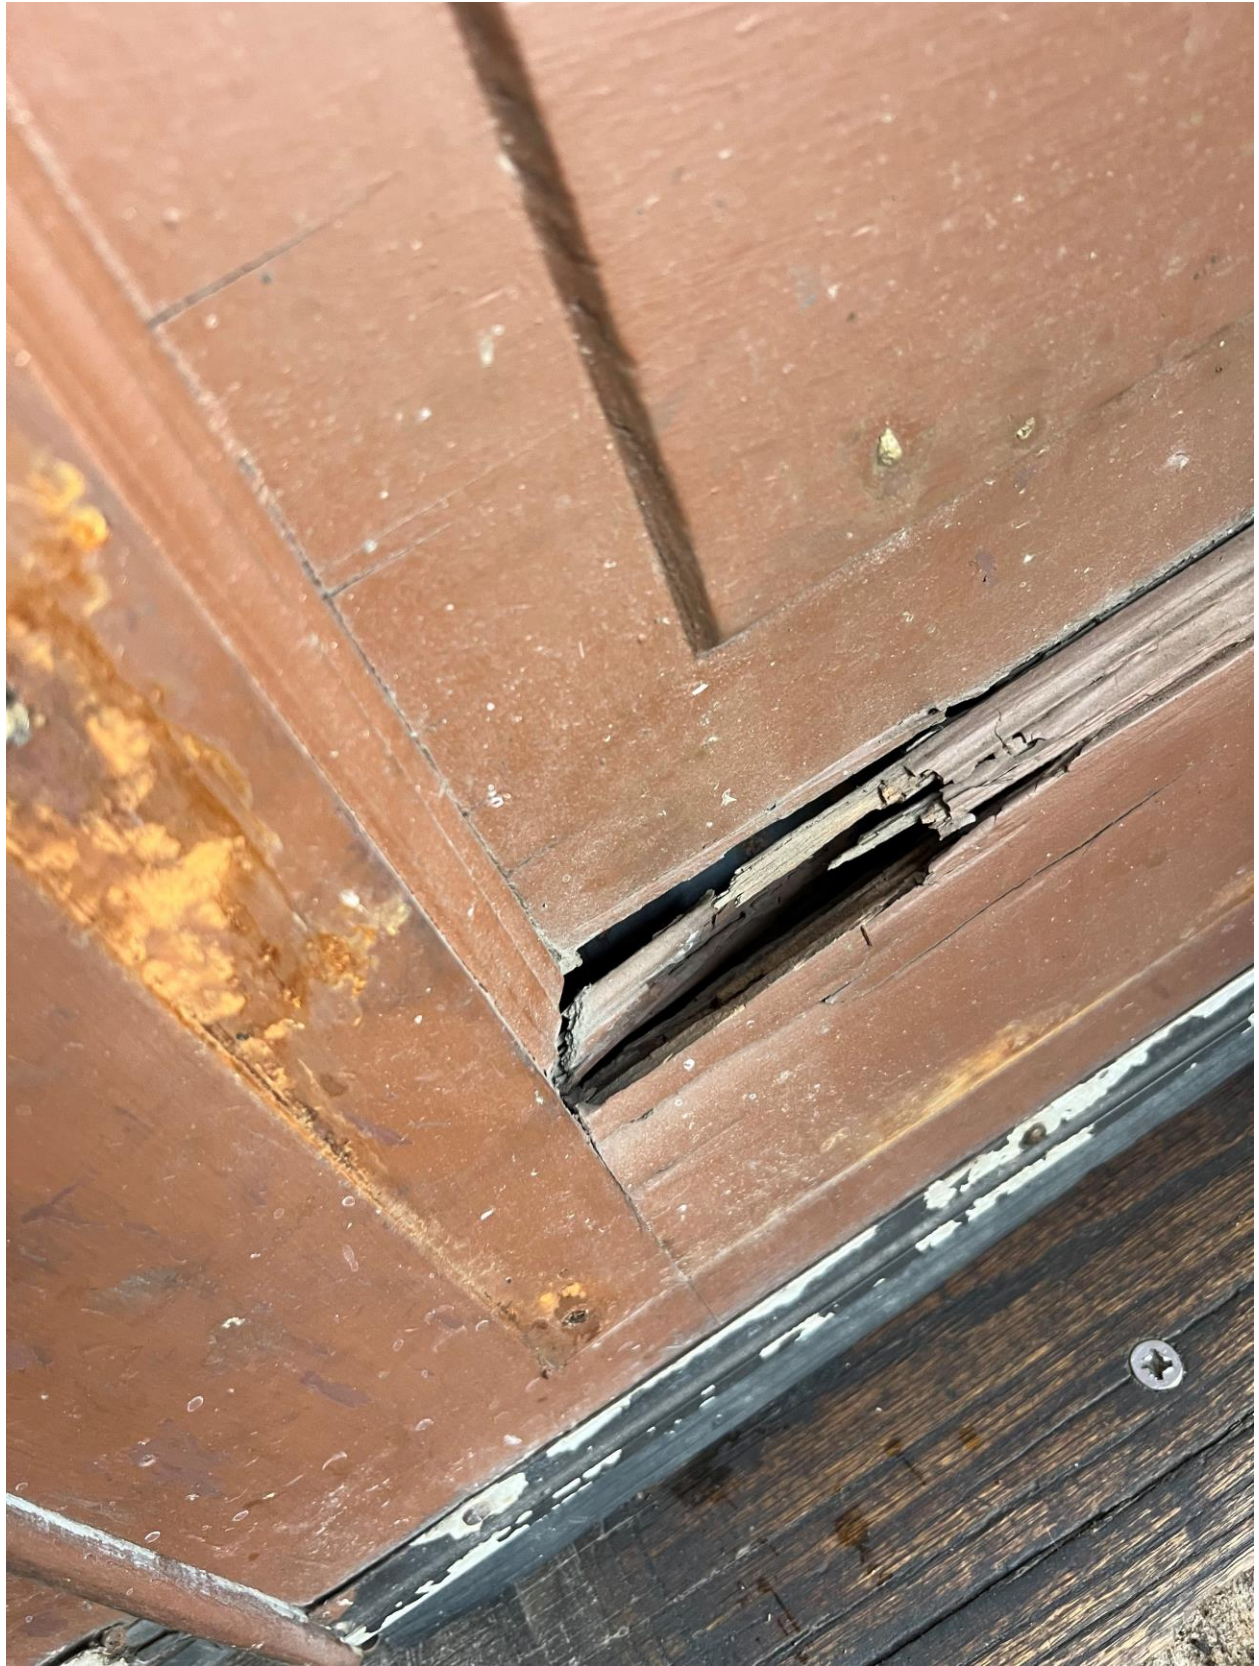
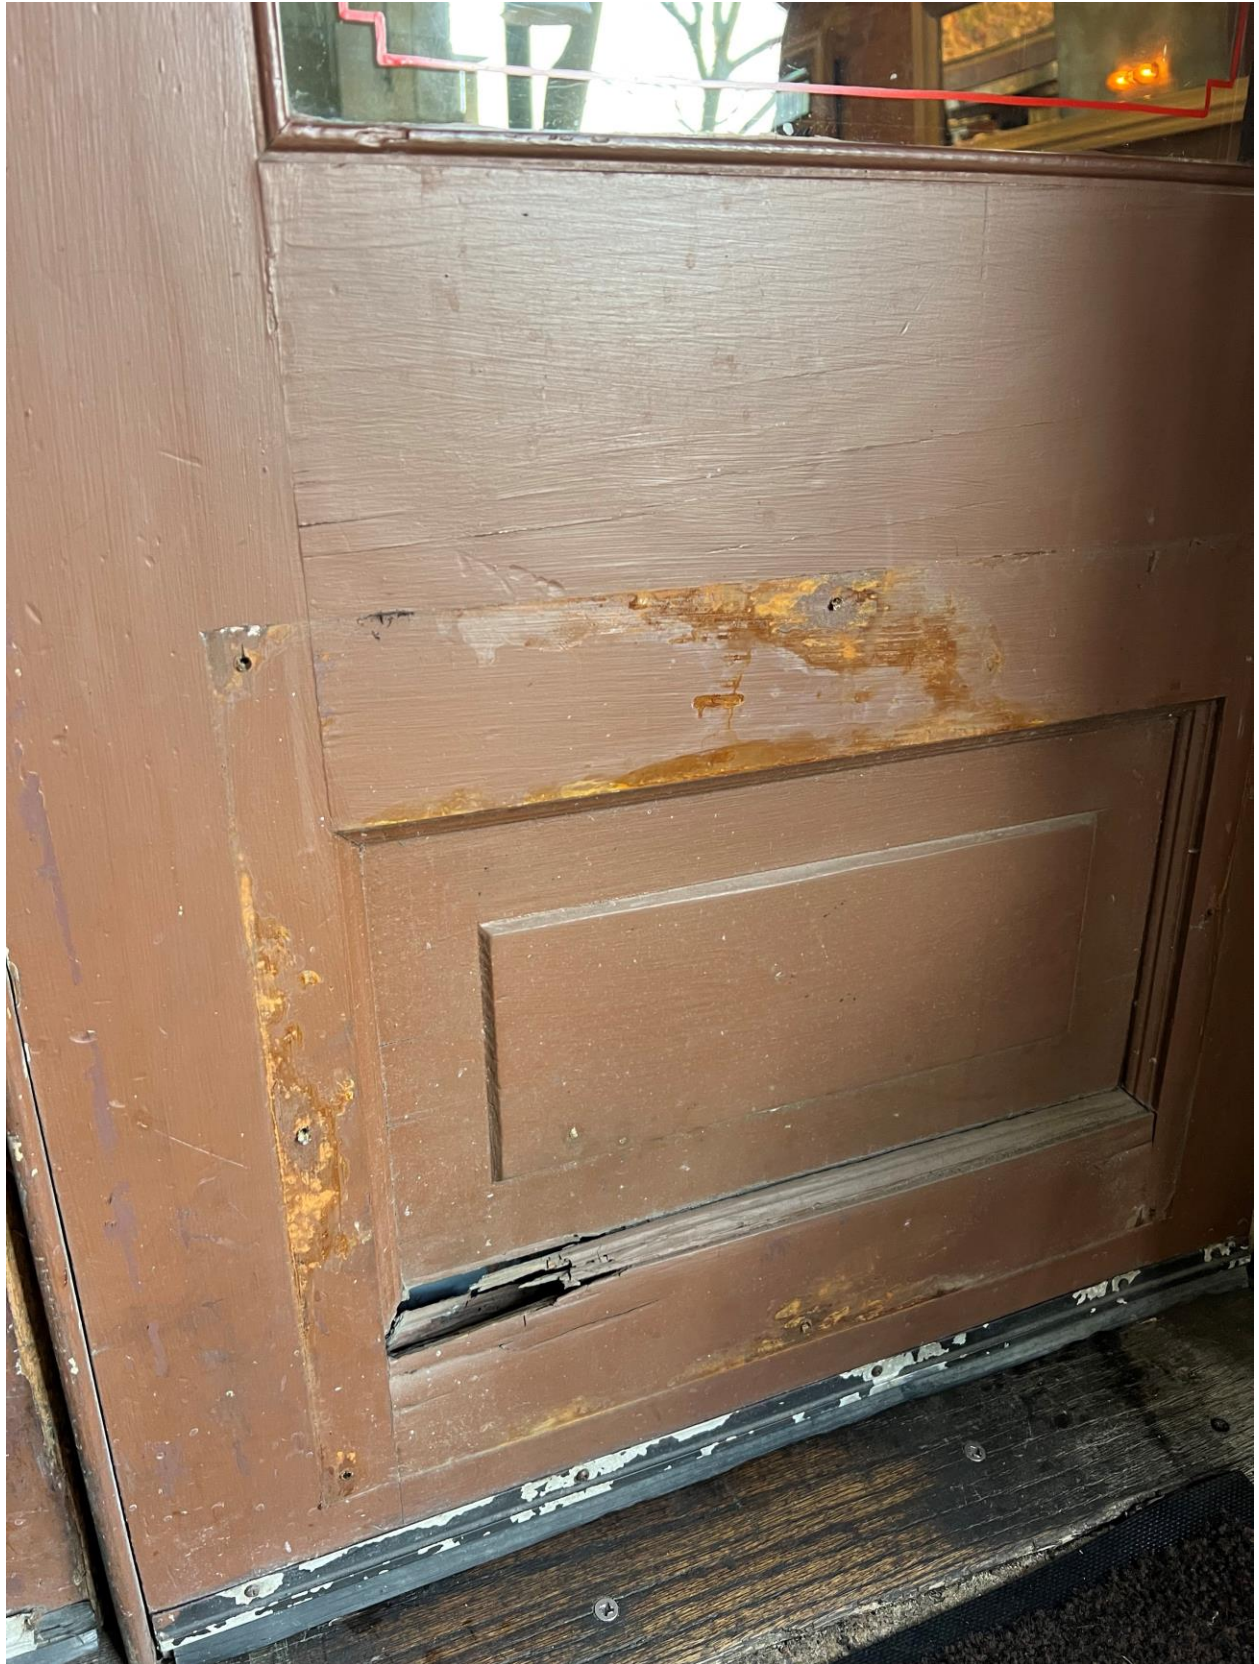
The exterior wood components of this building need to be repaired in several areas. Contractor is proposing to remove wood that is degrading directly above the compromised area by cutting the wood at a miter and replacing with the same species of wood. The wood species is pine and each piece will be adhered with finished nails and painted. Below is a drawing that demonstrates how the wood will be repaired, as well as photos of the compromised areas.
