COVER SHEET

Heritage Preservation Grant - Historic Garage Renovation

1316 W 6th St
Austin, TX 78703
10/16/08
LAS #P0177-22

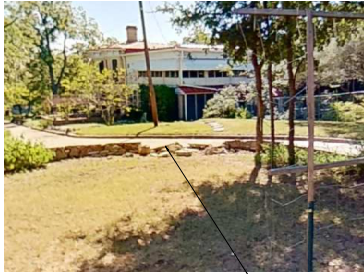
PHOTO 2: REPAIR AND REBUILD CRESCENT RETAINING WALL. DATE 2022-JUL-30.

- REPAIR AND REBUILD CRESCENT RETAINING WALL TO ORIGINAL HEIGHT; TOTAL LINEAR FEET: 84'-6"; V.I.F. REFER TO PHOTO 2.
- EXCAVATE, REPAIR, AND REBUILD EXISTING RETAINING WALL. REFER TO HISTORIC PHOTOS 4 AND 5.
- REPLACE ROOF WITH NEW CEDAR SHAKE ROOF.

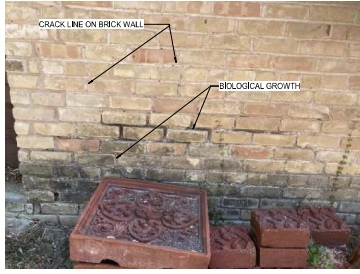
PHOTO 3: BRICK CRACKS AND BIOLOGICAL GROWTH ON SOUTH FACADE. DATE 2022-JUL-30.

1. REPLACE WITH NEW CEDAR SHAKE ROOF.
2. REPAIR DOOR, REPLACE WITH NEW TRIM, FRAME, NEW PAINT FOR DOOR, TRIM, FRAME PAINT TO MATCH HISTORIC PAINT COLOR. REFER TO PHOTOS 9 AND 14.
3. REMOVE BIOLOGICAL GROWTH. REFER TO PHOTOS 13 AND 15.
4. REPAIR CRACKS ON BRICK. REFER TO PHOTOS 13 AND 14.
5. INSTALL KIOSK TO DISPLAY PROPERTY HISTORY AND PROJECT INFORMATION.
6. INSTALL NEW DOWNLIGHT TO LIGHT KIOSK.

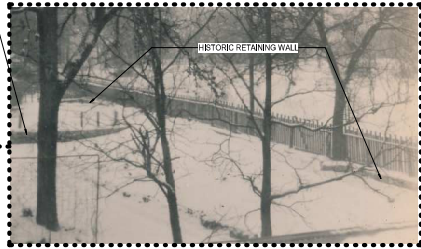
PHOTO 5: ZOOMED VIEW OF HISTORIC PHOTO 4

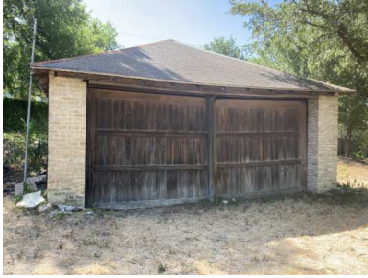
PHOTO 7: GARAGE DOOR ON WEST FACADE, DATE 2022-JUL-30.

- REPAIR, RESTORE AND PAINT DOOR TRIM FRAME. REFER TO PHOTOS 7-9.
- REPLACE STRUCTURAL WOOD BEAM ABOVE BARN DOOR WITH STEEL BEAM. ATTACH DOOR TRACK TO STEEL BEAM.
- REMOVE AND REPLACE FLOOR SLAB.
- INSTALL NEW AIR CONDITIONING UNIT.

- SHEET SPECIFIC NOTES
- REPLACE WITH NEW CEDAR SHAKE ROOF.
 - REPAIR DOOR. REPLACE WITH NEW TRIM, FRAME. NEW PAINT FOR DOOR, TRIM, FRAME. PAINT TO MATCH HISTORIC PAINT COLOR. REFER TO PHOTOS 7 AND 8.
 - REPLACE STRUCTURAL WOOD BEAM ABOVE BARN DOOR WITH STEEL BEAM. ATTACH DOOR TRACK TO STEEL BEAM. REFER TO PHOTO 12.
 - REMOVE BIOLOGICAL GROWTH. REFER TO PHOTOS 15-17.

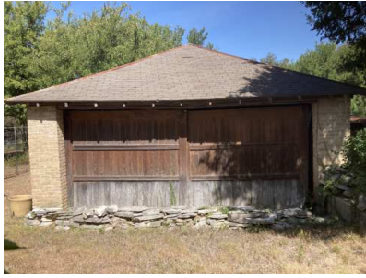
PHOTO 8: GARAGE DOOR ON EAST FACADE, DATE 2022-JUL-30.

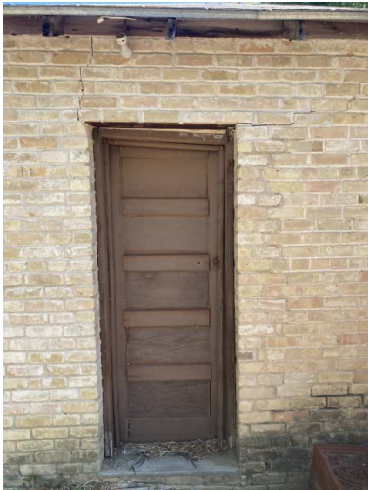
PHOTO 9: DOOR ON SOUTH FACADE, DATE 2022-JUL-30.

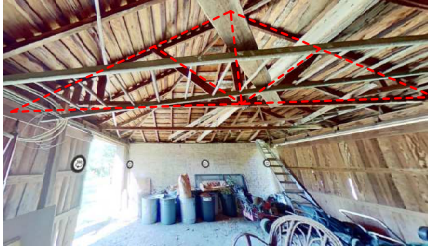
PHOTO 10: ROOF TRUSS, DATE 2022-SEP-27.

- PROTECT, REPAIR, AND REINFORCE EXISTING ROOF TRUSS. ADJUST TRUSS TO BEAR ON NEW STEEL BEAMS. REFER TO PHOTO 10.
- PROTECT, REPAIR, AND REINFORCE EXISTING ROOF RAFTERS. REFER TO PHOTO 11.
- REPLACE STRUCTURAL WOOD BEAM ABOVE BARN DOOR WITH STEEL BEAM. ATTACH NEW DOOR TRACK TO STEEL BEAM. REFER TO PHOTO 12.

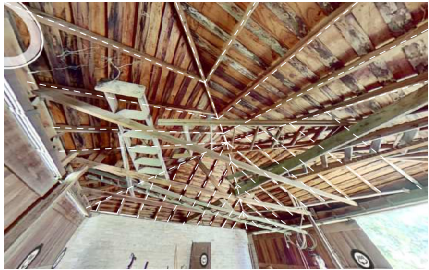
PHOTO 11: ROOF RAFTERS, DATE 2022-SEP-27.

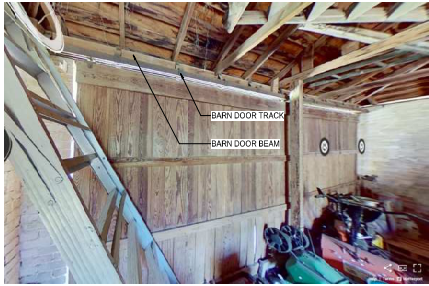
PHOTO 12: BARN DOOR, BEAM AND TRACK, DATE 2022-SEP-27.

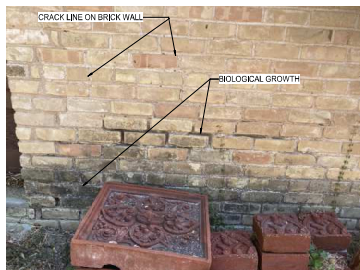
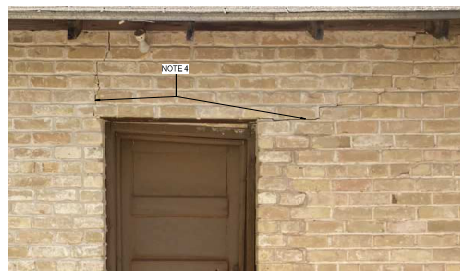
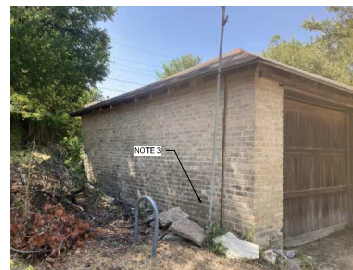
PHOTO 16: BIOLOGICAL GROWTH ON SOUTHWEST FACADE

PHOTO 17: BIOLOGICAL GROWTH ON NORTHWEST FACADE
