## **Background**

## **Diagnosis**

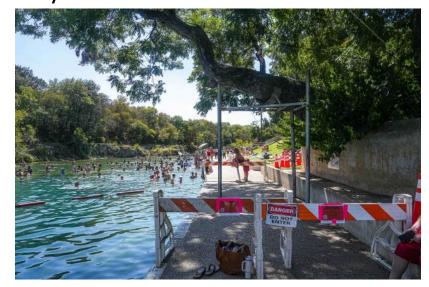
Brittle cinder fungus can cause healthy looking trees to collapse

Additional support rope has been installed

Area immediately below the tree has been restricted from public

access
