**HISTORIC LANDMARK COMMISSION**  
**Applications for Certificates of Appropriateness**  
**November 4, 2026**  
**HR-2026-130922**  
**Hyde Park Historic District**  
**4115 Avenue D**

Replace non-historic windows on a contributing church structure.

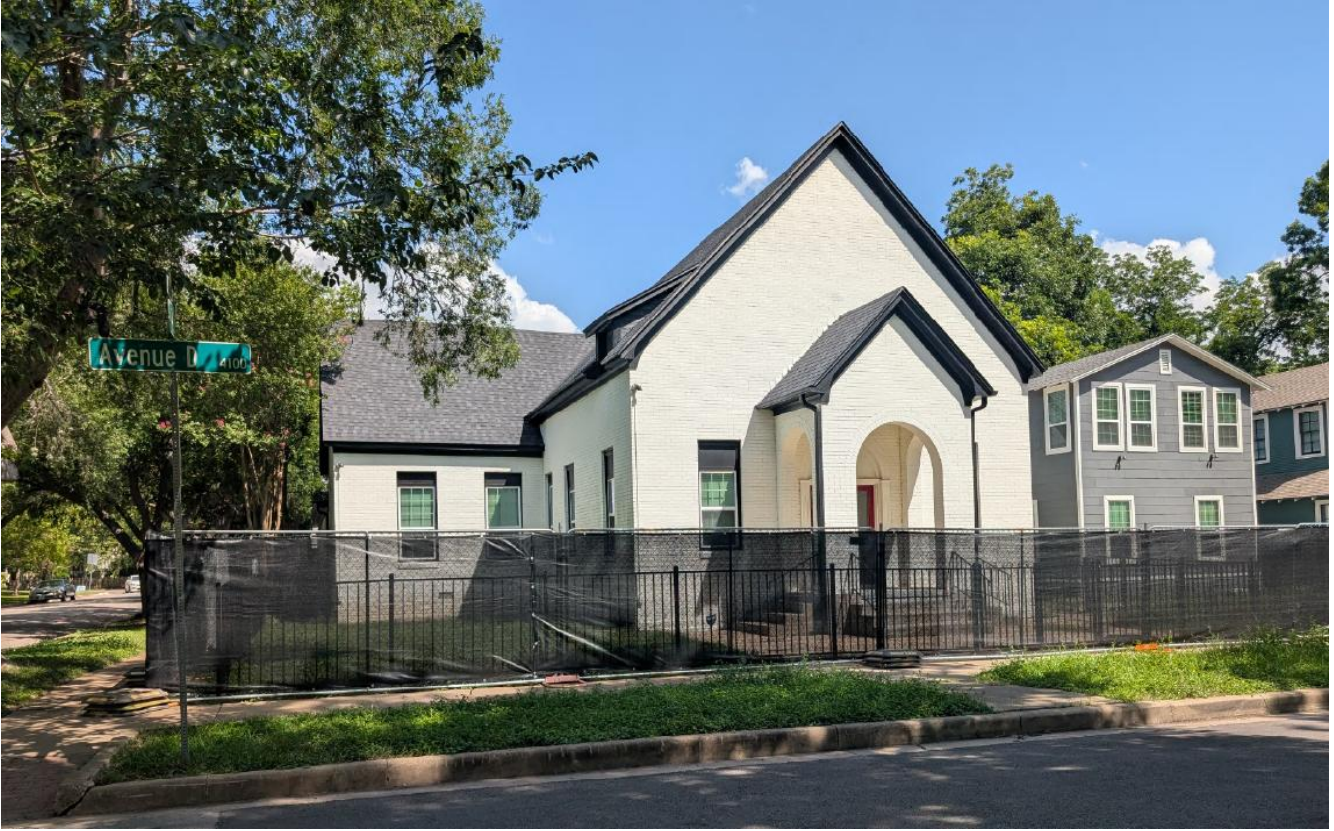
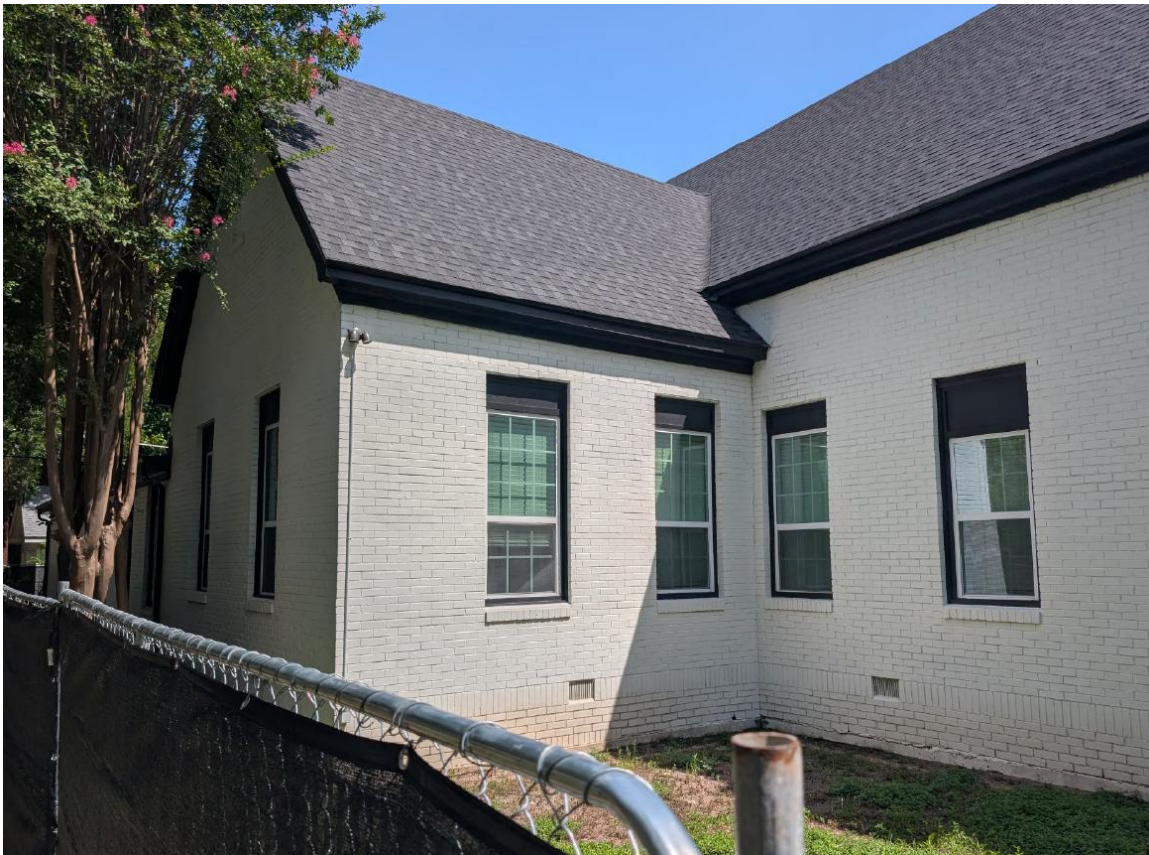
This former church is located at a prominent corner in the Hyde Park neighborhood. It is constructed of brick, which has been inappropriately painted, and features a steep cross-gabled roof clad in shingles. There are two small dormers toward the front of the roof structure, and the side-facing gables each have a small attic vent. The front of the church features a small stairway to access the main entry, with an entrance at the side for accessibility. Windows have all been replaced with fixtures that are too small for their openings.

All windows on the church structure are proposed to be replaced. Prior to unpermitted work, the fixtures all appear to have been wood framed units, with 1-over-1s present at the front half of the building and 2-over-2s at the rear half, in the portion of the church that served as office space. These units were all lost during a previous owner's work and no physical evidence remains of them in the openings. Existing windows are white vinyl frame fixtures with false muntins and green tint. None of these windows are properly sized for their openings, and gaps have been filled with wood paneling painted black. This choice of color makes the size issue stand out even more visually, and greatly

*Site visit photos, 2026. Windows have been replaced with fixtures that do not fit their openings.*

Proposed windows are wood clad aluminum, and are sized appropriately to their respective openings. While wood hung windows that have a painted appearance would be ideal and highly recommended by staff, the proposed solution would be considered approvable for remediation of inappropriate work elsewhere in the district. Glazing appears to be clear and colorless, with a low-emissivity film serving as an alternative to tint.

Windows will need to be inspected to ensure that they fit properly and that no additional damage is done to historic material. Windows must also be located at an appropriate depth in their openings to ensure they do not look too deep or shallow. Past images of the original windows can be used as guidance for placement.

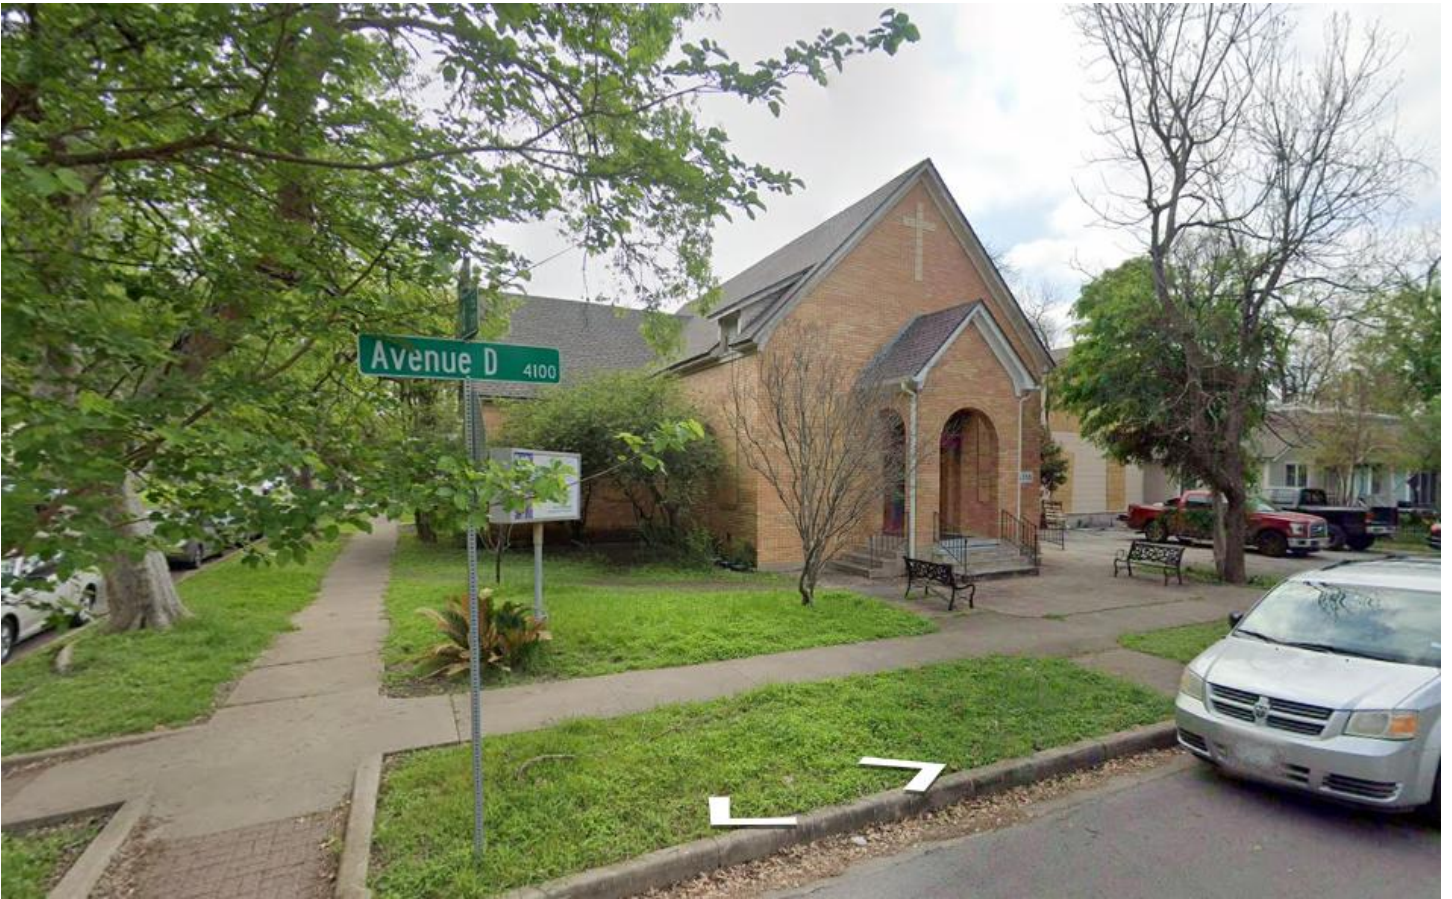
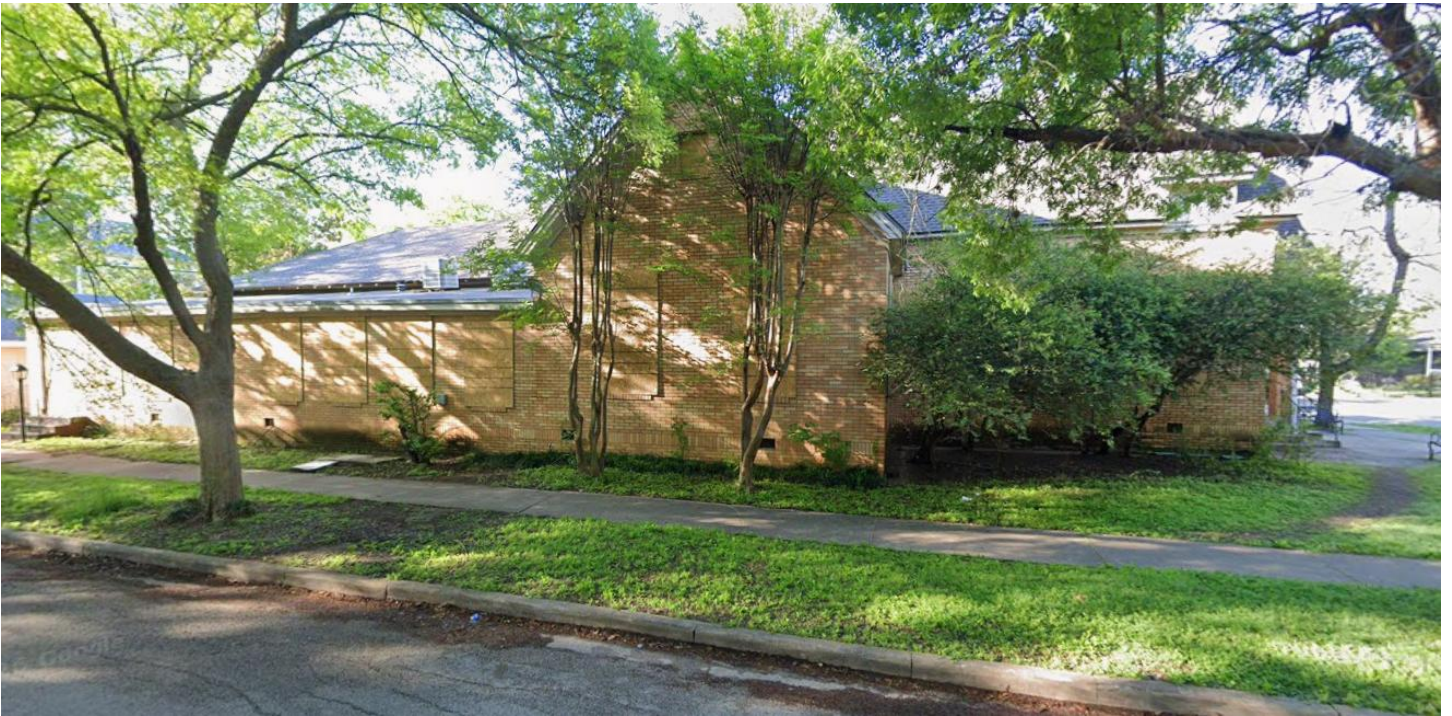
*Google Streetview, March 2024. Note the appearance of original brick and boarded up windows.*
