RE: JOLLYVILLE TRANSMISSION MAIN: PARD SITE; PRELIMINARY KARST
SURVEY RESULTS

A karst survey of the PARD site for the Jollyville Transmission Main on 11 Mar 2010 by Zara Environmental revealed 2 potentially significant karst features within the 150 ft CEF (critical environmental feature) buffer. For the purposes of this preliminary report, these features will be referred to as JVPARD-03 and JVPARD-04.

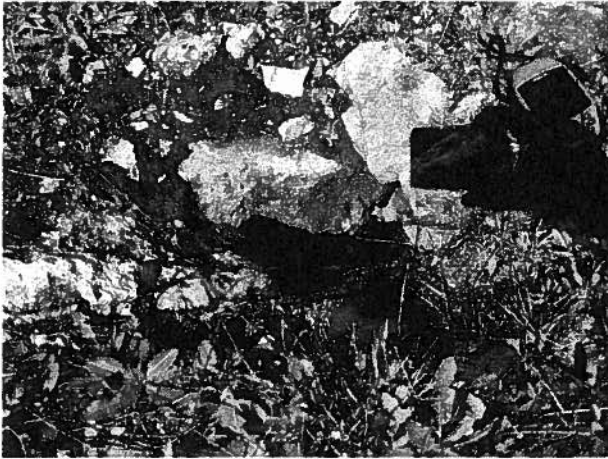
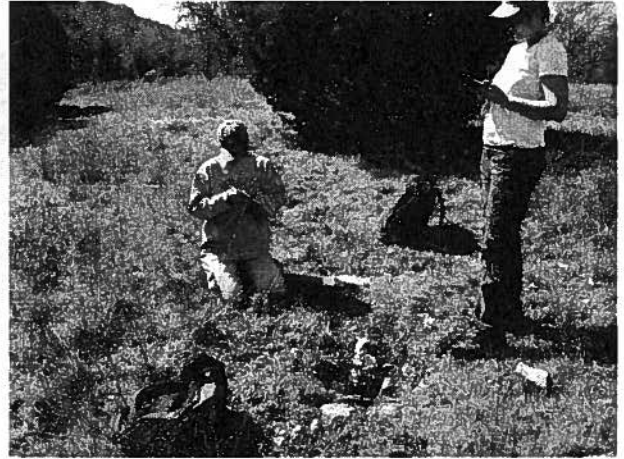
Fig. 1. JVPARD-03

JVPARD-03 is a potential sinkhole with an entrance of 0.3 m by 0.2 m and a visible depth of approximately 1.5 m. The void space opens up below the entrance to an area that might be humanly accessible with minor excavation. Due to the collapse development of the feature and the presence of modern soils and clean-washed rocks, this feature has a high probability of being habitat for karst species (USFWS guidelines 2006). This feature receives sheetwash recharge from an area approximately 50 m by 20 m which lies mainly inside the site boundary. Excavation to enlarge this feature for biological monitoring and biological monitoring following USFWS guidelines is recommended for this feature.

These features are similar in appearance to JVPARD-02 which proved to be non-karstic after minor exploratory excavation revealed non-native fill consisting of rocks and bricks. There is a chance that this entire field consists of non-native fill; however, preliminary investigation indicates that features JVPARD-03 and JVPARD-04 have a significant potential for karst species habitat according to USFWS guidelines and for recharge due to their size and location.

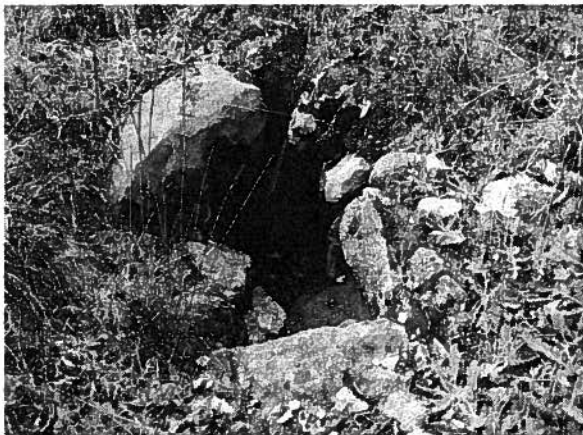
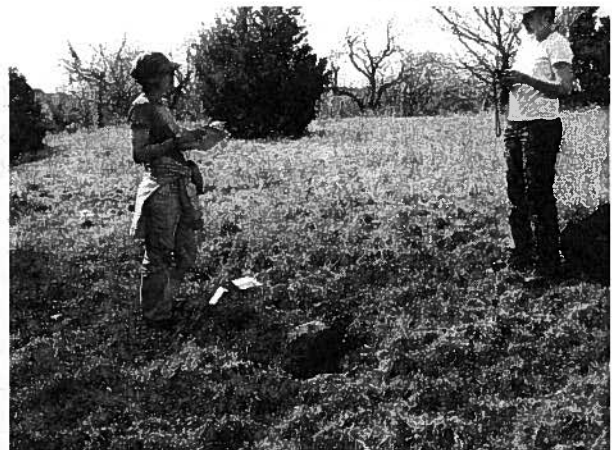
Fig. 3. JVPARD-04

JVPARD-04 is a potential sinkhole with an entrance of 0.6 m by 0.3 m and a visible depth of approximately 1 m. The void space continues out of site as a tube that trends towards JVPARD-03. JVPARD-04 is approximately 5 m to the north of JVPARD-03, and there is a chance that they may connect to each other. Due to the collapse development of the feature and the presence of airflow and clean-washed rocks, this feature has a high probability of being habitat for karst species (USFWS guidelines 2006). This feature receives sheetwash recharge from an area approximately 50 m by 20 m which lies mainly inside the site boundary. Excavation to enlarge this feature for biological monitoring and biological monitoring following USFWS guidelines is recommended for this feature.
