Lower Bull Creek District Park Contact Recreation Use Assessment Update, January 2011

January 2011; SR-11-07

City of Austin Watershed Protection Department Austin/Travis County Health and Human Services Department

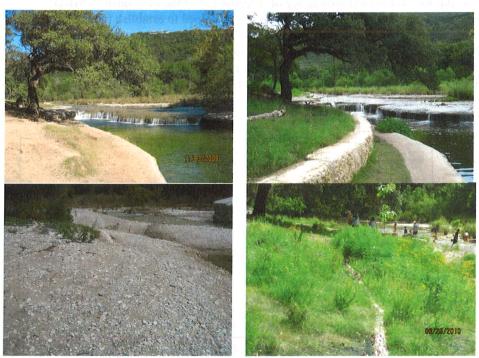
Figure 7. Area near the "horseshoe" waterfall looking upstream: Before restoration (Top left), after restoration (top right), after Tropical Storm Hermine (lower left); Area upstream of waterfall soon after restoration showing successful revegetation (lower right)

park is in a floodplain, the flooding and deposition is a natural occurrence and was not unexpected. In the long term this deposited material will be beneficial to the riparian landscape. However, in the short term WPD is proceeding to re-establish the limited areas of vegetation that were impacted which may extend the time required for full establishment of the new vegetation. Although the damage to the overall project was considered minimal, the landscape near the limestone block wall will require additional time to heal. As for the creek itself, the former "horseshoe" waterfall area was completely filled in by sediments (Figure 7).
