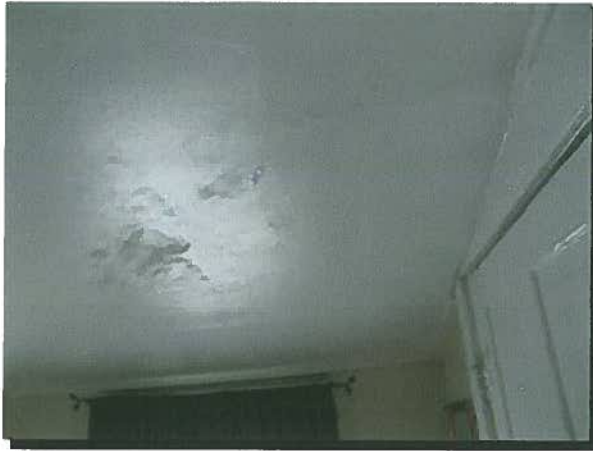
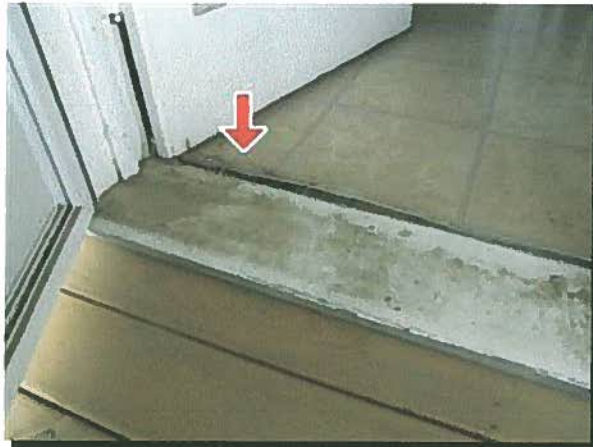
F. Picture 8

There are several trip hazards door thresholds. These transition areas should be made smooth, or gently ramped to their respective planes.

F. Picture 9 Lifted floor covering, raised threshold.

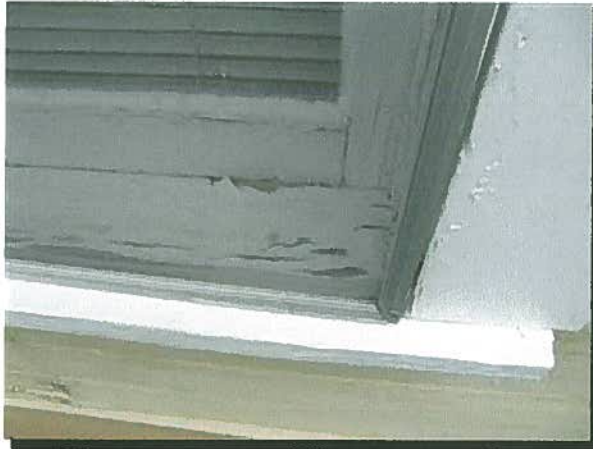
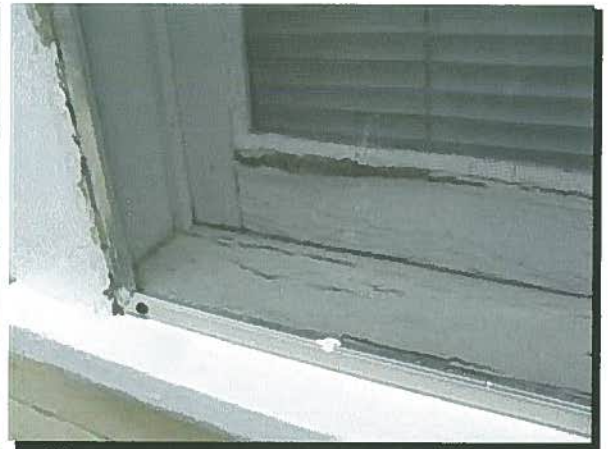
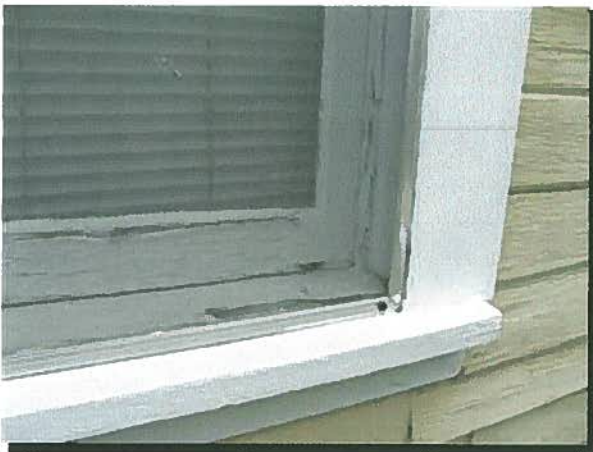
H. Picture 1

☒ Though some were functional, windows and frames are generally in a state of disrepair, deteriorating. Paint on frames tested present for lead. Replacement recommended. Double pane window replacements are available that match the current style, but will provide better energy efficiency.

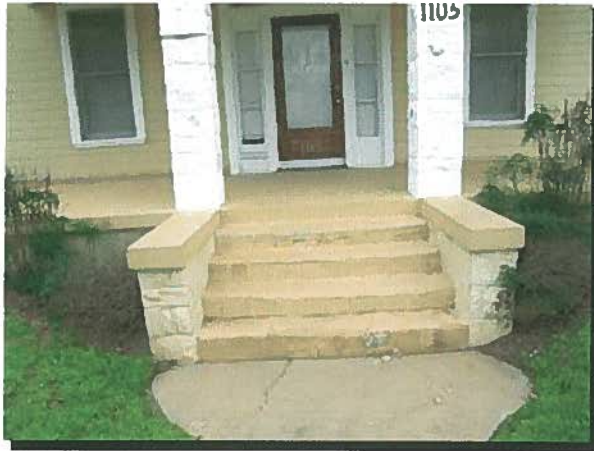
I. Picture 1

☒ Stair handrails missing, required at front entry.

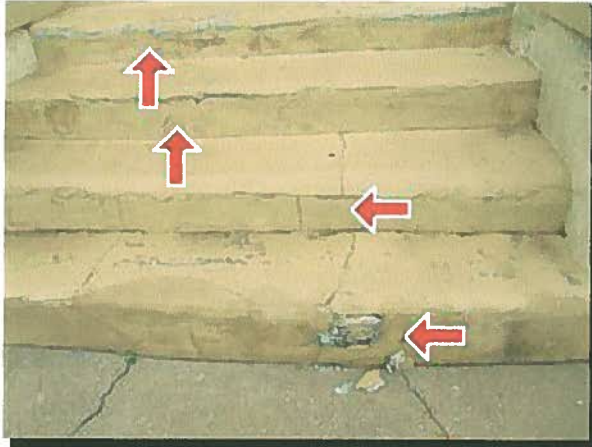
I. Picture 2

☒ Front step masonry is deteriorating(cement application over flag/limestone). Mason to repair.

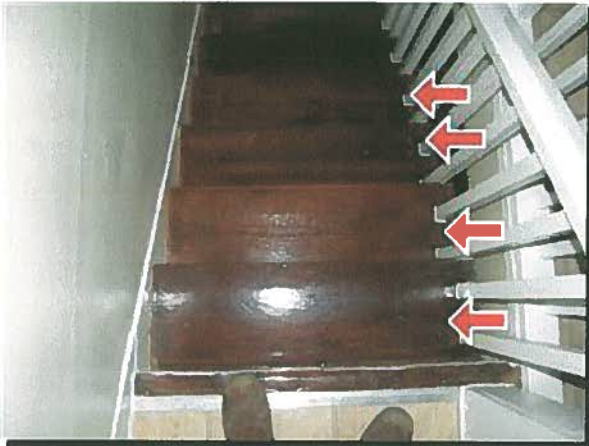
I. Picture 3

☒ Interior staircase: treads near top of stairs are soft. Inspector could not access underneath staircase to observe support structure. Recommend contractor to access area to determine need for structural enhancements.

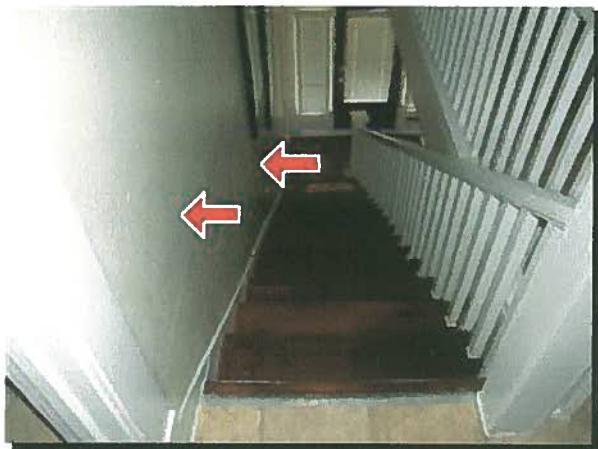
I. Picture 4

☒ Grippable handrail needed at interior stairway.

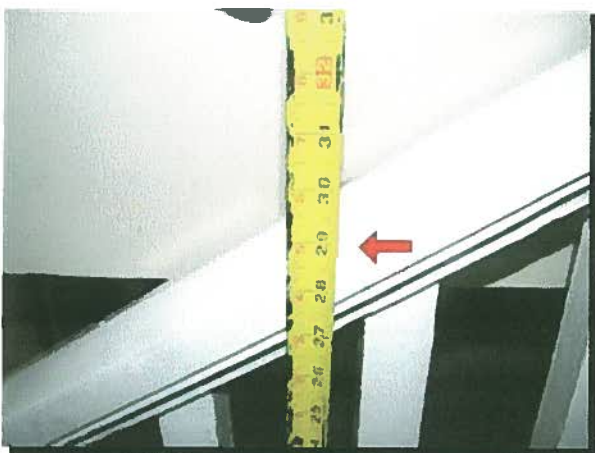
I. Picture 5

Existing handrails at improper height. Current standard is minimum 34-36".

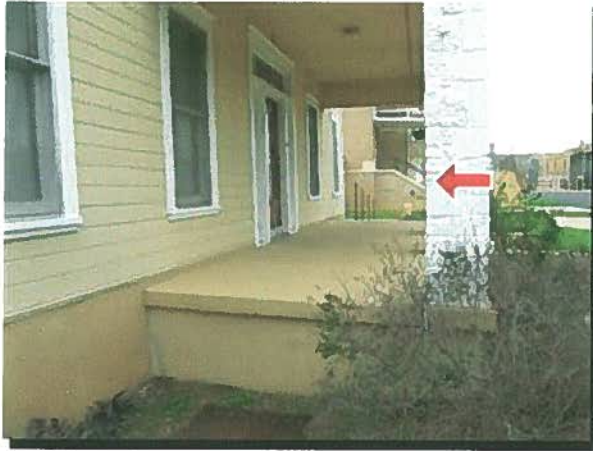
K. Picture 1

☒ Guard/handrails recommended at left side of front patio.

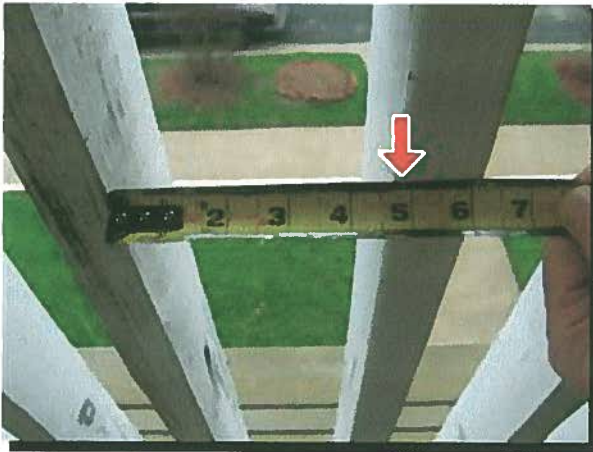
K. Picture 2

☒ Deck balusters are improperly spaced greater then 4 inches apart as called for by today's child safety standards

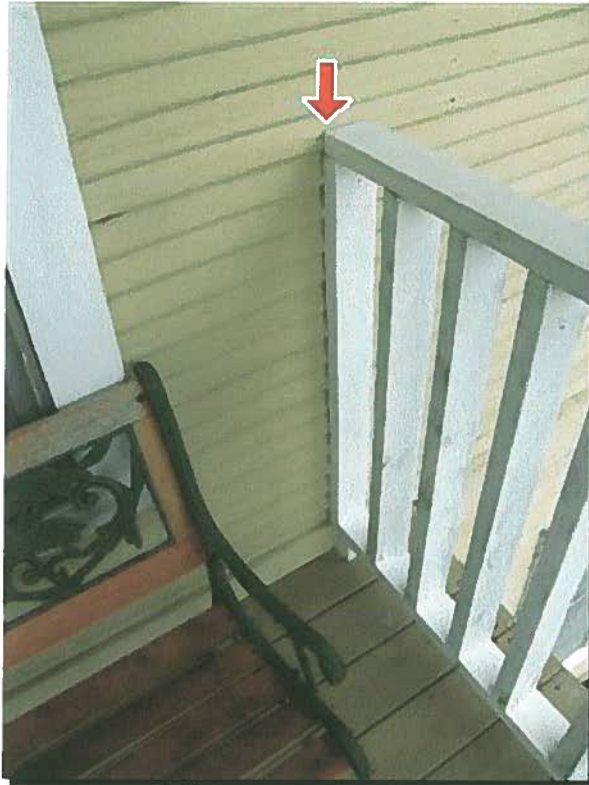
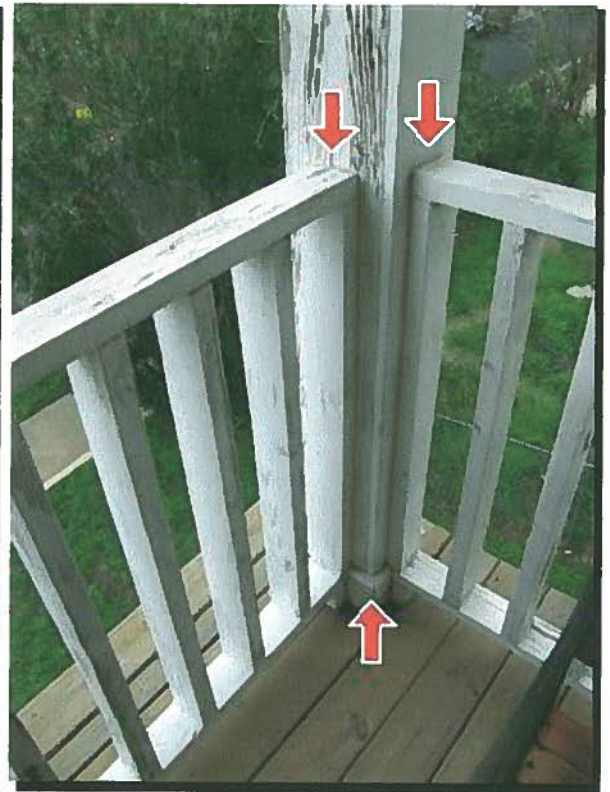
K. Picture 3

☒ Additional metal brackets/hangers recommended at handrail to post abutments for longevity, added safety.

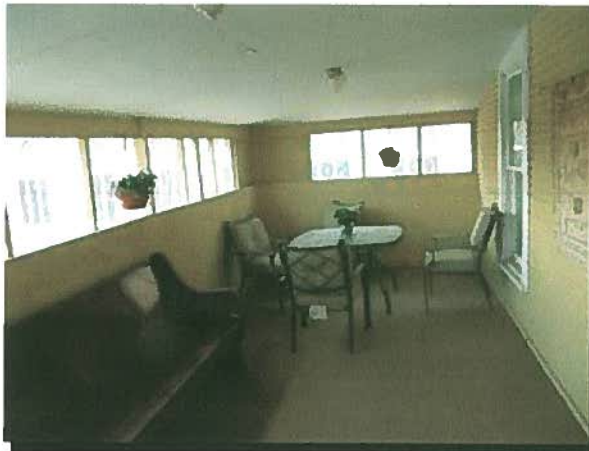
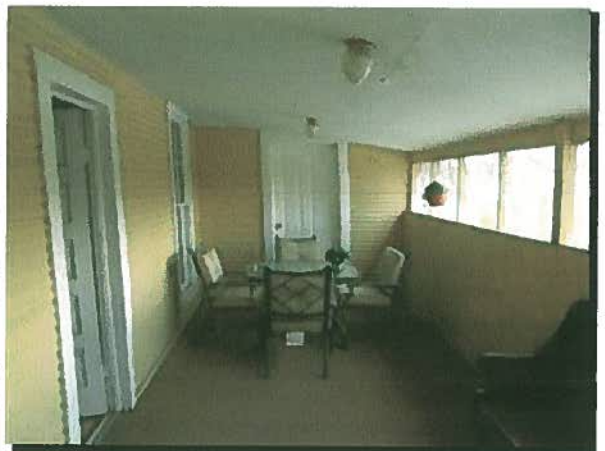
K. Picture 5

☒ Windows recommended for upstairs rear patio/deck. Walls do not appear to be properly constructed for window installation, and will require modification and upgrades. These could coincide with modification of roof slope (see roof covering section for clarification).

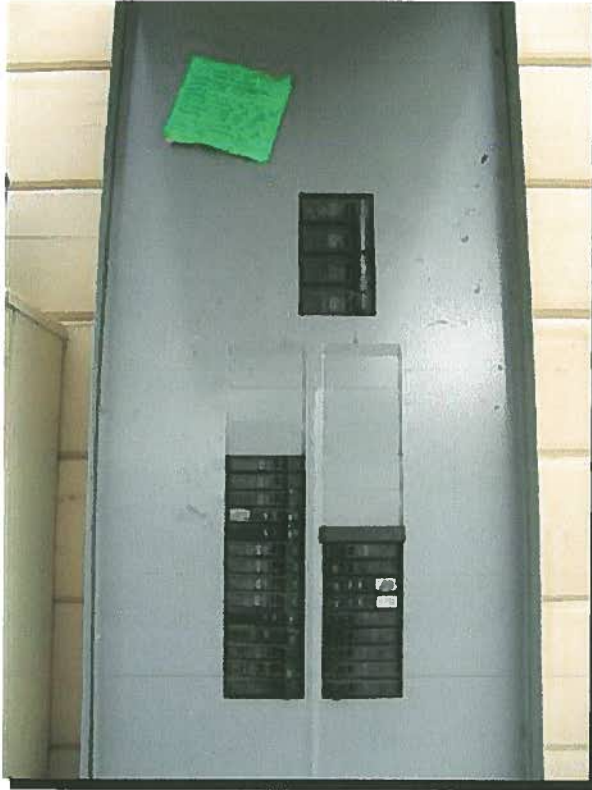
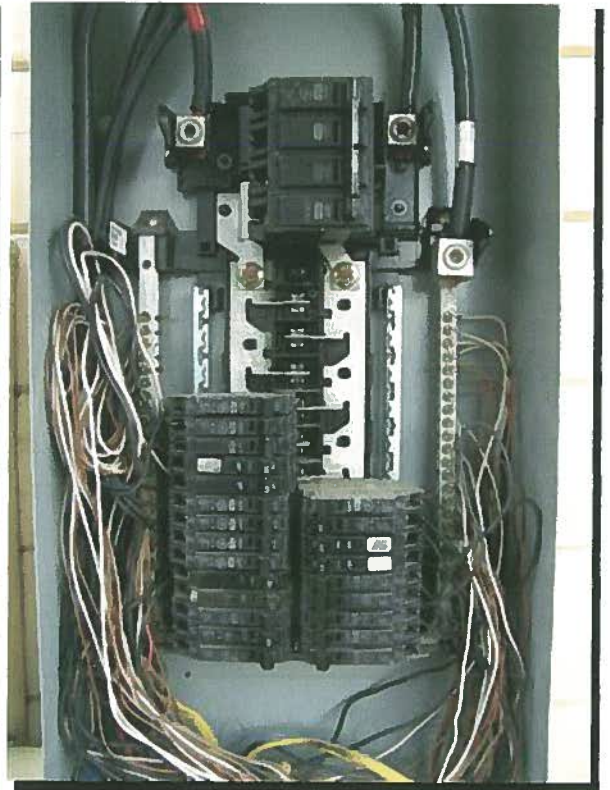
A. Picture 1

I could not locate the ground wire. The ground wire may not be present or could be hidden from view by construction materials. I recommend an electrician verify or install a ground wire.

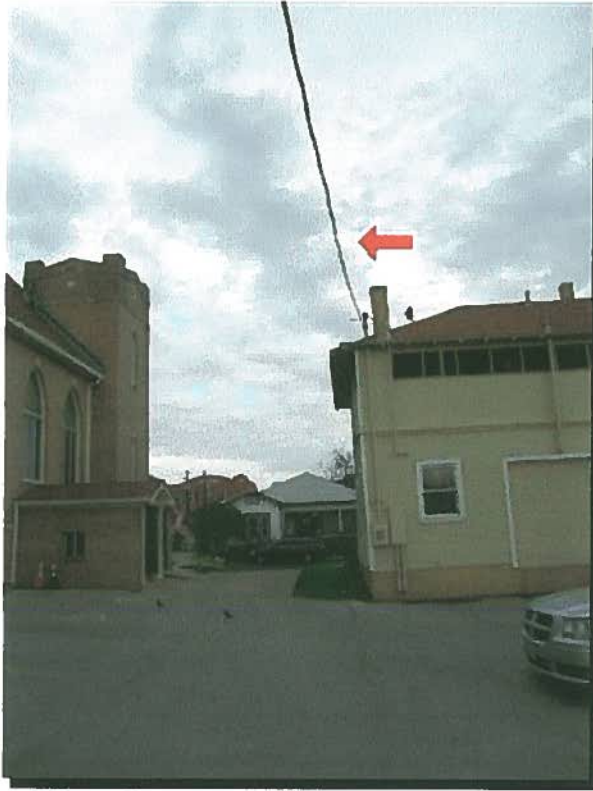
A. Picture 3

☒ The electrical service conductors clearance (outside) from the ground is less than 18 feet. Line should be raised by a licensed electrician.

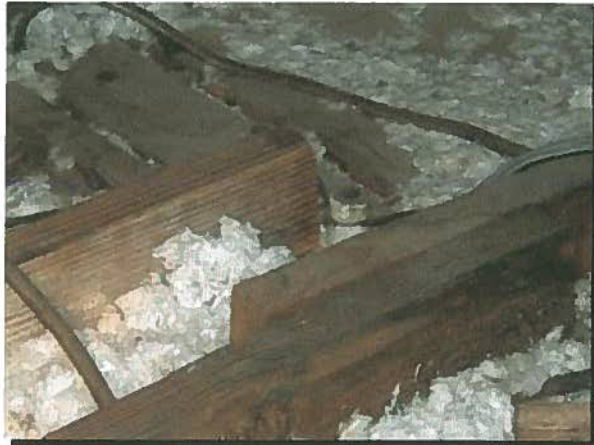
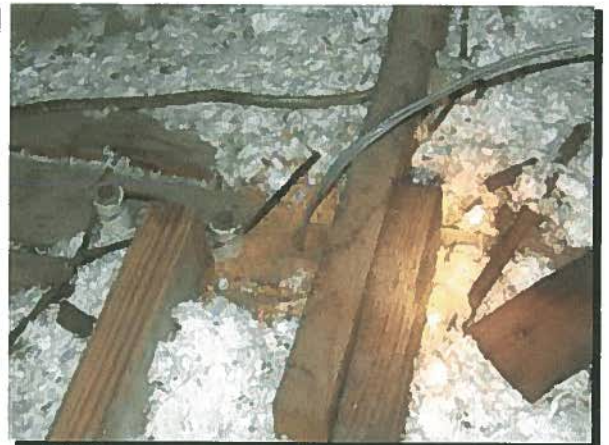
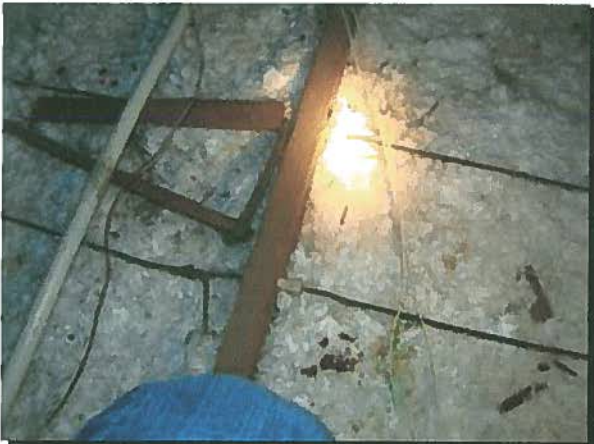
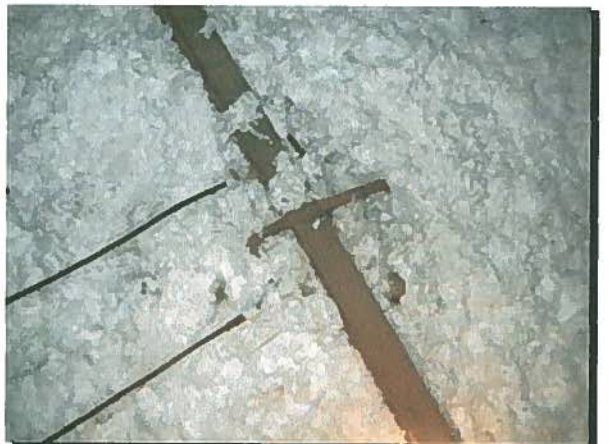
B. Picture 1

☒ The attic is insulated and "Knob and Tube" wiring is present. As a safety rule Knob and Tube wiring should never have insulation covering this wire or over heating can occur. This is a potential fire hazard and should be repaired. Replacement of old wiring to be performed.

B. Picture 4 Completely covering bare conductors.

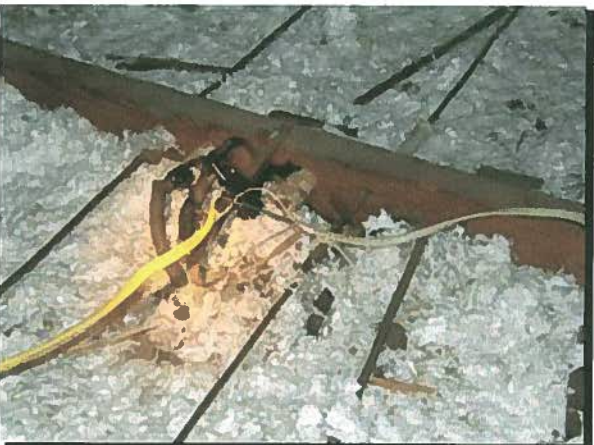
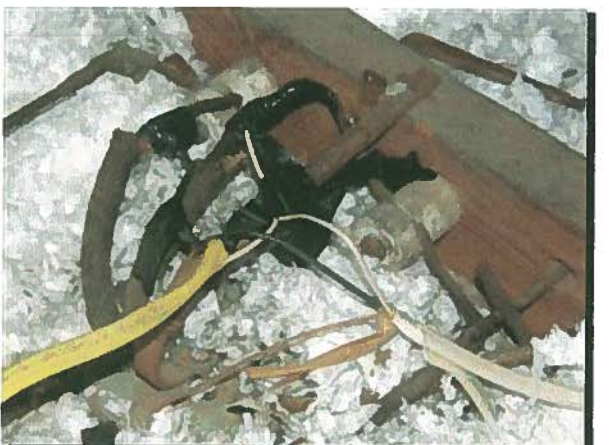
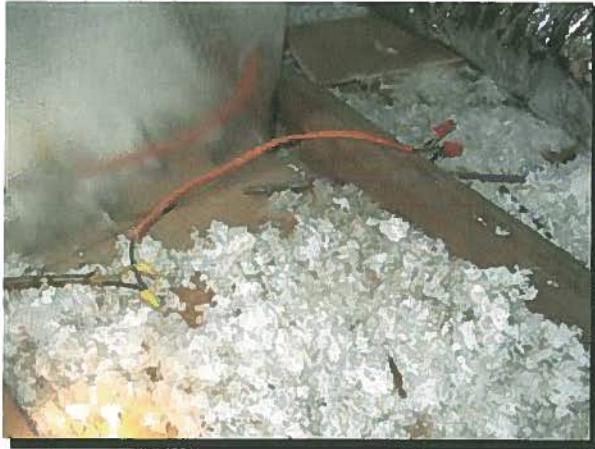
B. Picture 5

☒ Irregular splices/connections made up outside of rated boxes, into older knob and tube wiring. This is a hazard and should be repaired. Older conductors to be replaced. Licensed electrician to evaluate for repairs.

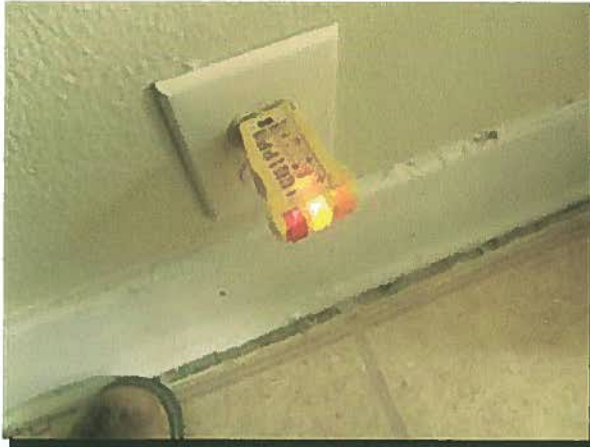
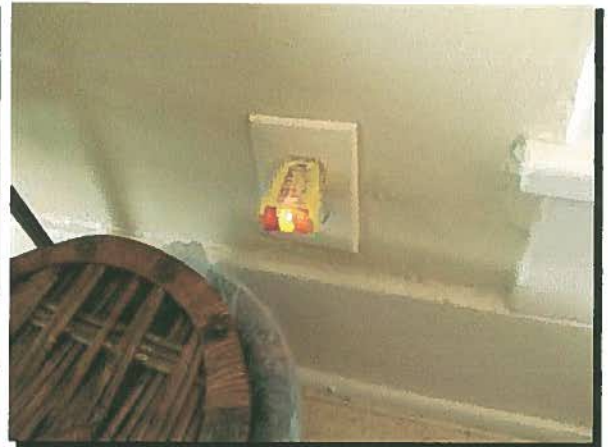
B. Picture 8

☒ Open ground, ungrounded circuits observed in upstairs areas.

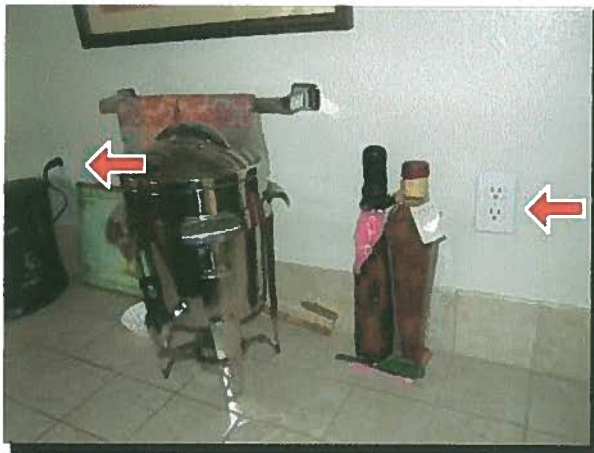
B. Picture 10

☒ There are no GFI (Ground Fault Interrupt) protected outlets in locations called for by today's standards (all kitchen, baths, non dedicated garage below 6', laundry, and exterior outlets)

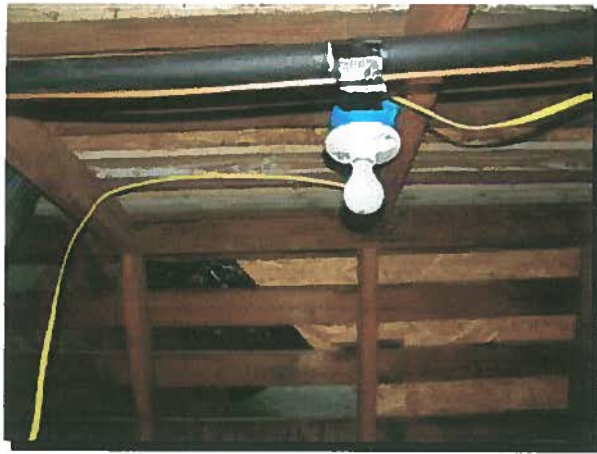
B. Picture 11

☒ Several of the interior light fixtures are missing proper bulb protection (wire cages/glass globes)

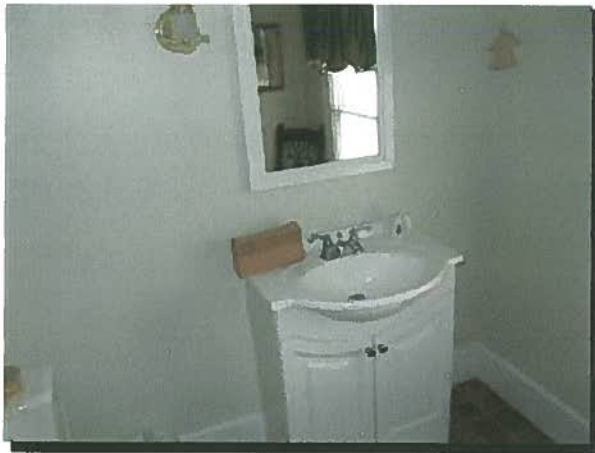
B. Picture 12

☒ There is no outlet found in bath. Recommend a duplex GFCI outlet be installed by a licensed electrician.

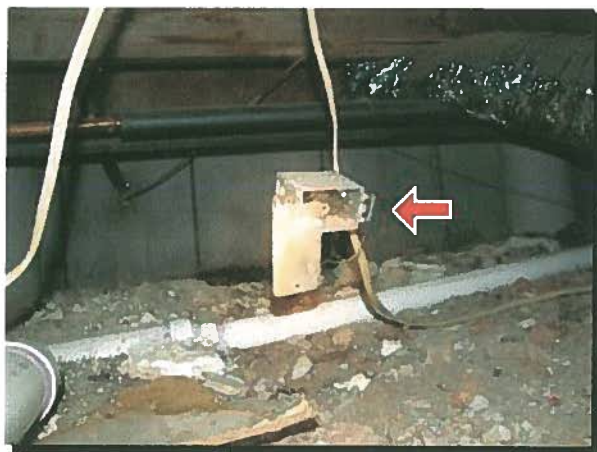
B. Picture 13

☒ Exposed connections/boxes in crawlspace. Repair.

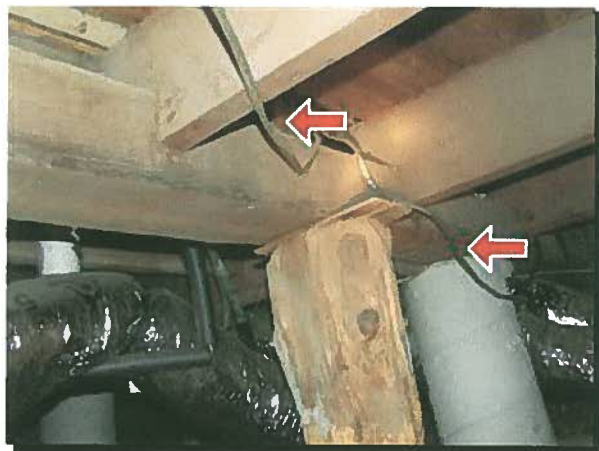
B. Picture 14

☒ Older cloth insulated branch circuitry observed in crawlspace. Recommend upgrading to current standard conductors (Romex) for safety.

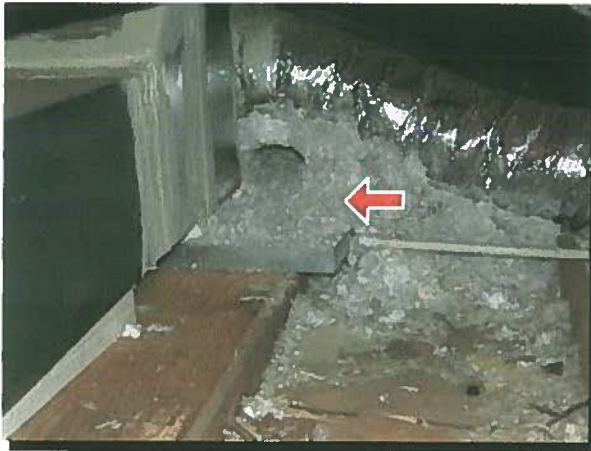
B. Picture 1

☒ Remove debris from the secondary drain pans to prevent clogging of drain lines.

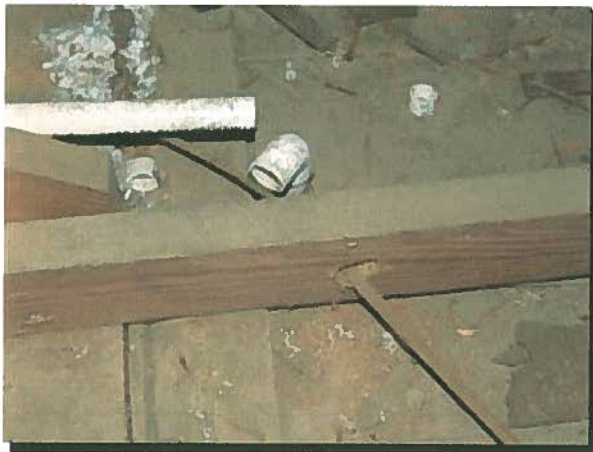
B. Picture 2

☒ Today's standards recommend insulating the primary condensation drain lines in attic installed AC systems to prevent condensation drips. Add insulation.

Repair disconnected pipe to exterior at attic penetration.

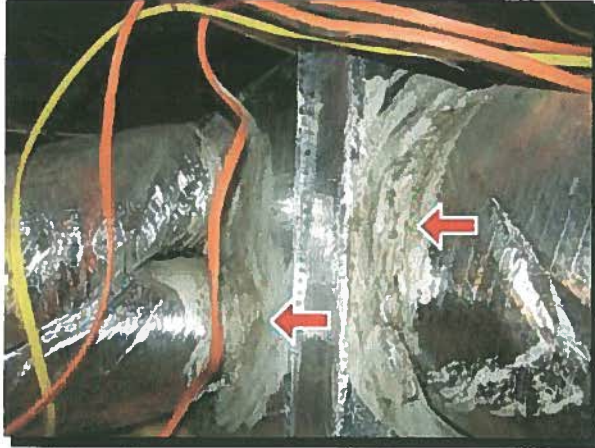
B. Picture 3

☒ The cooling system plenum shows signs of past excessive moisture conditions (bio-growth stains). Ensure air flow is not restricted (dirty filters) and the condensation drain line is periodically flushed to prevent drain line blockage

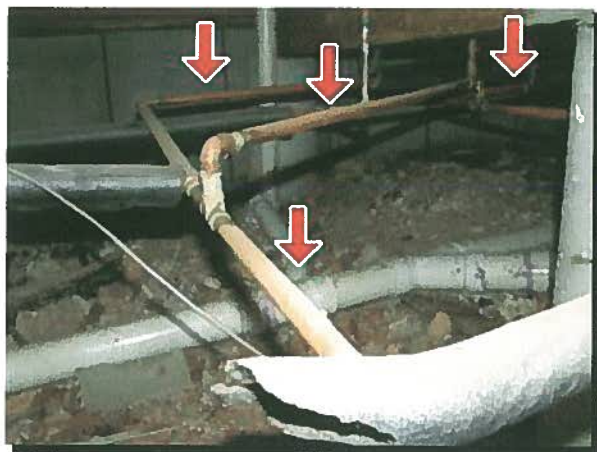
A. Picture 1

☒ Supply pipes not insulated in crawlspace as required.

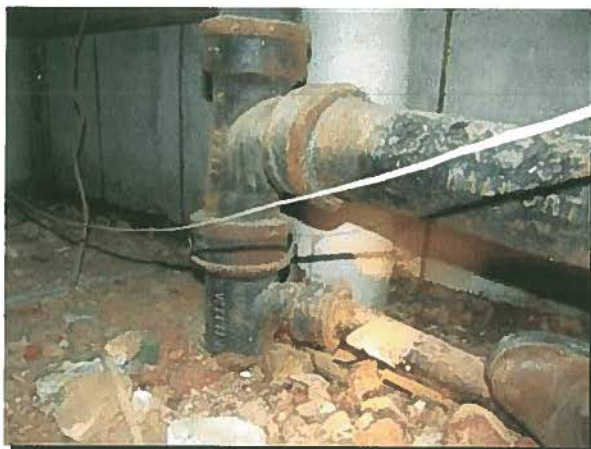
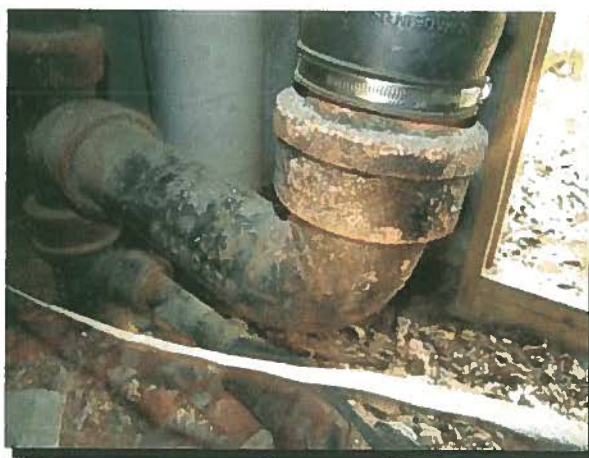
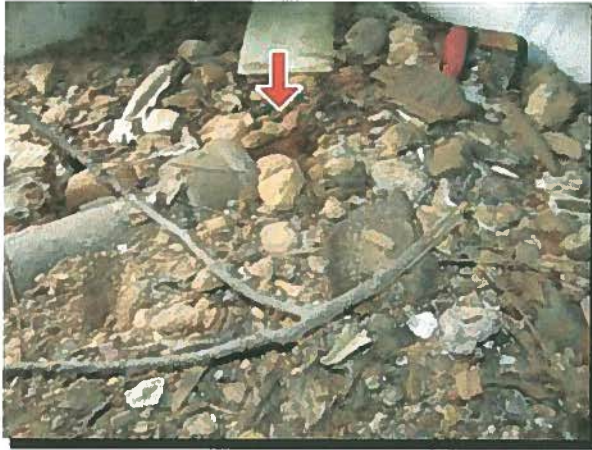
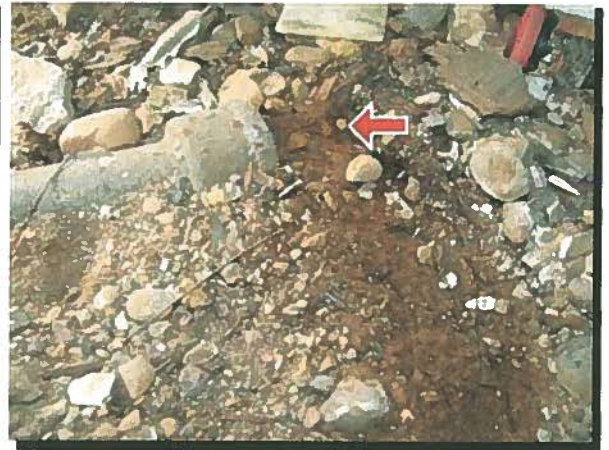
B. Picture 1

☒ Home has a combination of original galvanized cast iron and some new PVC drains and vents. Iron lines of this age are known to develop leaks and clogs overtime. Not all drain problems may be detectable. There was one drain line observed in the crawlspace that had collapsed in the soil. This should be evaluated by a licensed plumber for repair. New drain line installation is likely, and depending upon the material used to drain into the main city drain (if still cast iron), an upgrade from the house to the main city line may be necessary. Recommend pulling permits on this item from the City of Austin.

B. Picture 4 Light removal of soil uncovered a collapsing drain pipe.

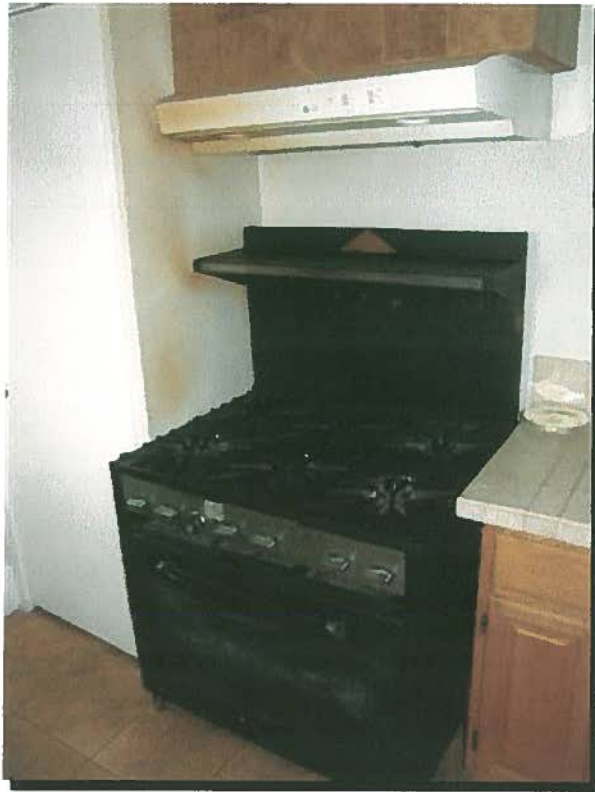
C. Picture 1

☒ Hood vent is undersized for range. Recommend upgrade.
