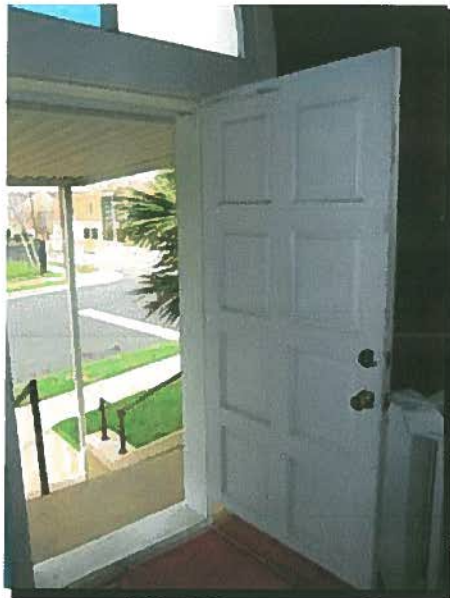
G. Picture 1 Not fire rated, no illuminated exit sign or emergency lighting.

☒ All exit doors to exterior to be made fire rated.

There should be illuminated exit signs viewable from exiting all rooms.

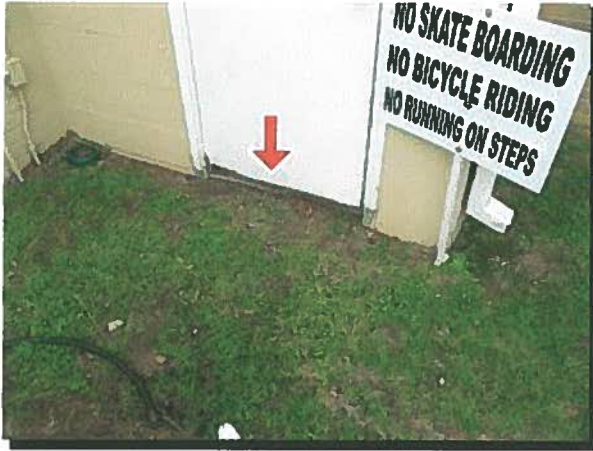
G. Picture 6

☒ Exterior doors, frames and thresholds are deteriorated. Require replacement.

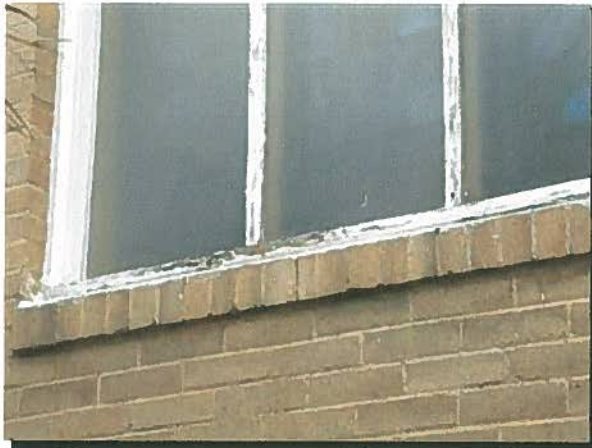
H. Picture 1

☒ Windows are all in disrepair, rotted. Frames are deteriorated and require replacement.

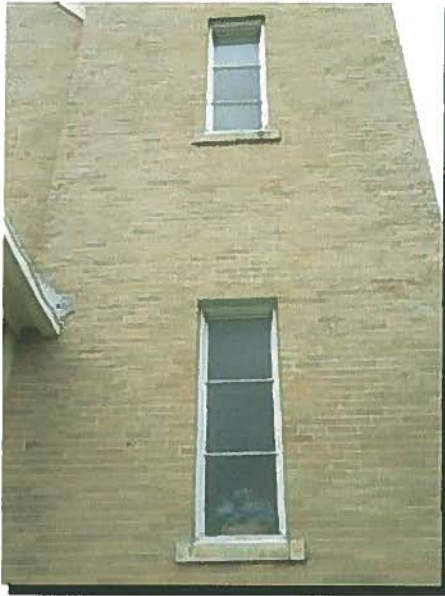
H. Picture 10 Improper glazing.

☒ Windows not safety rated in required areas. Plexiglass has been inserted in most lower level windows. These should be replaced with properly rated safety glass.

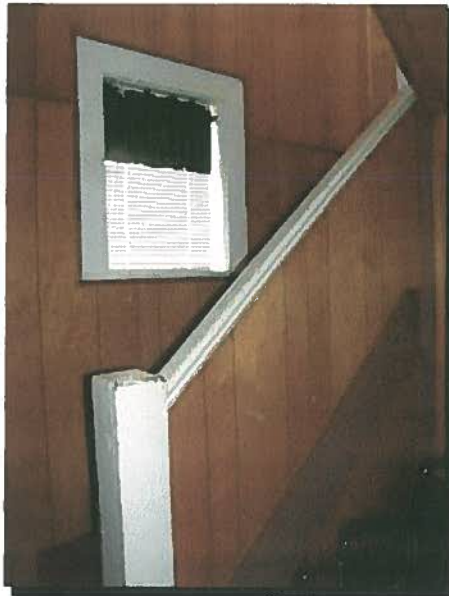
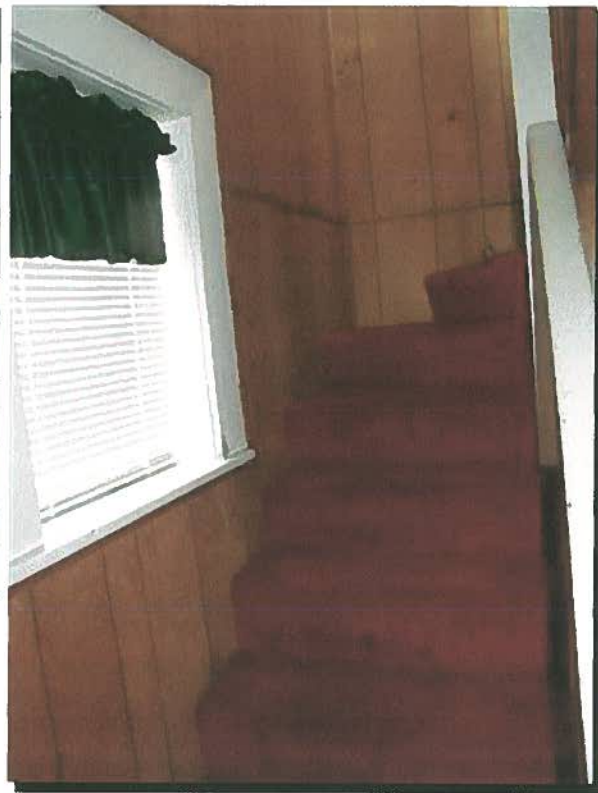
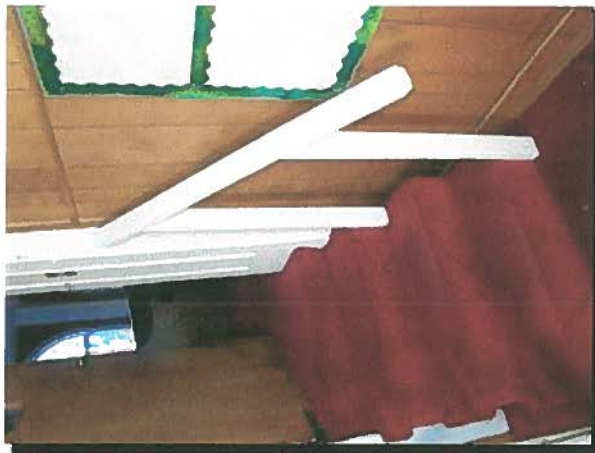
☒ Graspable handrails missing in interior locations. Where rails are present they are too wide to grip. Most interior rails are loose. All interior railings should be updated to conform to current standards :graspable; 36 inches in height; where open to fall balusters to be spaced no greater than 4 3/8 apart; able to withstand 200lb load vertical and horizontal.

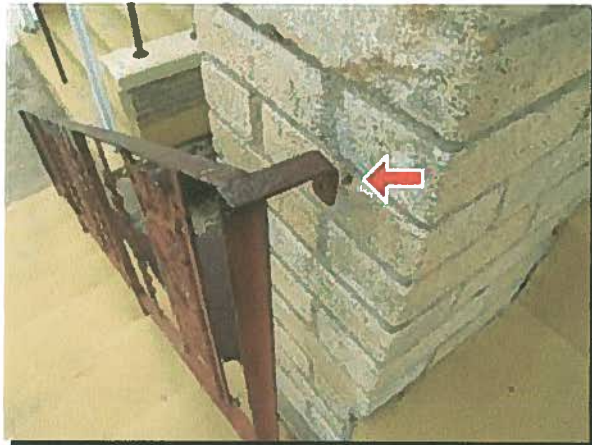
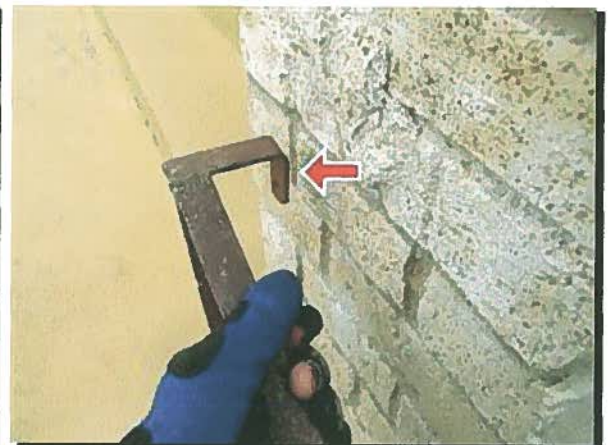
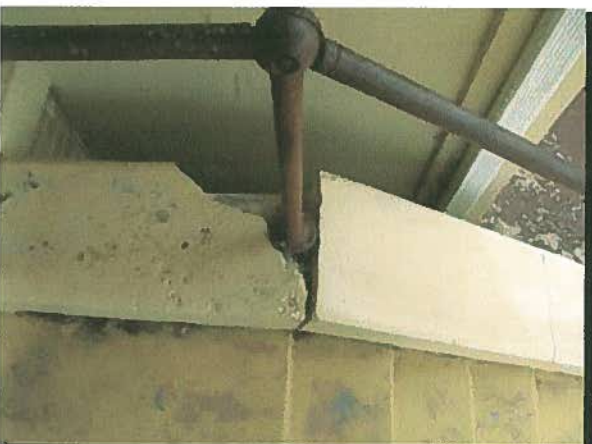
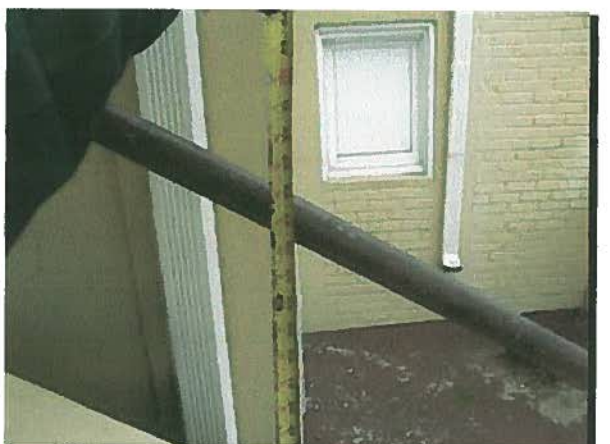
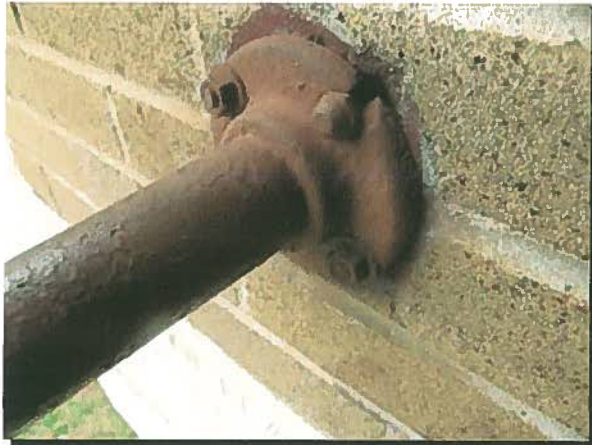
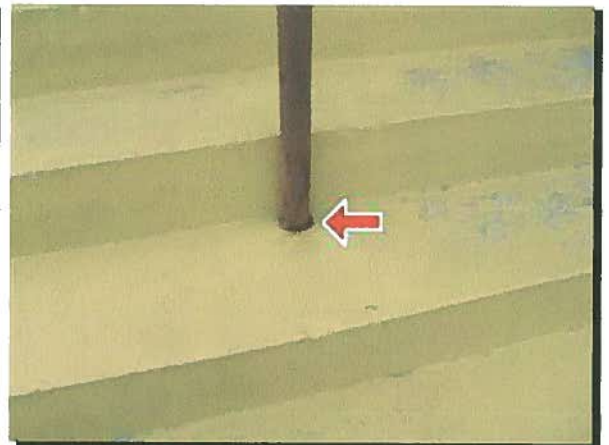
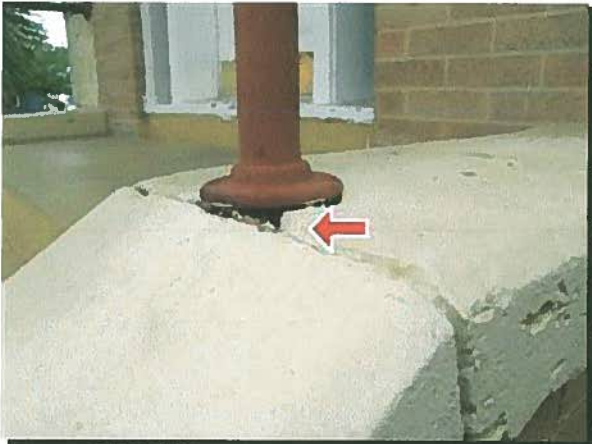
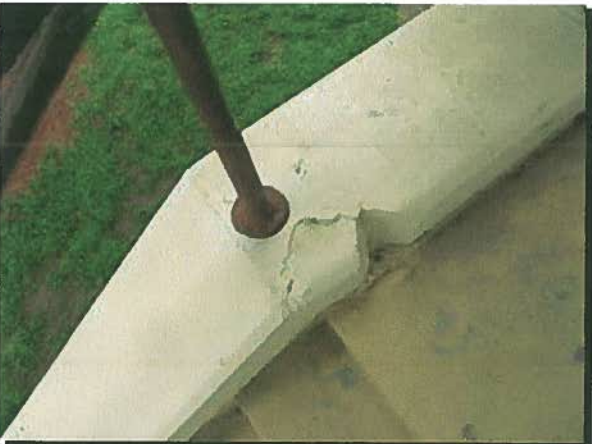
☒ Rails are loose at posts, walls. Stonework is deteriorated in areas and does not support posts and railing as required (200 lb vertical and lateral). Additional support needed. Masonry/stone may be

required to be replaced. A qualified mason should evaluate and repair. (harder, more dense and durable stone may be advised).

Railings to be installed per current standards of 36 inches in height, baluster spacing no more than 4 3/8 inches apart, support 200 lb load vertically and laterally, graspable.

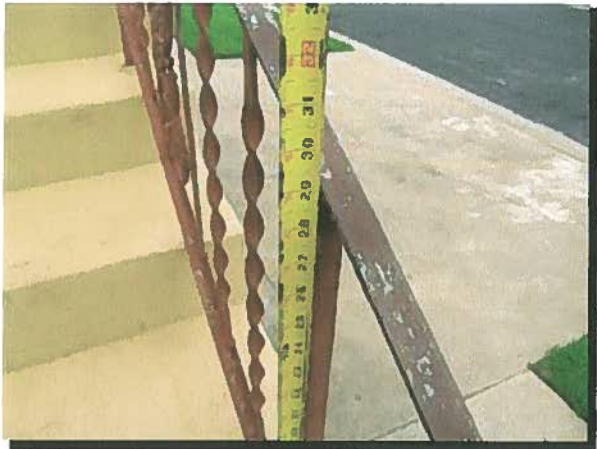
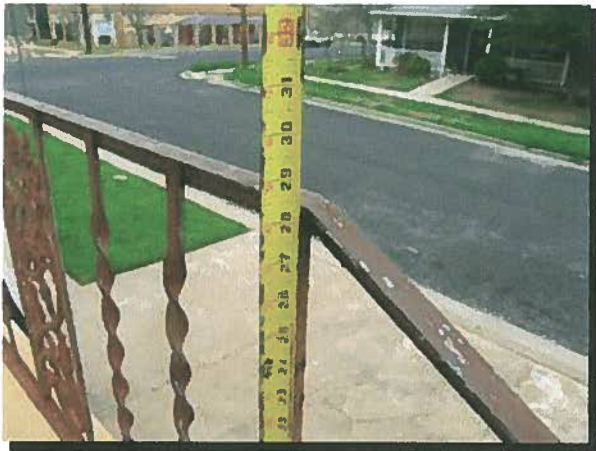
☒ Exterior railings are improper height, not rated for required weight load (200 lb vertical, lateral), baluster spacing is greater than required max of 4 3/8 inches. These railings should be updated to current standards for safety concerns.

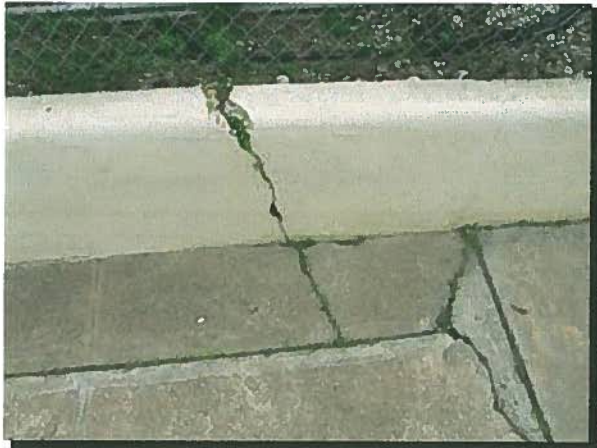
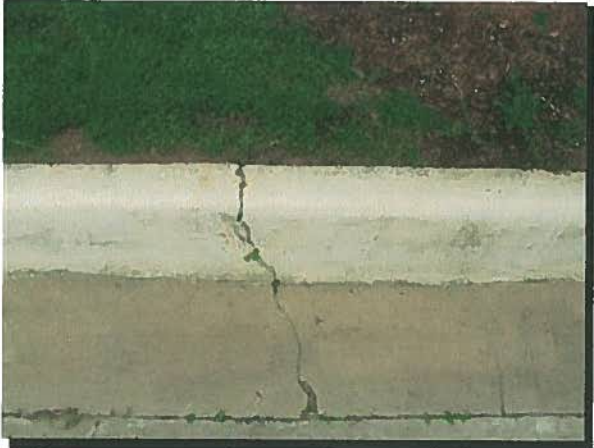
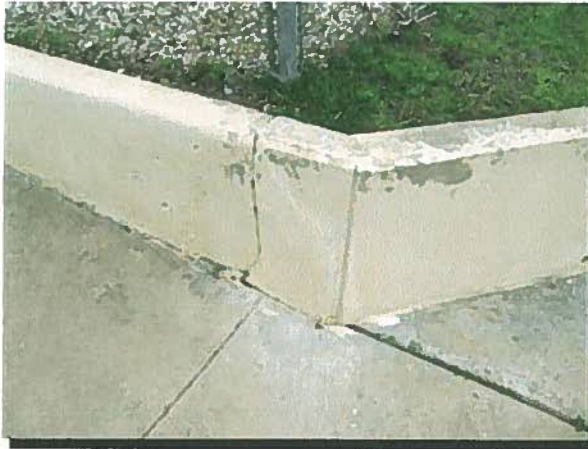
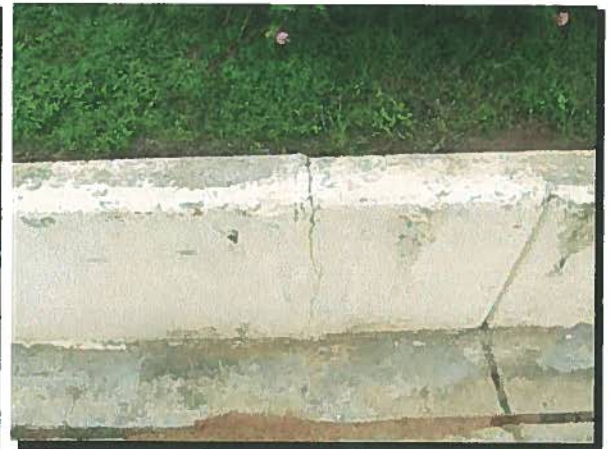
☒ Exterior retaining walls are cracked, shifted and deteriorating in areas. Subterranean tie back method unknown. These areas should be excavated for repair.

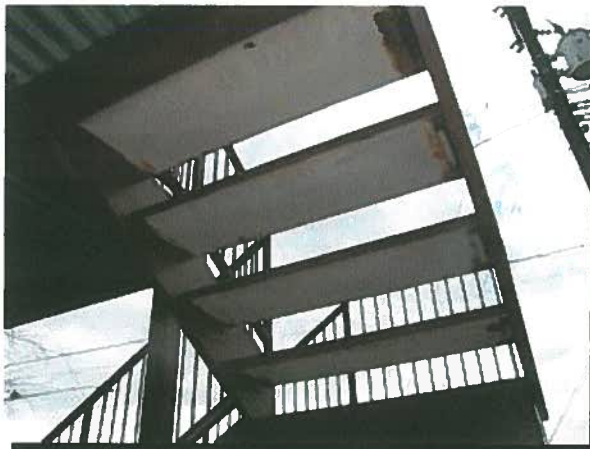
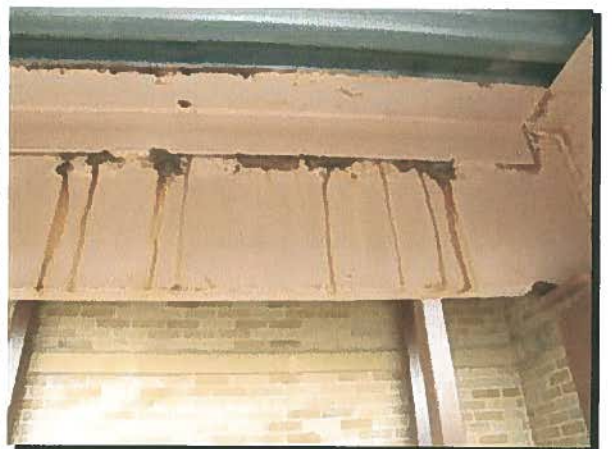
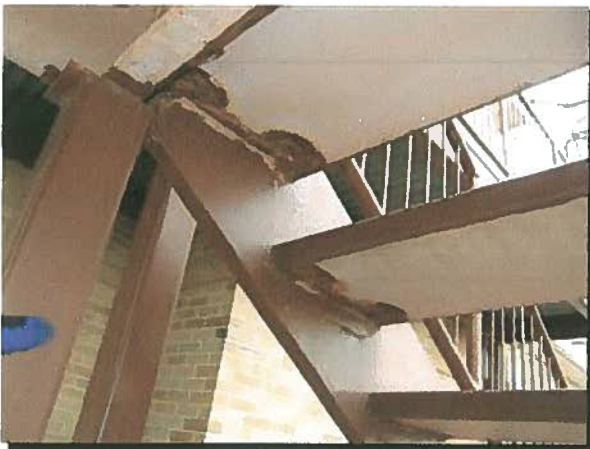
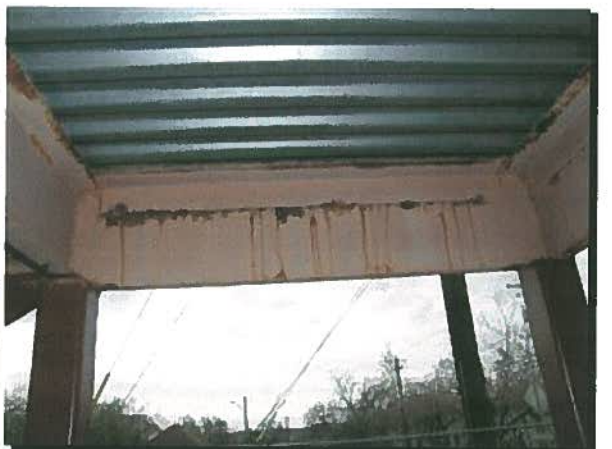
☒ Rear staircase has signs of rust and beginning corrosion. Recommend removal of rust and heavy application of rust prohibitive paint.

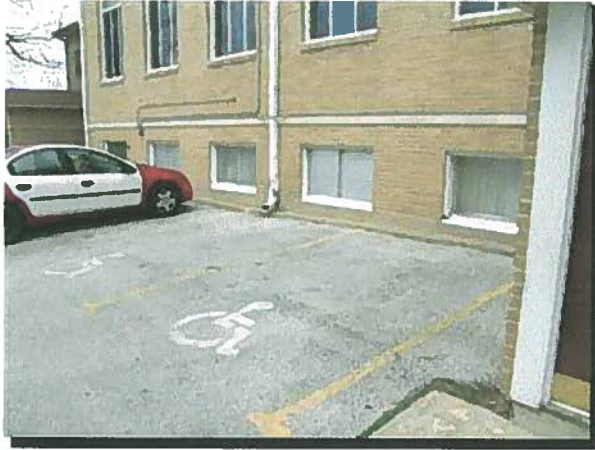
L. Picture 1

☒ Posts or parking stops are needed to prevent impact to building walls, windows and drainage systems at west location.

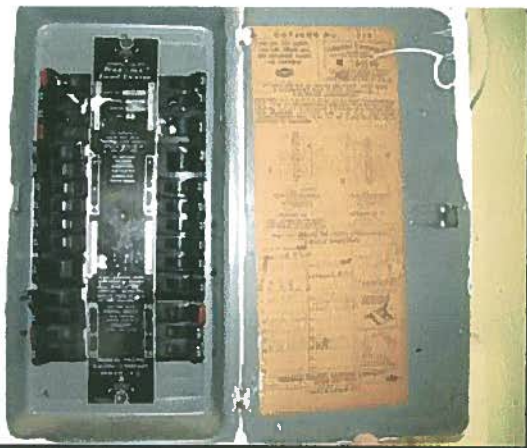
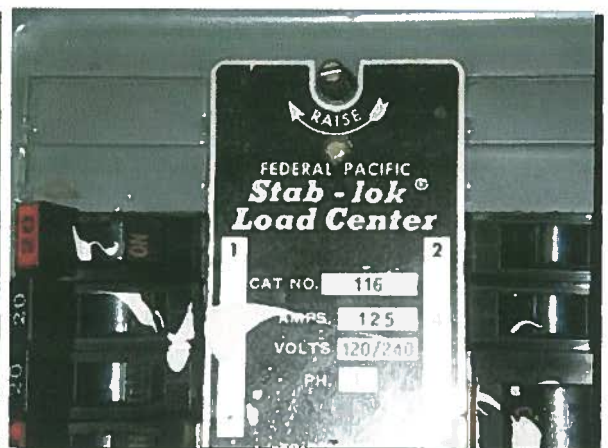
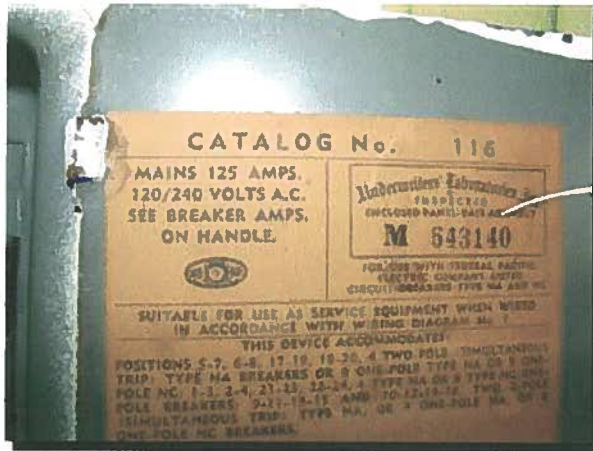
☒ Main service panel manufactured by Federal Pacific Electric (FPE). These panels have documented trip hazards and are no longer manufactured. Replacement of the panel or further evaluation by a licensed electrician is required.

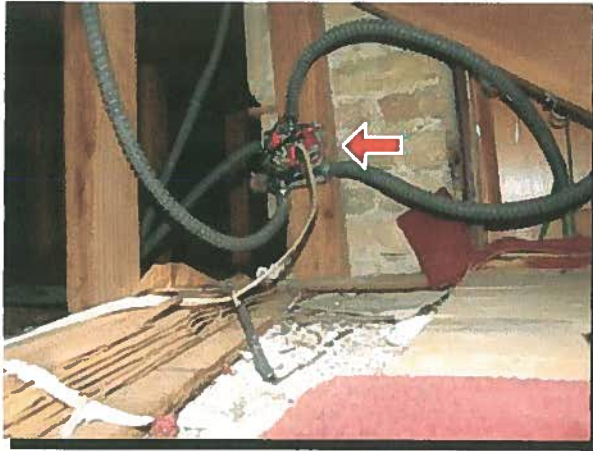
B. Picture 1 Under east tower staircase.

☒ Exposed connections, open boxes.

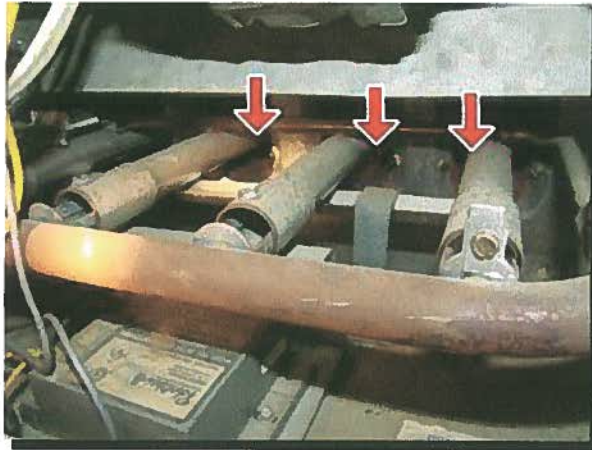
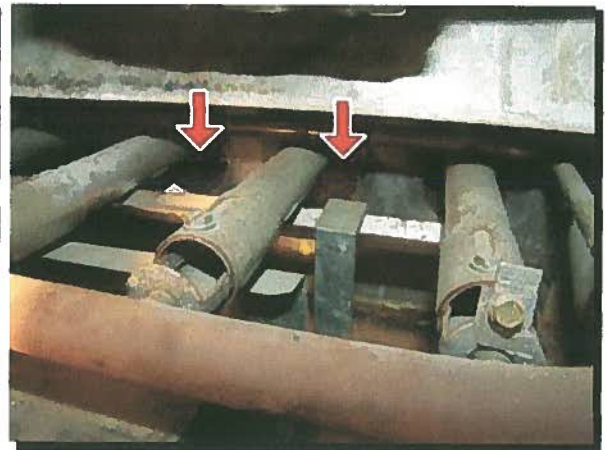
- ☒ Heat exchangers located kitchen area were highly corroded, do not appear safe. A licensed HVAC technician should evaluate for replacement.

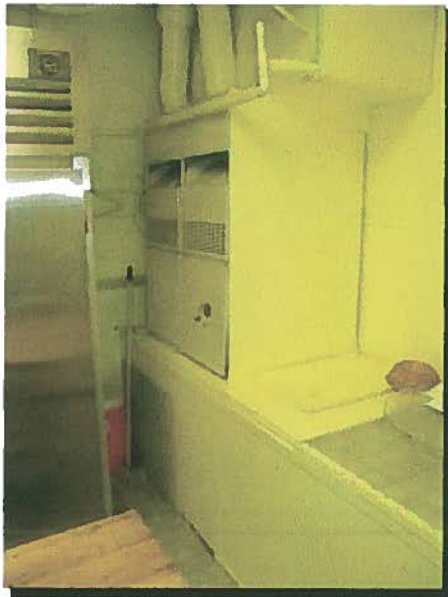
A. Picture 3

☒ Combustion air deficient. Current standards call for furnace combustion air to be provided from attic or exterior. Air vents from attic (2) should extend 12" from ceiling and 12" above base of closet floor for proper air circulation and supply.

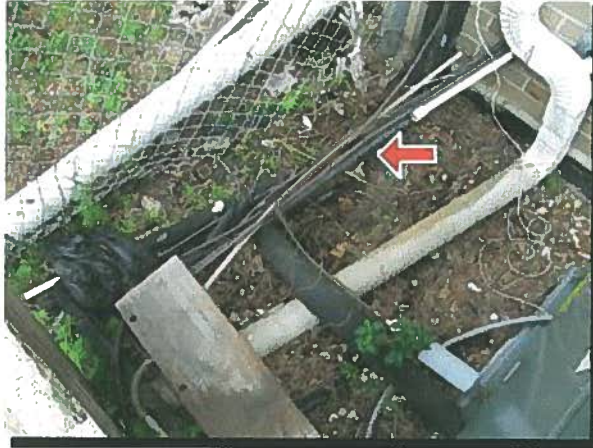
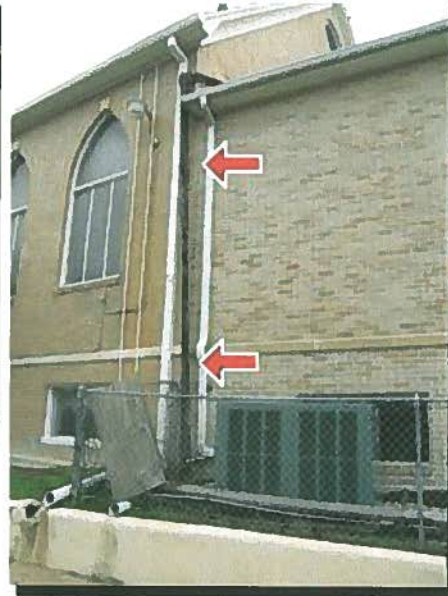
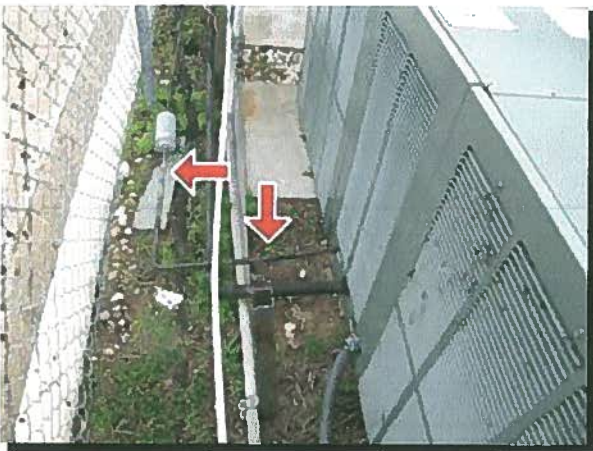
☒ Repair/replace insulation on refrigerant lines between building and condenser.

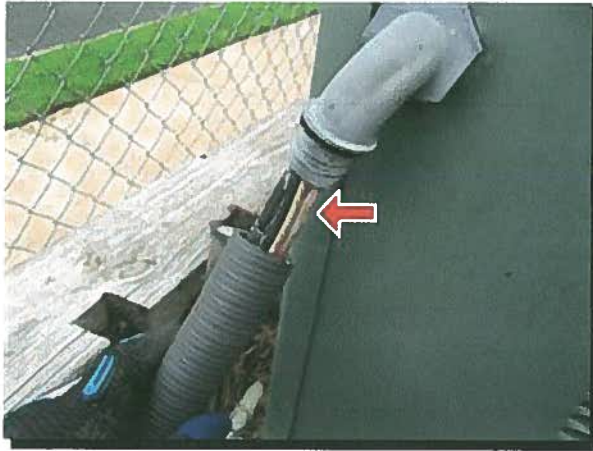
B. Picture 4

☒ Loose conduit at units. In need of repair.

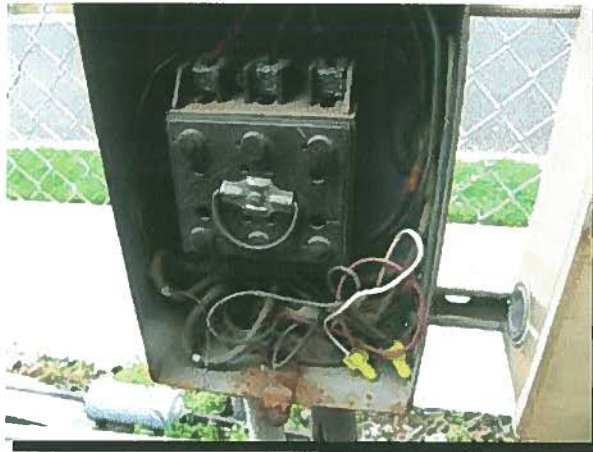
B. Picture 5

☒ Electrician should remove/repair hazardous connections made up inside emergency pull breaker panels at condenser units.

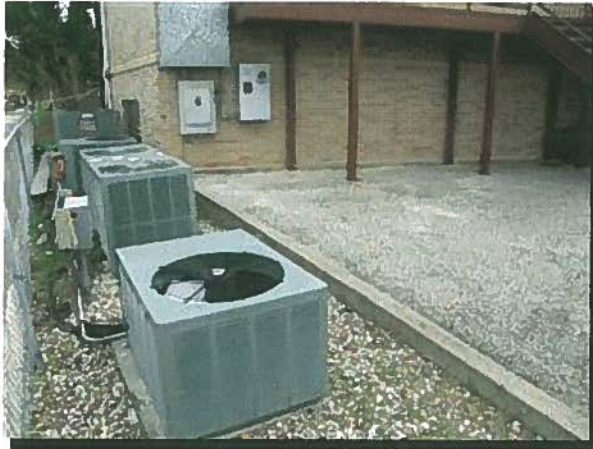
B. Picture 6

☐ Not required, but relocating HVAC units over to asphalt slab, away from pedestrian areas is recommended. This would allow units to be enclosed in protective cages to prevent from high incidence of theft of late. This would also make units more accessible and allow for removal of deteriorated scaffolding that is currently resting on coolant lines.

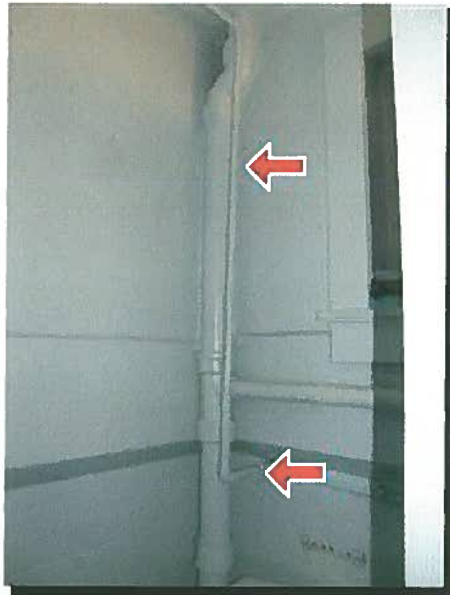
A. Picture 1

☒ Galvanized pipes observed in bath areas. These are known to corrode and clog over time, leading to failure. A licensed plumber should replace as needed.

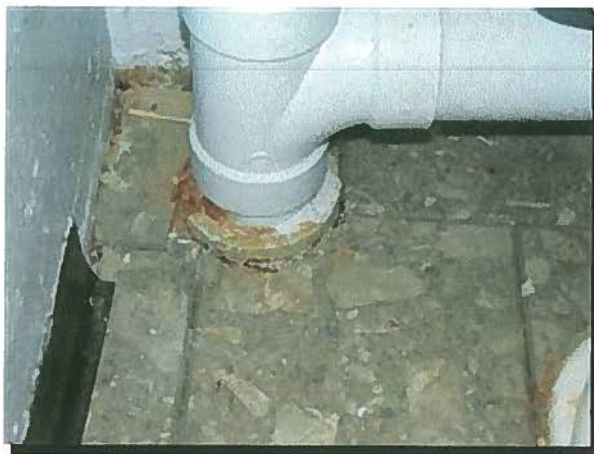
B. Picture 1

☒ The building has a combination of original cast iron and PVC drain lines. Note; cast iron drain lines are known to clog/leak overtime and may require periodic clean-out. No blockage noted at time of inspection.

A hydrostatic leak test is recommended to determine the presence of any subterranean leaks.

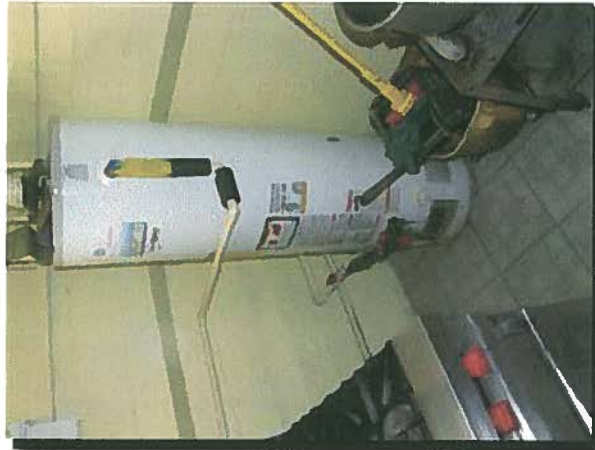
C. Picture 1

Unit was functioning normally at time of inspection.

- ☒ The Hot Water heater abuts to an interior wall and there is no emergency leak catch pan installed. Today's standards now require a catch pan that is plumbed to the exterior in locations where tank leaks could cause interior water penetration.
- ☒ Hot Water Heater is not elevated 18" above the basement floor as called for by today's standards
- ☒ Water supply lines are not properly insulated in the water heater closet.
- ☒ The hot water heater flue is not secured (sheet metal screwed) to the combustible draft bonnet
- ☒ Combustion air deficient. For interior installation of furnace type appliances, adequate combustion air should be supplied from exterior or attic spaces. Recommend weather strip appliance door, install air vents. Call Randal @ 922-5097 for information regarding standards, codes.

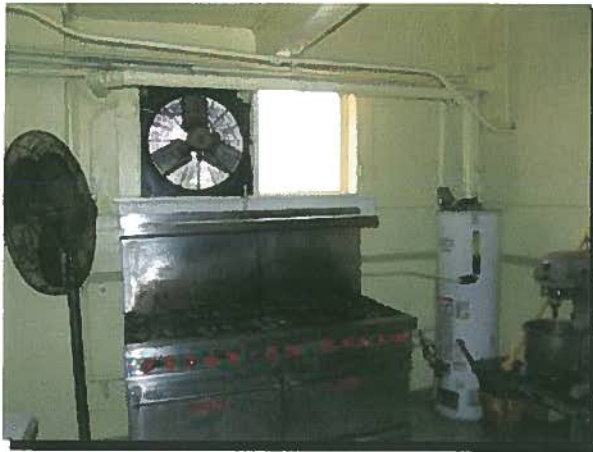
C. Picture 1

- ☒ No hood vent present as required, venting to exterior. Window to be sealed over, vent hood installed venting directly to exterior.

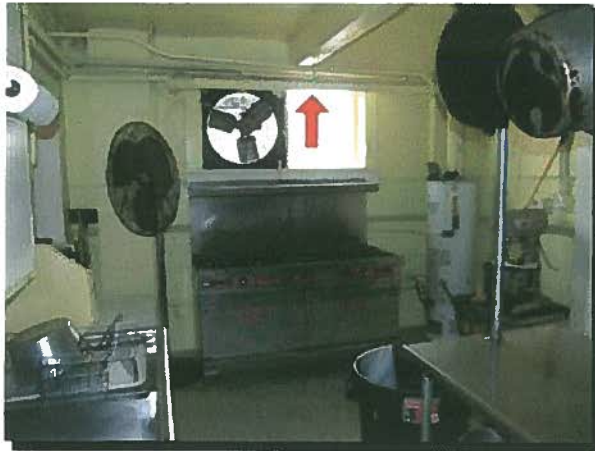
C. Picture 2

No automatic fire prevention devices installed as required by current standards.

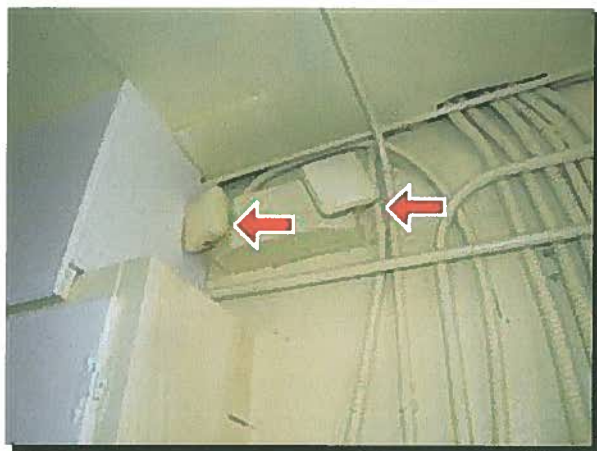
I. Picture 1

☒ Some basement emergency lights had been painted over. These require replacement.
